Property address

Date of inspection

26th June 2017

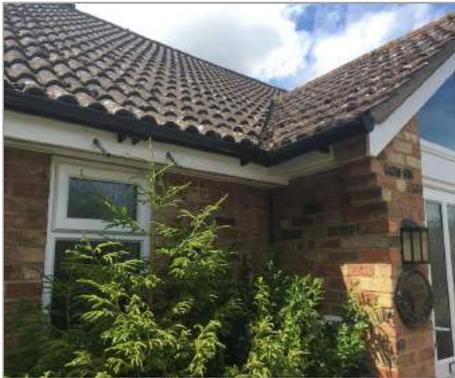
Photo - 4

The verge requires clearing out of moss and other potential obstructions. The verge to the projecting gable roof requires repointing.

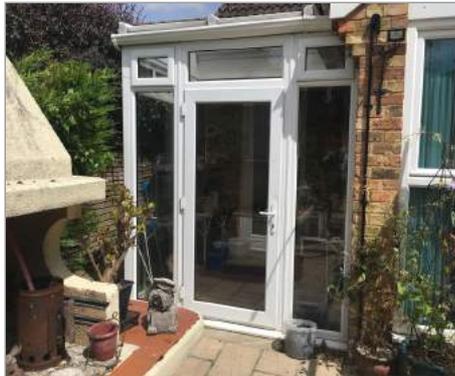
Photo - 11

One of the top panes of the conservatory requires replacement as the seal has gone.

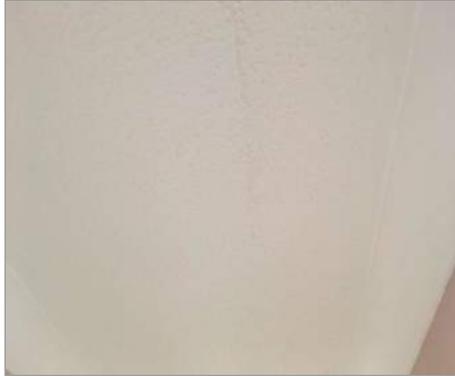
Photo - 20

In the rear end bedroom with the built in wardrobes there was evidence of a patched up crack with bulging. The crack appears to be straight and is believed to be due to poor fixing of boards or contraction and expansion at board edges. There is a water tank and cylinder in the loft so it is possible that they or possessions in the roof space have overloaded this area of ceiling.

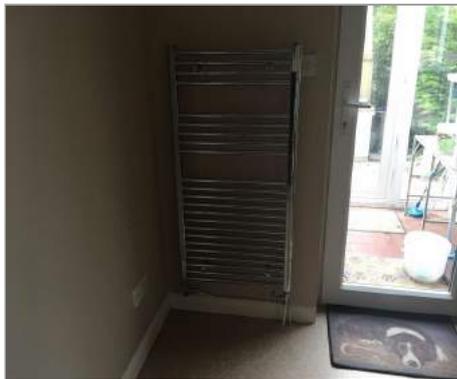
Photo - 53

The heating system comprises oil fire boiler, radiators throughout and wall mounted thermostat. In addition in the living room is a solid fuel burning appliance within the fireplace. 3

In the absence of certification surveyors have to give designation three to this item.

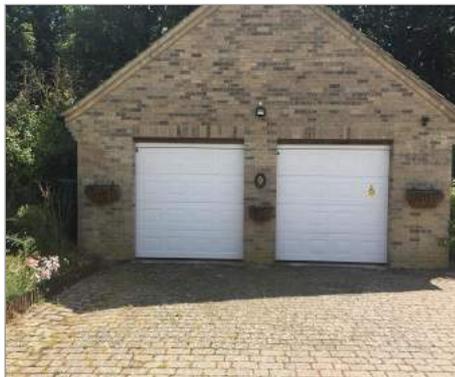
Photo - 63

The garage appears to be in fair condition with all rainwater goods, soffits and fascias being UPVC however, repointing is required to the roof verge in places. The rear and side on the boundary could not be inspected.
