***FAILURE  
ANALYSIS  
CASE  
STUDIES II***

Edited by  
**D.R.H. Jones**

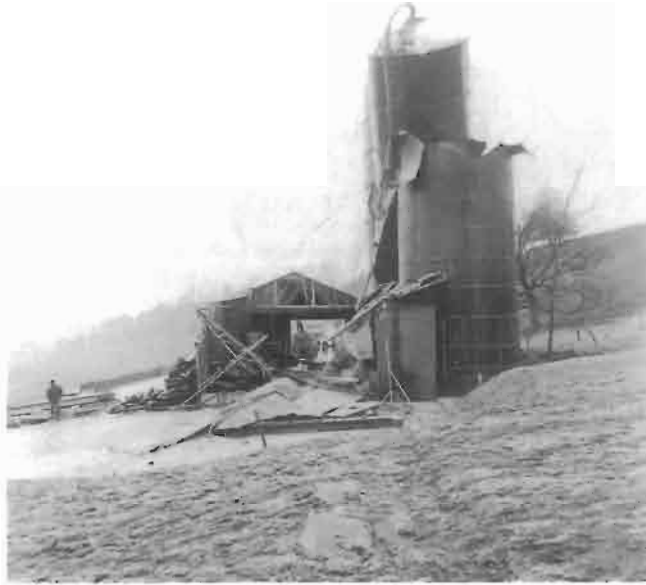
Fig. 1. Damaged silos: view of the site.

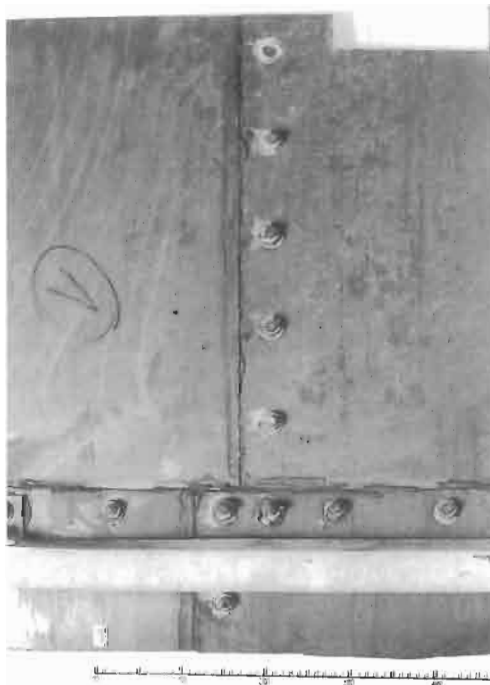
Fig. 2. Bolted joints of the sheets used for the silo. In the lower part, a reinforcement ring was attached.

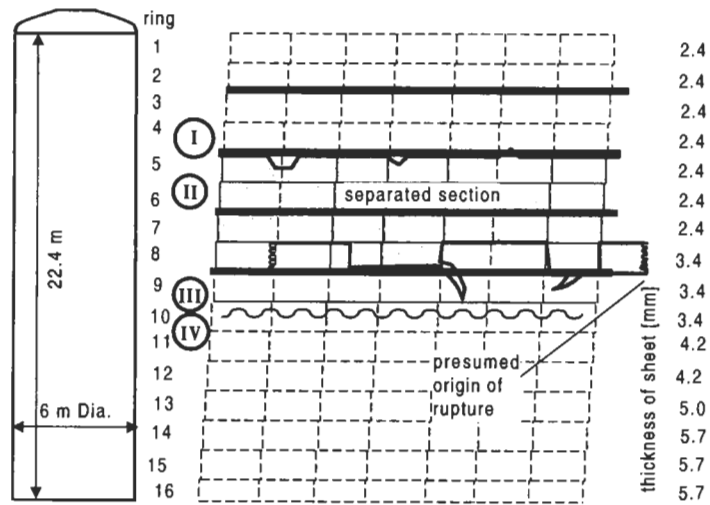
Fig. 3. Schematic drawing of the silo, showing the location of the rupture: (I) level theoretically necessary for bursting by hydrostatic pressure; (II) level for filling with 407 t; (III) permissible filling for density of  $1.05 \text{ kg l}^{-1}$ ; (IV) level after bursting.

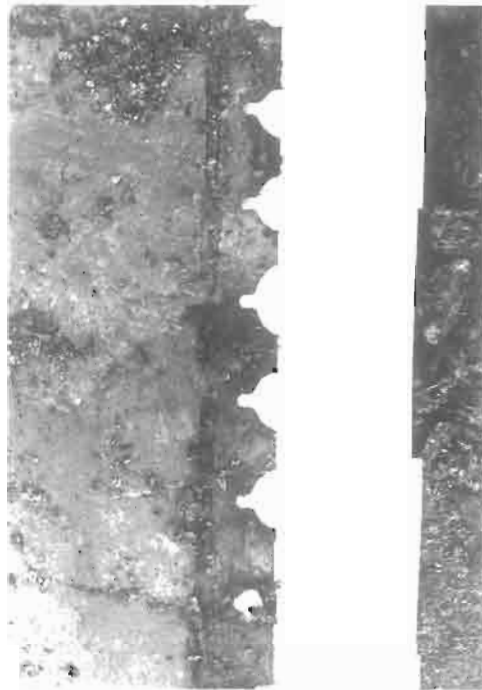
Fig. 4. Longitudinal bolted joint, presumably at location of start of rupture.

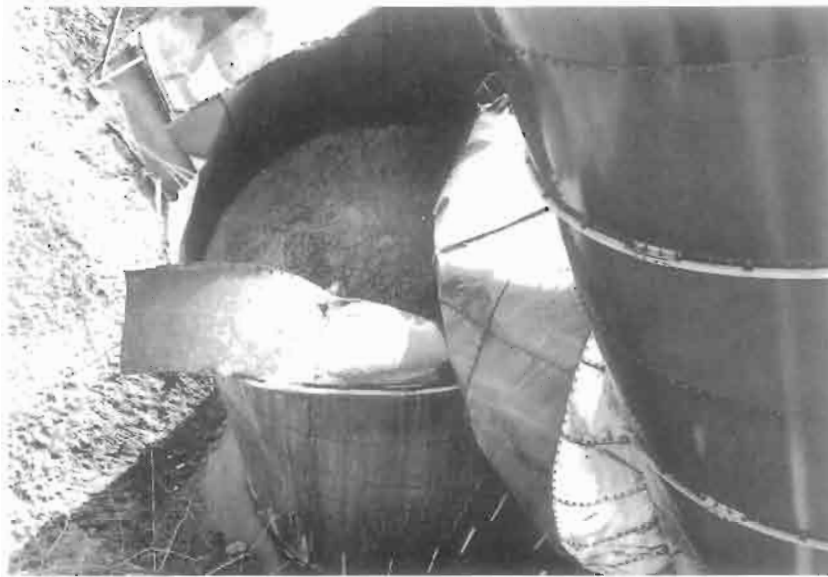
Fig. 5. Top view of failed silo, showing remaining filling level.

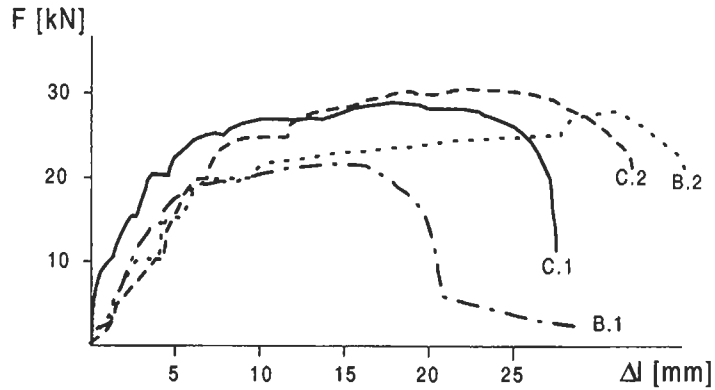
Fig. 7. Behaviour of bolted joints in tension tests.

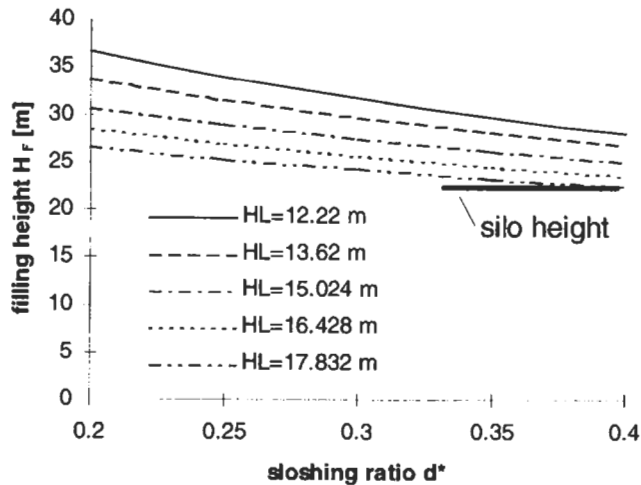
Fig. 9. Filling height of the silo necessary to produce the observed spurting distance, assuming different sloshing ratios  $d^*$  and different levels  $H_L$  for the initial leakage.

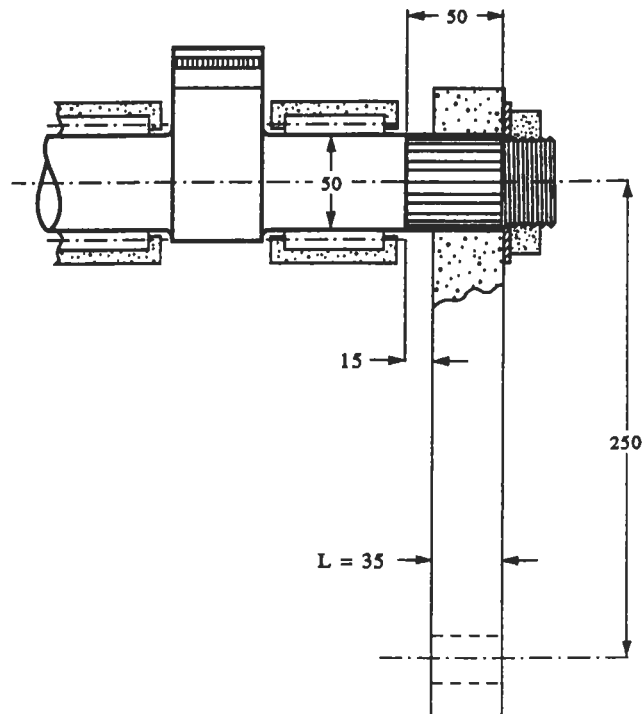
Fig. 1. Side view of the steering shaft. Dimensions in mm.

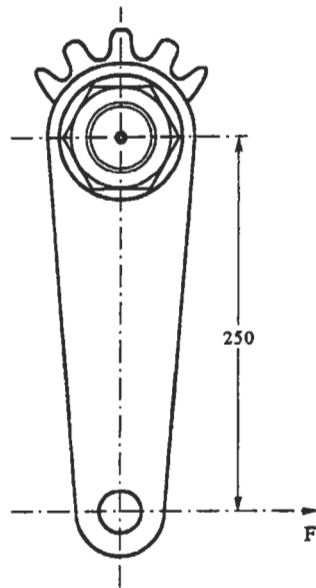
Fig. 2. End view of the steering shaft. Dimensions in mm.

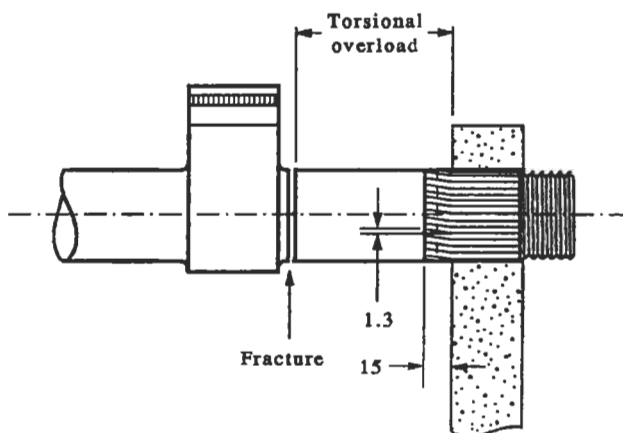
Fig. 3. Side view of the shaft, showing the plane of the fracture and the region of torsional overload. Dimensions in mm.

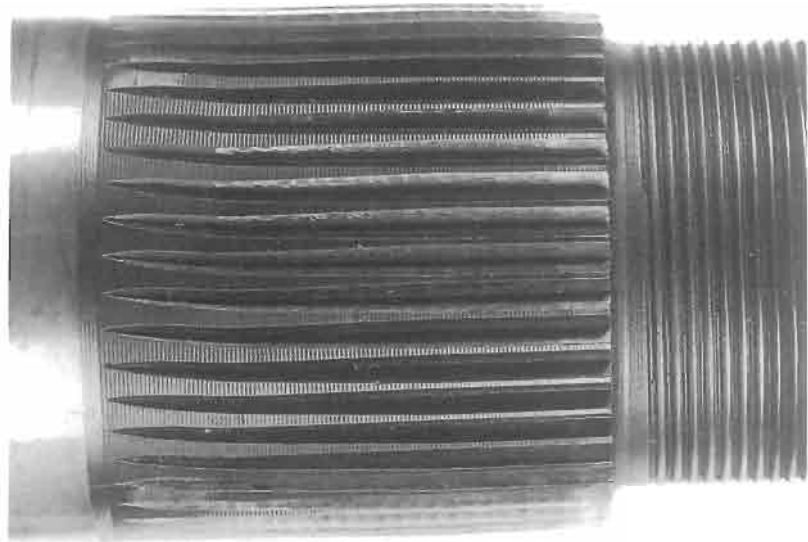
Fig. 4. Photograph of the splined section of the steering shaft, showing the twisted splines.

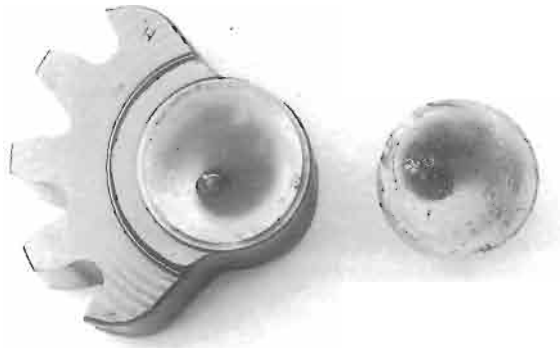
Fig. 5. Photograph of the matching fracture surfaces.

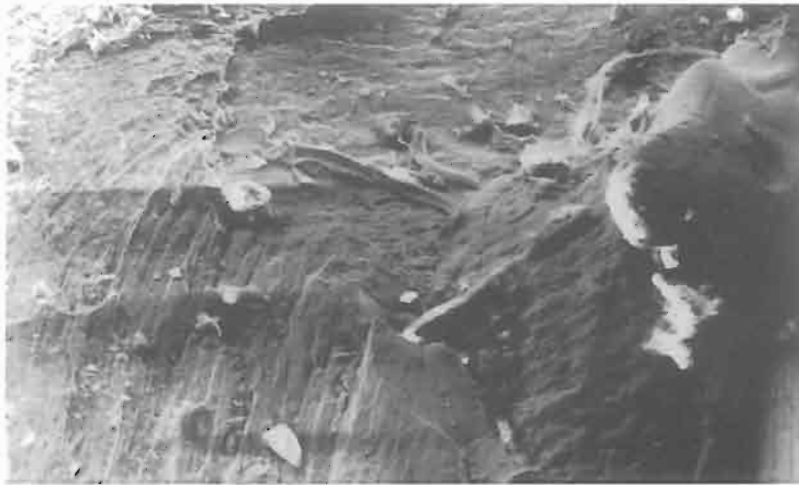
Fig. 6. Scanning electron micrograph taken from the shear part of the failure. Magnification: 153 times.

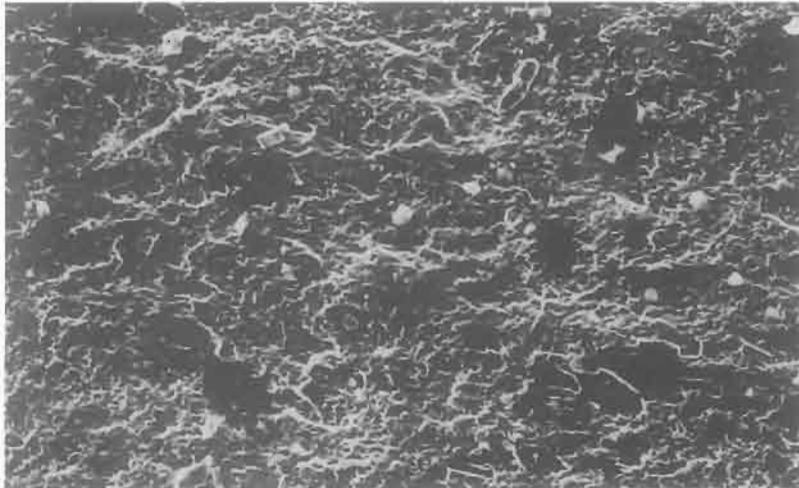
Fig. 7. Scanning electron micrograph taken from the fibrous part of the failure. Magnification: 292 times.

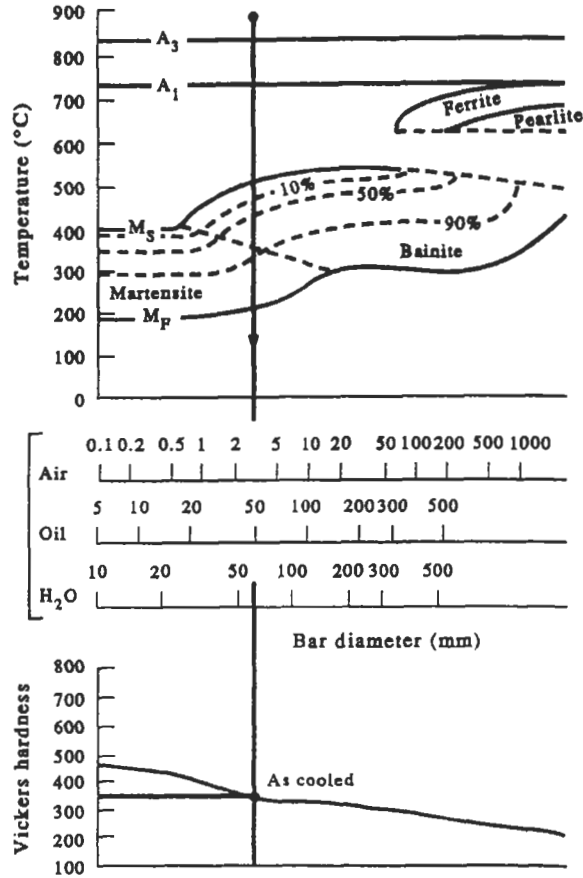
Fig. 9. Continuous cooling transformation diagram for the steel of the shaft [2]. Before quenching, the samples were first heated at 900 °C for 4 h.

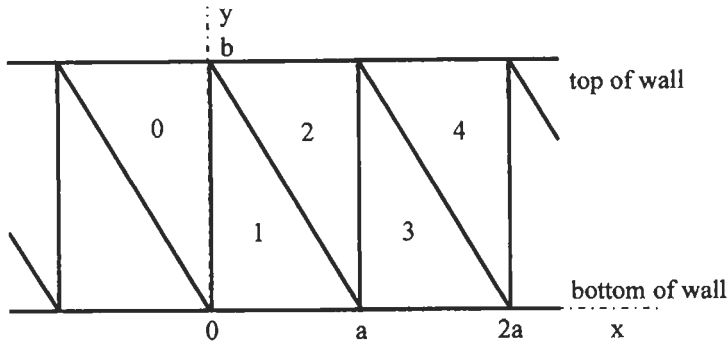
Fig. 3. Elevation and reference axes.

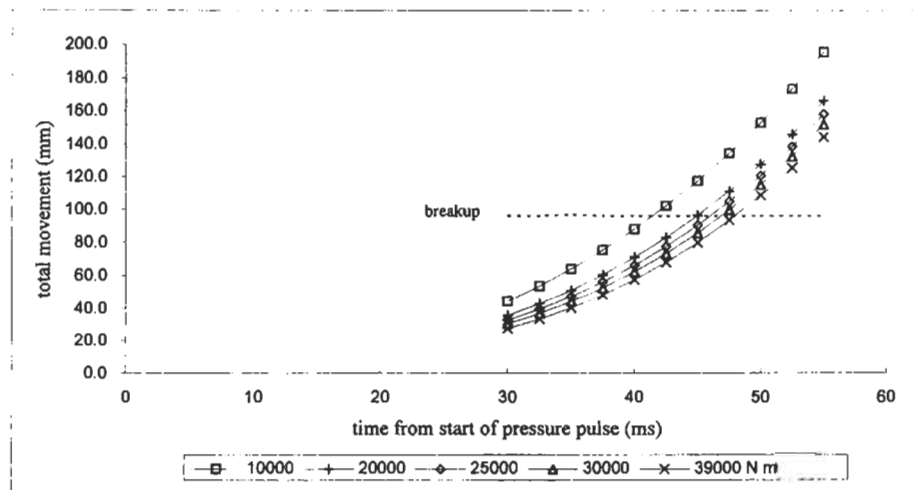
Fig. 6. Elastic-plastic analysis: movement at centroid as function of  $D$ .

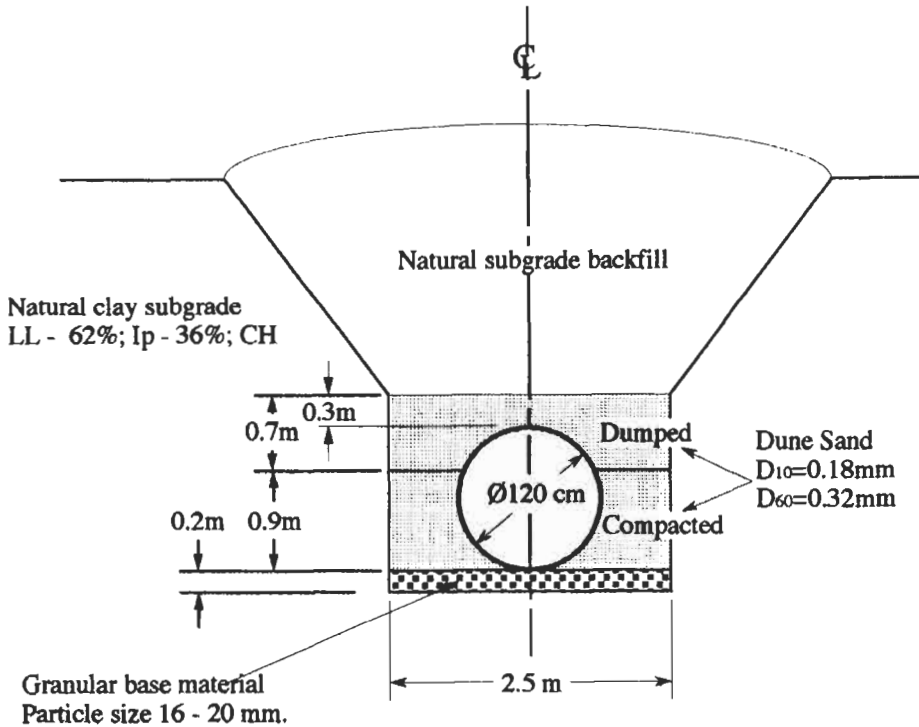
Fig. 1. Typical design section of the trench-pipe system.

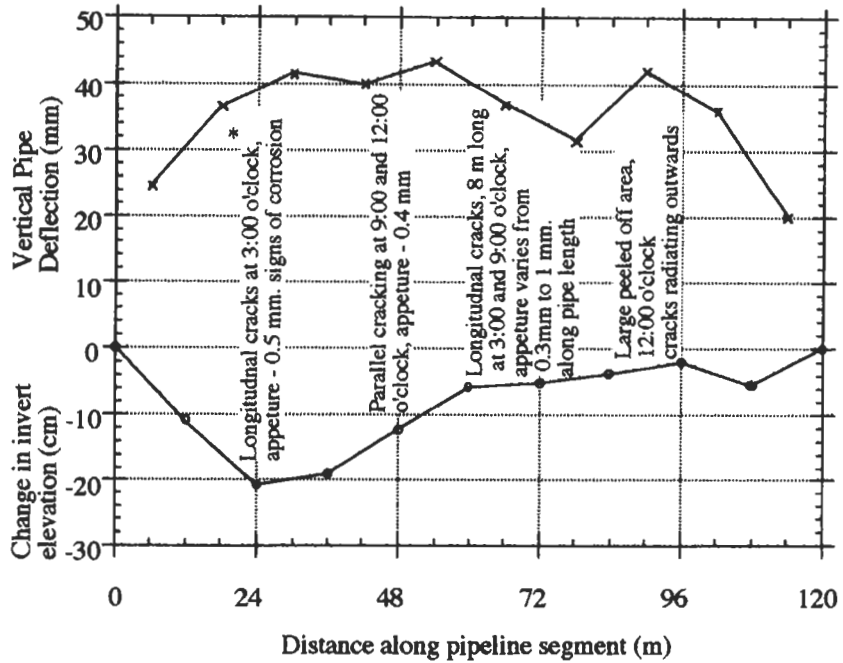
\* examples of damage description from along pipe segment AA11-AA12

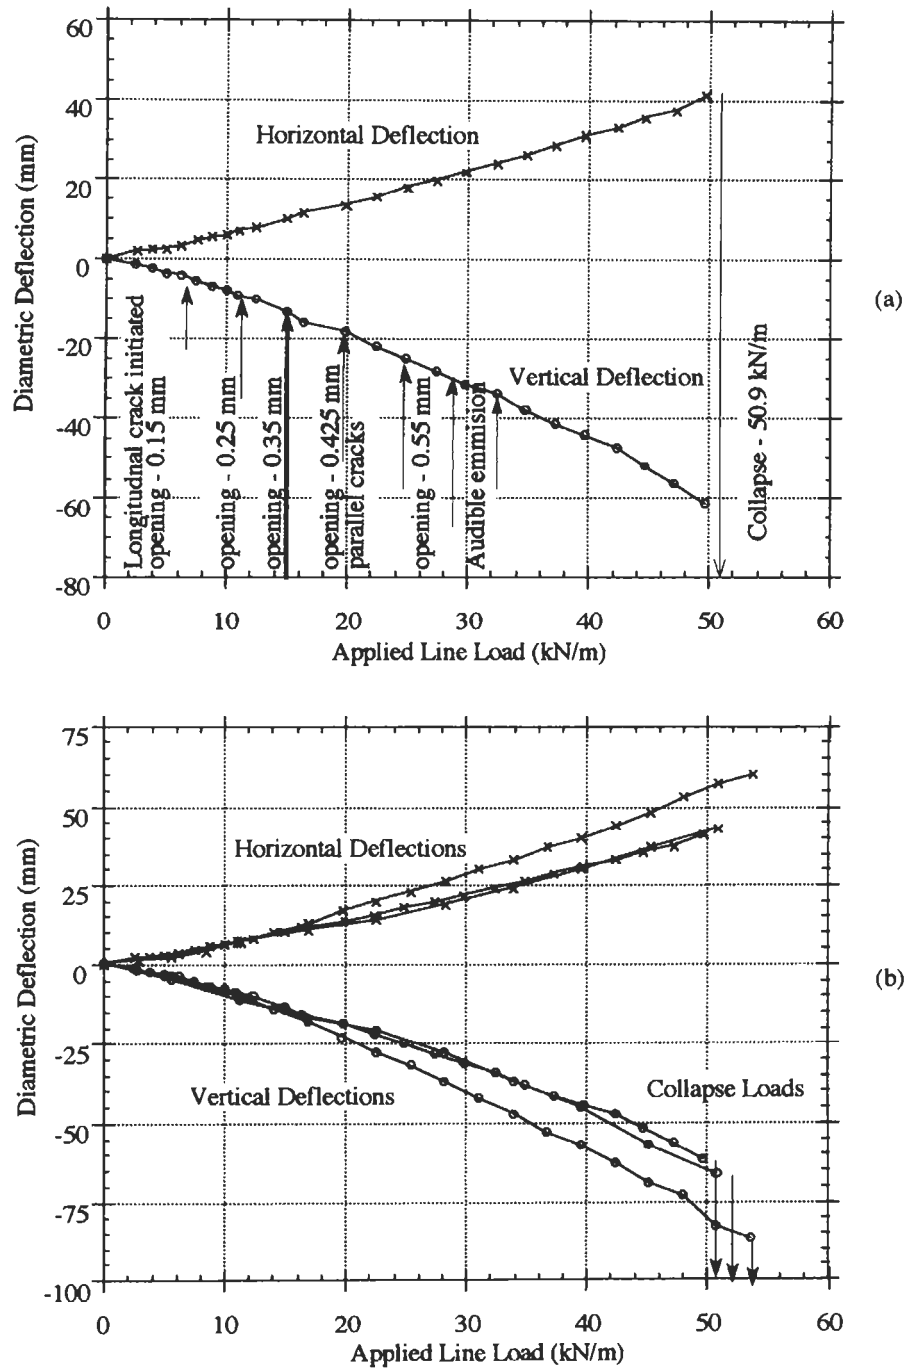
Fig. 3. Pipe load-deformation tests: (a) including damage observations, (b) comparison of results for three sections tested.

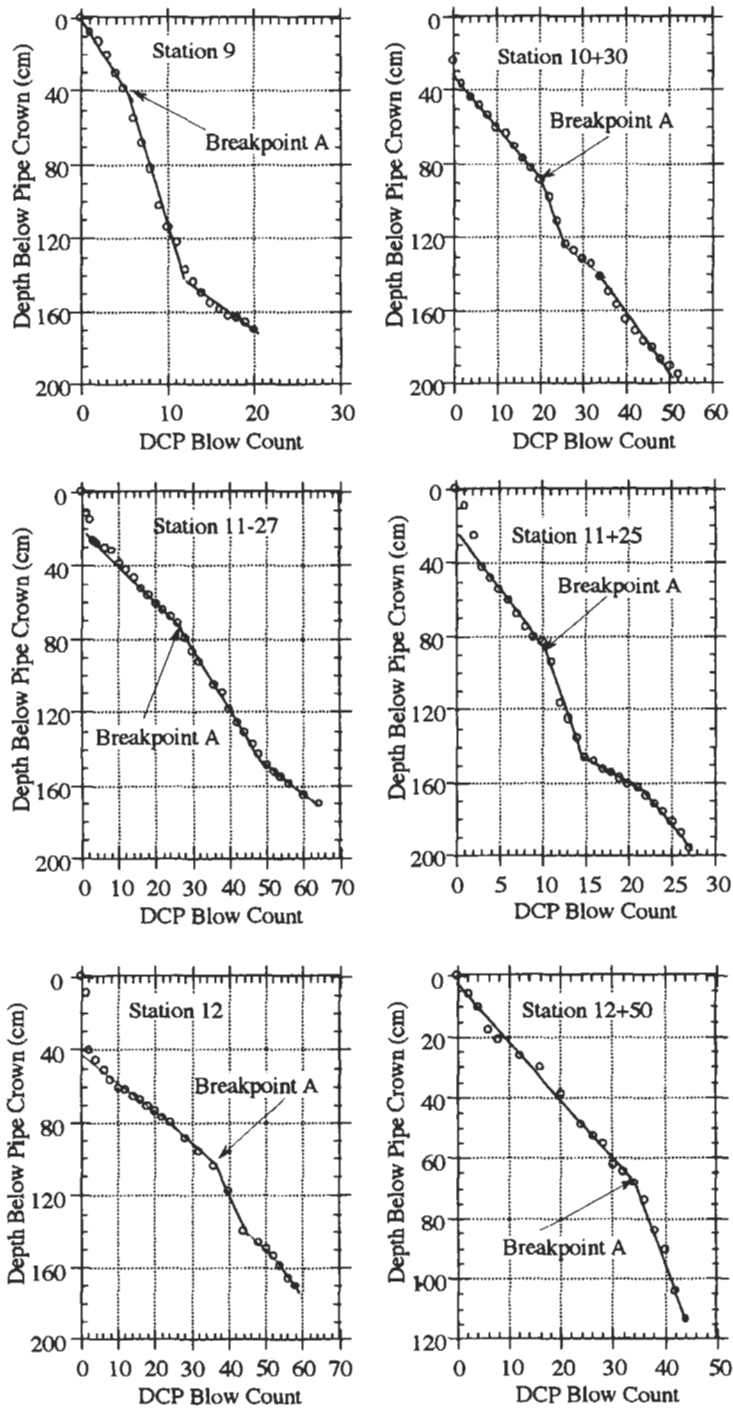
Fig. 4. DCP sounding data.

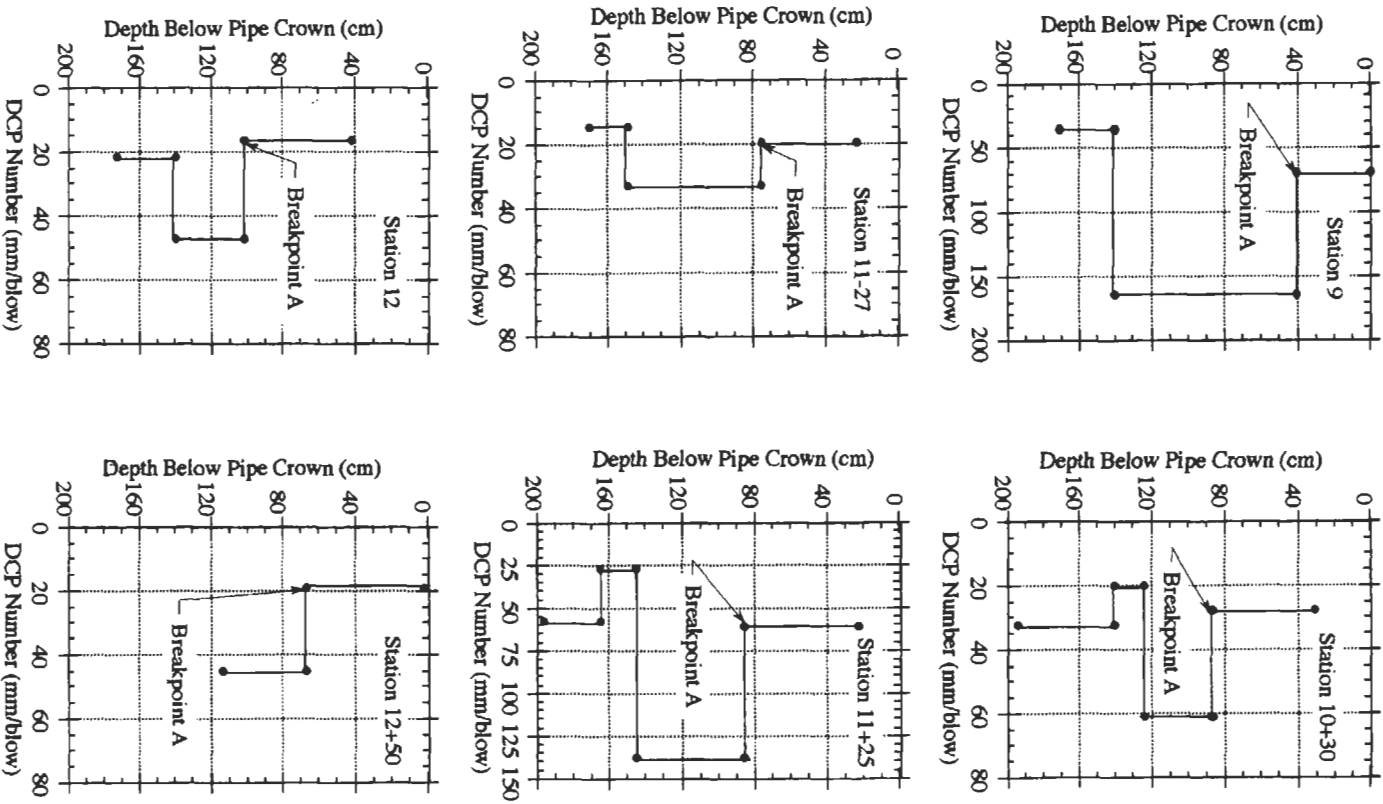
Fig. 5. DCP number versus depth profiles.

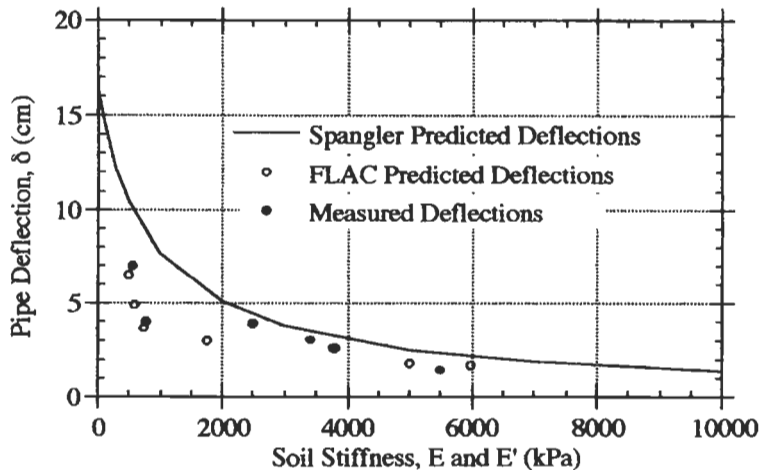
Fig. 8. Pipe deflection vs side backfill stiffness.

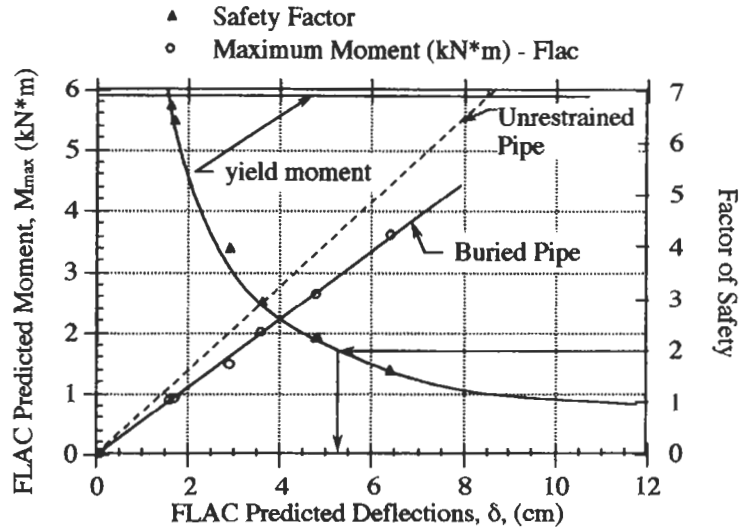
Fig. 10. Maximum moment, safety factor, deflection plot.

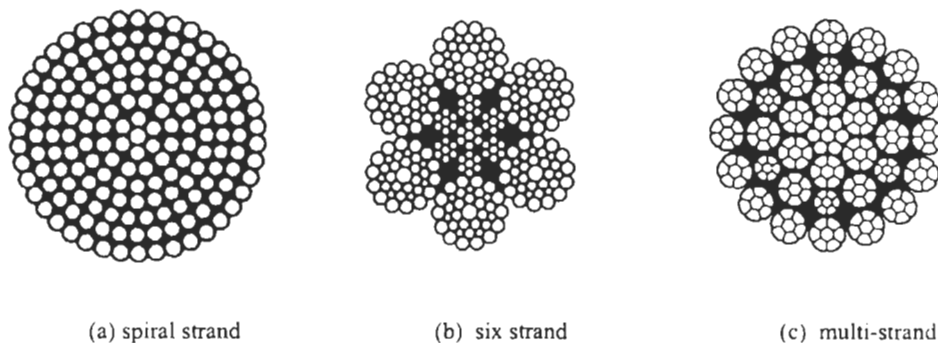
Fig. 1. Typical rope constructions.

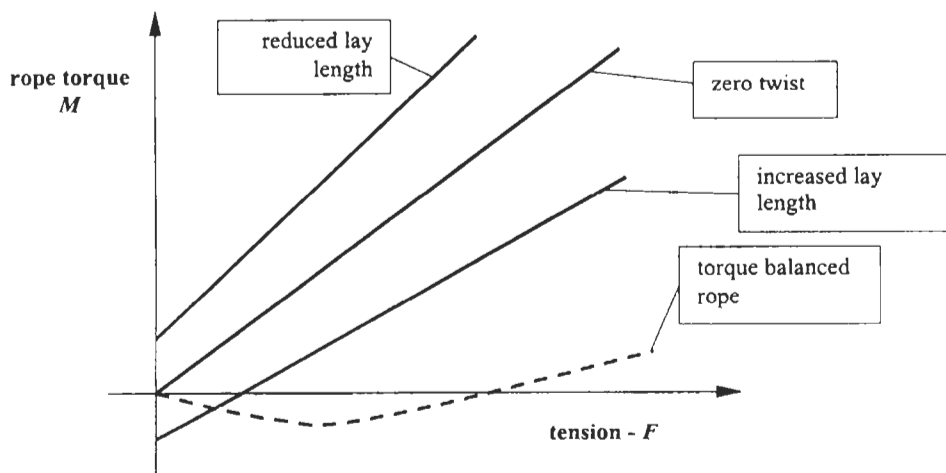
Fig. 2. A schematic representation of axial torque as a function of rope tension showing the characteristics typical of six strand rope (as manufactured, twisted up, and untwisted), and a nominally torque balanced rope for comparison (the dashed line).

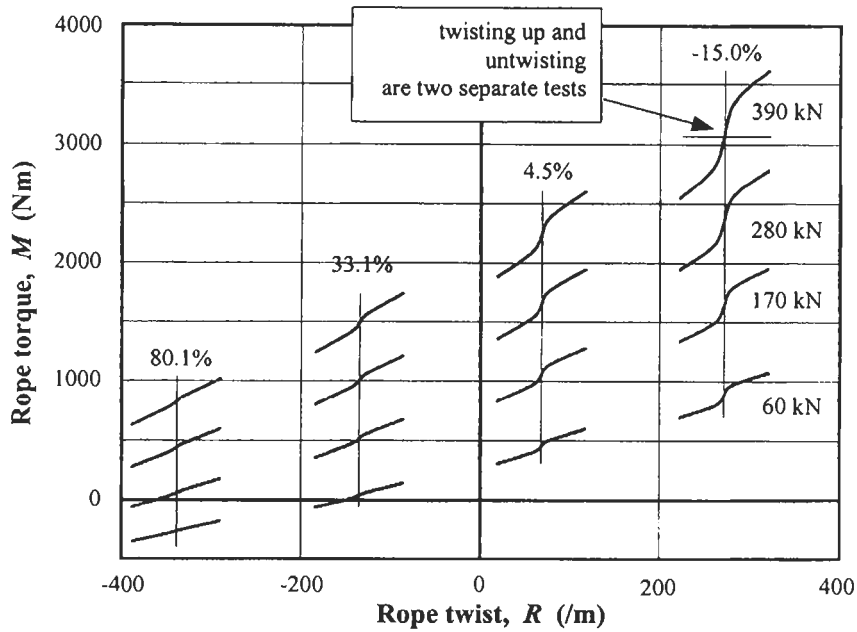
Fig. 3. Results of series of torsional tests at constant tensile loads on 46 mm triangular strand Lang's lay rope, from Rebel [7].

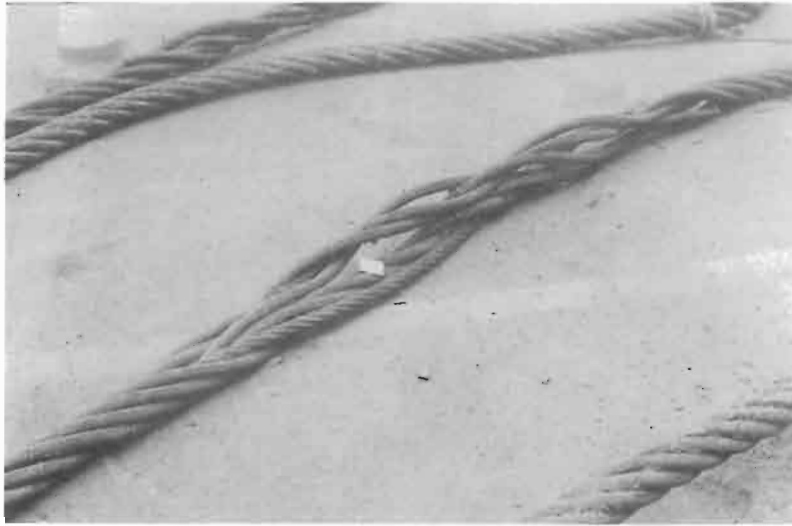
Fig. 4. Destraining of a six strand mooring rope.

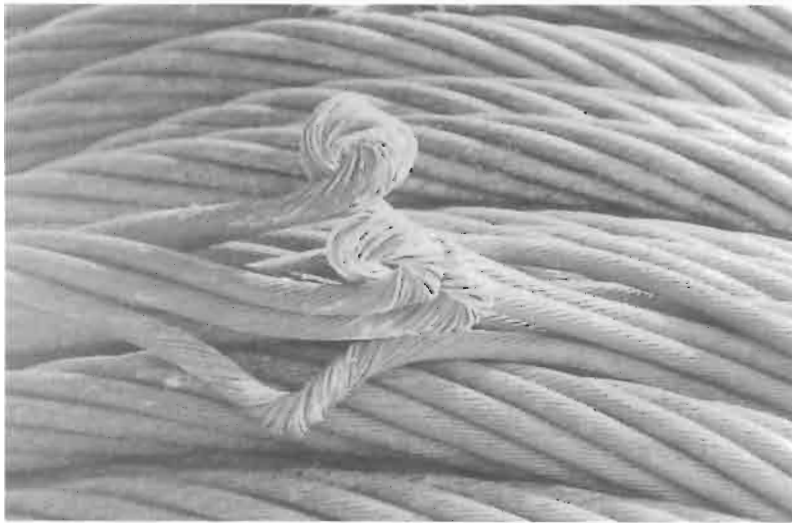
Fig. 5. Hockles formed in the individual strands of an eight strand work wire.

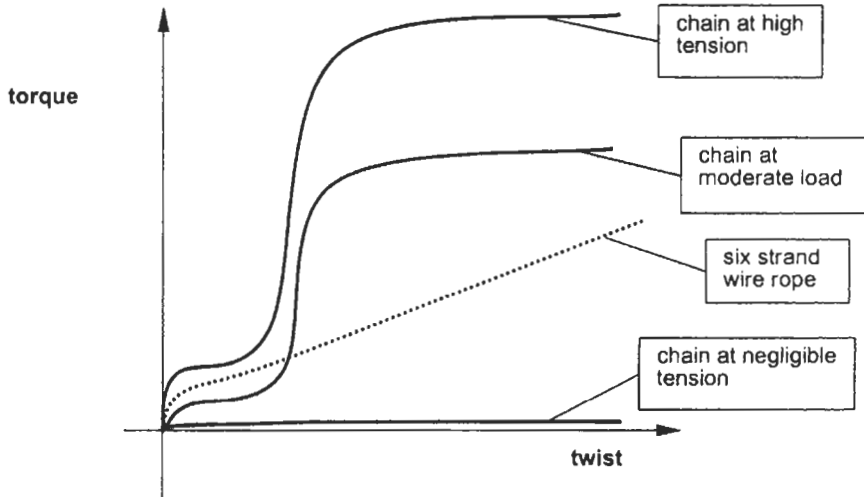
Fig. 6. Schematic representation of the proposed torsional behaviour of chain as a function of tensile load, compared with a six strand wire rope.

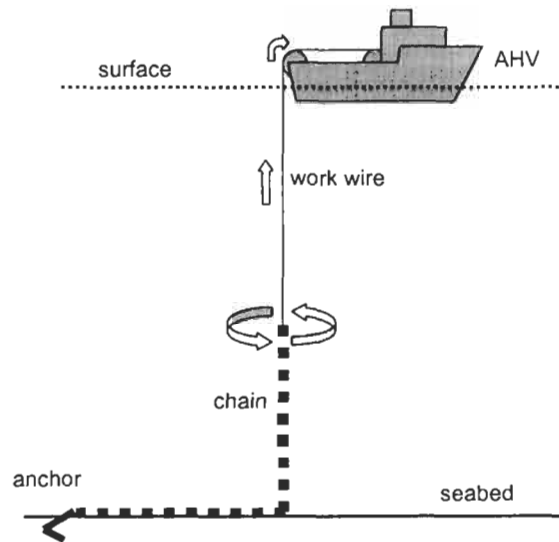
Fig. 7. Schematic representation of anchor handling vessel (AHV) lifting the anchor chain with six strand wire rope 'work wire'. The increasing tension as more chain is lifted causes rotation at the point of connection between rope and chain, the turns accumulating in the chain at zero tension on the seabed.

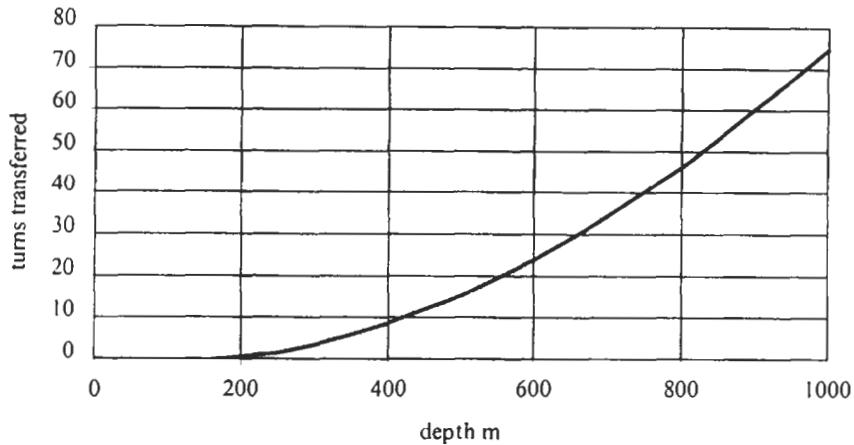
Fig. 9. Number of turns transferred from the chain when tensioned as a function of water depth.

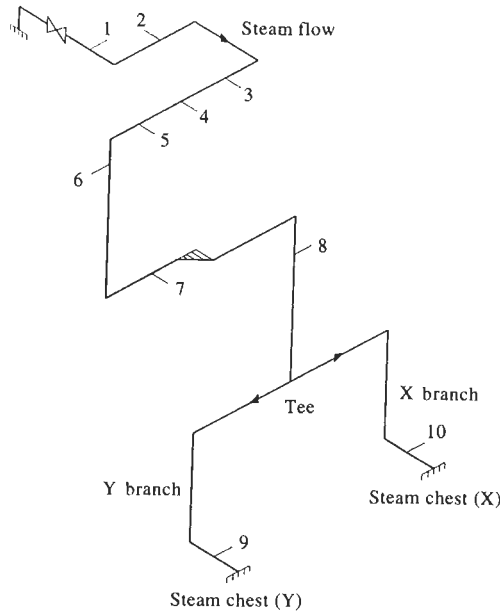
Fig. 1. Path of the pipe from the secondary superheater outlet header to the two steam chests. The numbers 1, 2, 3 etc. refer to hanger sites.

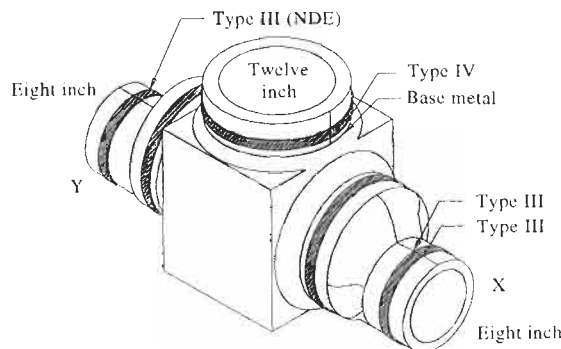
Fig. 2. At the forged tee, steam enters through the 12 in. line, and divides into two streams, along the 8 in. lines. Sites where creep cracking was found are labelled type III, base metal, or type IV, according to the sort of cracking found there.

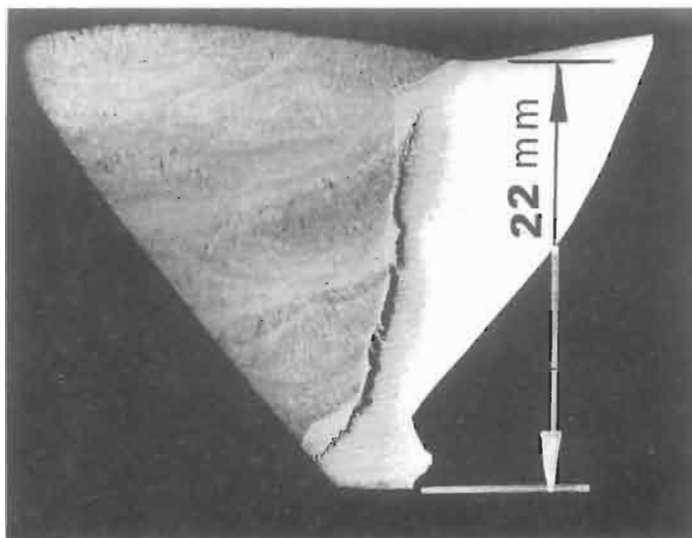
Fig. 3. Section through the cracking whose discovery prompted this investigation. It is in the 8 in. line on the X side of the tee. The cracking extended from the bore to a spot 90% through-wall. The cracking ran through the inner part of the HAZ. (Nital etch, bright field.)

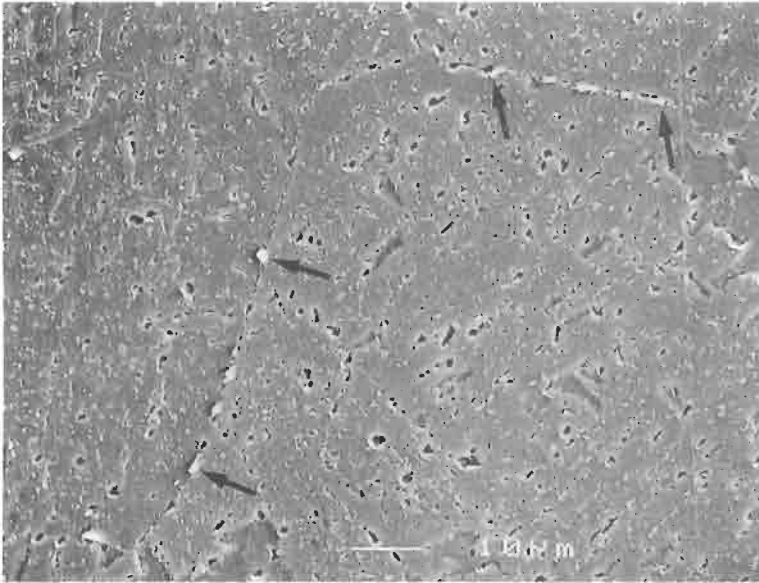
Fig. 4. Photomicrograph from a replica taken on the outside surface of the reducer to 8 in. pipe weld on the X side of the tee. It shows aligned voids along grain boundaries in the pipe side HAZ of the weld. This is the most advanced stage of creep damage that was seen on the outside surface of the 8 in. pipe. It is the stage that would immediately precede microcracking. (Nital etch, cellulose acetate replica, scanning electron micrograph.)

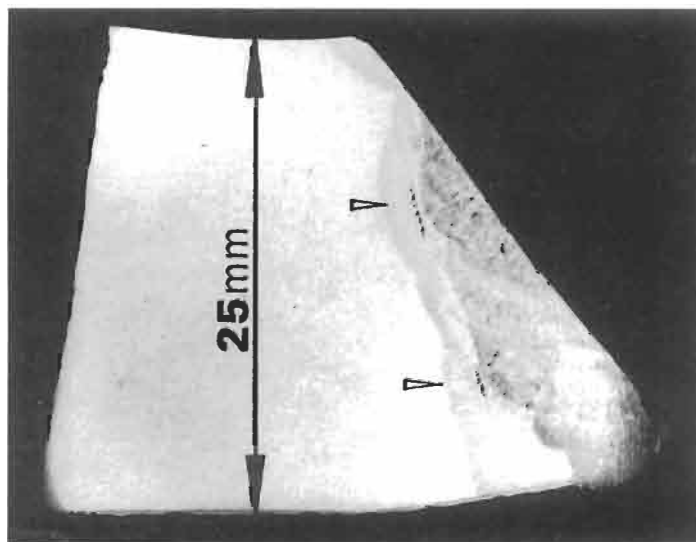
Fig. 6. Section through the X side of the reducer to pipe weld. The two arrows indicate small clusters of creep cracks. They are in coarse-grained parts of the HAZ. (In this case, the HAZ is the reducer HAZ. In Figs 3 and 5, the cracked HAZ was the 8 in. pipe HAZ.) (Nital etch, bright field.)

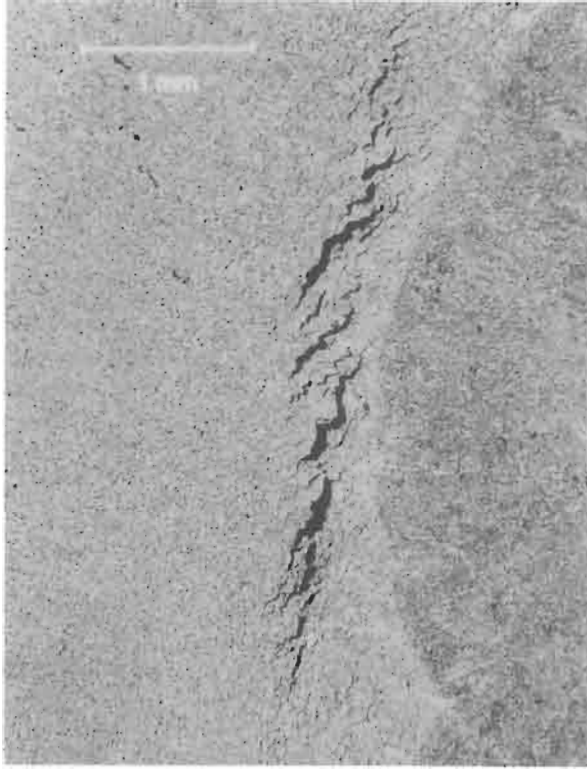
Fig. 7. One of the clusters of cracks in the HAZ on the reducer side of the weld joining the X-side reducer to the 8 in. pipe HAZ. The whole cluster is about 3.8 mm top to bottom.

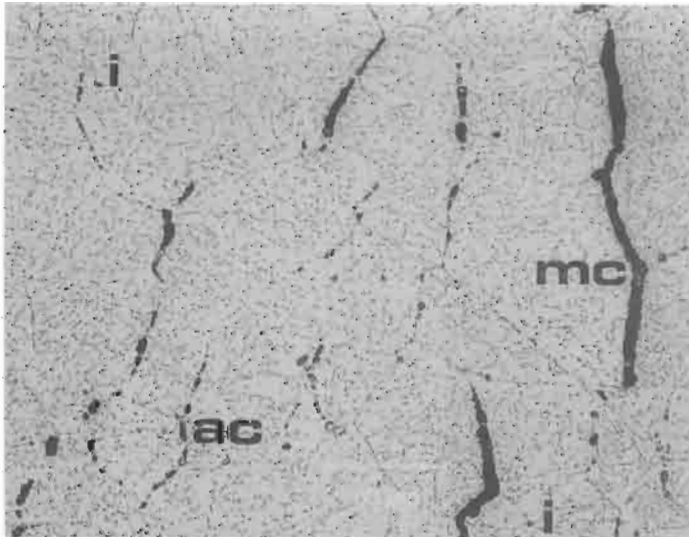
Fig. 8. This is close to one of the clusters of cracks in the reducer's HAZ. There are isolated grain boundary cavities, *i*, aligned groups of cavities, *ac*, and microcracks produced by the coalescence of aligned groups, *mc*. These are three stages in the progressive generation of creep cracks. (As in Figs 5-7, this is a coarse-grained region of the HAZ.) (Nital etch, bright field.)

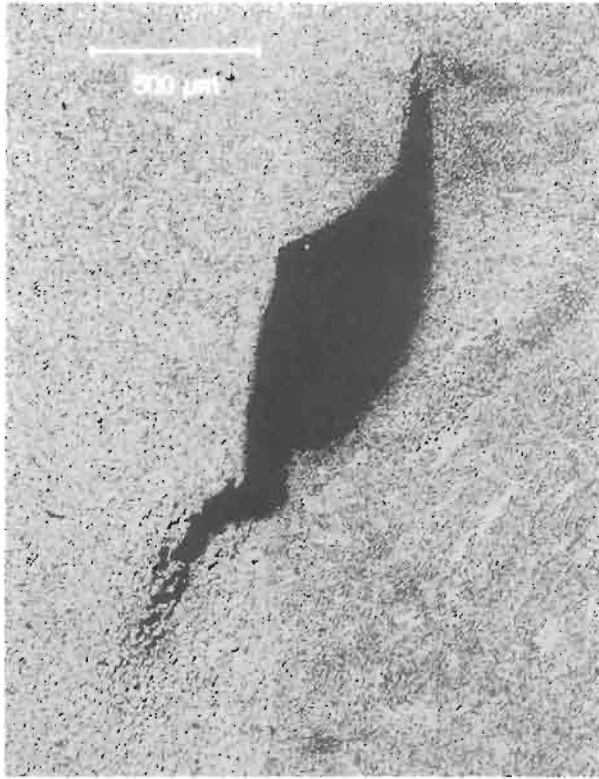
Fig. 9. This lack-of-fusion/slag flaw on the fusion line had extended about 500  $\mu\text{m}$  by creep. Where it grew into the HAZ, it grew into fine-grained material, and there was a very high density of creep rupture voids. (The darker material on the right is weld metal.) (Nital etch, bright field.)

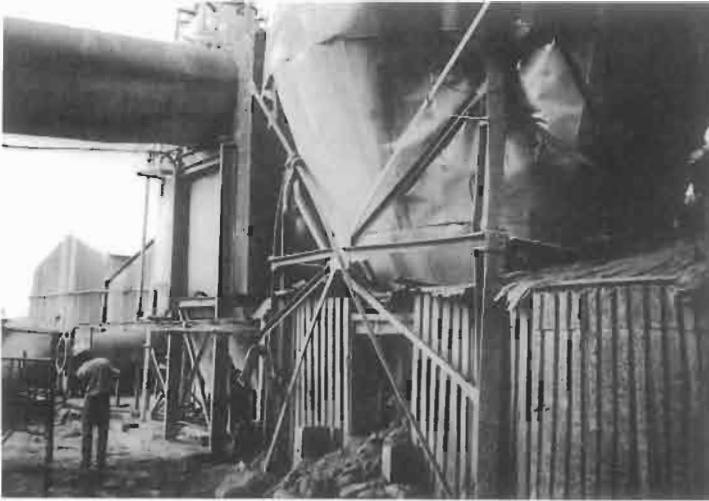
Fig. 1. View of base of collapsed drier.

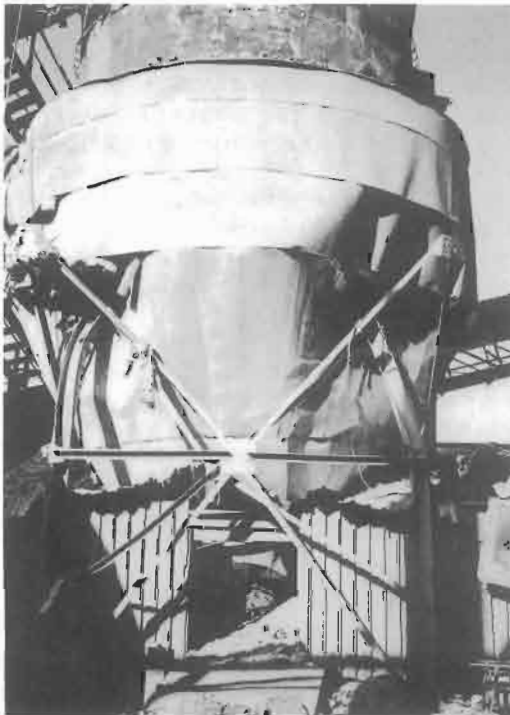
Fig. 2. View of base of collapsed drier.

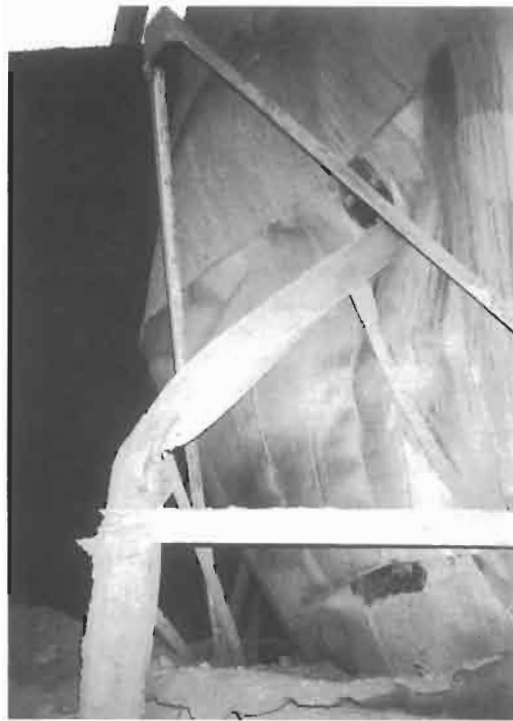
Fig. 3. View of buckled column.

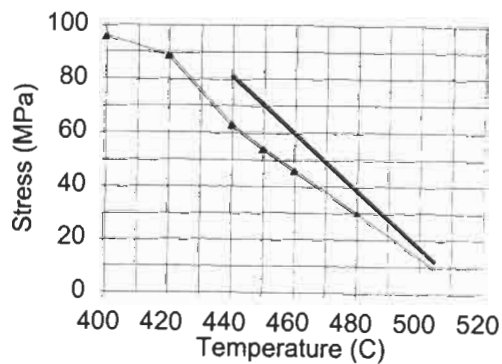
Further, extrapolation for temperatures  $>480^{\circ}\text{C}$  is necessary. There is a justification for using

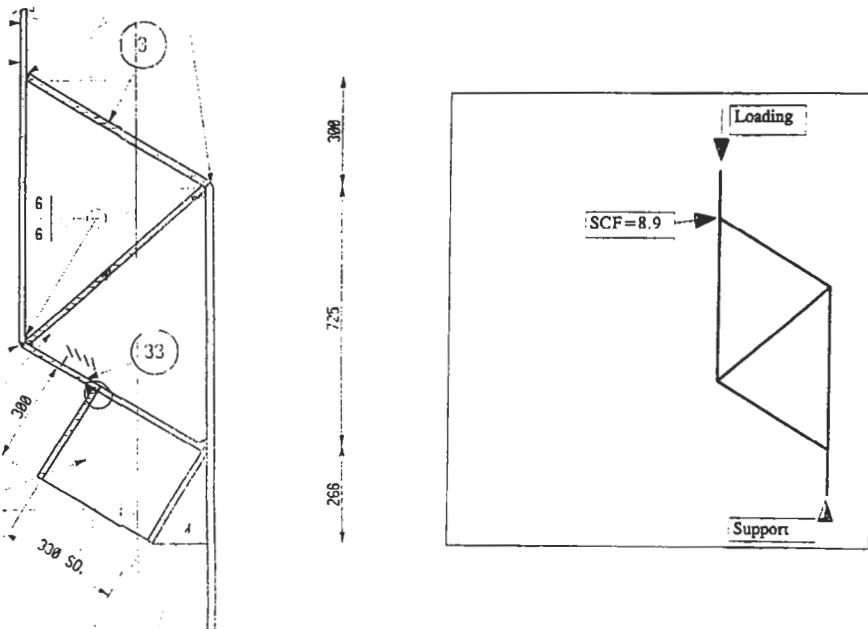
Fig. 5. Gas duct cross-section.

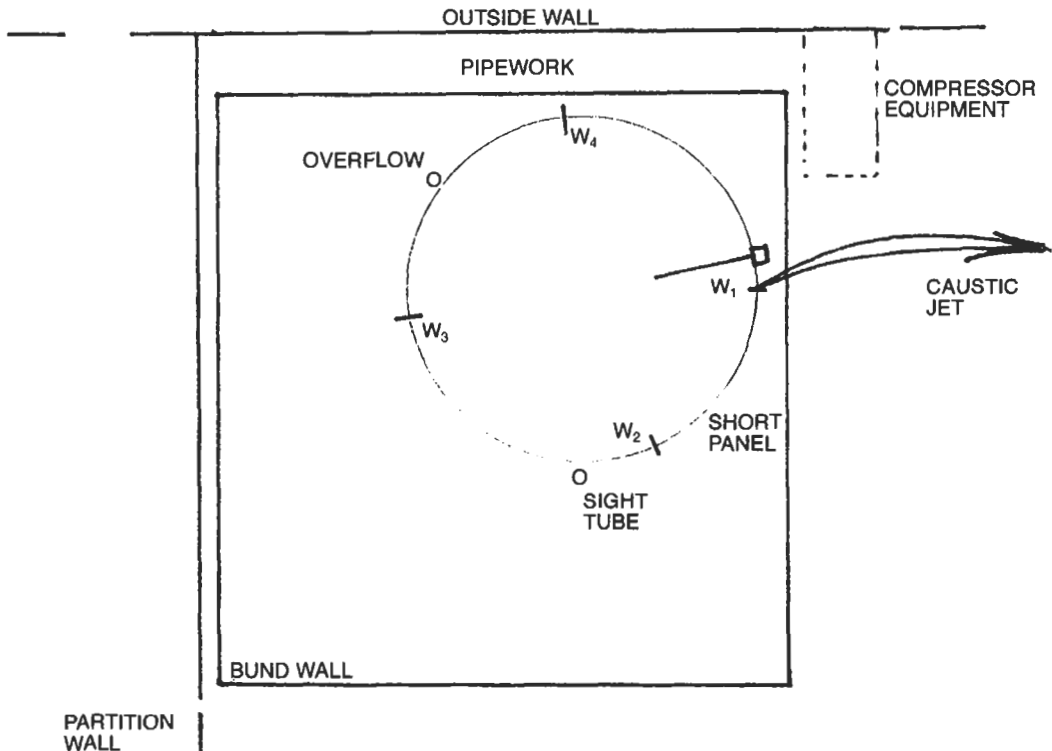
Fig. 1. Sketch plan of the caustic soda tank (diameter ca 2.7 m), showing four vertical welds (W1–4) and their position relative to the bund wall. Three of the four plastic panels had a contour length of ca 2.5 m, the fourth being shorter, at about 1.2 m. An internal heating element lay below the critical crack, but had apparently never been used. The sight and overflow tubes led to the top of the tank.

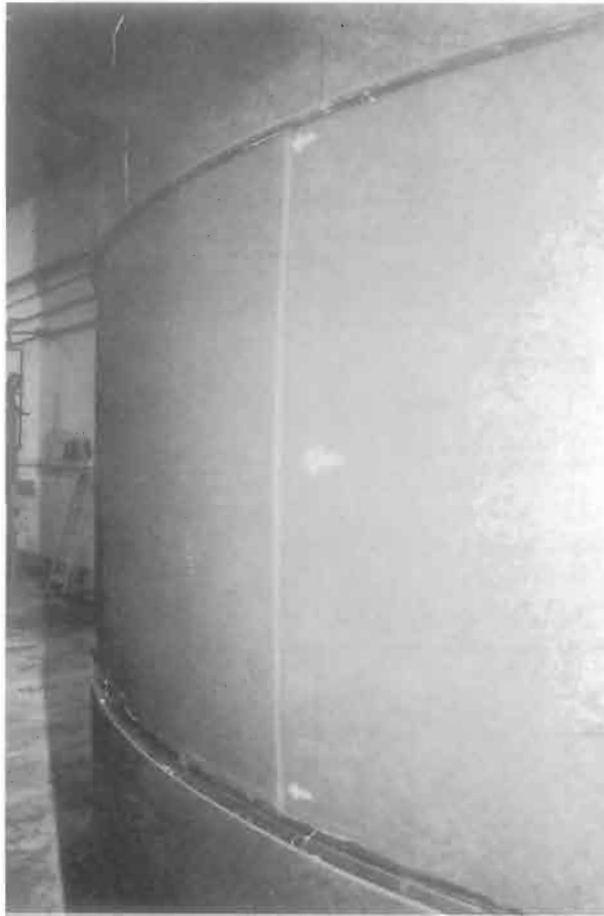
Fig. 3. Face view of the failed weld in the plastic panels of the tank. The large white arrow indicates the position of the crack initiation point in the centre of the weld, the crack eventually widening to the points shown by the two smaller arrows. The surface surrounding the failed weld is pristine and totally undamaged, with no abrasive wear or traces of impact damage.
