***FAILURE  
ANALYSIS  
CASE  
STUDIES II***

Edited by  
**D.R.H. Jones**

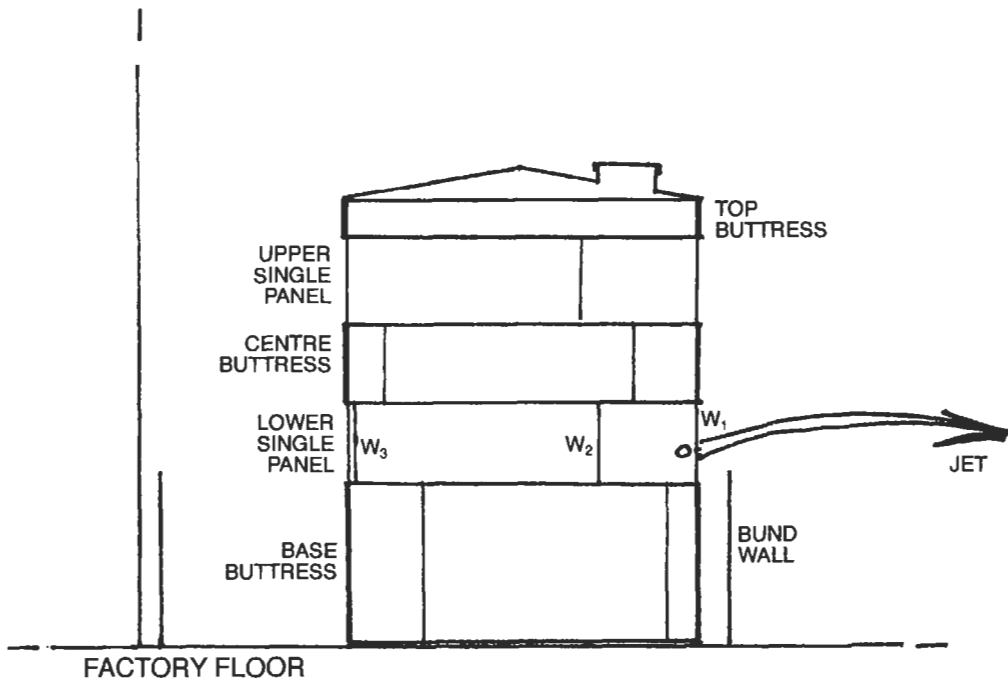
Fig. 4. Sketch section of the failed caustic soda tank, from the office side of the factory floor. It consisted of rectangular thermoplastic panels welded together, and reinforced with three extra horizontal buttresses (shown by the bold lines). The critical crack started (point O) in a vertical weld (W1) in the lower of the two unreinforced parts of the tank, and the jet rose in a gently curving arc above the bund wall.

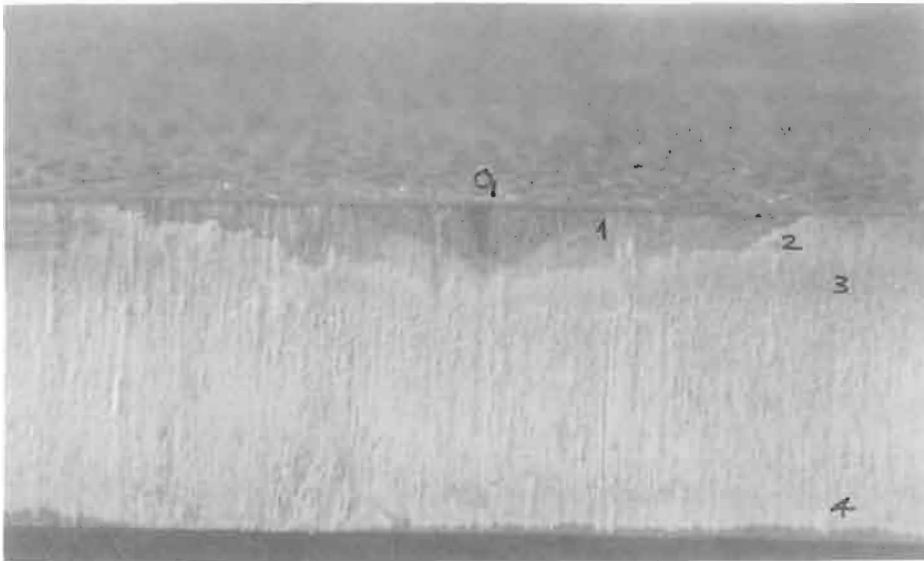
Fig. 5. Close-up of the origin of the critical crack in the main fracture surface, taken using oblique lighting to highlight surface features. There are four propagation zones (1–4) visible around the large pit ( $O_1$ ) which opens to the outer surface of the 12 mm thick section through the skin of the tank.

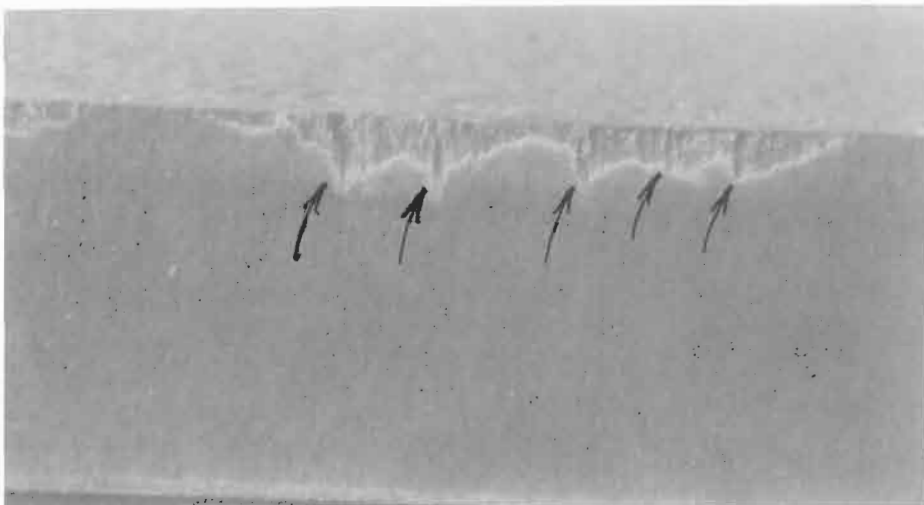
Fig. 6. Close-up of set of pits (arrows) on the outer surface of the critical weld, with brittle crack zone connecting the set, created during one of the early loadings. The pits are pin-holes created by thermal welding and not detected by subsequent spark testing. The sub-critical crack zone was intersected by the critical crack during the final catastrophic failure.

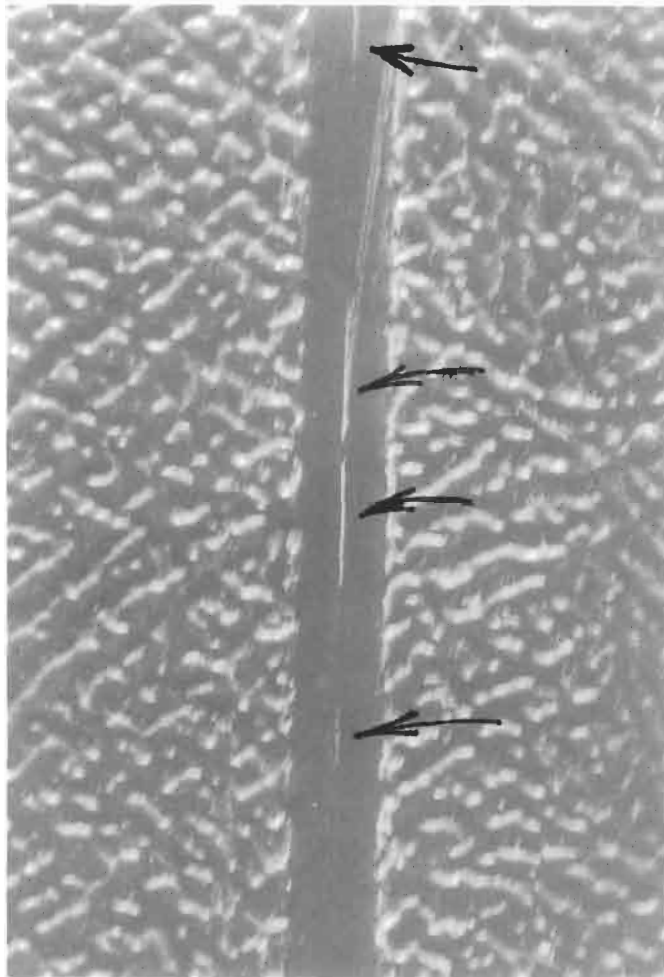
Fig. 7. Close-up of hairline subcritical cracks (arrows) in another vertical weld of the failed tank. The weld was adjacent to that which failed, occurring about the same height, towards the centre of the panel. The cracks were found during re-inspection of the tank, by dusting the welds with fine talcum powder, and represent sub-critical cracks formed during loading the tank with caustic soda. The weld itself is about 2.5 mm wide.

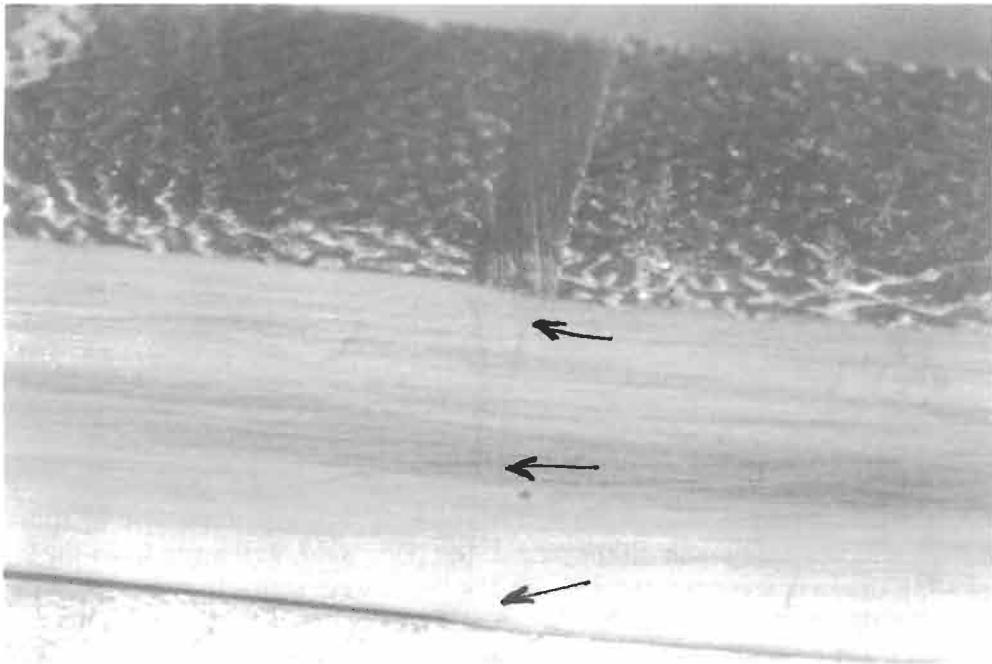
Fig. 8. Close-up of weld section from an intact panel. The section has been finally polished with 1600 grade emery paper and exposed to boiling xylene vapour. The weld appears wider at the outer and inner surfaces of the panel (arrows), and the darker central line represents the original join of the sheets. The weld section from the failed panel showed a slightly thinner central zone.

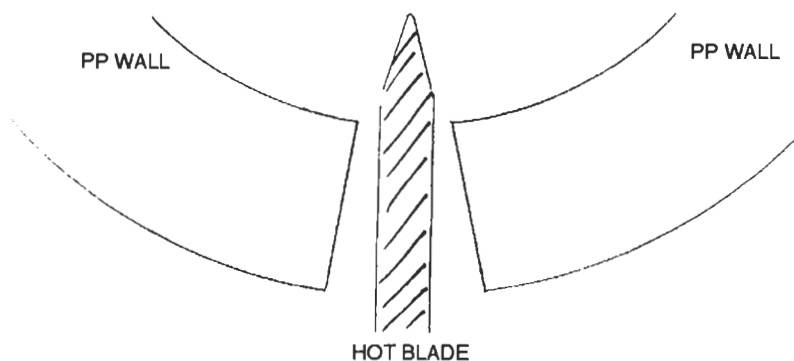
Fig. 9. Weld formation in final closure of plastic panels to form large diameter hoop. The panels are bent round to meet a hot knife, the knife is withdrawn, and the two ends pressed together to form the final joint. One problem is that the panels are still in a state of strain, which is not relieved. Stress relaxation will occur with time, but residual stresses may contribute to early failures if the design itself is faulty.

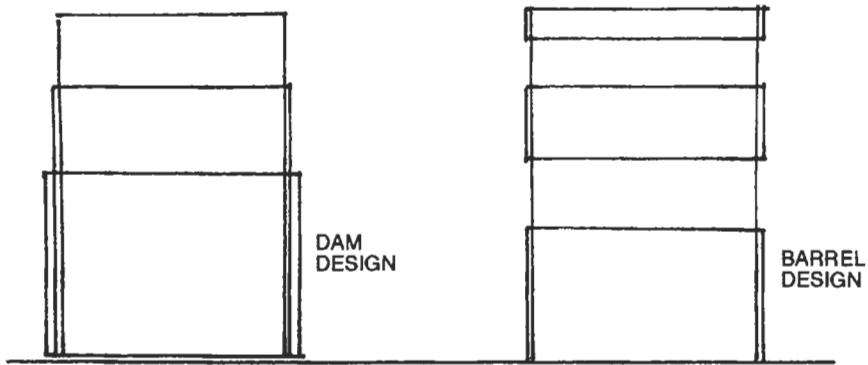
Fig. 10. Contrasting designs for large storage tanks, with dam design at left and barrel design at right. The dam design has concentric walls to resist a steadily increasing hydrostatic pressure, while the barrel design has buttresses to protect the horizontal welds thought to be most at risk.

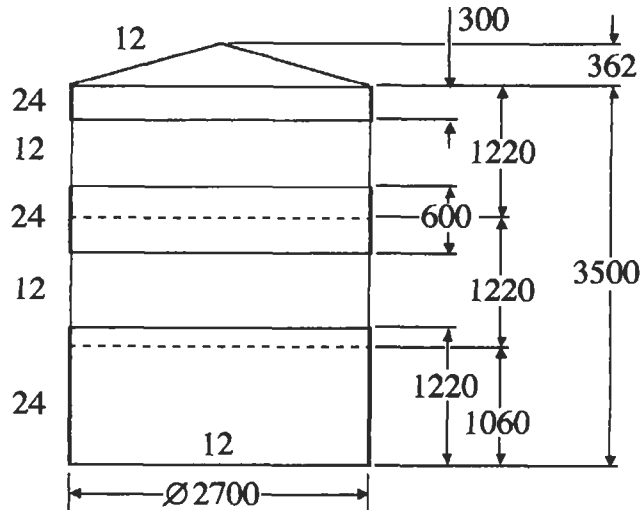
Fig. 1. Sketch showing wall thicknesses and dimensions (in mm) of the failed tank.

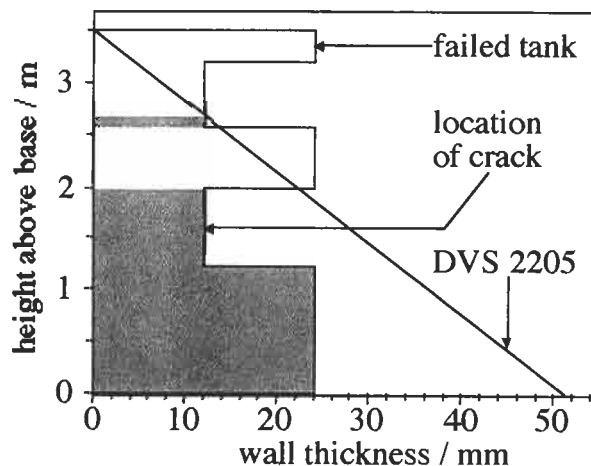
Fig. 3. Variation of wall thickness,  $s$ , of failed tank with height,  $h_{\max} - h$ , from its base compared with that specified by DVS 2205 design code (shaded areas are less than the code's thicknesses).

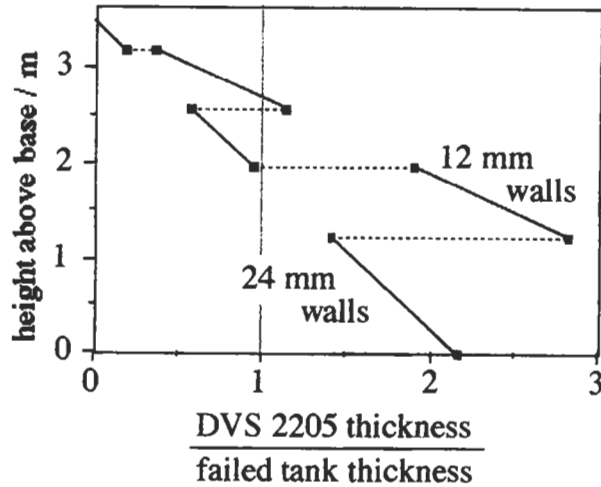
Fig. 4. Ratio of DVS 2205 wall thickness to that used in the failed tank and its variation with height above the base of the tank.

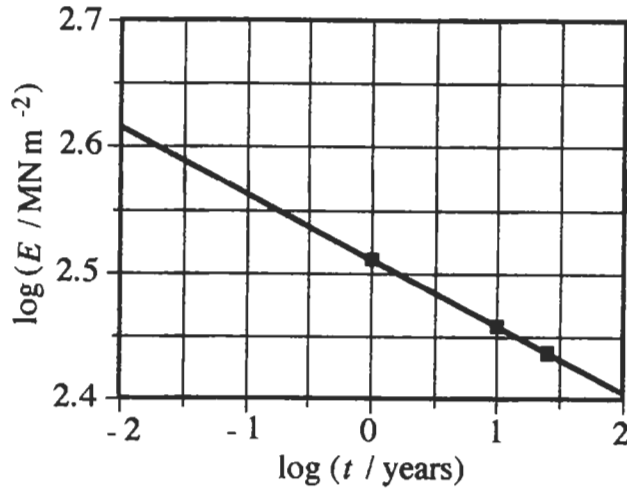
Fig. 6. Creep modulus vs time for polypropylene copolymer (data from Figs 24–26 of DVS 2205 Part 1).

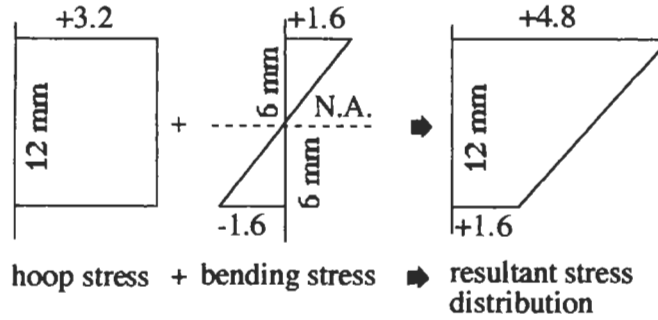
Fig. 7. Schematic addition of stress distributions through the thickness of the tank wall (stresses are shown in  $\text{MN m}^{-2}$ ; tensile stresses are taken to be positive).

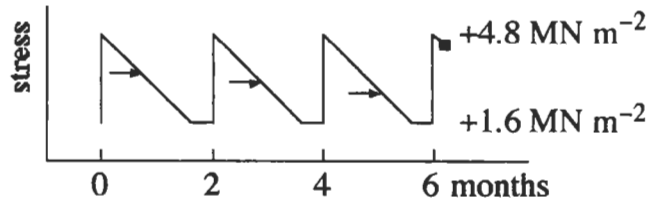
Fig. 8. Schematic of stress variation at outer surface in response to filling cycles of the tank: the arrows indicate schematically the critical stress for slow crack growth.

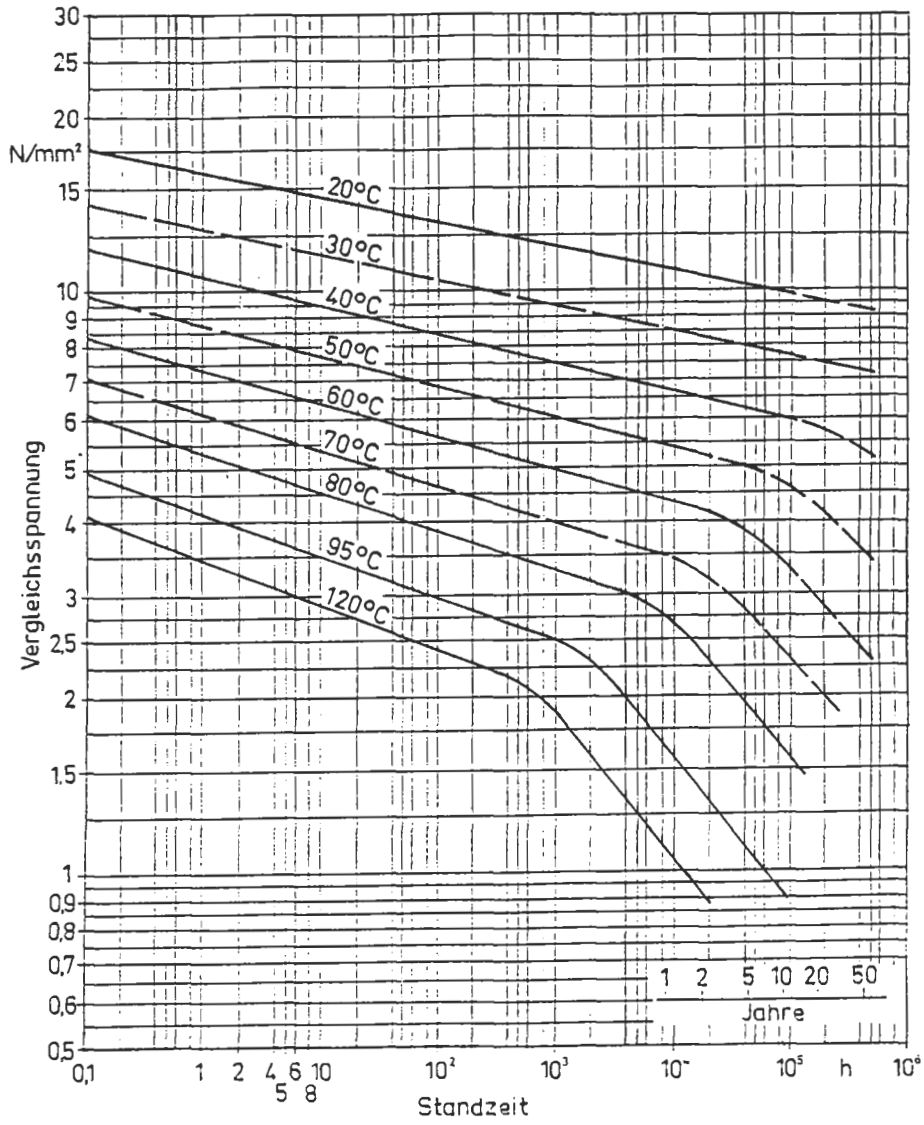
Fig. A1. Creep rupture curves for polypropylene (PP) Type 2 pipes conforming to DIN 8078 (Fig. 7 from DVS 2205 Part 1).

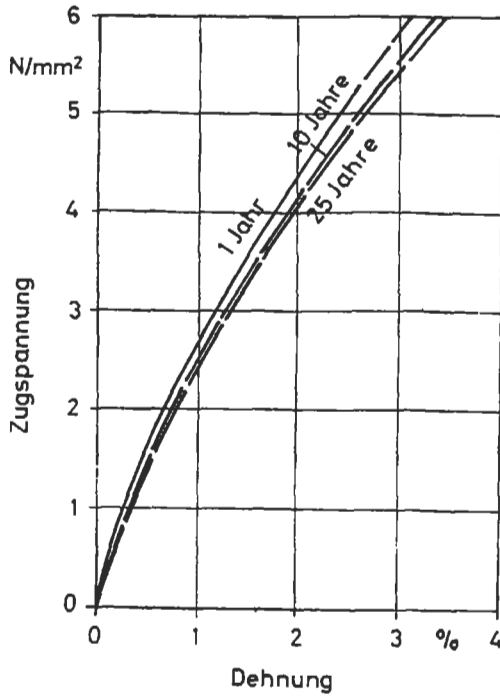
Bild 15. Isochrones Spannung-Dehnung-Diagramm von Polypropylen (PP), Typ 2, für 20°C.

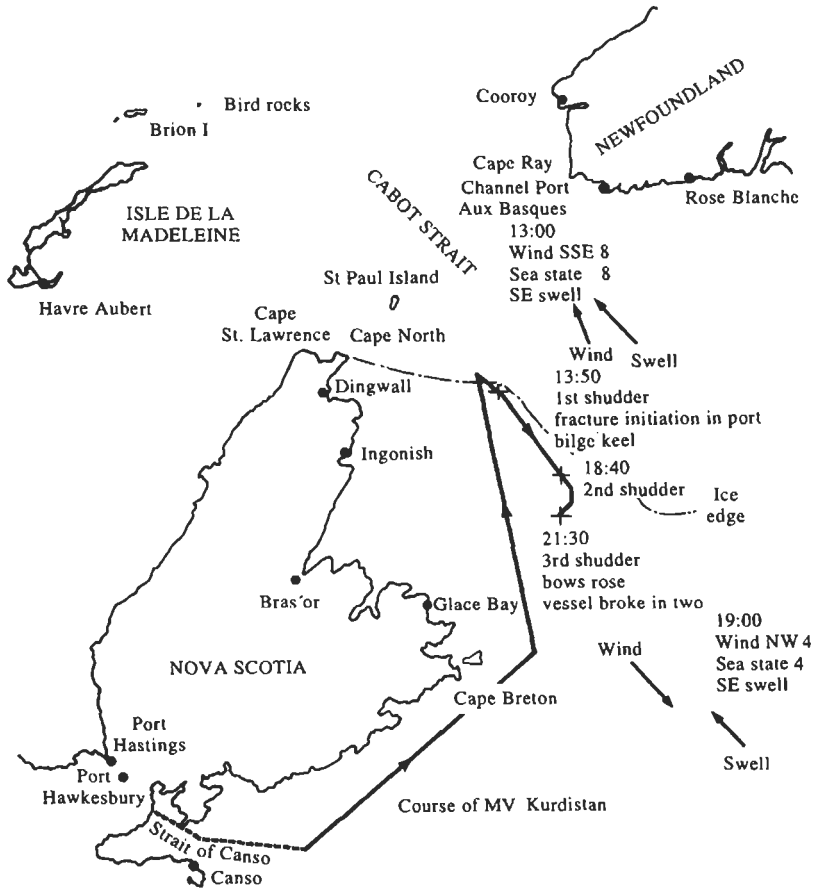
Fig. 1. Course of the MV *Kurdistan*: 15 March 1979.

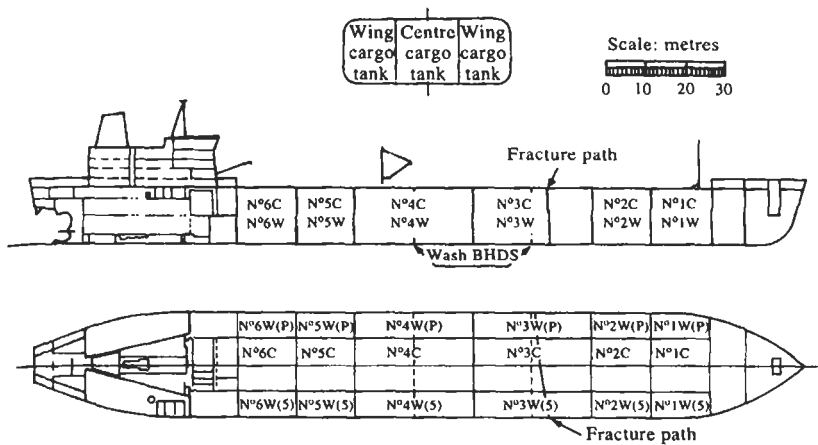
Fig. 2. General details of the MV *Kurdistan*.

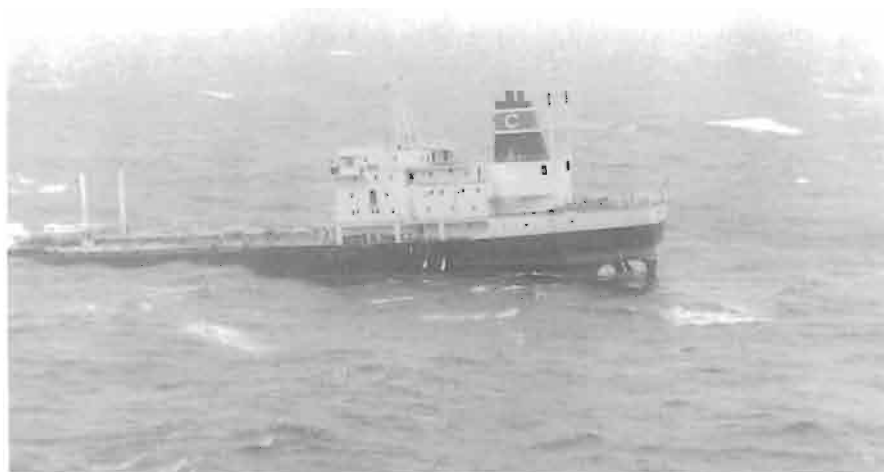
Fig. 4. Stern section of MV *Kurdistan* after breaking in two.

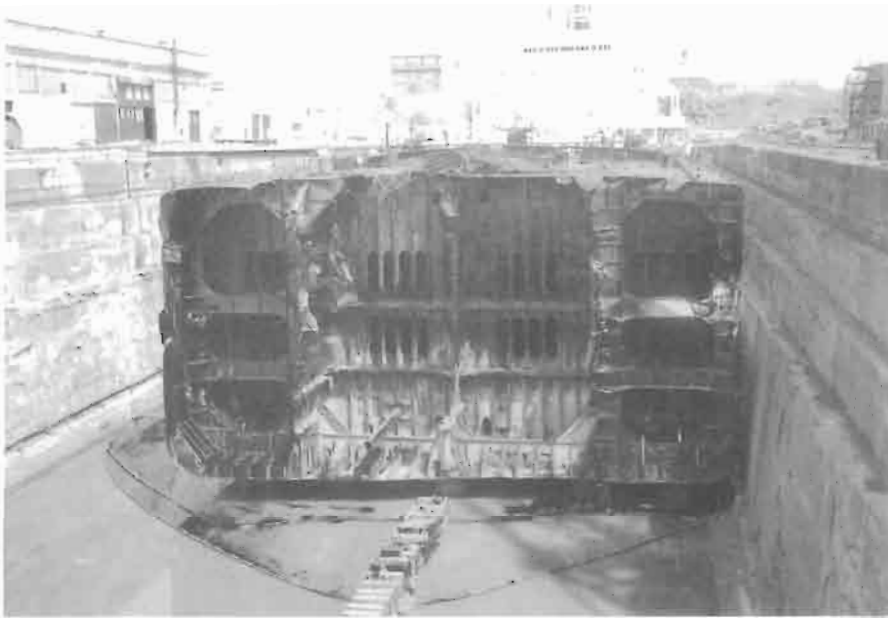
Fig. 5. General view of the stern section of the MV *Kurdistan*.

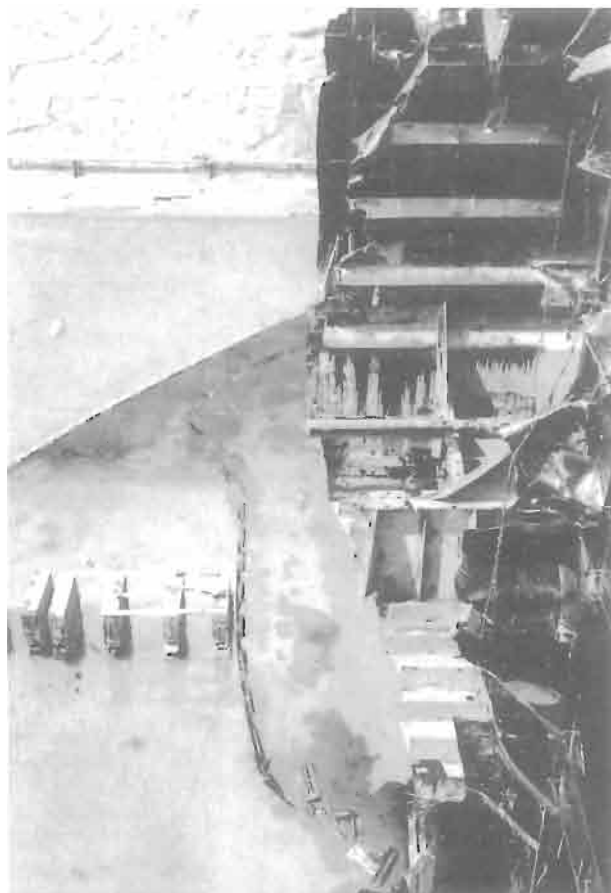
Fig. 6. View of longitudinals, centre girder and bottom shell from port side of vessel.

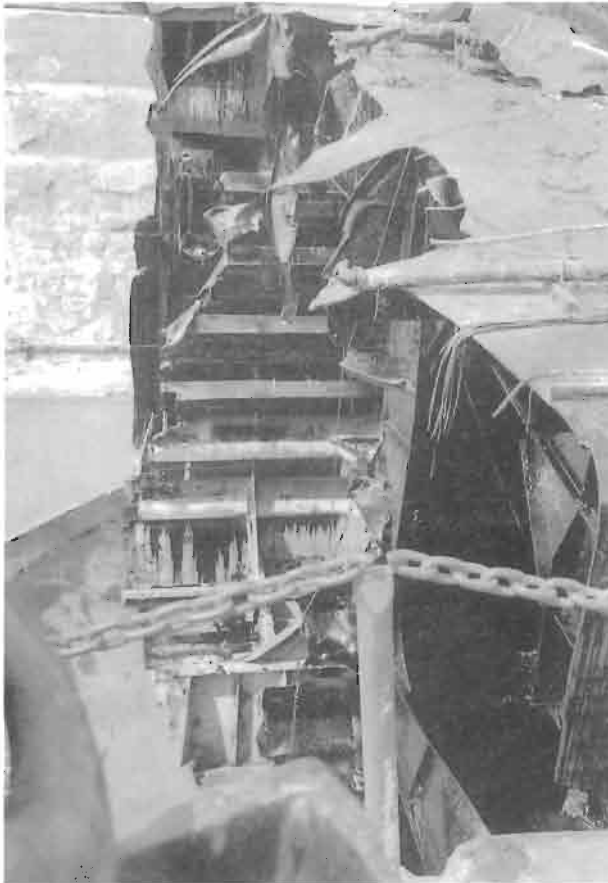
Fig. 7. Side view from port showing fractures to bulkheads, port gunwhale and deck plating.

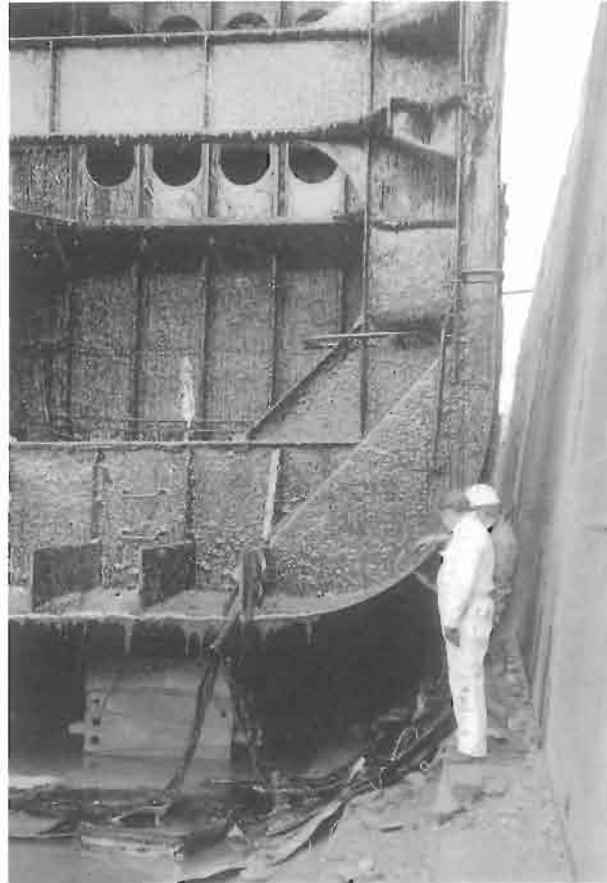
Fig. 8. Port bilge keel and keel showing three longitudinals, bilge bracket and fracture face of hull plating.

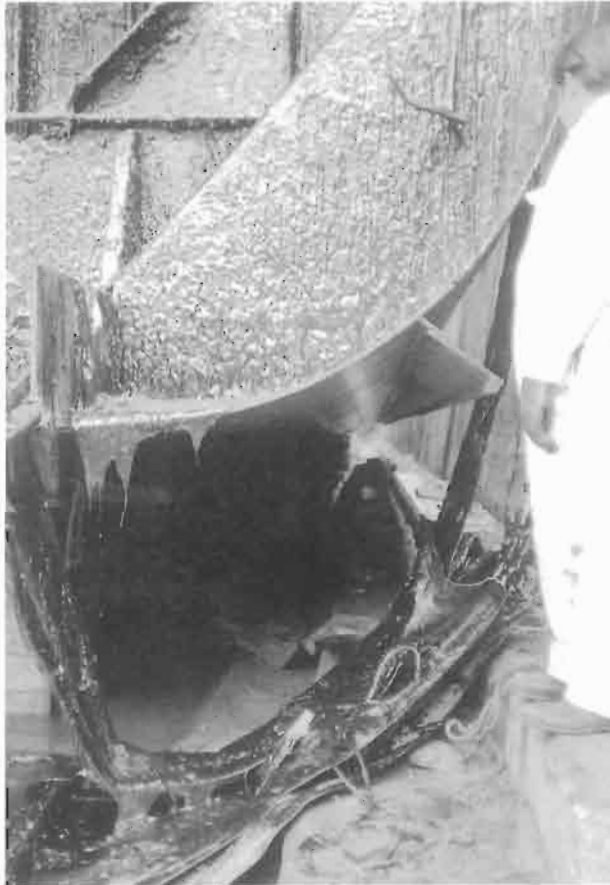
Fig. 9. Port bilge keel showing bilge bracket: also showing longitudinal.

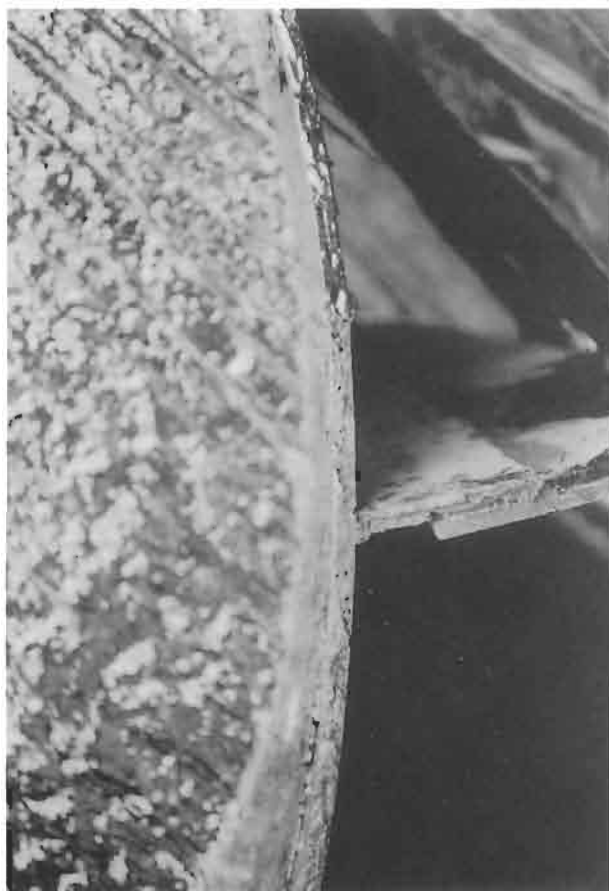
Fig. 10. Port bilge keel-to-keel detail.

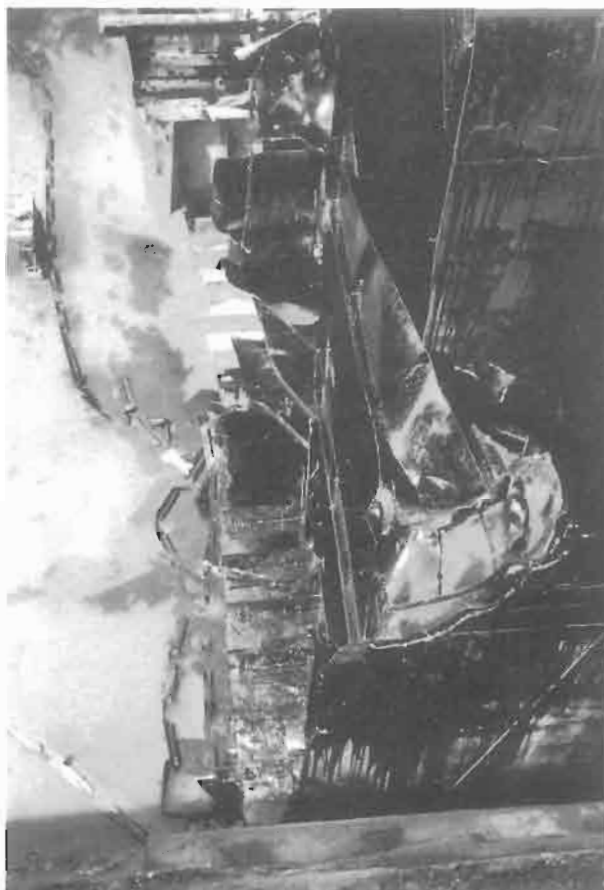
Fig. 13. Port hull plates and longitudinal bulkhead fractures: deformation to the web frame on the port side is also visible.

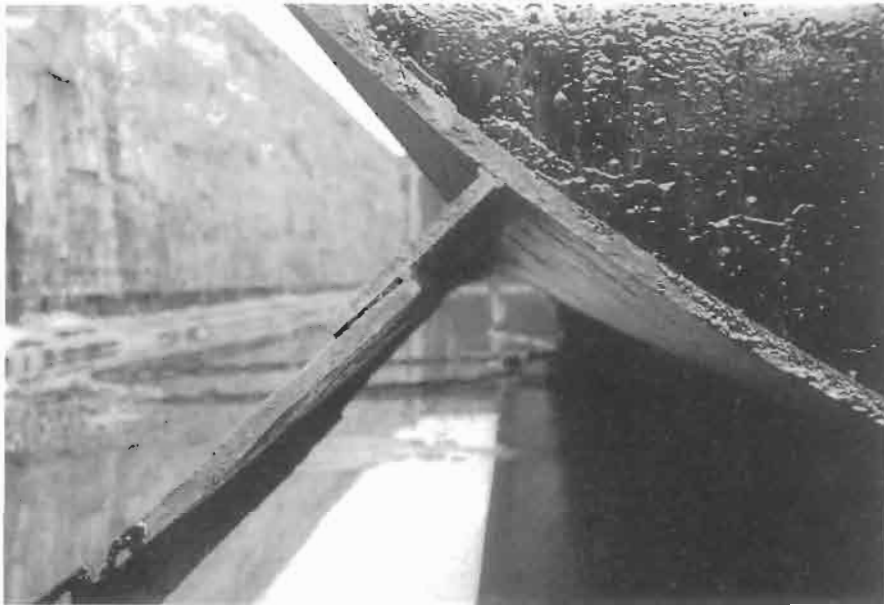
Fig. 14. Starboard bilge keel.

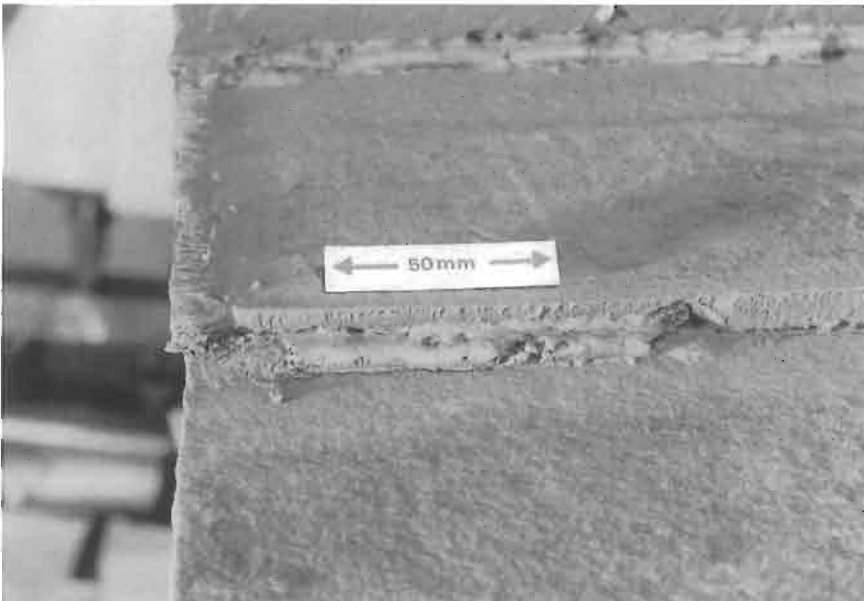
Fig. 16. Intermittent lap fillet weld in sample 1 between ground bar and bulb bar, seen from above.

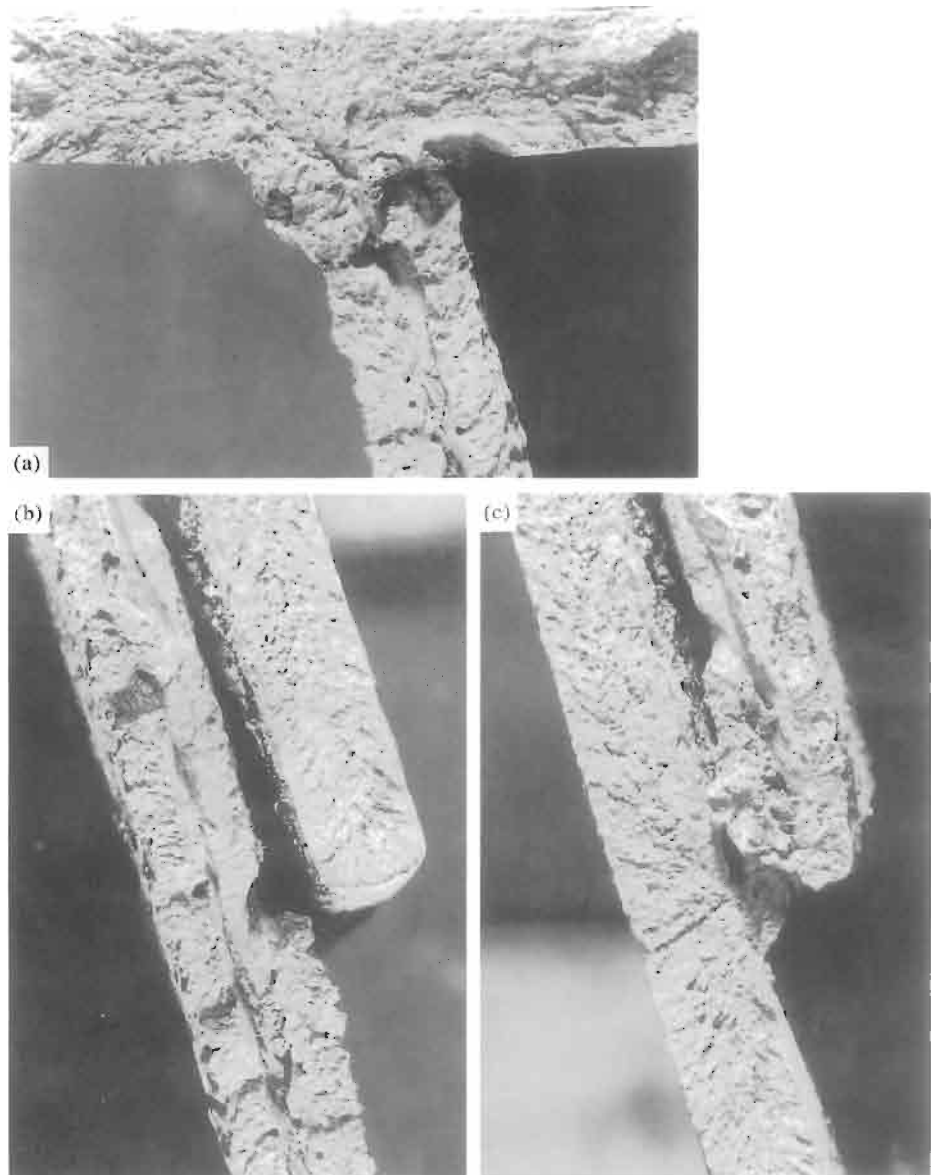
Fig. 17. Close-ups of port bilge keel.

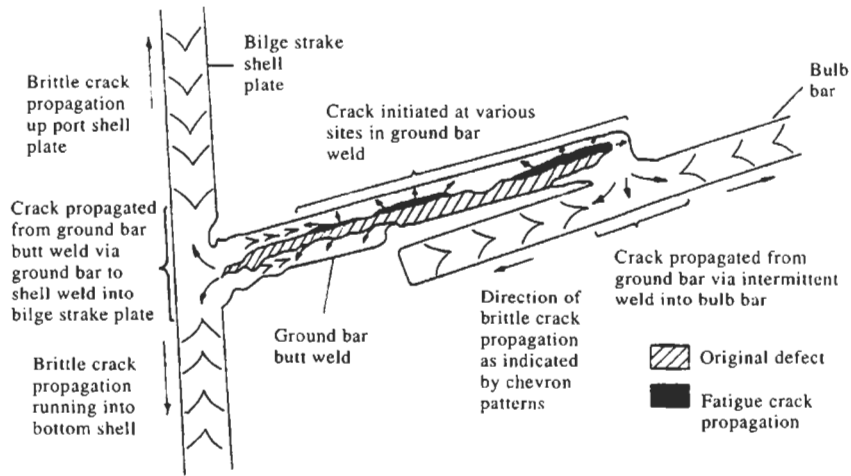
Fig. 20. Crack initiation in ground bar weld and subsequent propagation into shell—port bilge keel detail.

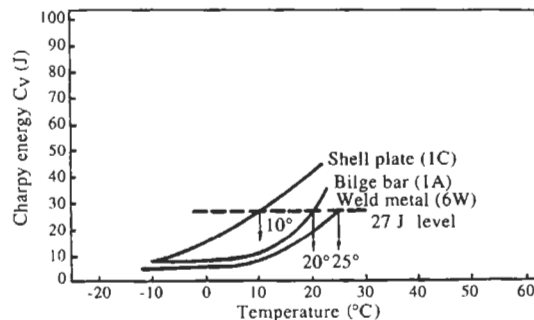
Fig. 21. Lower bound Charpy curves—port bilge keel.

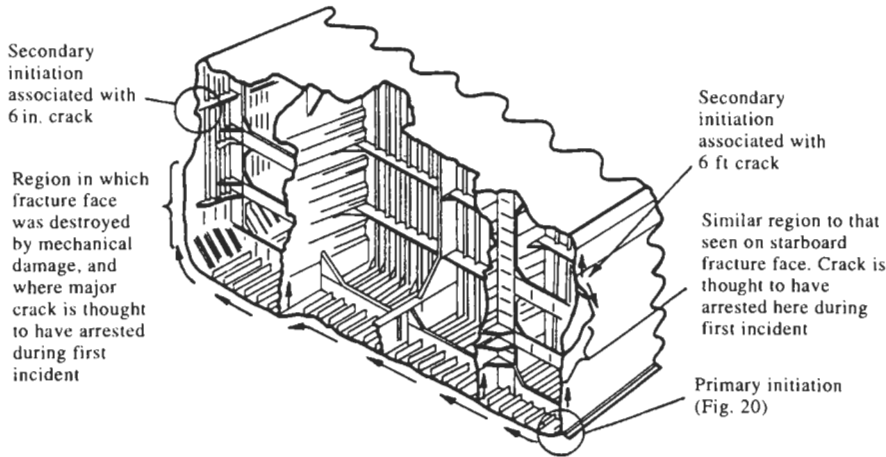
Fig. 22. Extent of crack propagation after the first reported incident. General view.

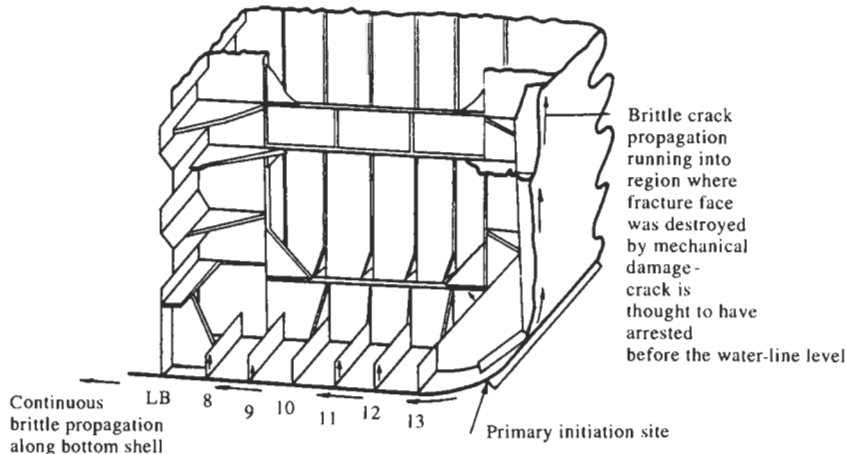
Fig. 23. Crack propagation—port bilge keel region during the first incident.

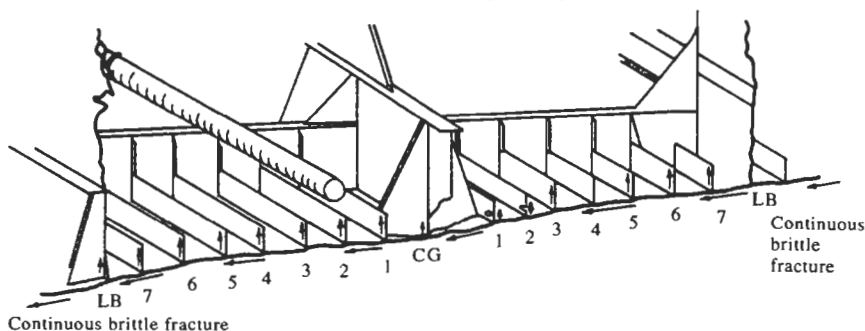
Fig. 24. Crack propagation during the first incident—bottom shell fracture.

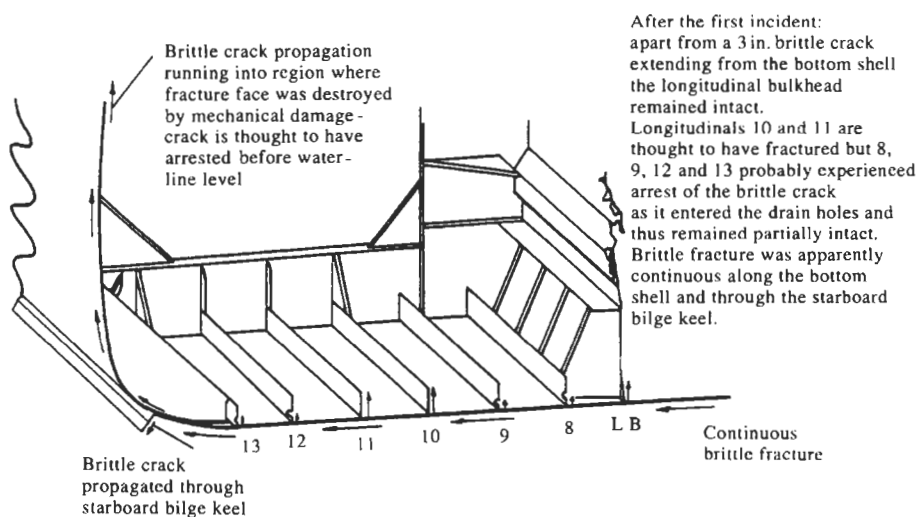
Fig. 25. Crack propagation during the first incident—starboard bilge keel region.

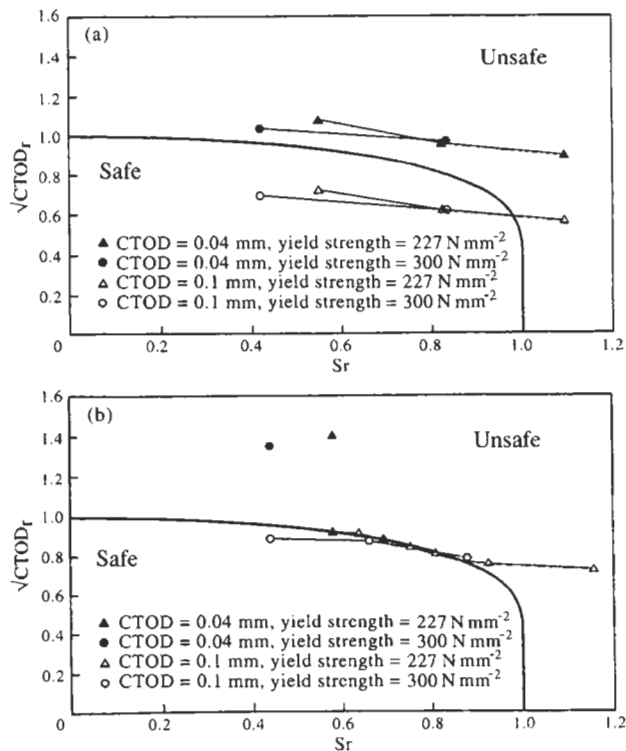
Fig. 26. (a) MV *Kurdistan* level 2 assessments—embedded defect assumption. (b) MV *Kurdistan* level 2 assessments—surface defect assumption.

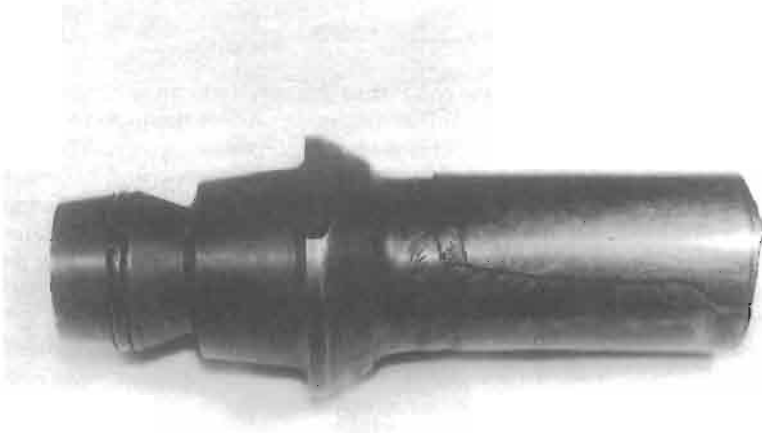
Fig. 1. Typical failed actuator piston rod showing the adapter, the circumferential weld and a large crack.

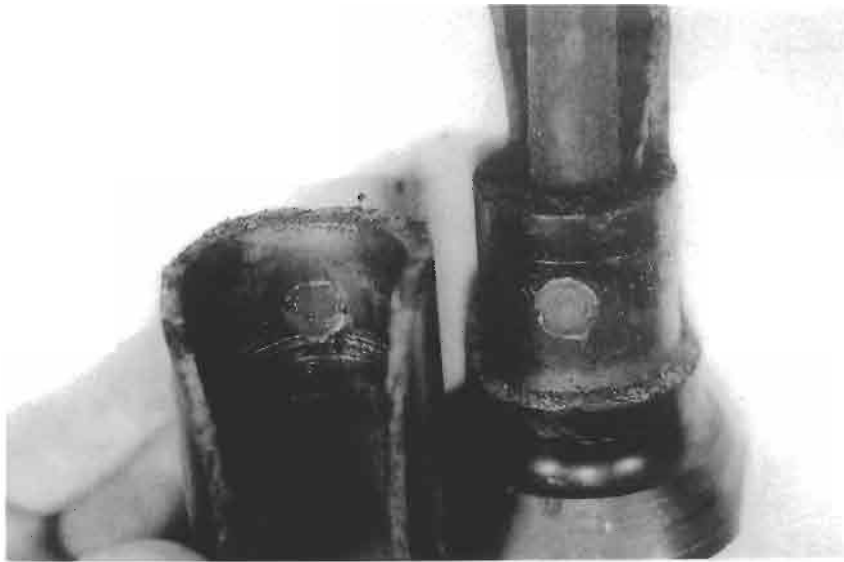
Fig. 2. Typical fracture through the centre of the weld and along the piston rod. The location of one of the rosette welds can be seen.

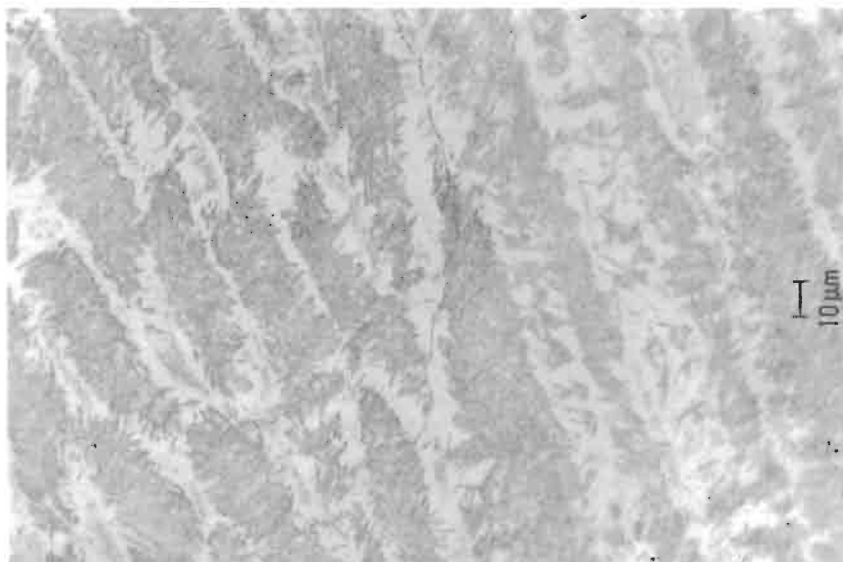
Fig. 3. Optical micrograph of one of the E312 welds showing austenite/ferrite duplex structure and a hairline crack (centre of photograph) (etchant: Vilella's etch).

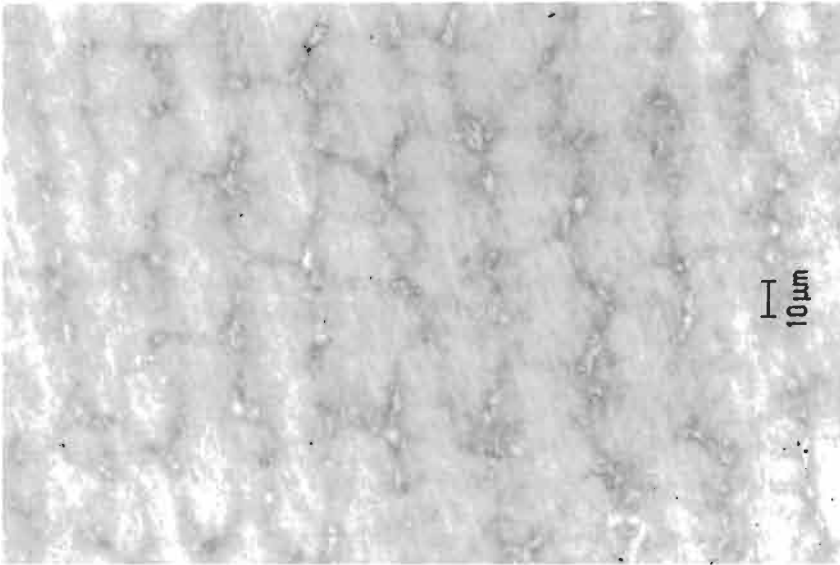
Fig. 4. Optical micrograph of one of the E312 welds showing severe carbide precipitation (etchant: Beraha's tint etch).

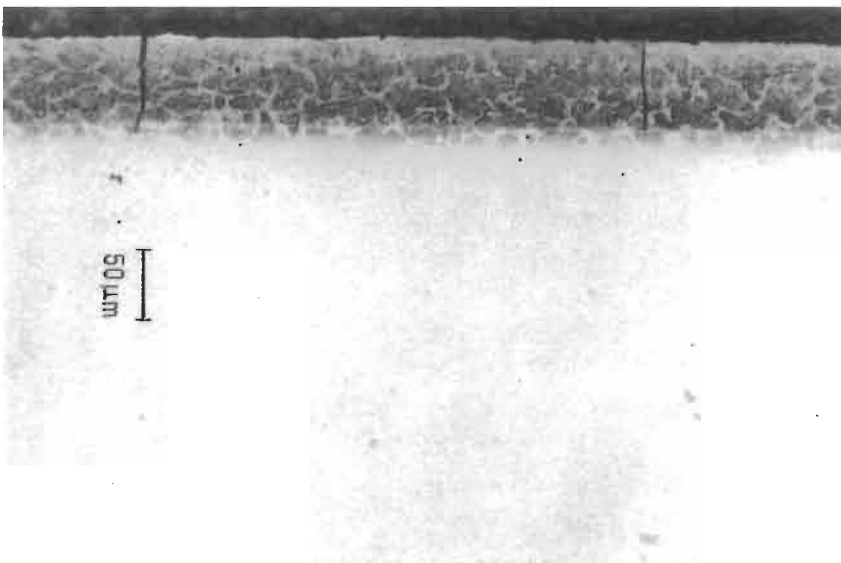
Fig. 5. Optical micrograph of the E312 weld showing cracks that originated after the nitriding (etchant: 2% Nital).

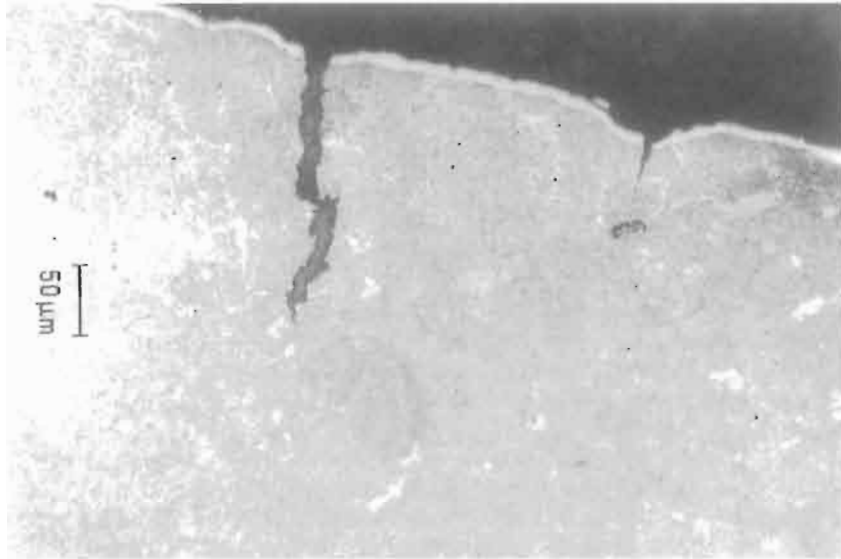
Fig. 6. Optical micrograph of the En32 steel immediately adjacent to the weld showing cracks that originated after the nitriding (etchant: 2% Nital).

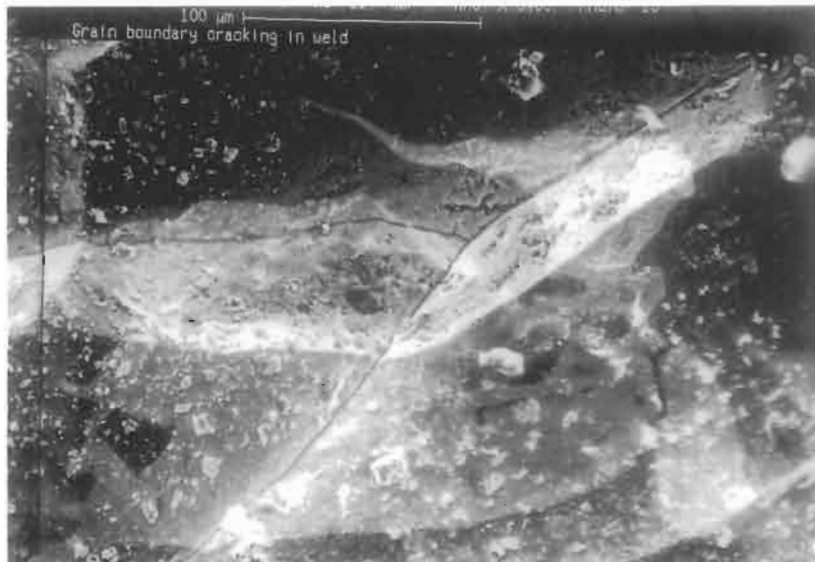
Fig. 7. SEM fractograph of the fracture surface as received. The intergranular nature of the fracture and secondary cracks can be seen.

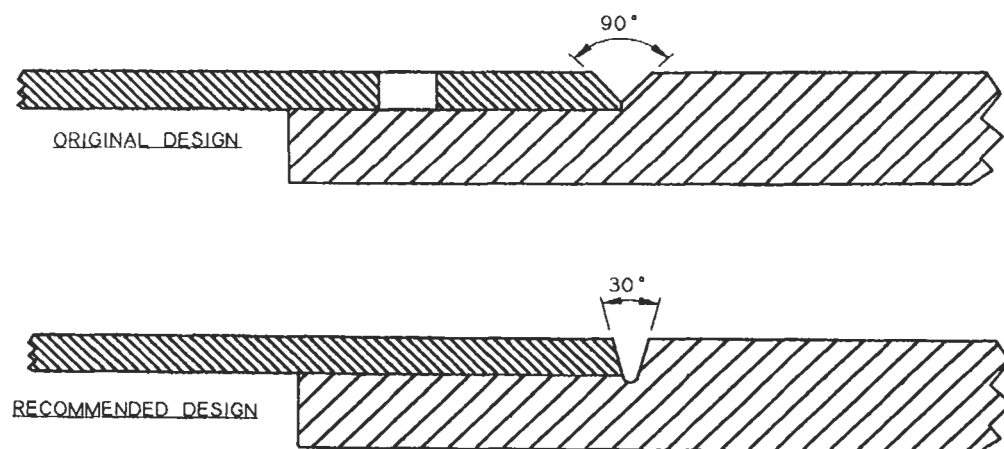
Fig. 8. Schematic drawings of the original and recommended weld preparations.

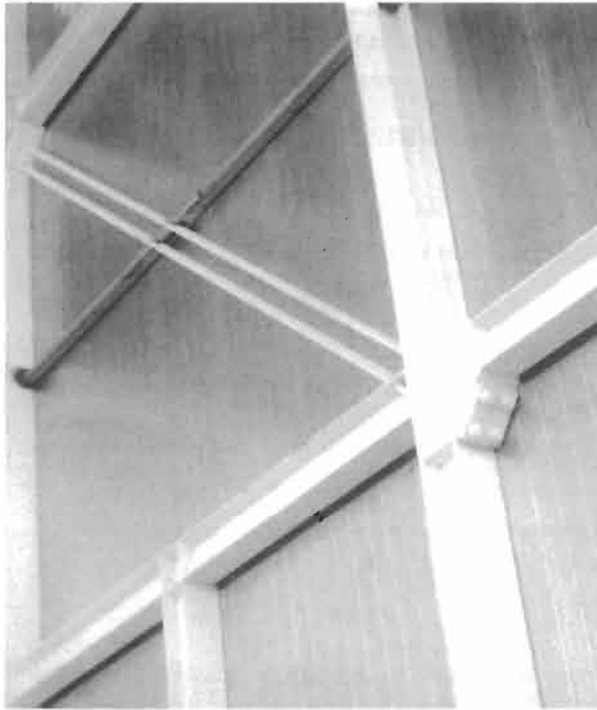
Fig. 1. Prestressed steel frame using two bars.

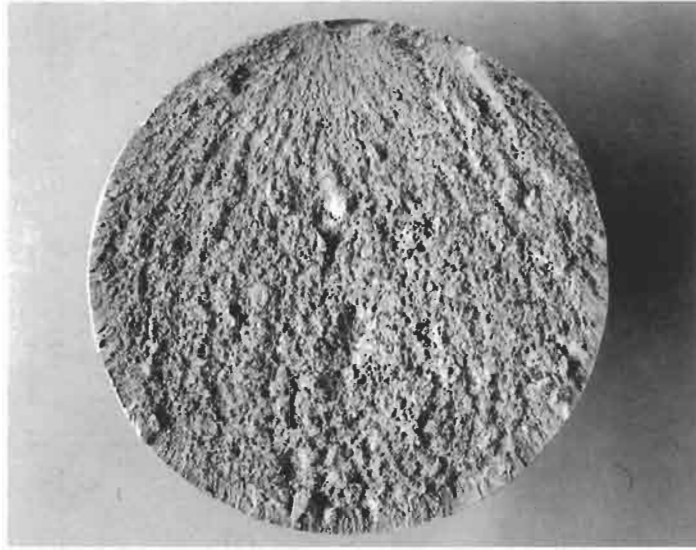
Fig. 2. Fracture surface of a broken bar.
