***FAILURE  
ANALYSIS  
CASE  
STUDIES II***

Edited by  
**D.R.H. Jones**

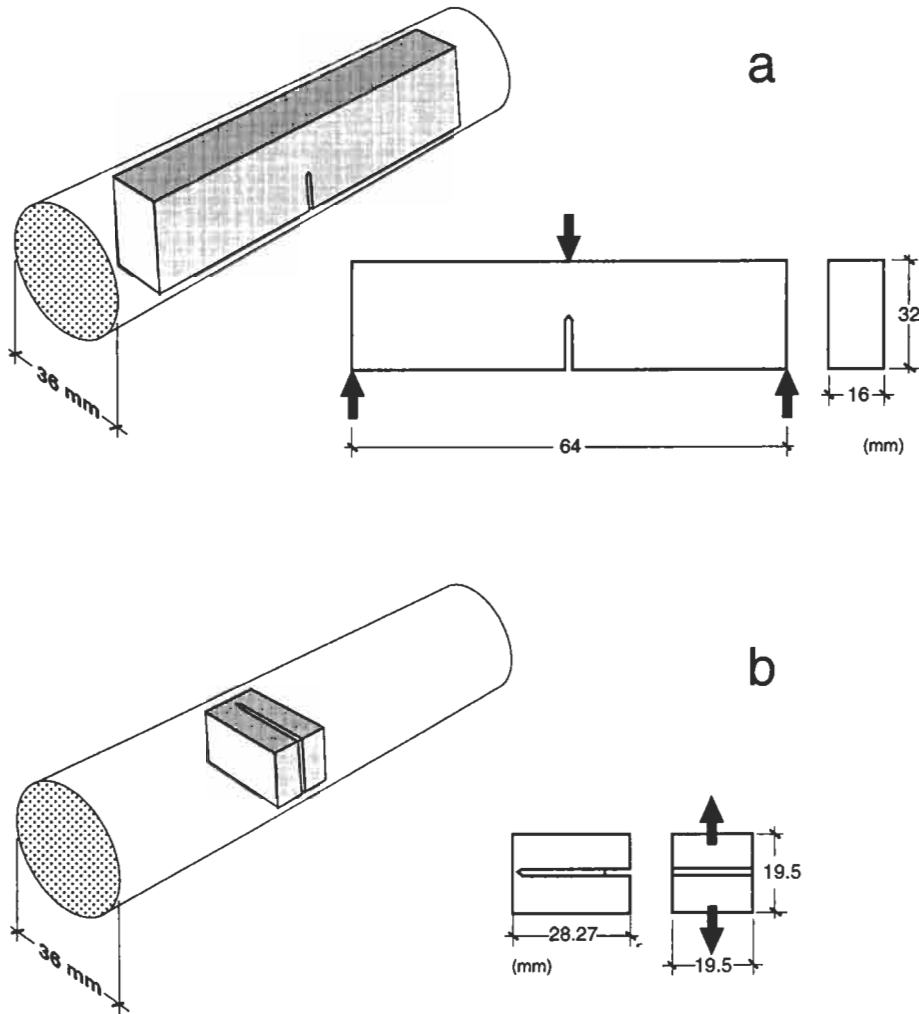
Fig. 3. Test samples for fracture toughness measurement. (a) Notched beams according to ASTM E 399. (b) Short bars according to ASTM E 1304.

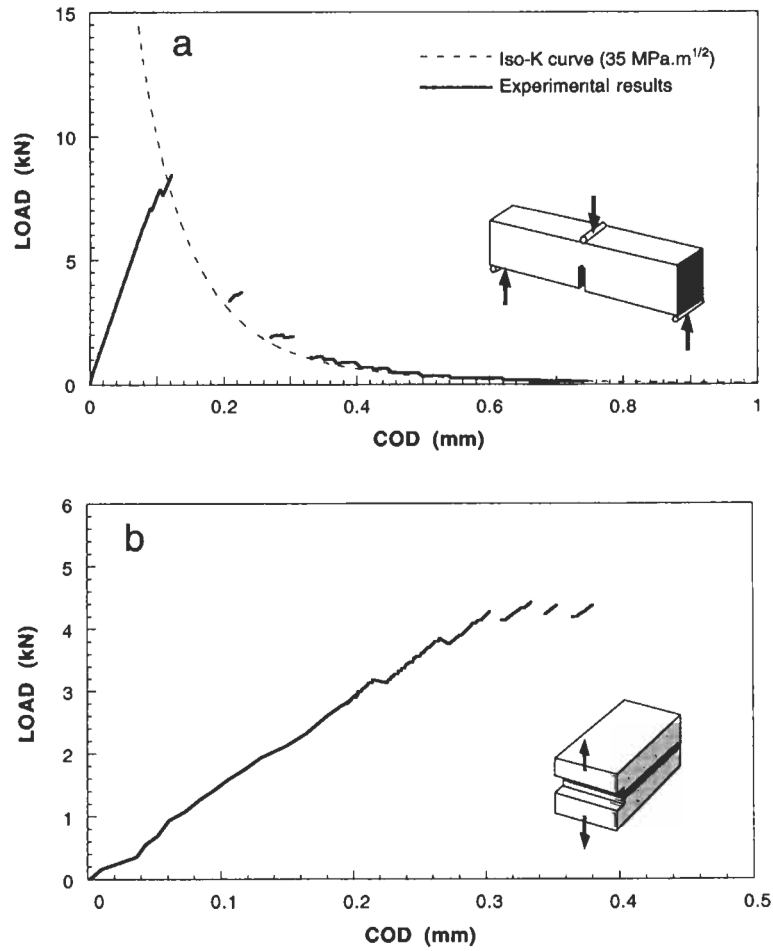
Fig. 4. Load vs crack opening displacement records. (a) Notched beams. (b) Short bars.

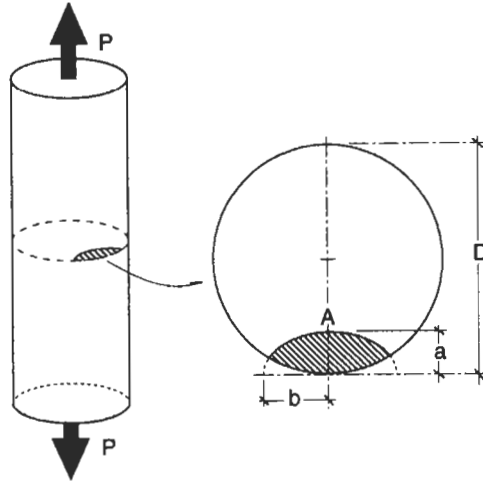
Fig. 5. Geometry and notation of the surface crack.

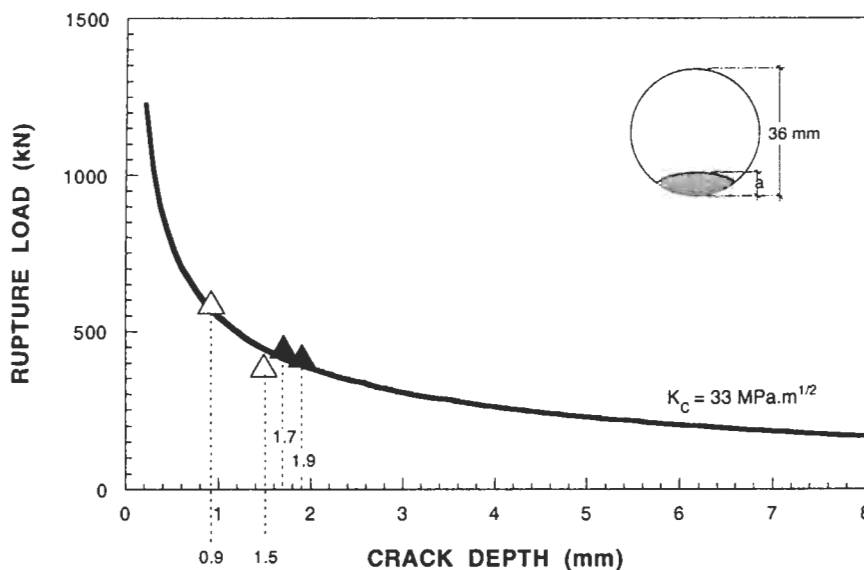
Fig. 6. Rupture load of a cracked bar as a function of crack depth (for  $D = 36$  mm and  $K_{IC} = 33$  MPa m<sup>1/2</sup>). (△), Actual cracks. (▲), Fatigue cracks (laboratory).

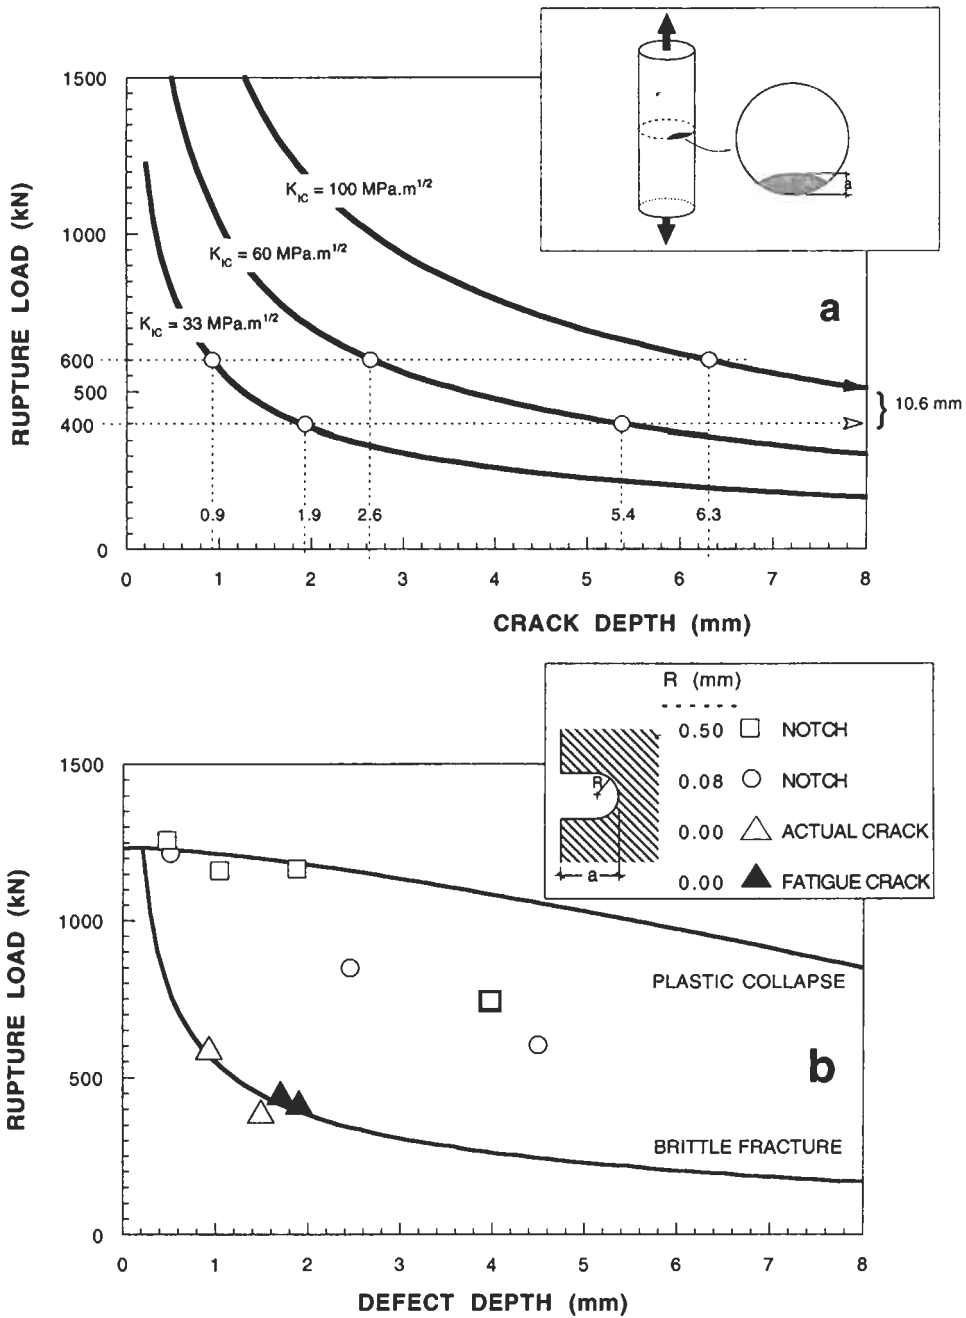
Fig. 7. Damage tolerance diagrams. (a) Cracks: influence of fracture toughness. (b) Notches: influence of tip radius.

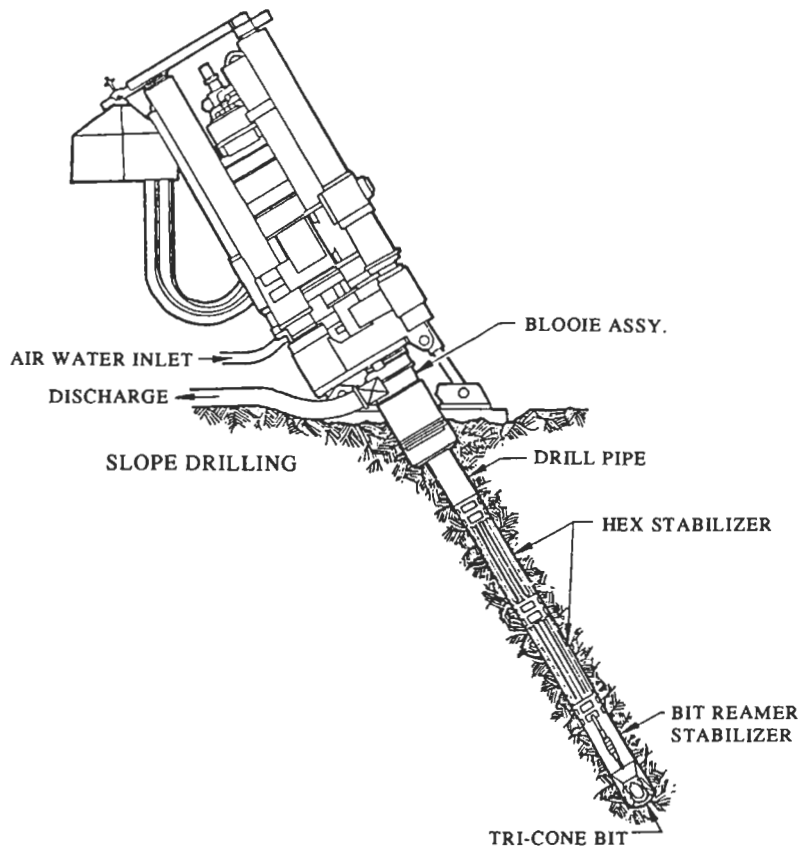
Fig. 2. Slope drilling of a pilot hole.

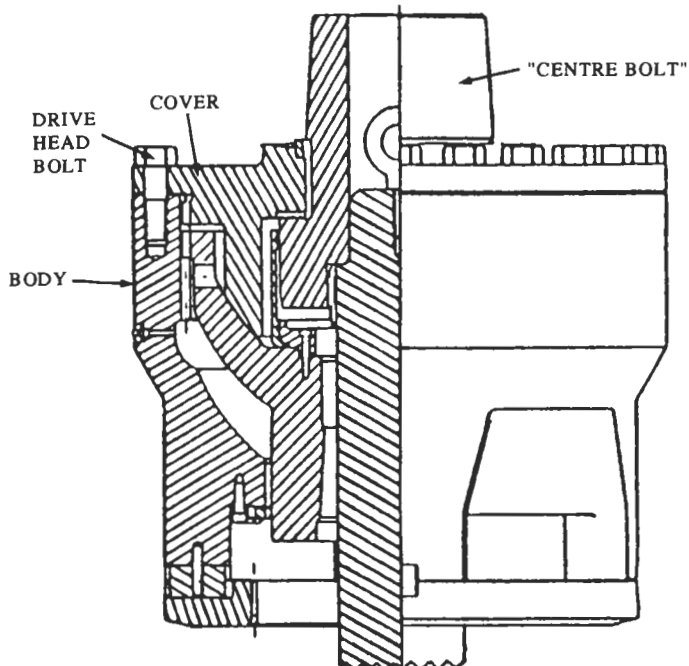
Fig. 5. Cutaway diagram of the drive head installation.

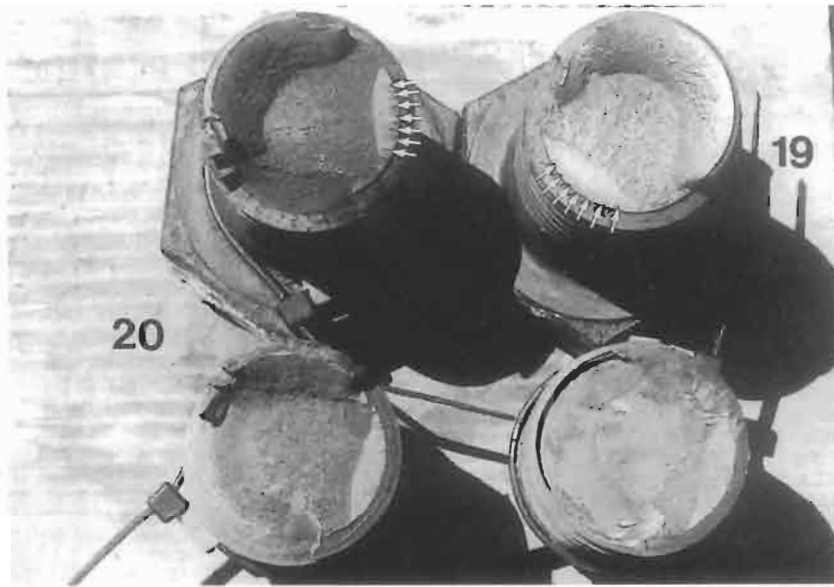
Fig. 6. Fracture surfaces of bolts 19 and 20, showing areas of fatigue from multiple origins (arrowed).

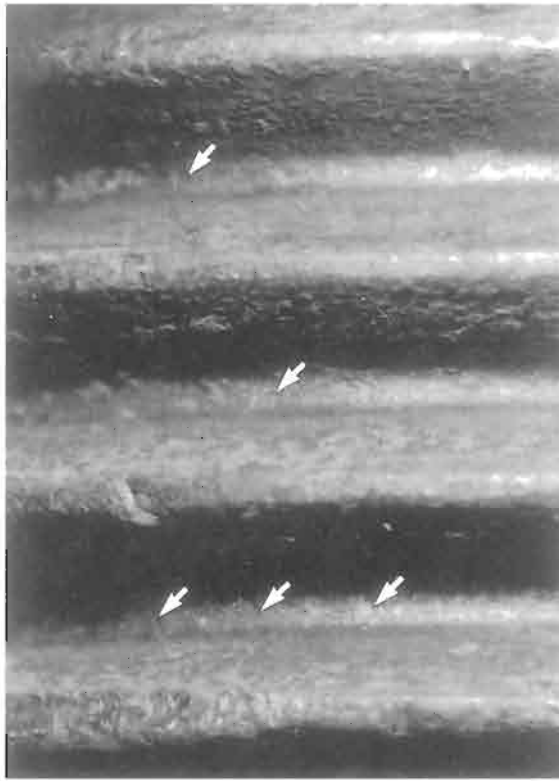
Fig. 8. General surface condition of the bolt threads, showing evidence of pitting corrosion (arrowed).

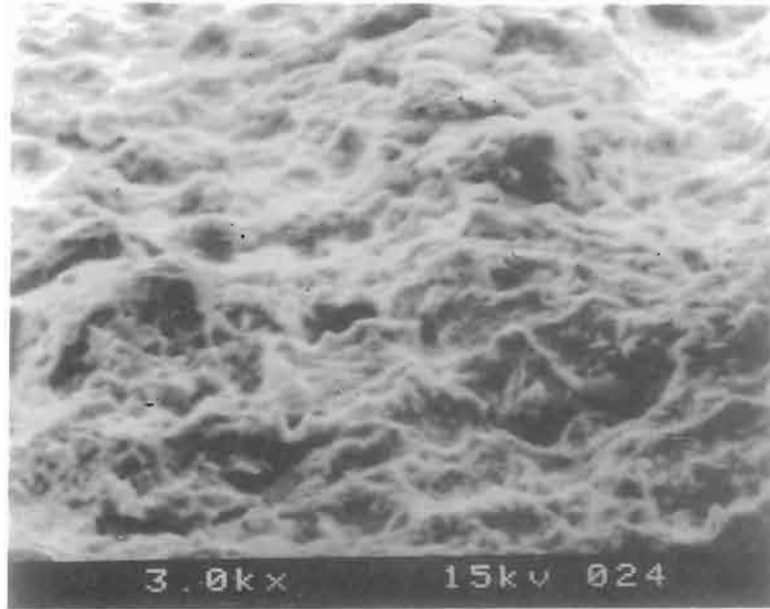
Fig. 9. Scanning electron fractograph showing features characteristic of fatigue.  $\times 3600$ .

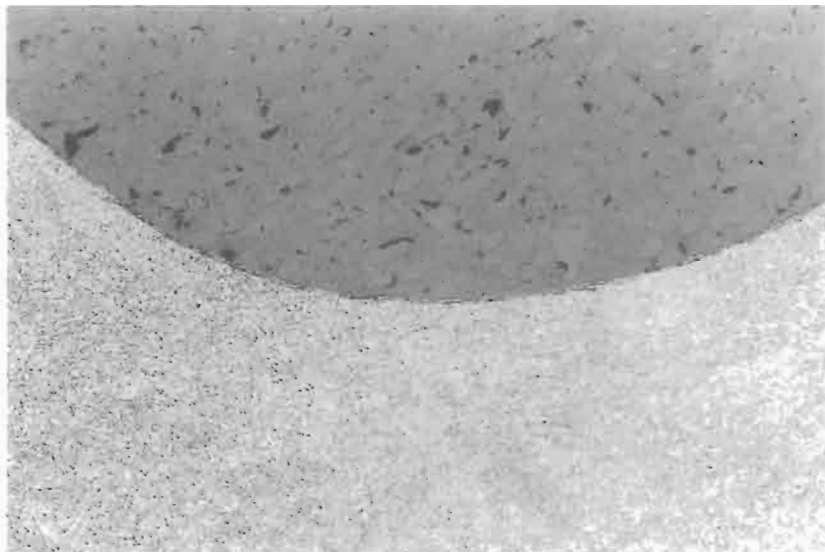
Fig. 10. Longitudinal section of a bolt thread root showing fine tempered martensite, and no material or manufacturing defects. Etched in 2% nital.  $\times 285$ .

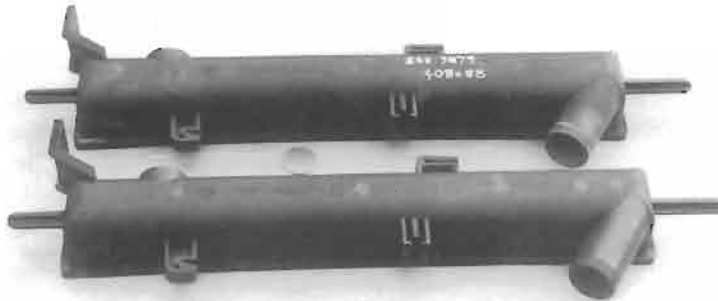
Fig. 1. Failed and new radiator boxes compared. The upper, failed sample cracked after 500 miles in service.

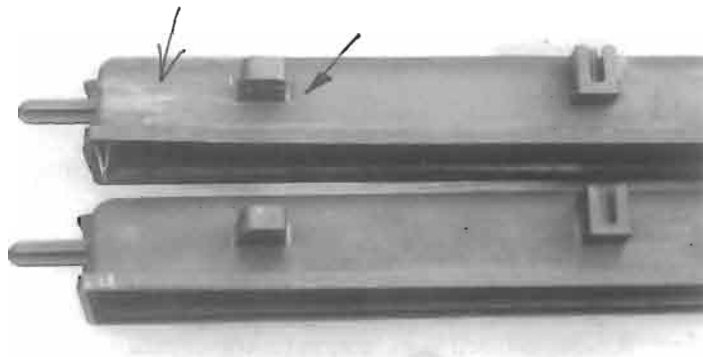
Fig. 2. Comparison of lower ends of upper, failed box and new box below. Closed arrow shows brittle crack which ran along inner corner of adjoining fan buttress. Open arrow shows contamination from leaking cooling water when tank was in situ.

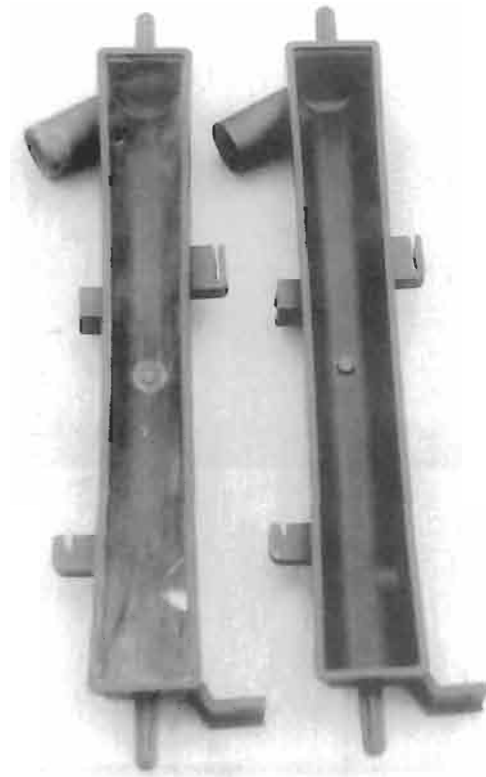
Fig. 3. Comparison of dimensions of failed (LHS) and new radiator boxes. Note longitudinal distortion of failed box.

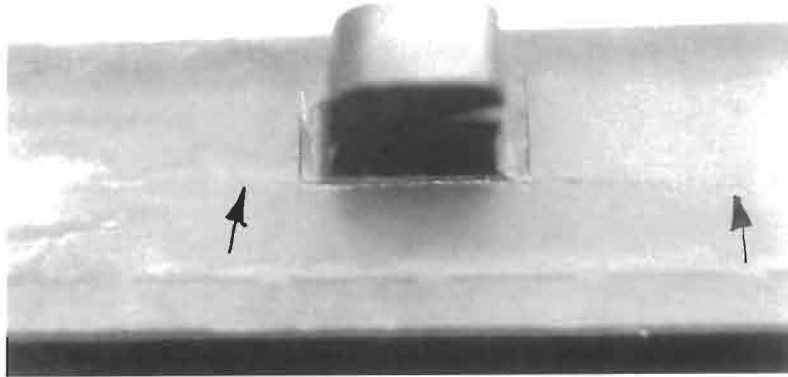
Fig. 4. Macrograph of brittle crack, running along stress concentration of buttress corner, and ending at points shown by closed arrows.

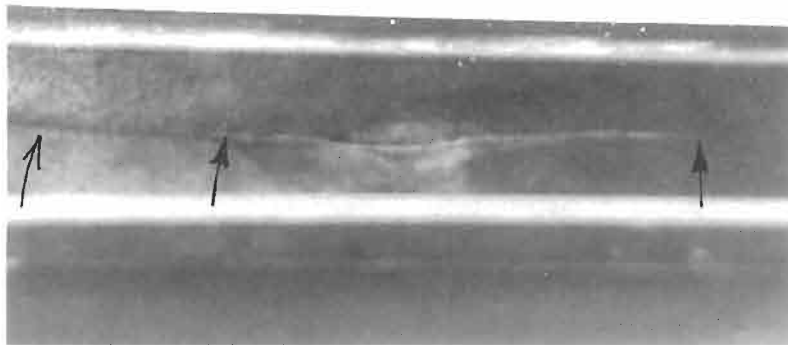
Fig. 5. Macrograph of brittle crack on inner surface, with ends shown by closed arrows. Weld line at left (open arrow) co-linear with crack, and surrounded by extensive flow line pattern.

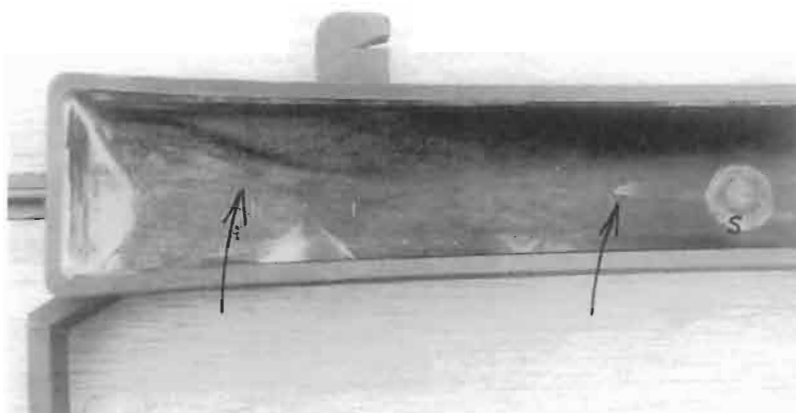
Fig. 6. Close-up of top inner surface of failed box showing complex flow lines (open arrow, left) and sprue (S). Cold slug near sprue at centre (open arrow, right).

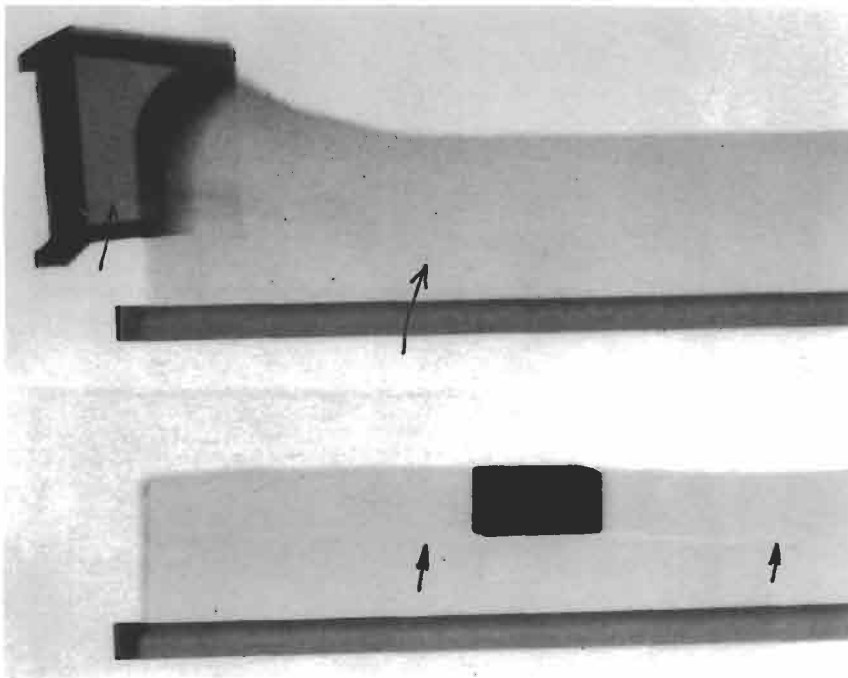
Fig. 9. X-radiograph of side of new tank (top) and part of failed tank (bottom). Trace of flow lines can be seen in the upper radiograph (between the open arrows). The crack is well shown in the lower section (solid arrows). The thick lower edges of both radiographs show variable density along their length due to internal voids.

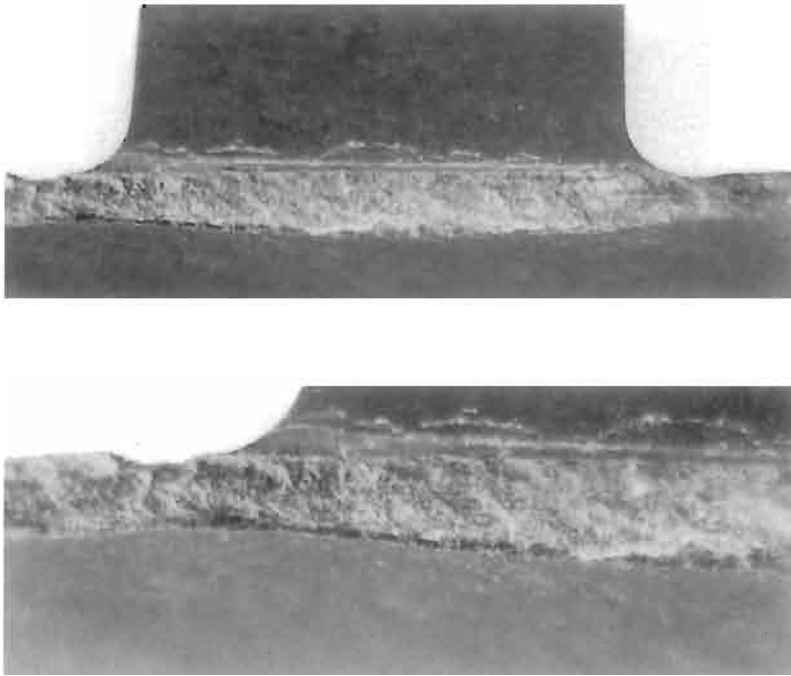
Fig. 10. Close-ups of main crack near buttress corner. Note lower edge shows what appears to be a weld line running into the bulk material.

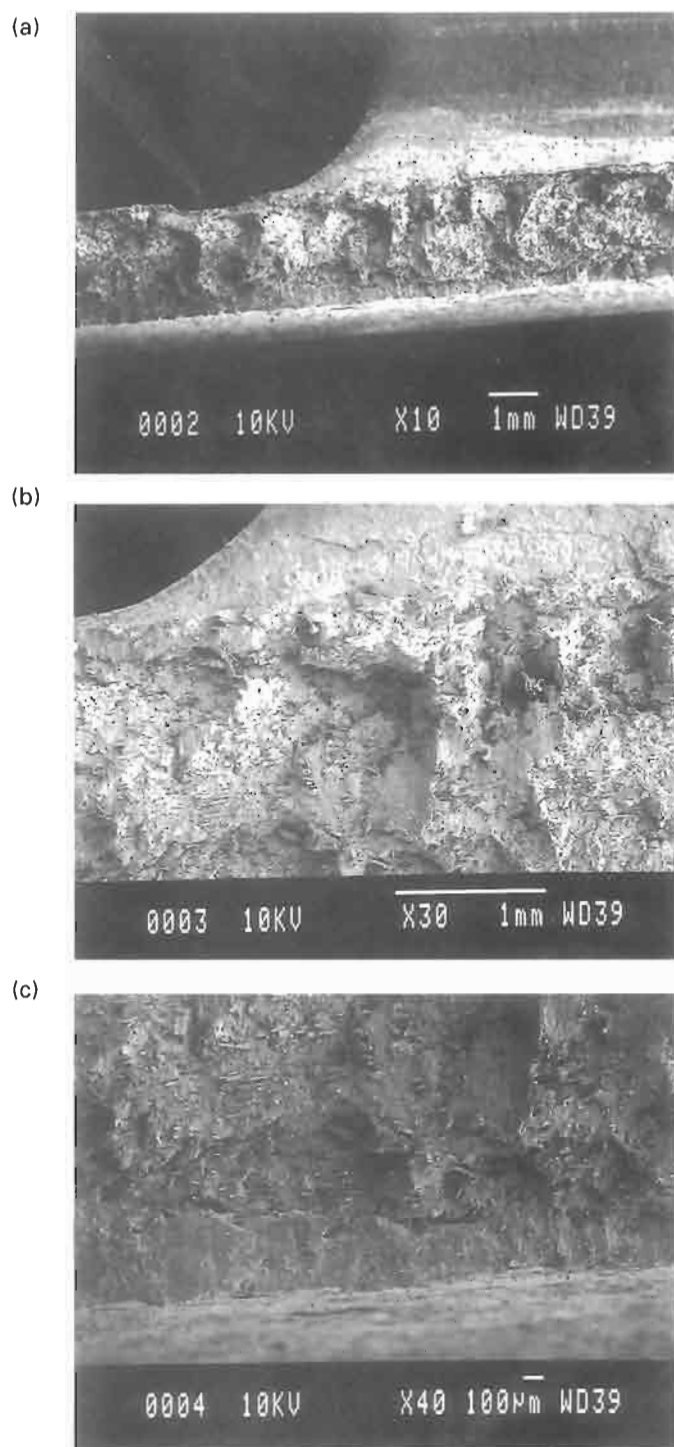
Fig. 11. Various SEM shots of fracture surface.

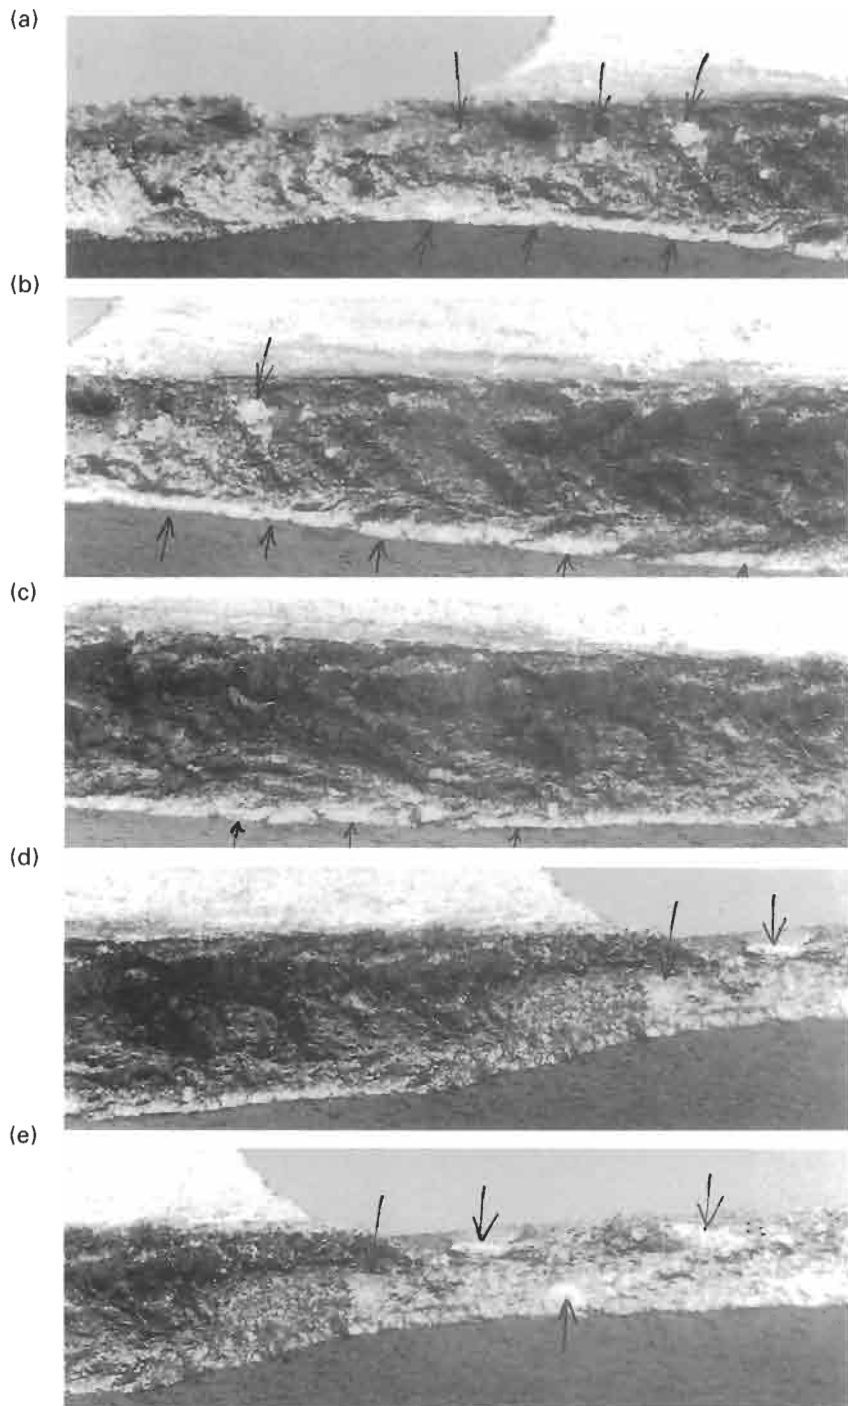
Fig. 12. Panoramic sequence of gold-plated fracture surface, left to right across crack from top to bottom. Remnants of cold slugs and lower weld line shown by open arrows.

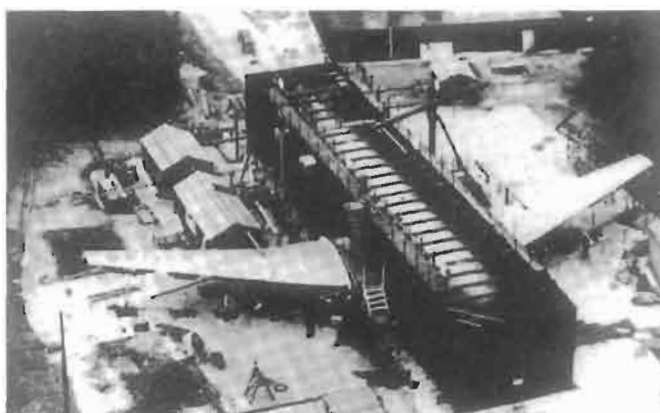
Fig. 2. Aerial view of Comet G-ALYU in testing tank. Crown Copyright. Reproduced with the permission of the Controller of HMSO.

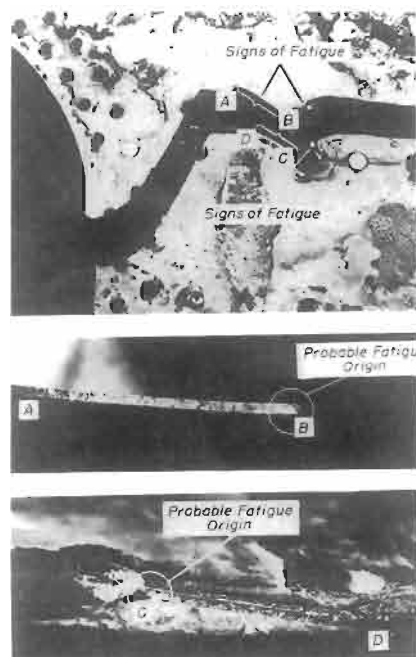
Fig. 4. Close-up views of the failure in the skin of Comet G-ALYP. Crown Copyright. Reproduced with the permission of the Controller of HMSO.

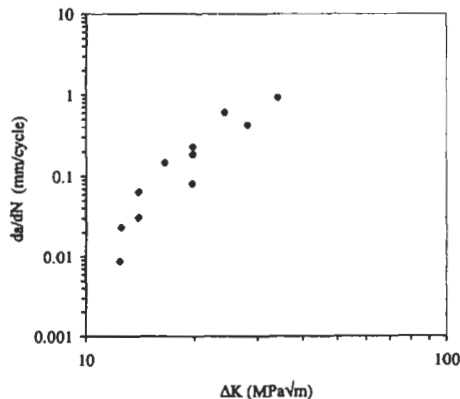
Fig. 5. Fatigue crack growth of the Comet I fuselage.

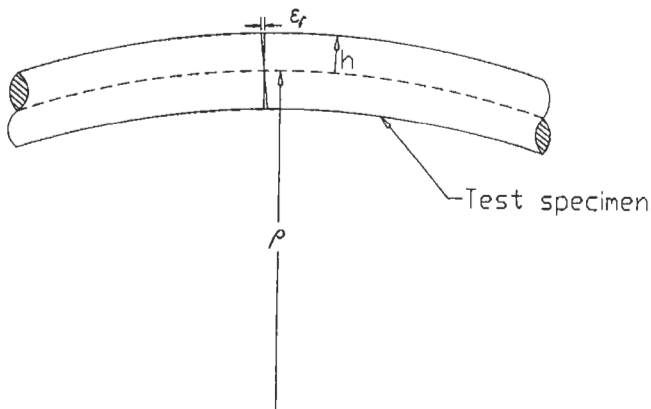
Fig. 2. Bending strain figure.

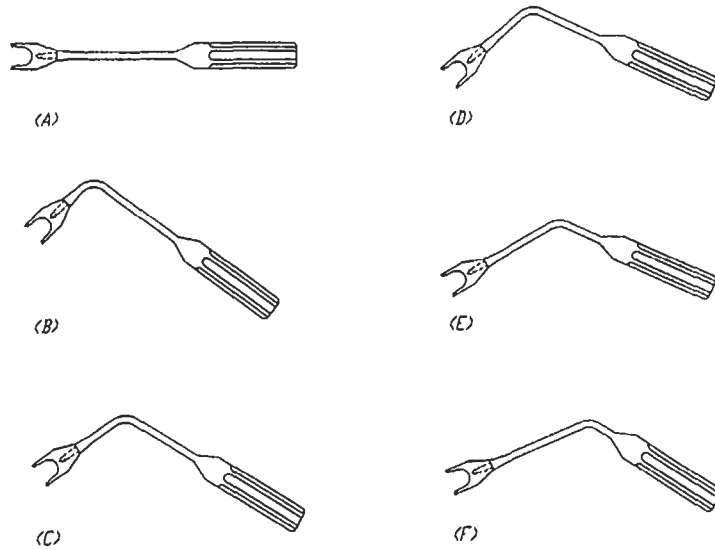
Fig. 3. Handle holder with typical bends used in surgery. (A) Handle holder before bending. (B-F) Handle holder with typical bends.

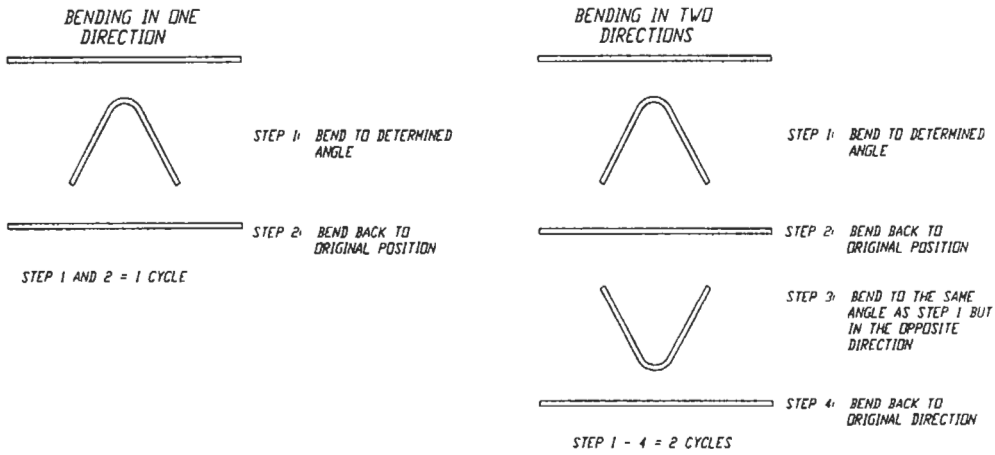
Fig. 5. Description of testing conducted.

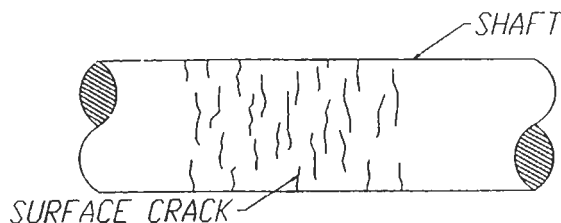
Fig. 6. Surface cracks.

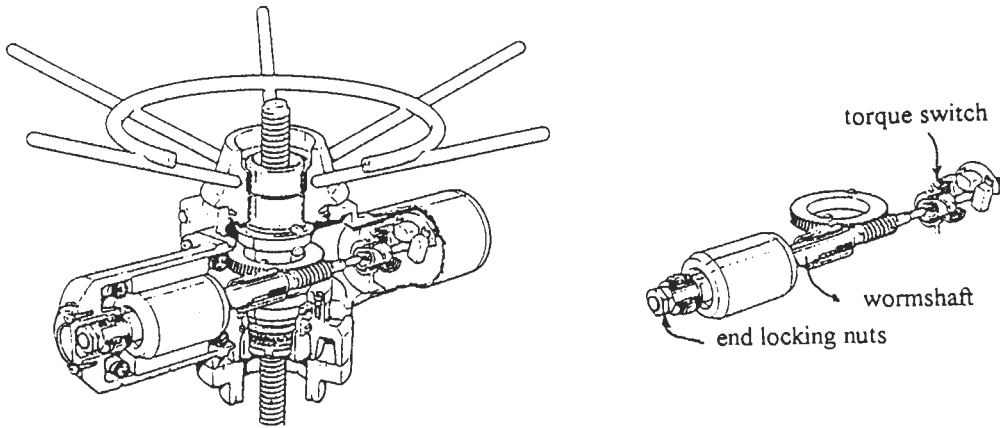
Fig. 1. Schematic diagram of a conventional Rotork actuator. The recessed locking nut (failure site) and wormshaft are clearly visible.

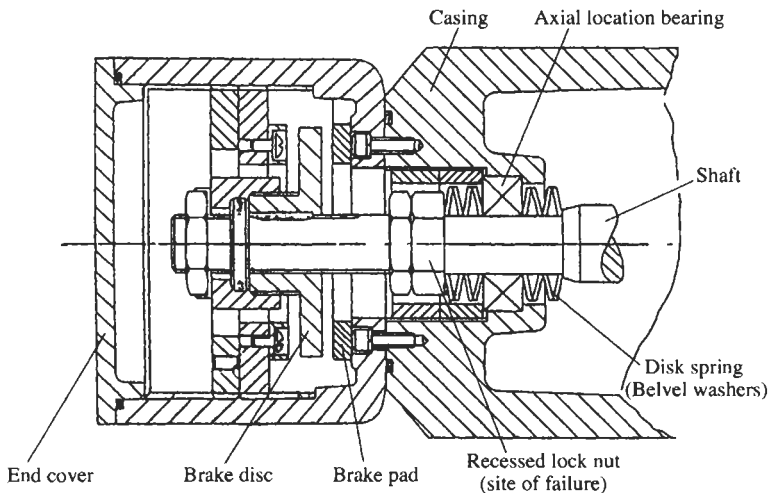
Fig. 2. Diagram of the modification made to the Rotork NABT 4 valve actuator, incorporating in particular the brake disc. The Belvel washer disc spring, locking nuts and axial location bearing are clearly apparent.

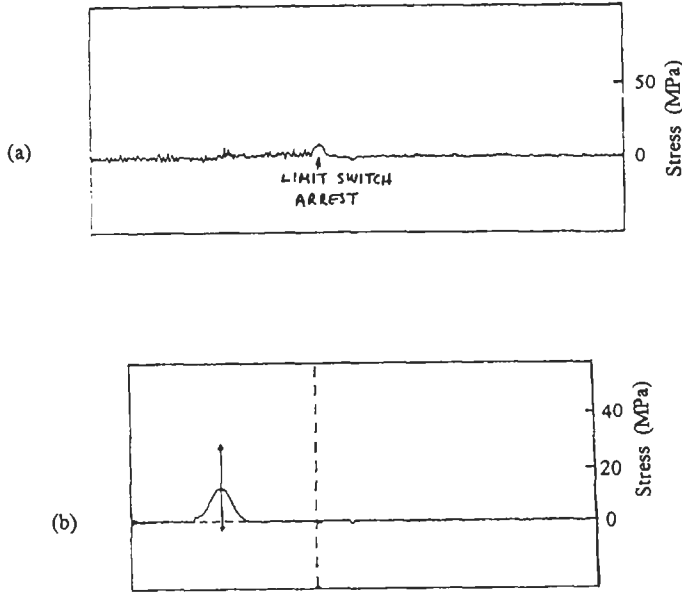
Fig. 5. Strain time traces for limit switch operation and arrest for (a) bending and (b) tension. In both cases the resultant stresses are small.

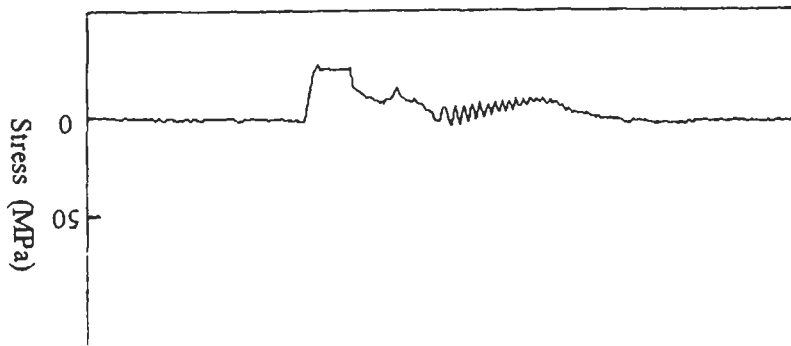
Test number	Measured strain offset after stall ( $\mu\epsilon$ )	Measured cyclic strain ( $\mu\epsilon$ )	Measured peak strain ( $\mu\epsilon$ )	Stress offset (MPa)	Cyclic stress (MPa)	Peak stress (MPa)
1	1567	502	2310	130	42	191
2	1732	630	2420	143	52	200
3	1780	583	2169	147	48	180
4	2024	575	2288	168	48	189
5	1970	620	2222	163	51	184
6	1582	625	2156	131	52	179
Mean	1776	589	2261	147	48.8	187

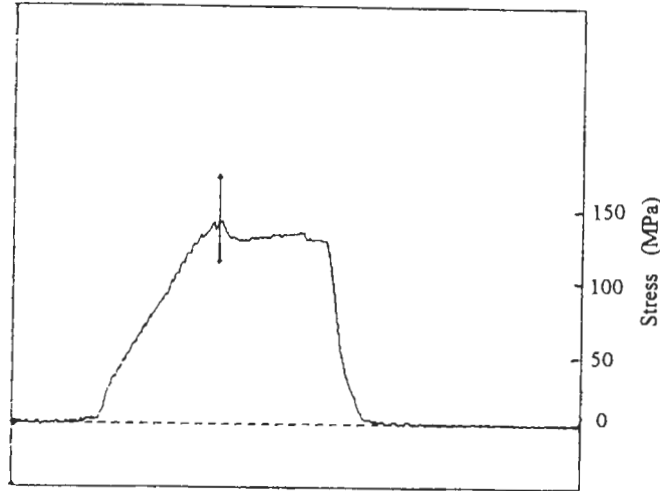
Fig. 7. Strain time trace in the bending configuration under so called "stall" conditions, with the disc brake completely removed. Far from exhibiting minimal stresses the trace shows substantial offset bending strains imposed through the Belvel washers and recessed nut assembly.

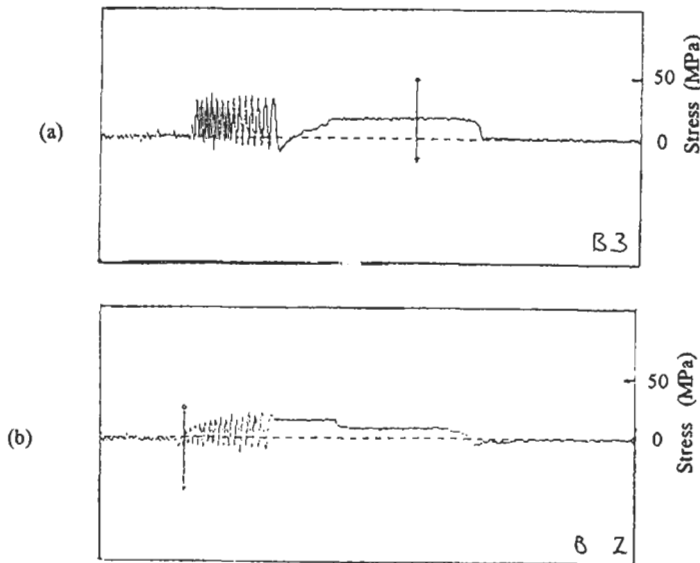
Fig. 8. Strain time traces for the long nut in bending configuration for arrest from (a) the disc brake and (b) under “stall” conditions with the disc brake removed (comparable to Figs 4 and 7). The large offset stress has effectively been removed.

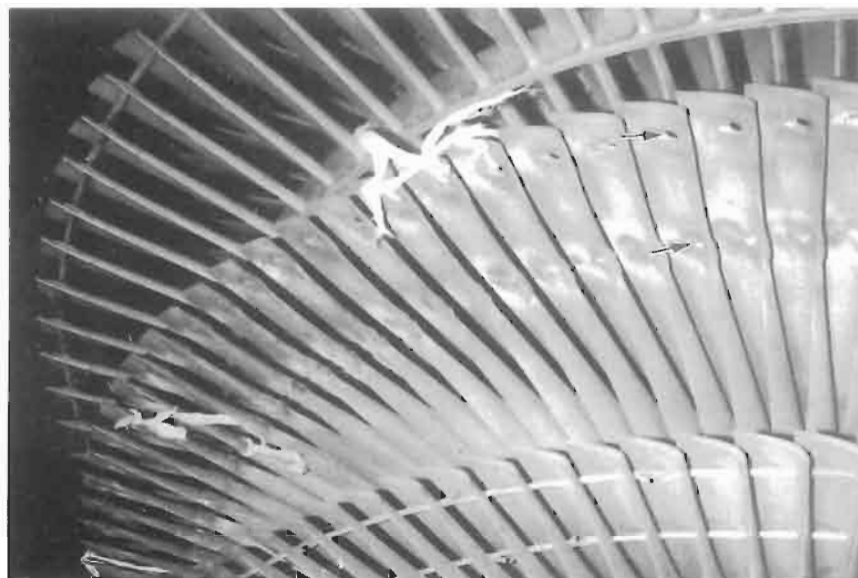
Fig. 1. Photograph showing the assembly of the blade without the lacing wire which has been removed by debrazing. Arrows indicate the position of lacing holes from where crack initiation occurred.

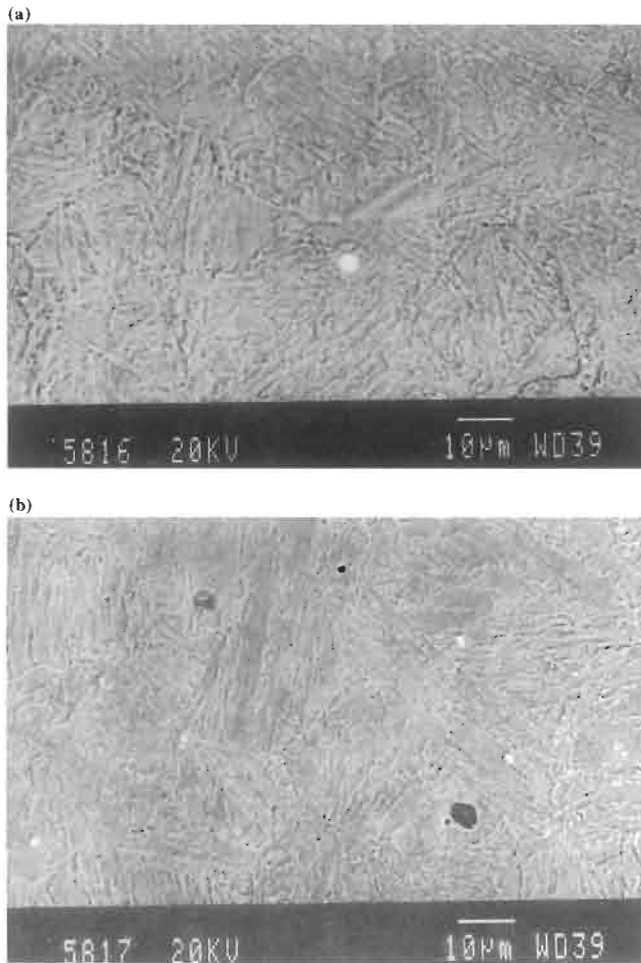
Fig. 2. (a) Tempered martensitic microstructure of the blade material; (b) tempered bainitic microstructure of lacing rod.

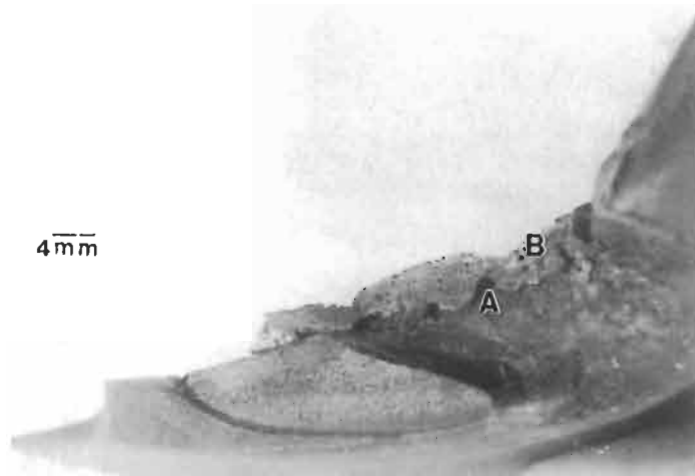
Fig. 3. Low magnification image of the fractured surface of the blade showing physical discontinuities (marked as A) and holes (marked as B) in the braze joint.

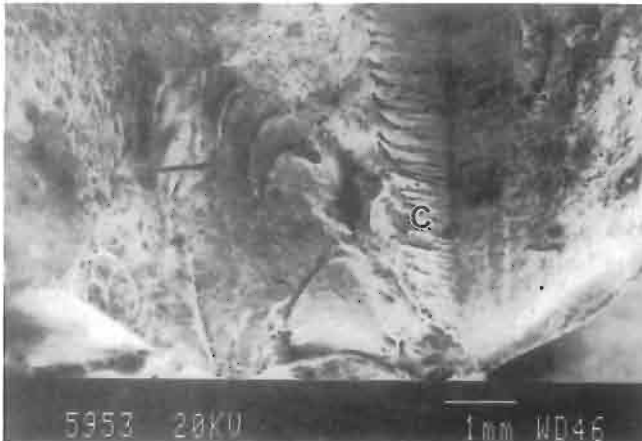
Fig. 4. (a) Crack initiation points marked by arrow head in optical micrograph; (b) SEM fractograph taken from area marked as 'X' in Fig. 4(a); (c) SEM fractograph from area marked as 'Y' in Fig. 4(a). Arrows indicate crack growth directions (dark line at the centre indicates the cut-mark along which fracture surface was cut into two pieces for SEM observation).

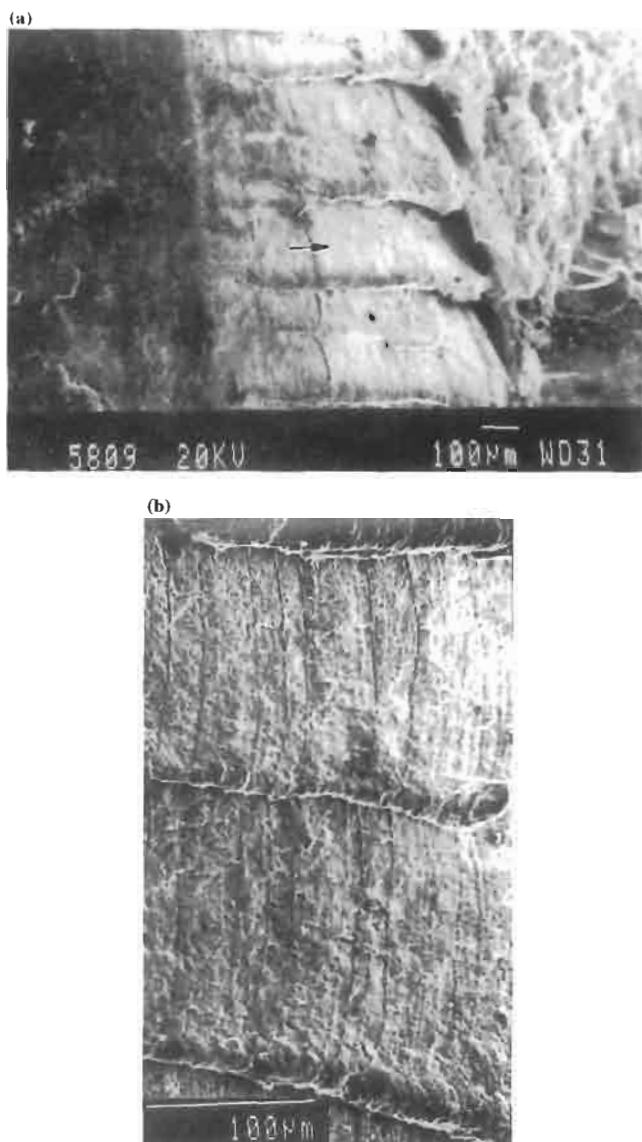
Fig. 5. (a) Enlarged area marked as 'C' in Fig. 4(c); (b) magnified portion of (a) revealing fatigue striations and ratchet markings. Arrow indicates the crack growth direction.

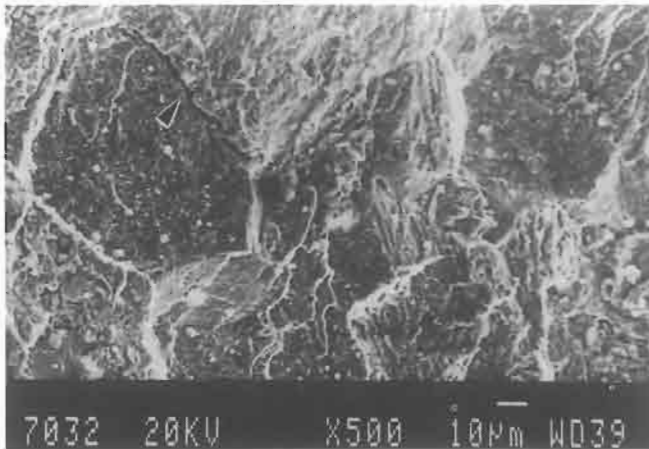
Fig. 6. Fractograph from the site marked as 'Z' in Fig. 4(a) showing the presence of intergranular features. Intergranular crack is indicated by the arrow head.

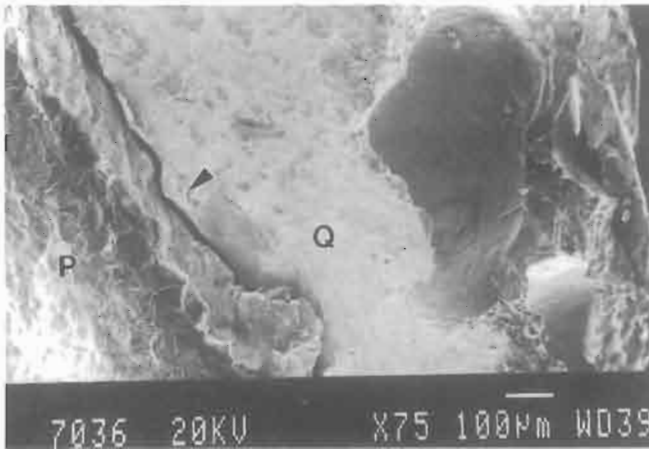
Fig. 7. Decohesion at the braze-blade interface (marked by arrow head). P: blade; Q: corroded portion of the braze.

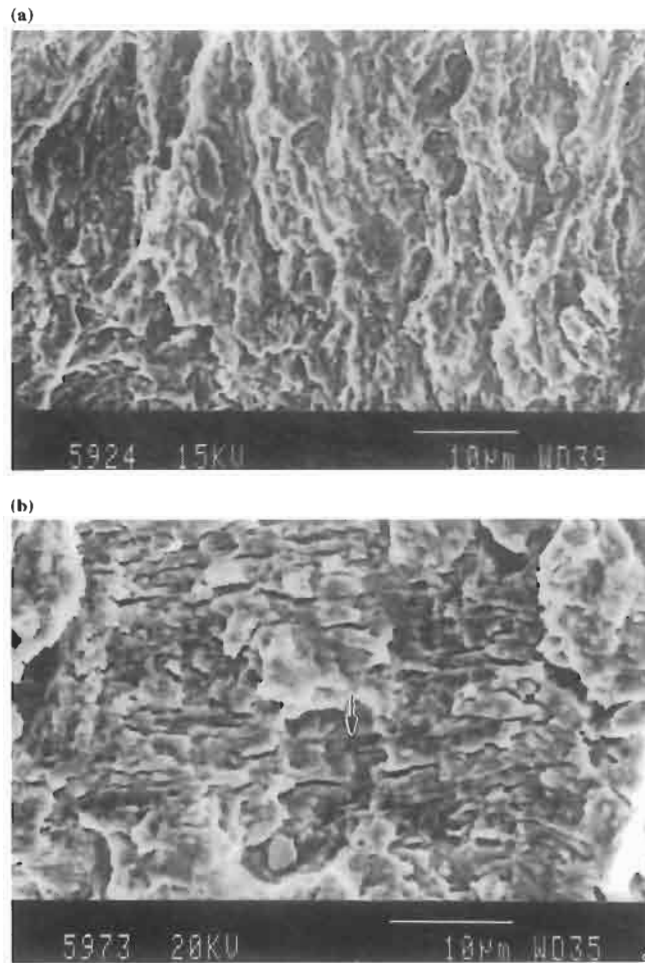
Fig. 8. Fractograph from simulated HCF test 1(a) and test 2(b). Fatigue striations can be noted in (b).

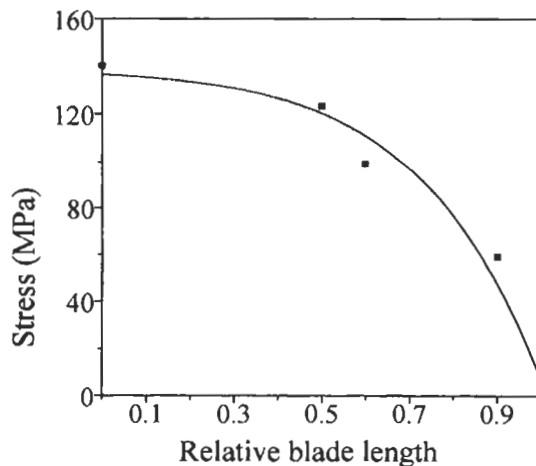
Fig. 9. Pattern of centrifugal stresses in an LP blade during operation at 50 Hz frequency.

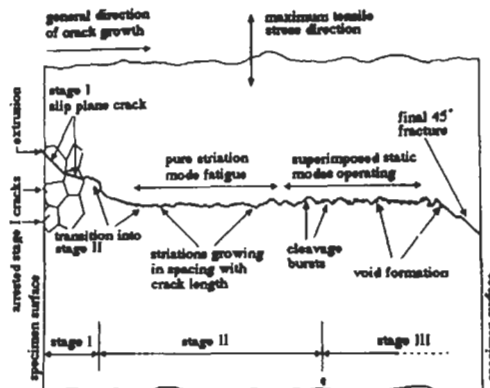
Fig. 10. Schematic diagram showing the nature of crack growth behaviour.

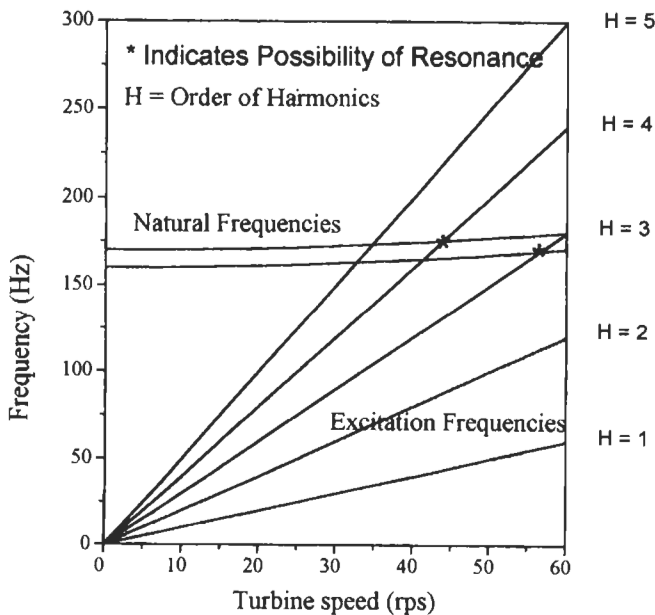
Fig. 11. Campbell diagram for understanding the possibility of resonance.

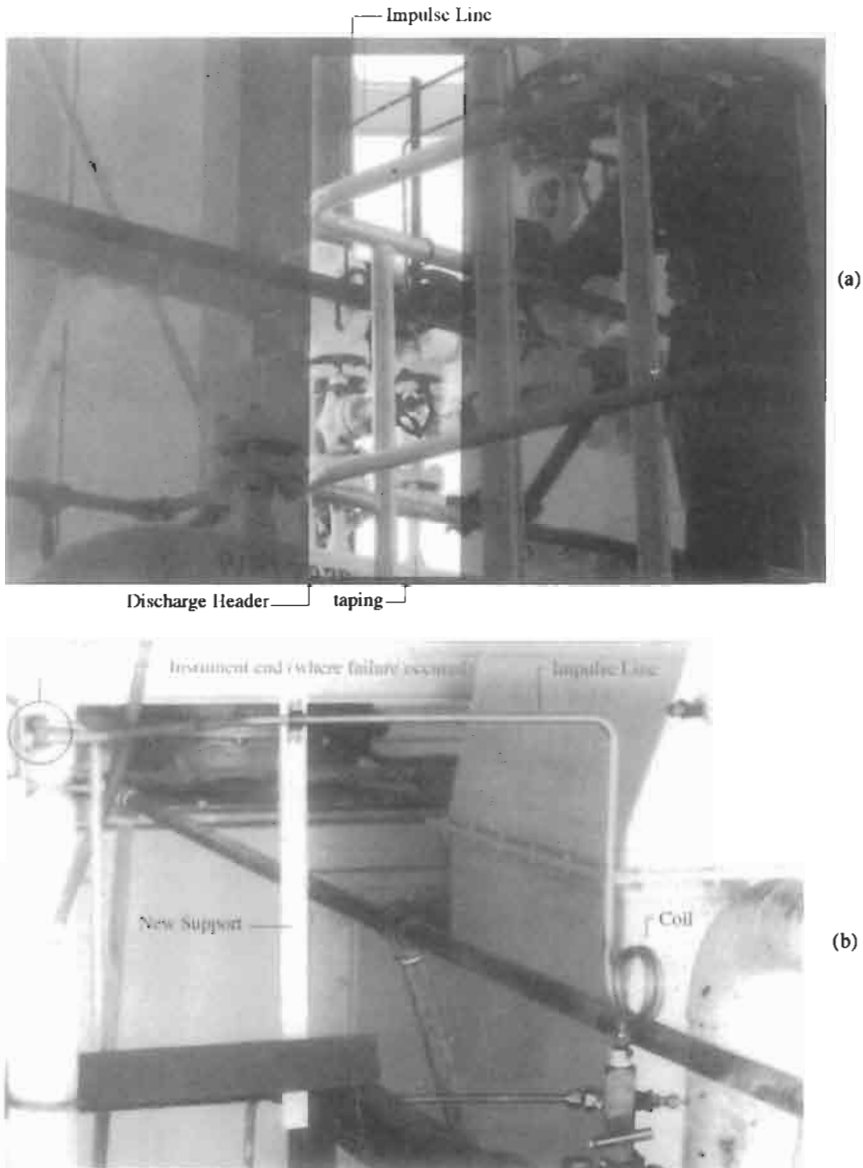
Fig. 1. A general view of the discharge header: (a) shows three pressure taps, two are connected, one is flanged-off. (b) shows a close-up of the impulse line, depicting the connection-type, coil, and support.
