***FAILURE  
ANALYSIS  
CASE  
STUDIES II***

Edited by  
**D.R.H. Jones**

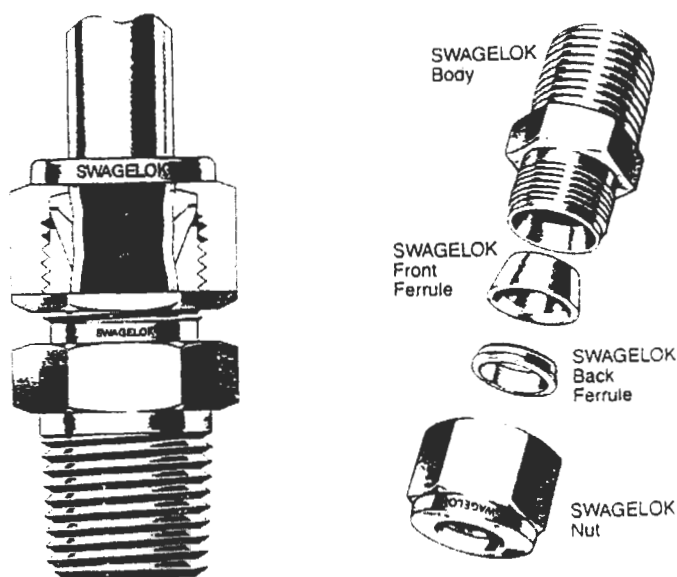
Fig. 2. 'Swagelok' connection type.

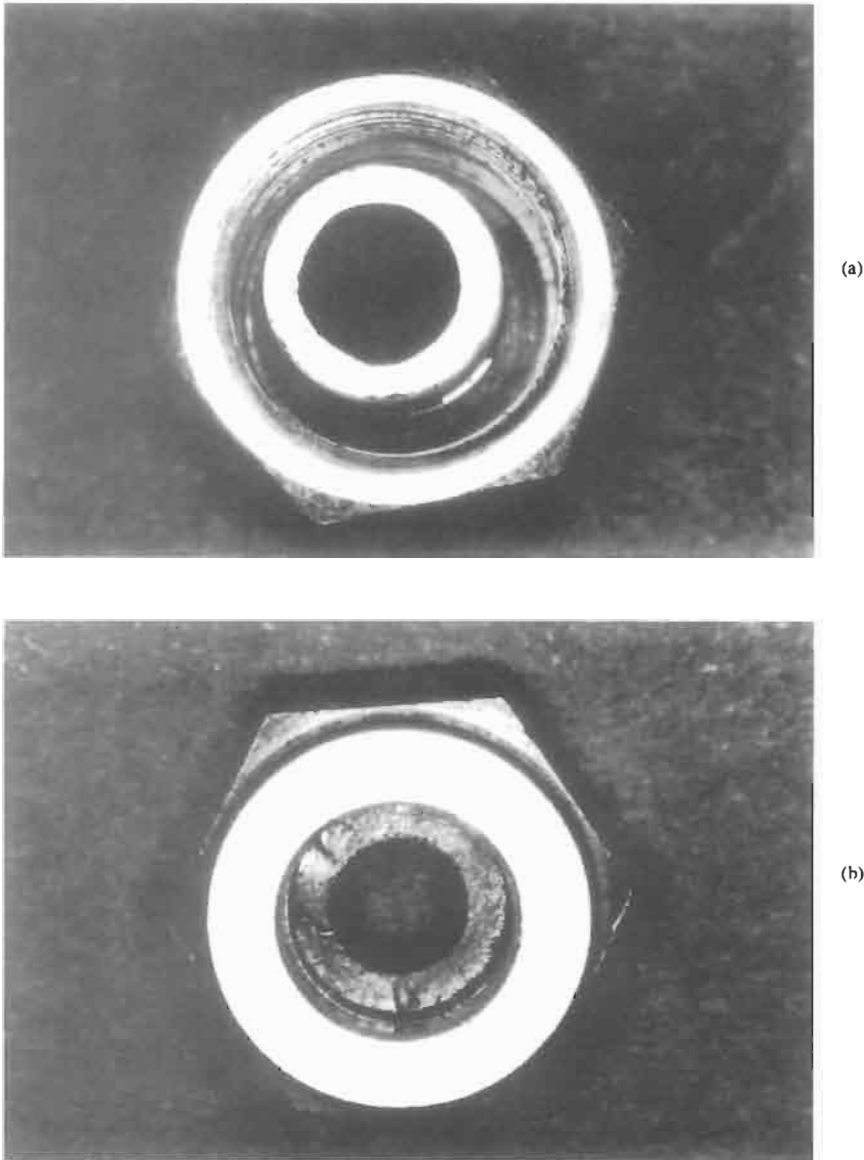
Fig. 3. End connector with the factured piece jammed inside the nut.

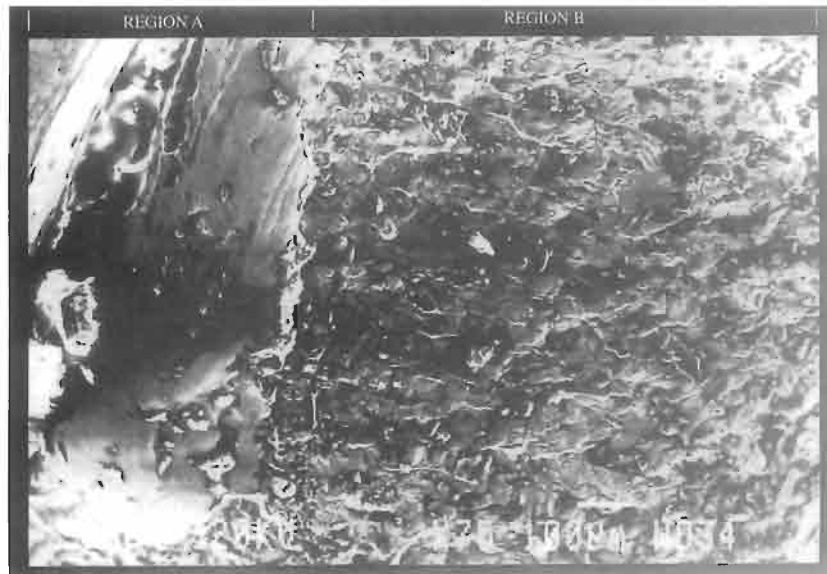
Fig. 4. Fracture surface taken close to the outer layer of the tubing.

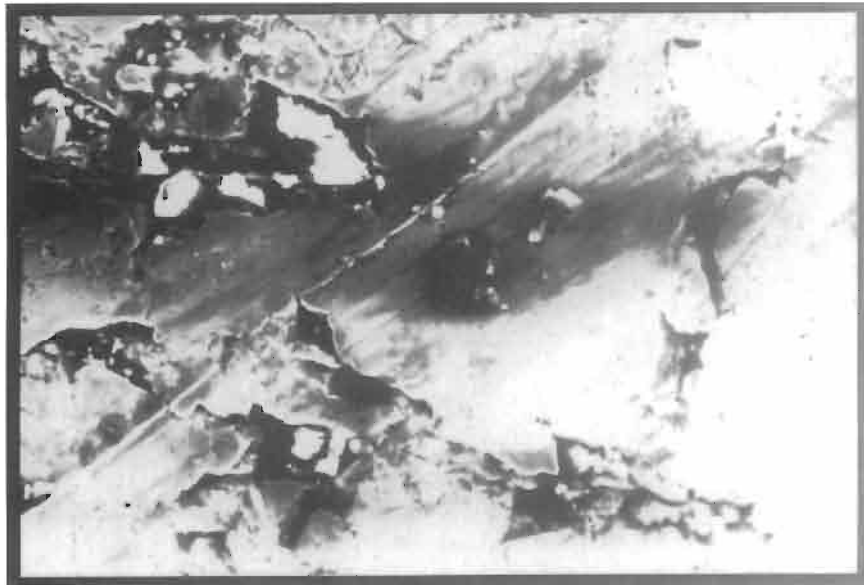
Fig. 5. Fracture surface within REGION A of Fig. 4.

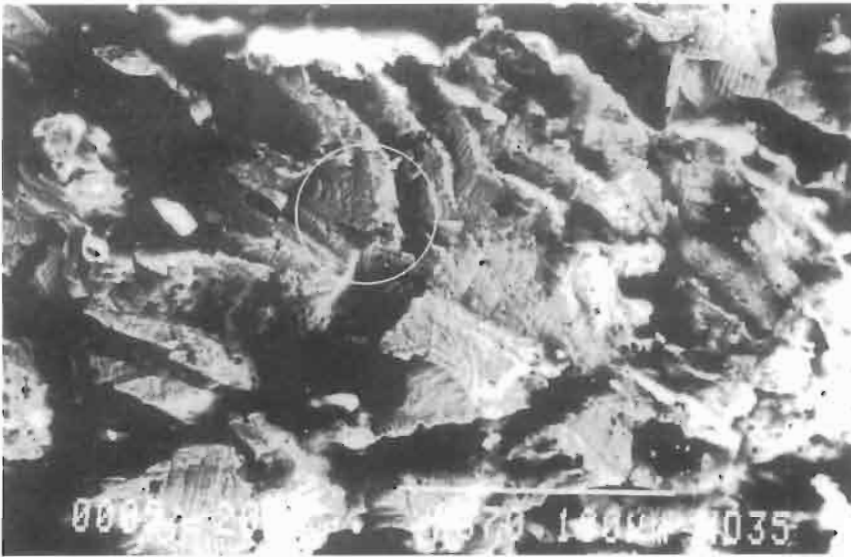
Fig. 6. Fracture surface away from the outer edges.

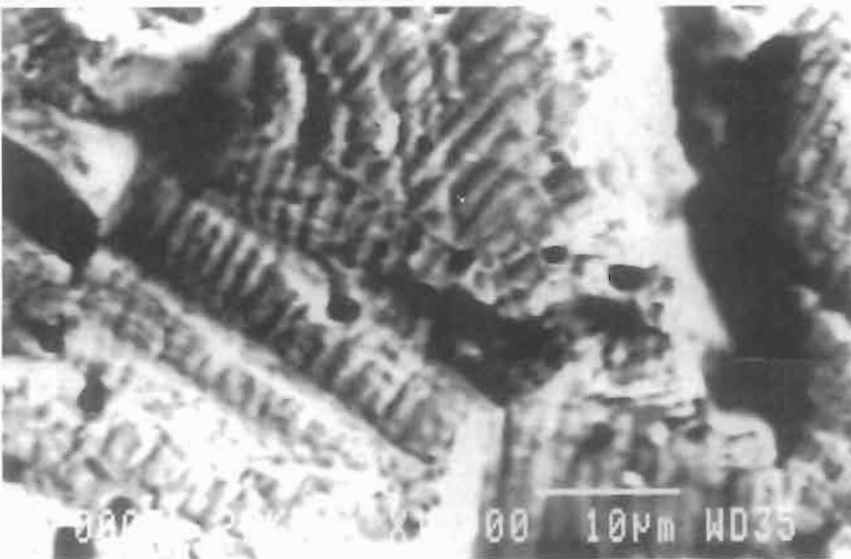
Fig. 7. Close-up view of the highlighted area in Fig. 6.

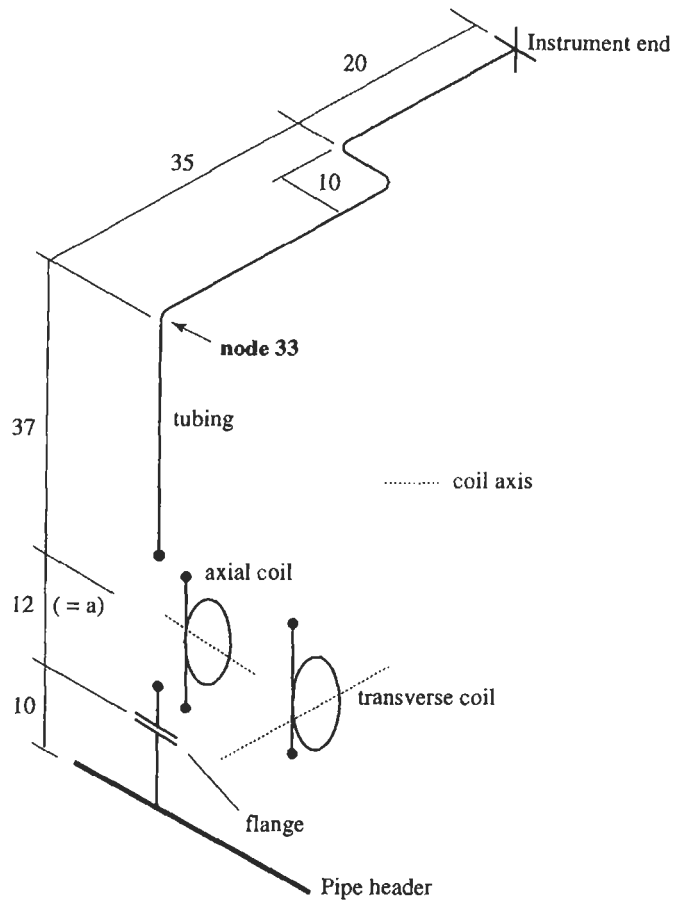
**Tubing:** Outside diameter,  $d_o = 9.5$  mm  
 Inside diameter,  $d_i = 6.3$  mm  
 Stainless steel type 316

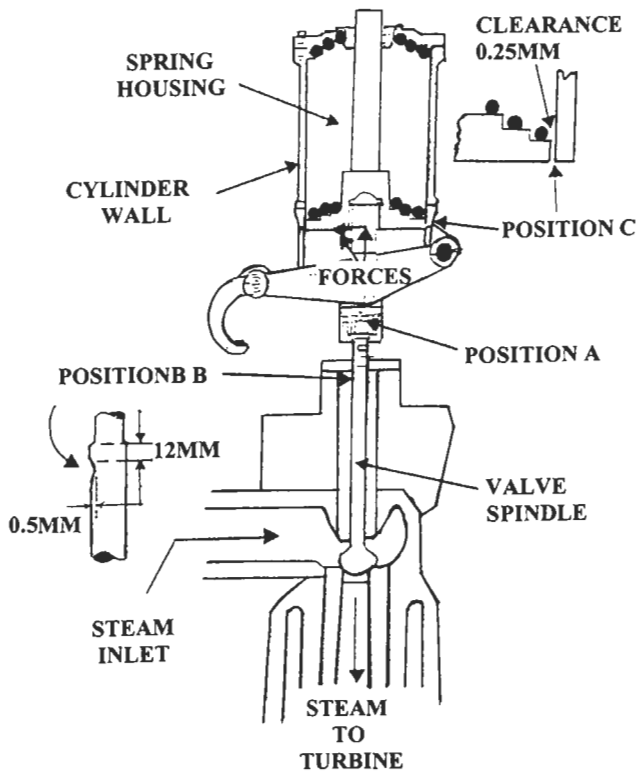
Fig. 1. Valve spindle system.

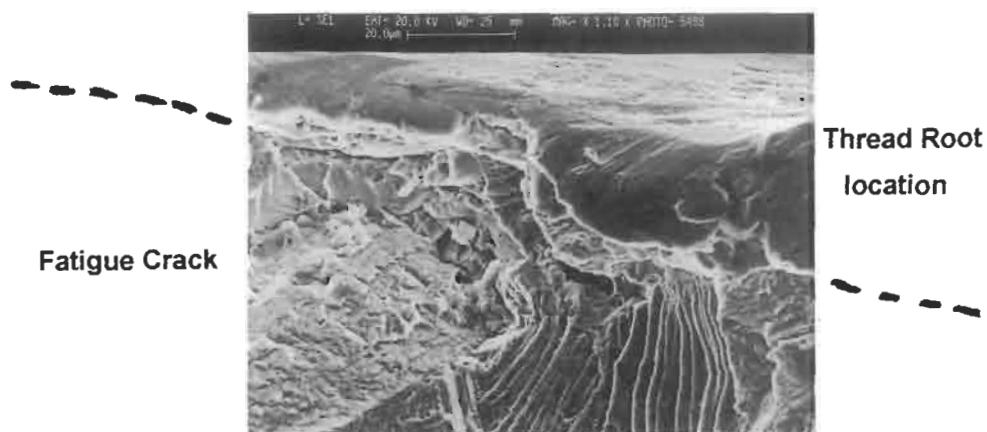
Fig. 2. Fatigue initiation site at thread root location.

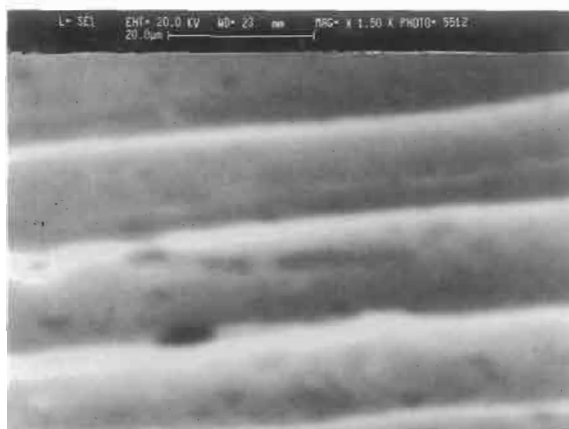
Fig. 3. Coarse fatigue striations. Striation spacing around 15  $\mu\text{m}$ .

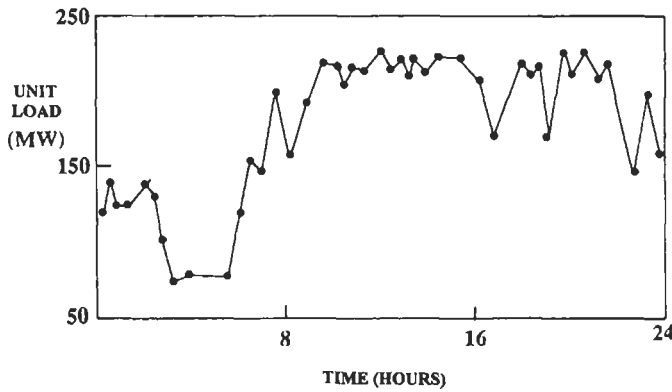
Fig. 4. Typical load profile.

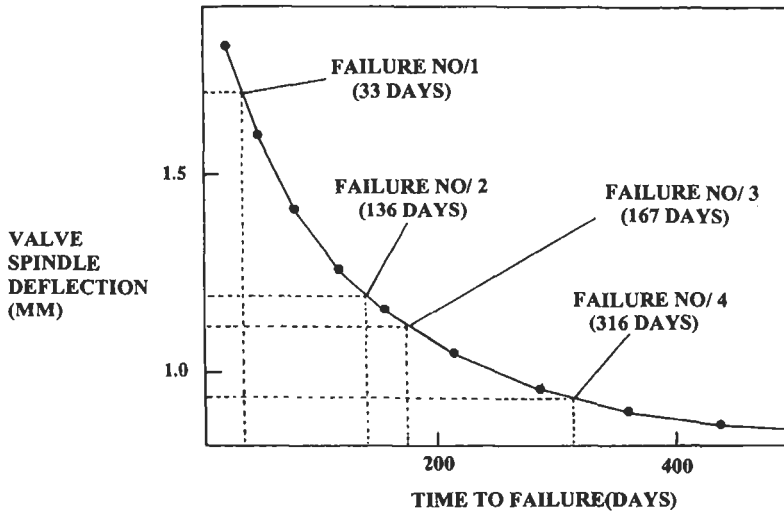
Fig. 5. Time to fatigue failure versus spindle deflection.

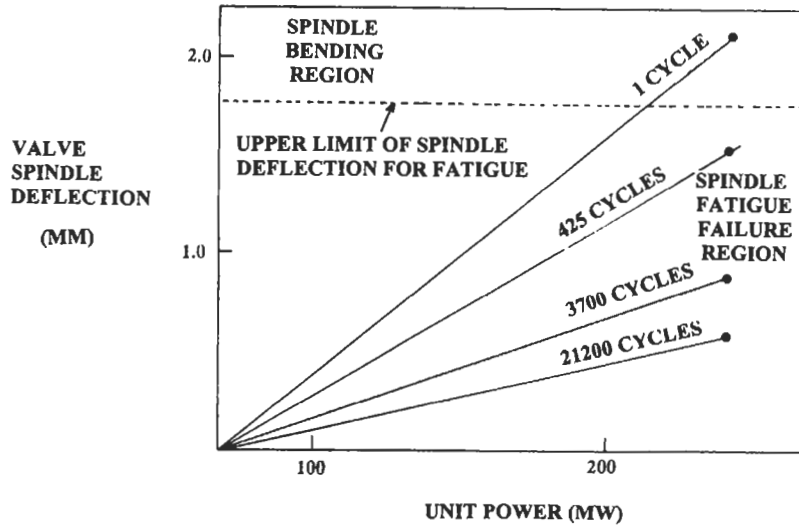
Fig. 6. Schematic of spindle deflection versus unit power and calculated cycles to fatigue failure.

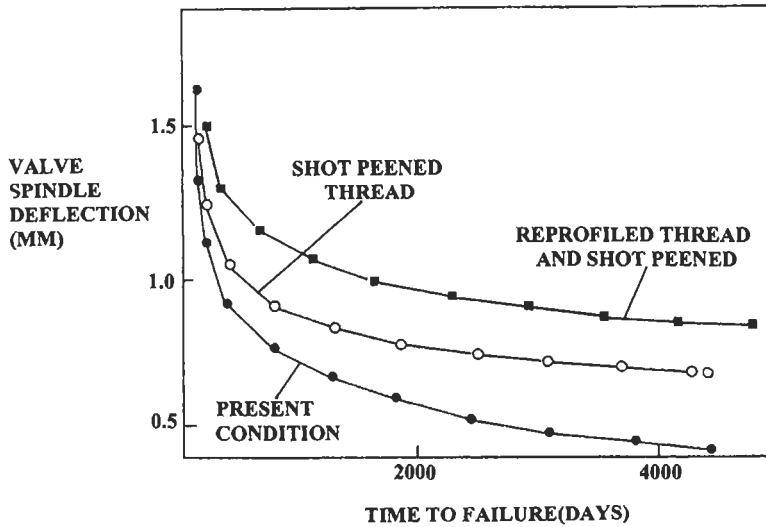
Fig. 7. Time to fatigue failure versus spindle deflection.

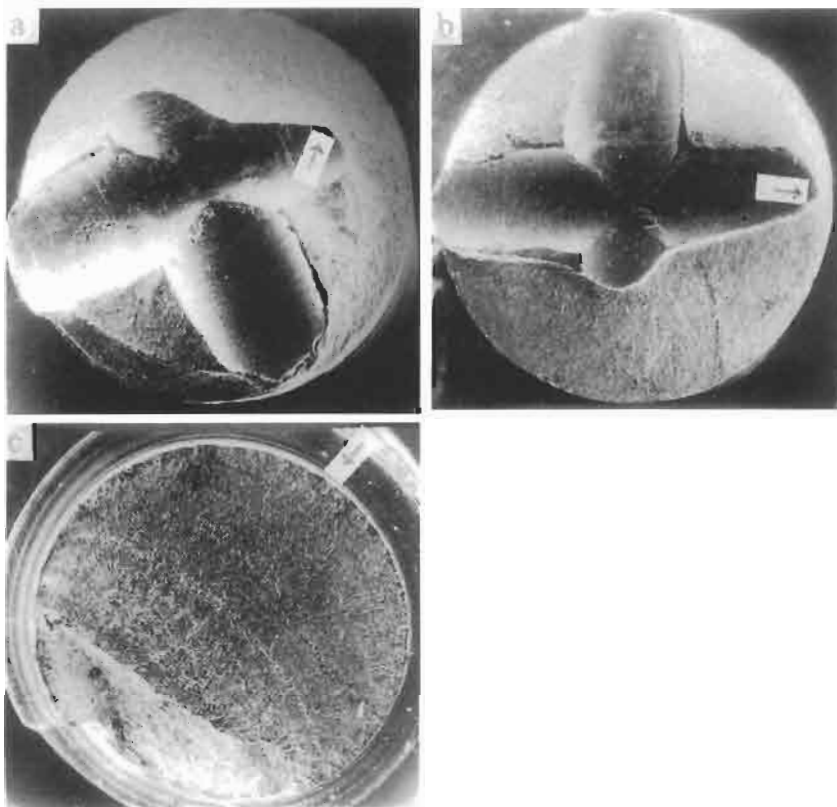
Fig. 2. Fracture surfaces of bolts. (a) 1#; (b) 2#; (c) 3#. Fracture origins are marked with an arrow.

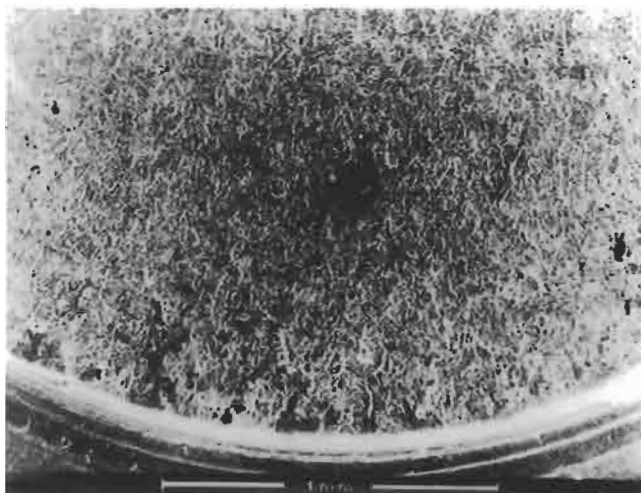
Fig. 3. Fatigue origin zone of 3# bolt.

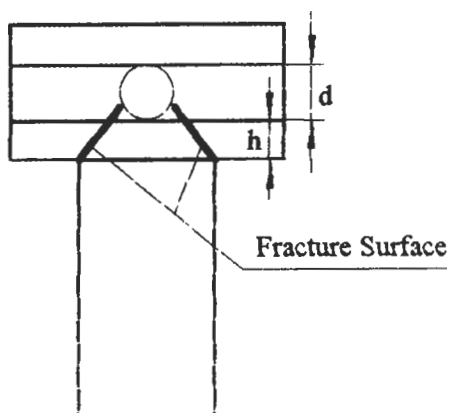
Fig. 5. Schematic of fracture position of 1# and 2# bolts.

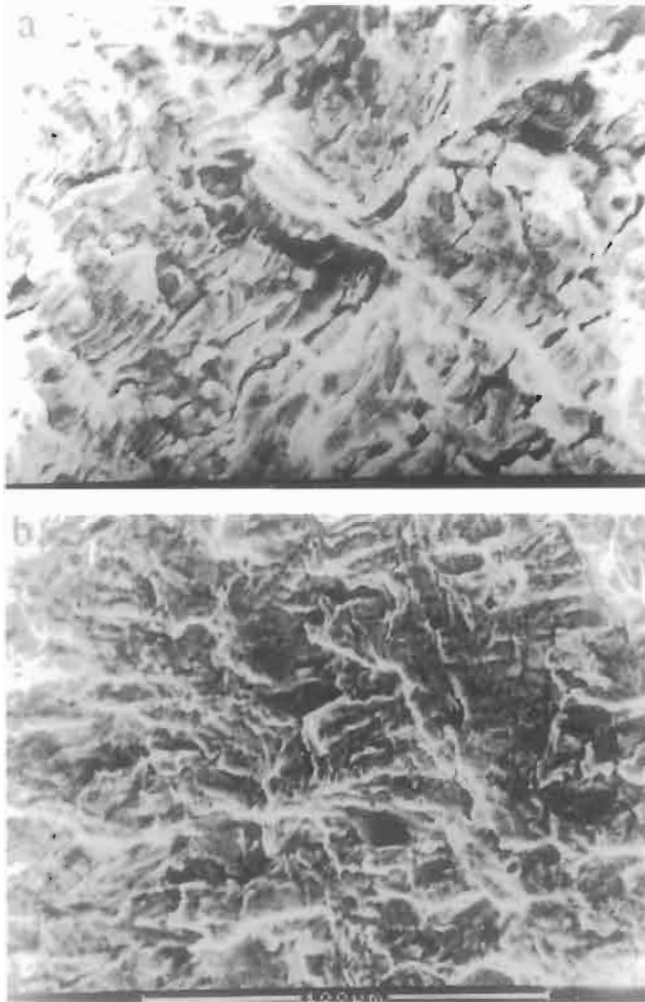
Fig. 6. Photographs of the fracture surfaces taken in the SEM. (a) 1#; (b) 2#.

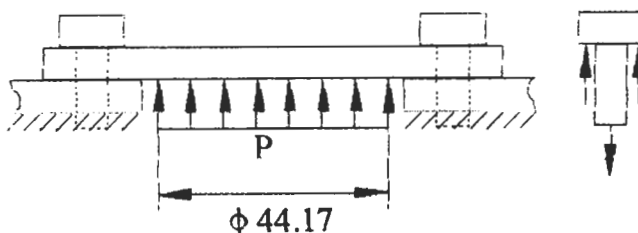
Fig. 7. Forces acting on the bolts.

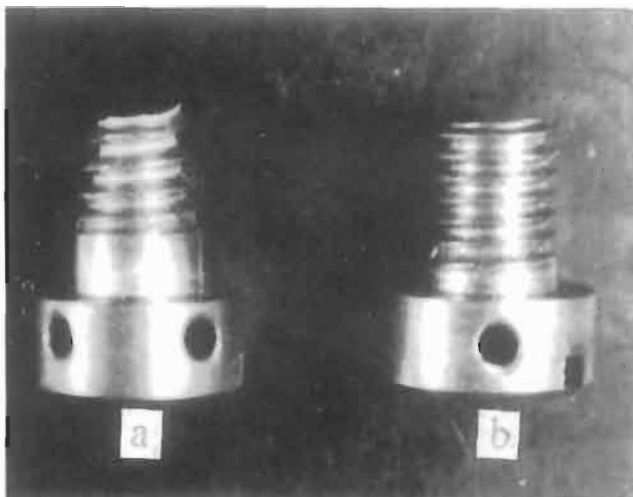
Fig. 9. Comparison of fracture surfaces for (a) tensile fracture, and (b) 3# bolt fatigue fracture.

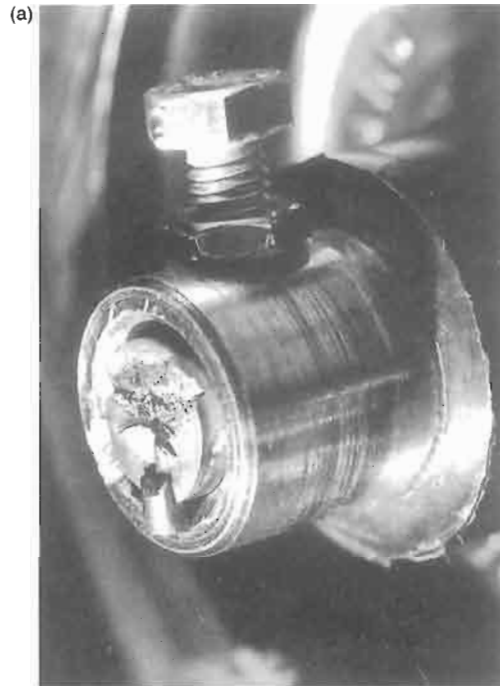
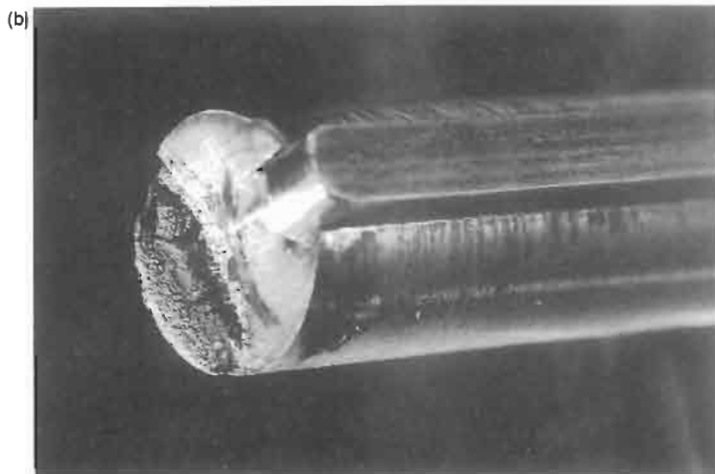
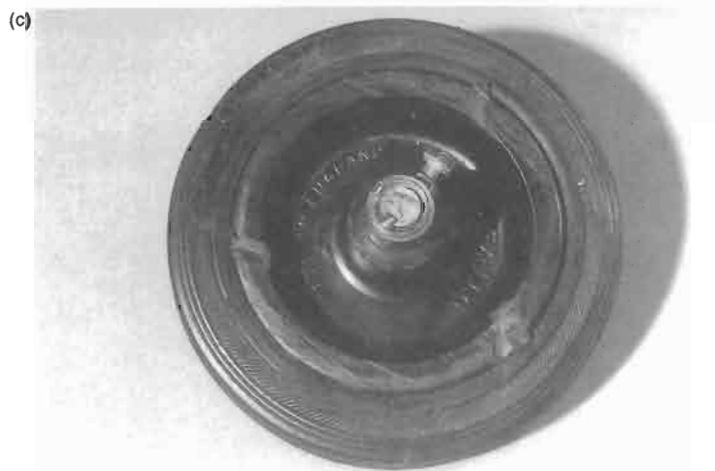
Fig. 3. The failed wheel shaft. (a) and (b) close examination of fracture; (c) failed hub portion and wheel.

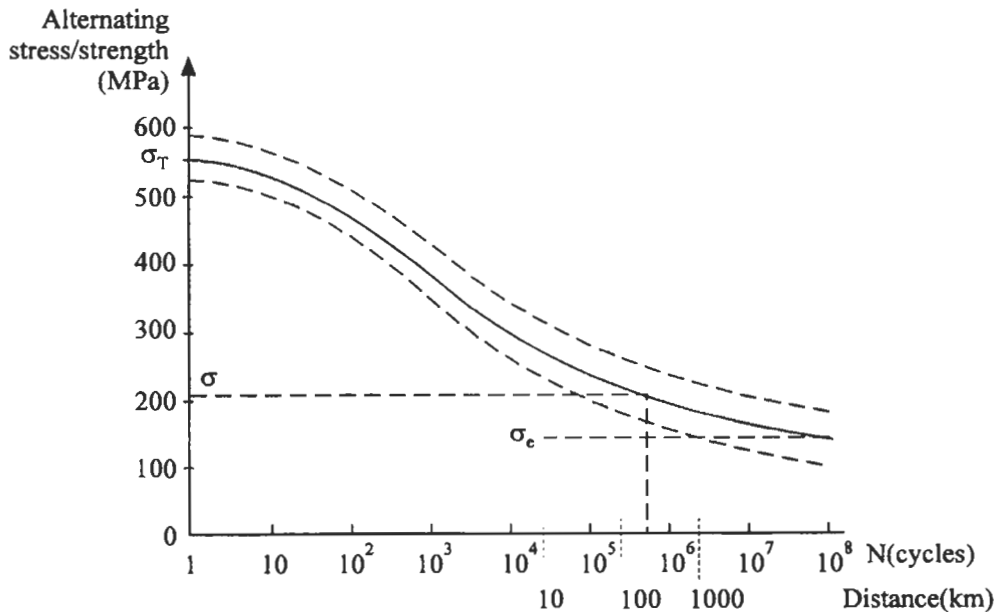
Fig. 4. Predicted  $S-N$  curve for stainless steel with stress concentration.

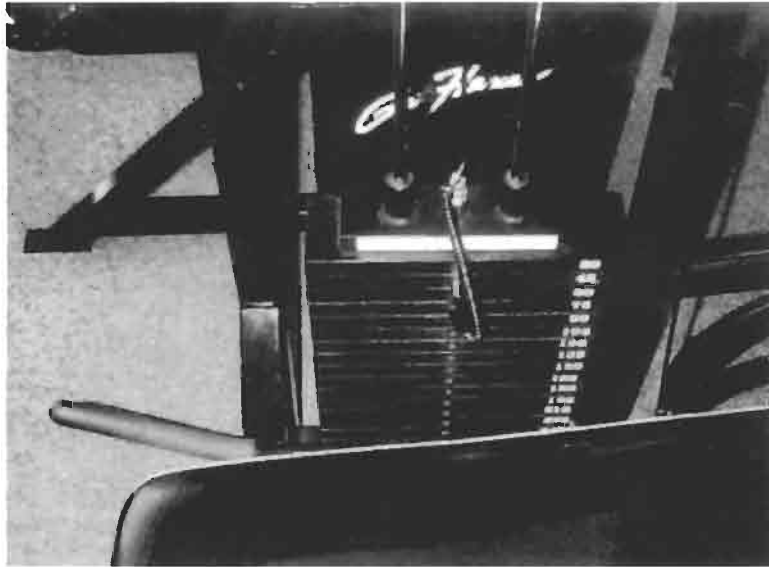
Fig. 4. Picture of weight stack.

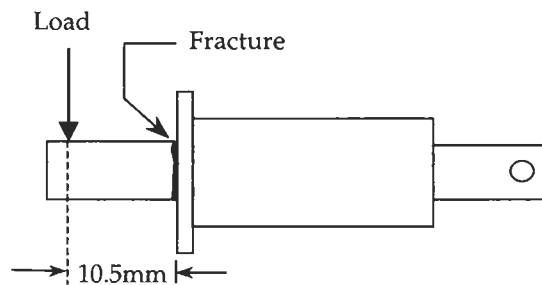
Fig. 5. Diagram of pin loading and failure.

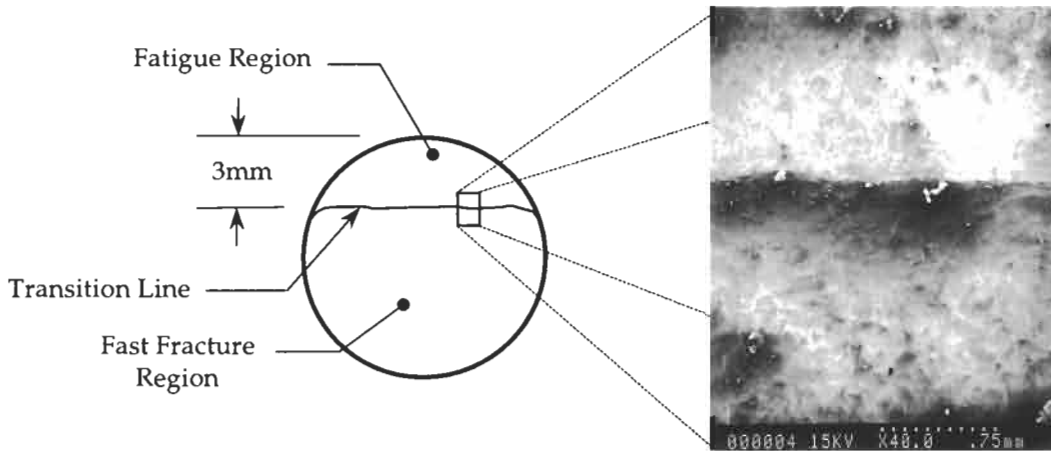
Fig. 6. SEM picture of the transition region from fatigue to fast fracture.

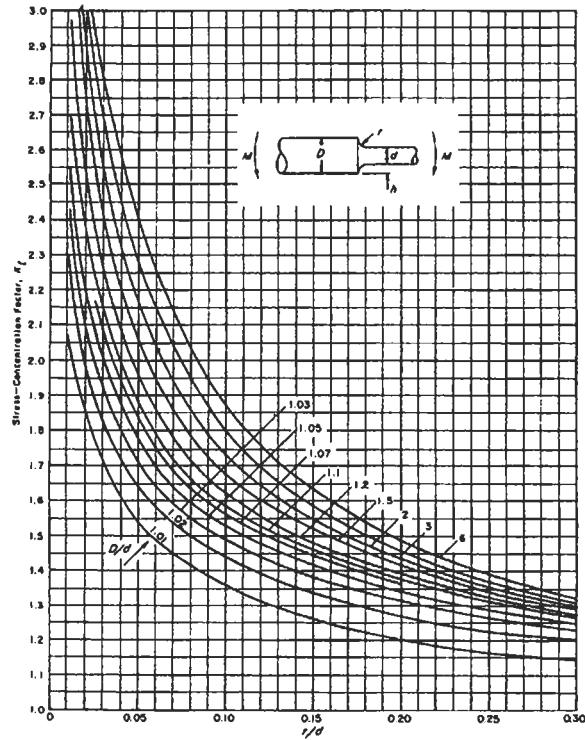
Fig. 7. Elastic stress concentration for a round shaft in bending. (Reprinted with permission from Machine Design, 1951. A Penton publication.)

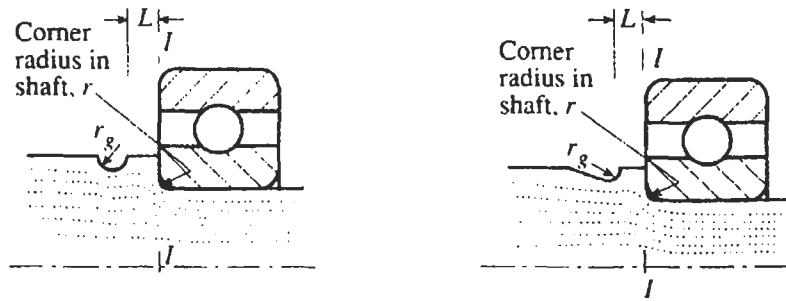
Fig. 10. Examples of relief grooves behind the shoulder to reduce the stress concentration at the radius,  $r$ . (Peterson's Stress Concentration Factors, Walter D. Pilkey, © 1997. Reprinted by permission of John Wiley & Sons.)

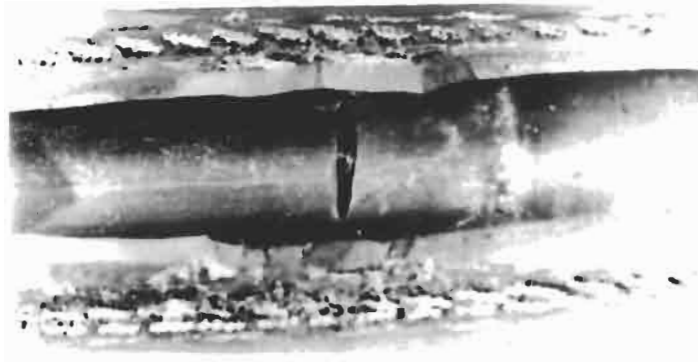
- (1) The steel wire layer was intact.
- (2) In all A type hosepipes, there was only one opening in the inner rubber layer. Similar results were obtained for most B type hosepipes except two, where two openings were observed.
- (3) The opening in the inner rubber layer was situated in the outside of the bend near the metal elbow adapter. The distance between the opening and the metal core is about 2.0–12.5 mm (see Fig. 2).
- (4) The openings in the inner rubber layer are circumferential, as shown in Fig. 2.
- (5) No other defects were observed in the inner layers of the hosepipes.

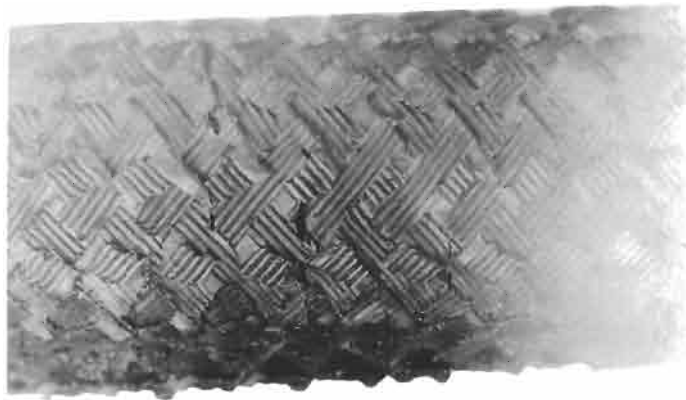
Fig. 3. The openings in the outer surface of the inside middle layer.

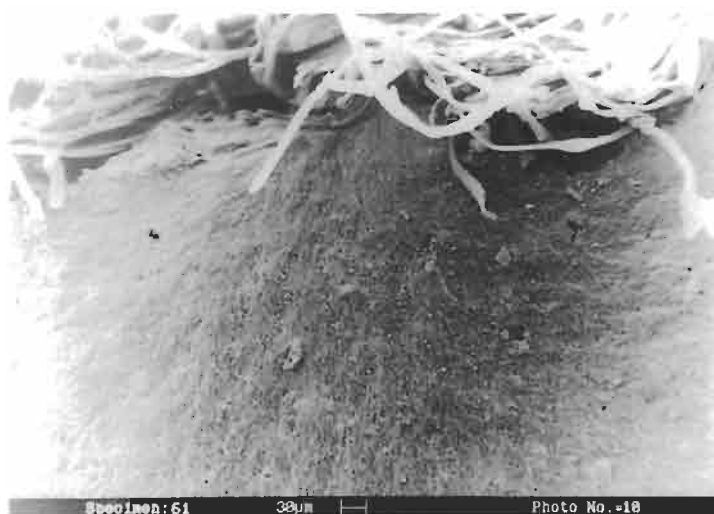
Fig. 4. The fracture appearance of an A type hospipe.

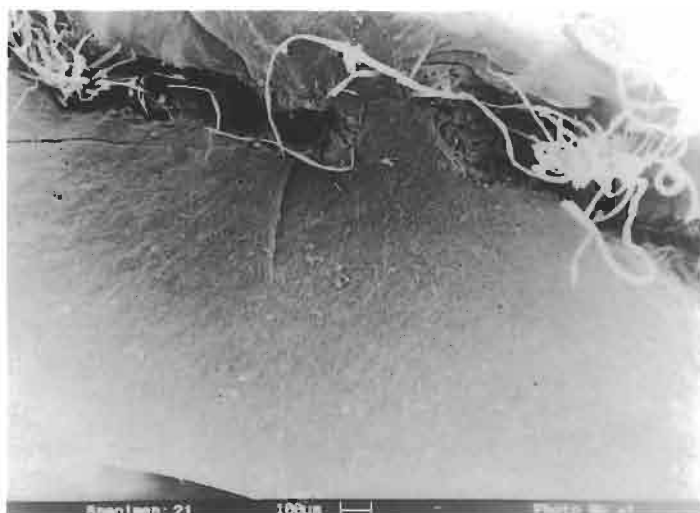
Fig. 5. The fracture appearance of a B type hosepipe.

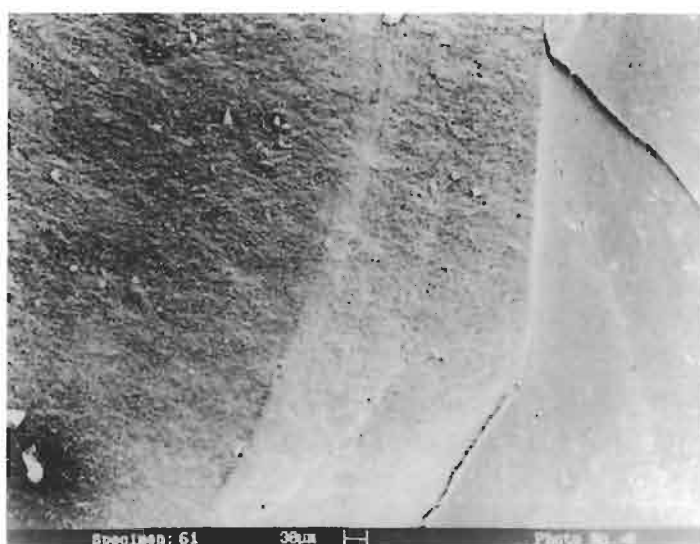
Fig. 6. Fatigue beach marks.

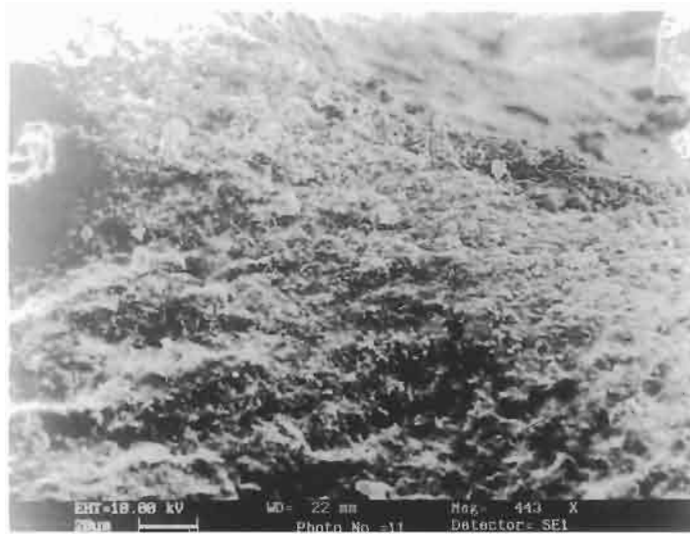
Fig. 7. The fracture appearance of small cracks.

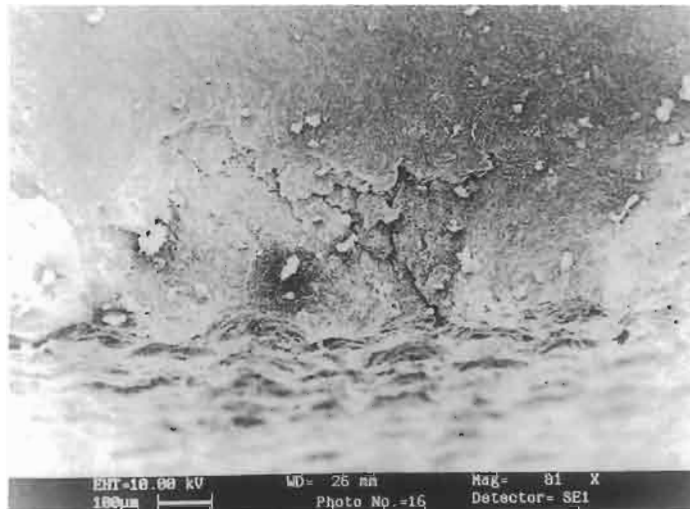
Fig. 8. The fracture appearance of the outer layer.

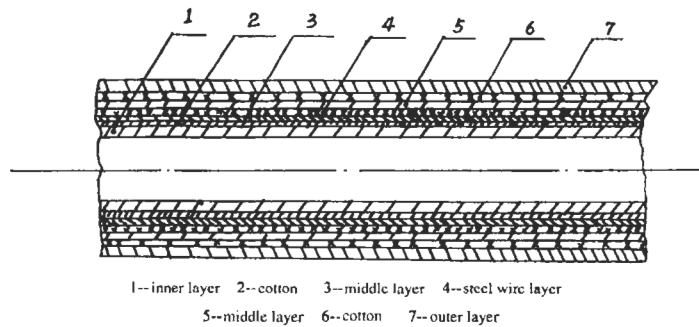
Fig. 9. Sectional diagram of the bursting hosepipe structure.

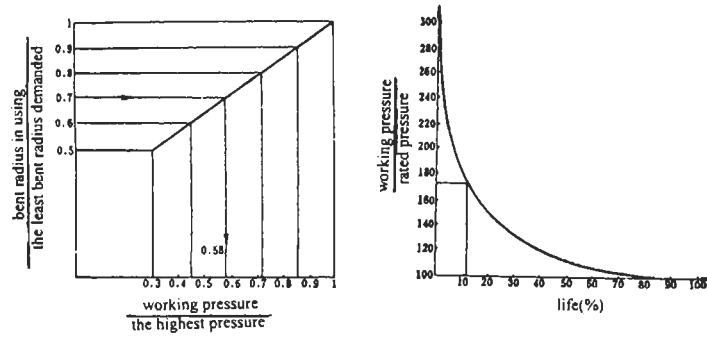
Fig. 10. Relation between bent radius, pressure capacity and working life of hosepipe.

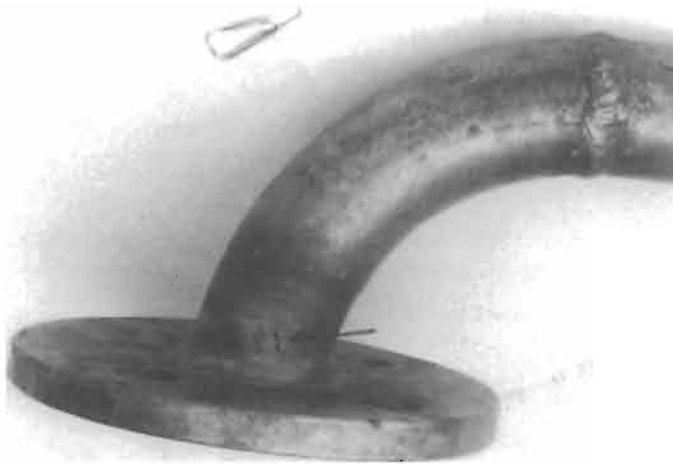
Fig. 1. Photograph of the pipe-to-flange joint (arrow shows the leaking portion).

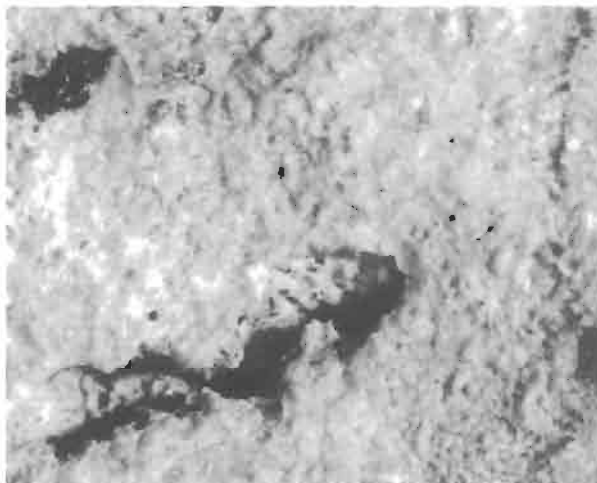
Fig. 2. Stereomicrograph of the crack on a pipe-to-flange joint.  $\times 16$

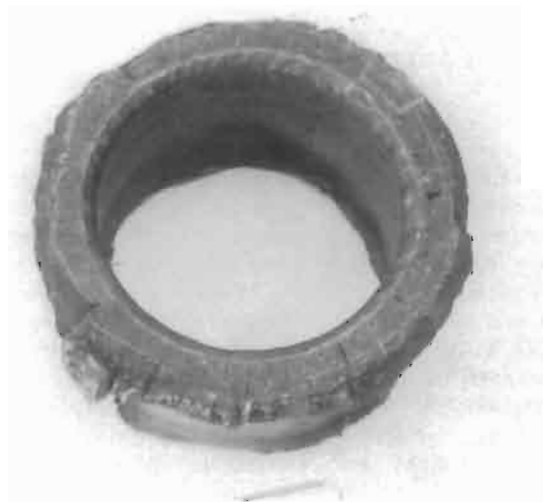
Fig. 4. Photograph of failed sight port flange.

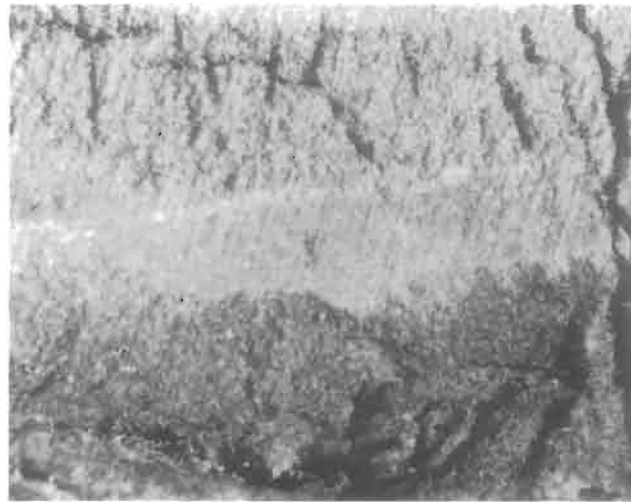
Fig. 5. Stereomicrograph of the cracked portion of the sight port flange. × 16

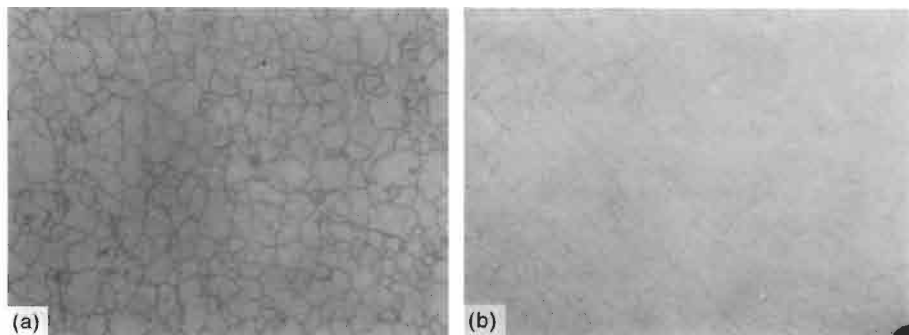
Fig. 6. Optical micrographs of sight port flange. (a) Flange portion (does not correspond to AISI 304 type). (b) Pipe portion (typical of AISI 304 microstructure). Both × 80.

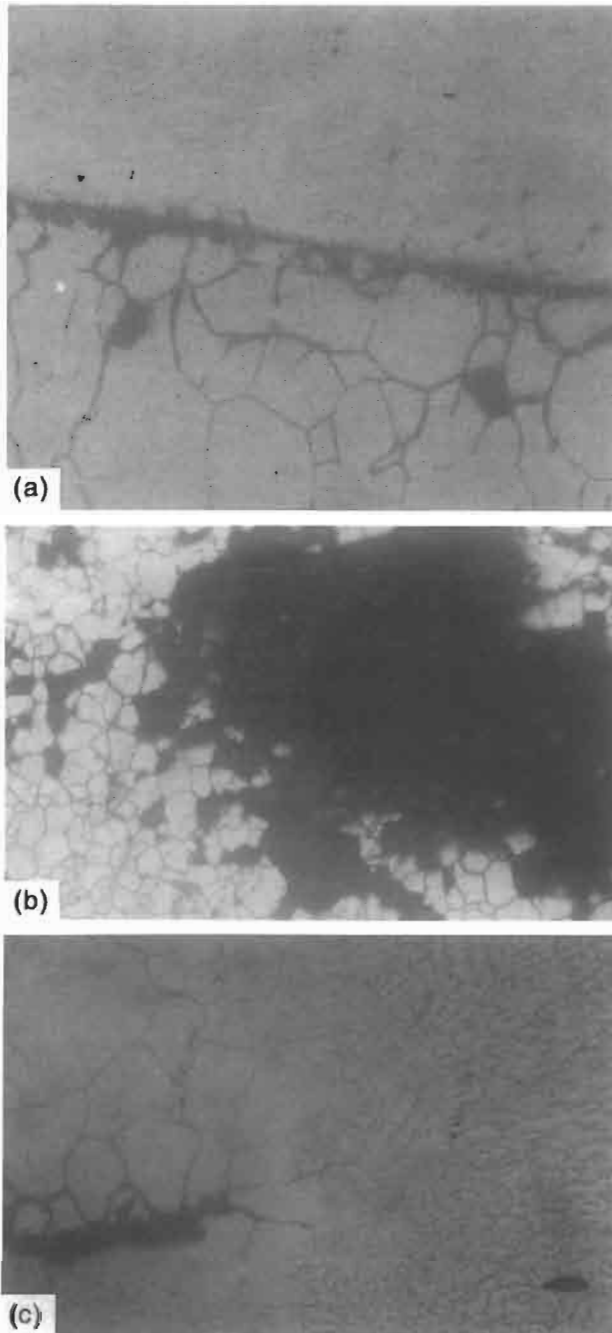
Fig. 7. Optical micrographs of sight port flange. (a) Interface between flange and pipe portion, showing corrosion attack on the interface and propagation intergranularly.  $\times 120$ . (b) Cracked area in the flange portion, showing individual grain dissolution.  $\times 80$ . (c) Weld region (dendritic type), flange (left top) and pipe (left bottom), showing corrosion attack in flange only.  $\times 120$ .

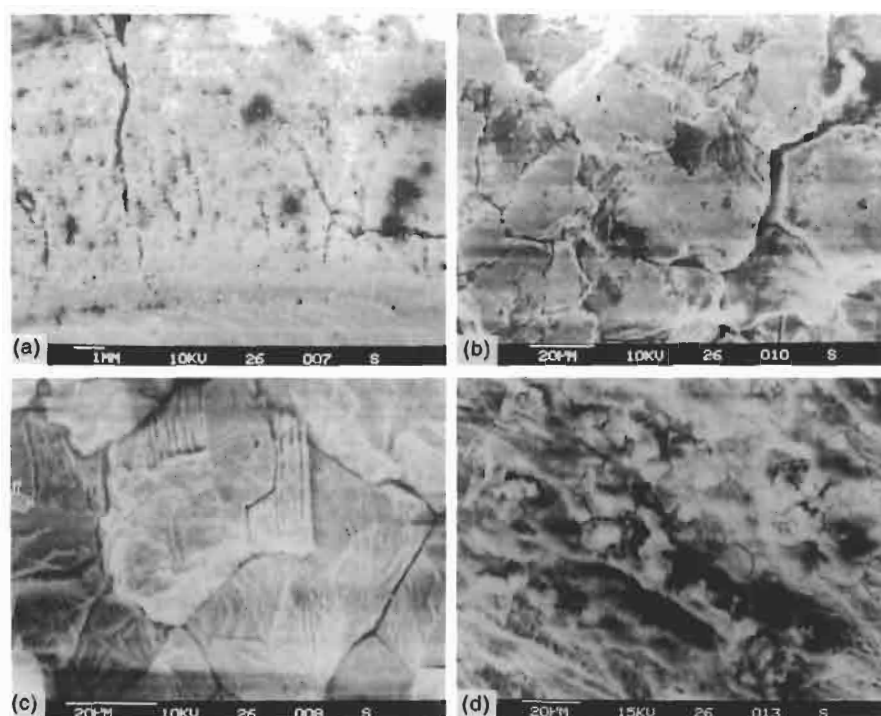
Fig. 8. SEM fractographs of failed sight port flange. (a) Radial cracks starting from the pipe-to-flange interface. (b) Intergranular cracks with grain dissolution. (c) Intergranular cracks with preferential attack along slip bands. (d) Corrosion product ( $\text{Fe}_2\text{O}_3$ ).

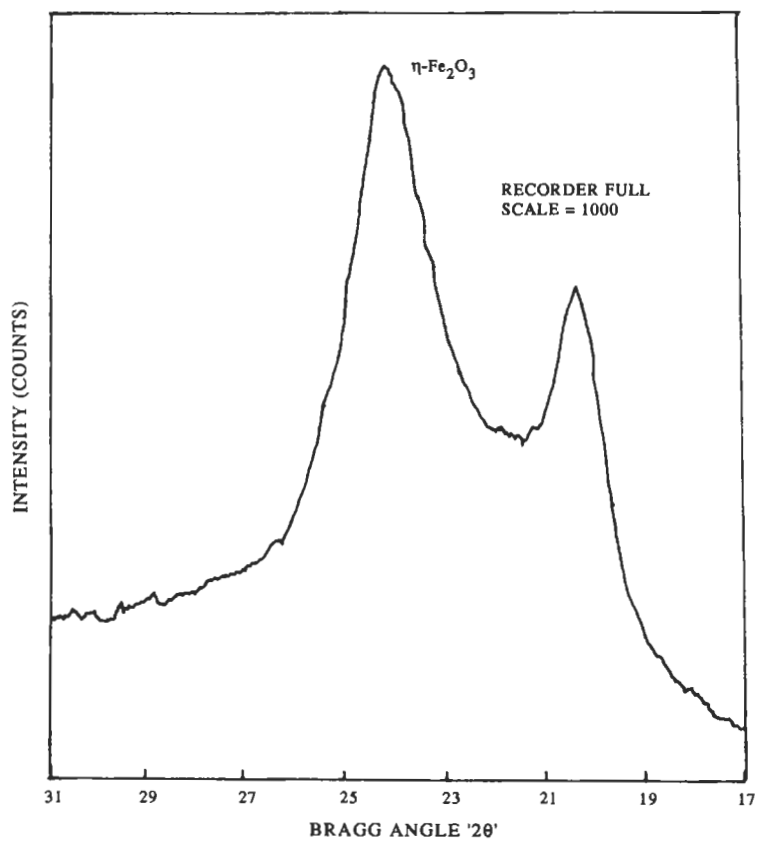
Fig. 9. XRD pattern of corrosion product ( $\text{Fe}_2\text{O}_3$ ) on sight port flange.

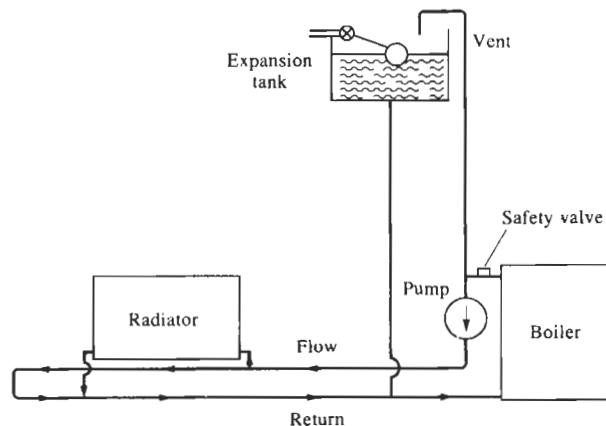
Fig. 1. Schematic diagram of a closed recirculating heating system.

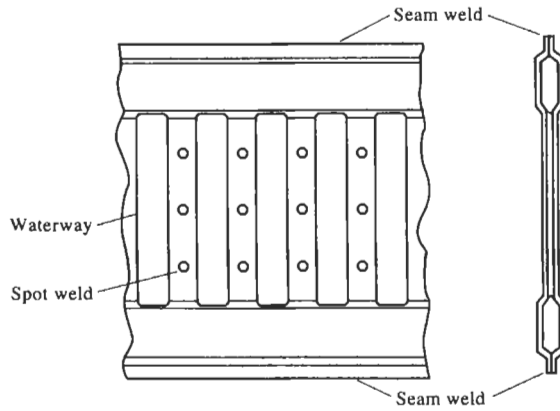
Fig. 2. Construction of a typical mild-steel radiator.

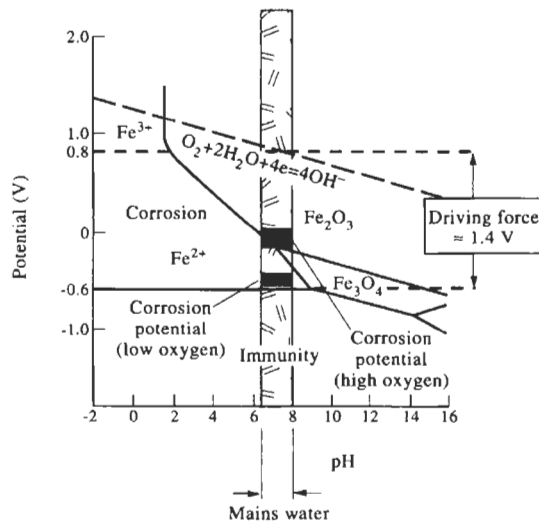
Fig. 3. The Pourbaix diagram for iron at  $25^\circ\text{C}$ , showing the oxygen-reduction reaction.

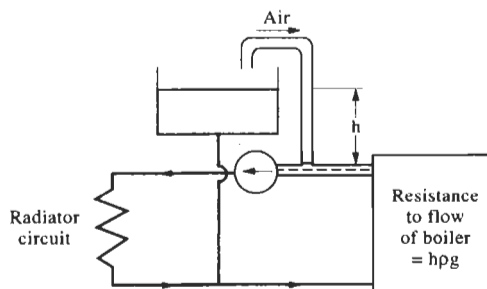
Fig. 5. Design fault 2—drawing air in through the vent.

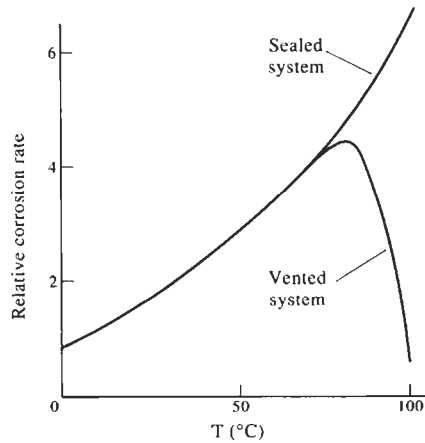
Fig. 6. Rate of corrosion of mild steel in aerated mains water as a function of temperature.

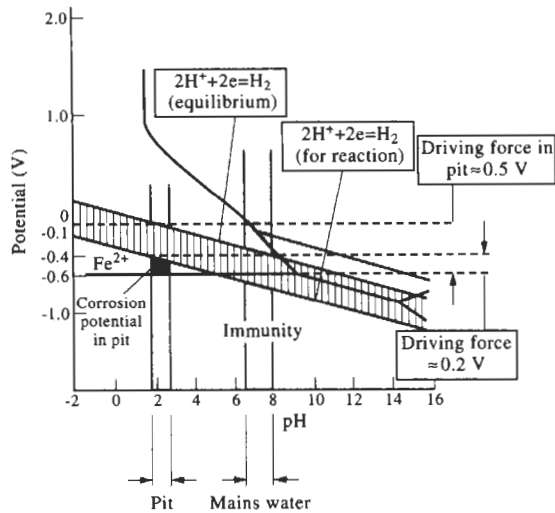
Fig. 7. The Pourbaix diagram for iron at 25 °C, showing the hydrogen-reduction reaction.

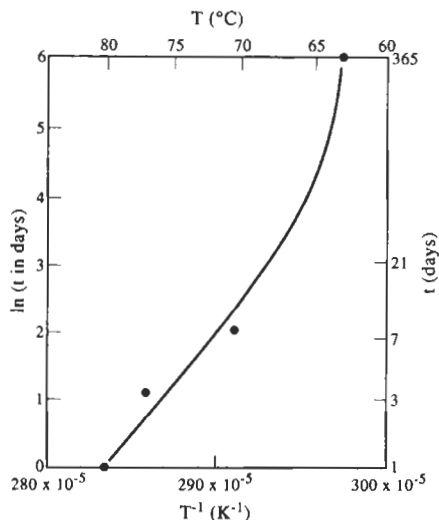
Fig. 8. Rate of hydrogen evolution as a function of temperature. Radiators have to be vented after a time interval  $t$ . Typical data only [4].

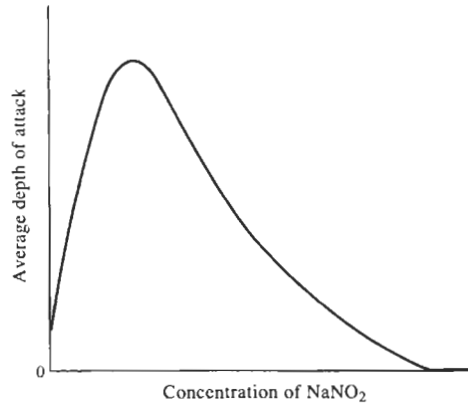
Fig. 9. Schematic effect of sodium nitrite concentration on the rate of corrosion of mild steel in mains water.

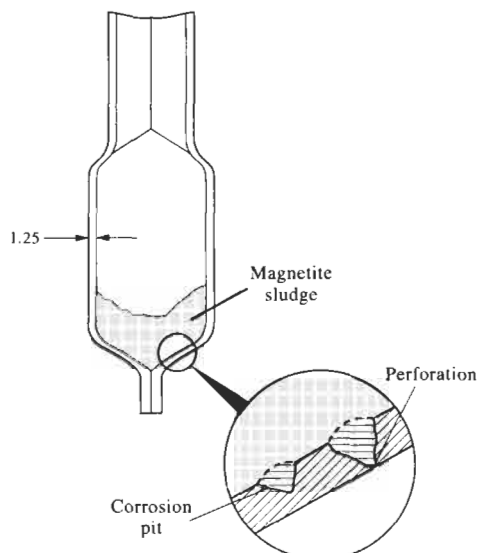
Fig. 10. A layer of magnetite sludge had formed in the water space at the bottom of the radiator. Pitting corrosion had occurred where the sludge covered the steel. Dimensions in mm.

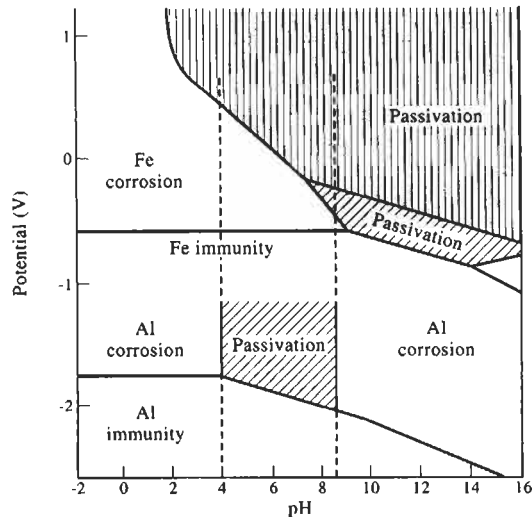
Fig. 13. Superposition of the Pourbaix diagrams for iron and aluminium at 25°C.

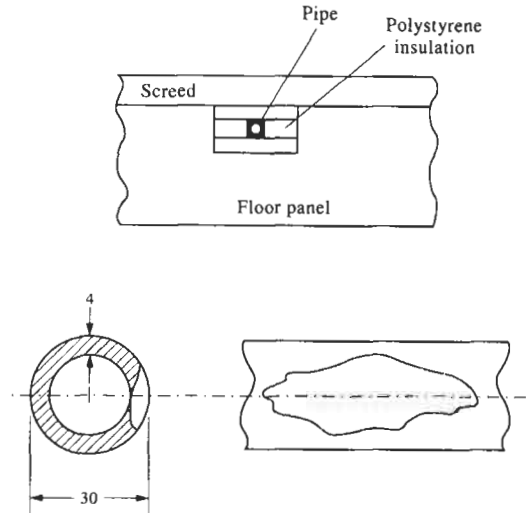
Fig. 14. The corroded steel pipe. Dimensions in mm.
