***FAILURE  
ANALYSIS  
CASE  
STUDIES II***

Edited by  
**D.R.H. Jones**

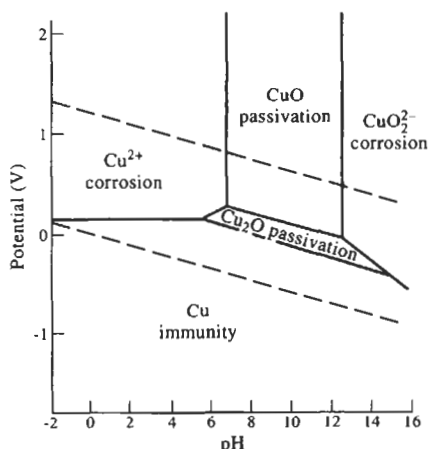
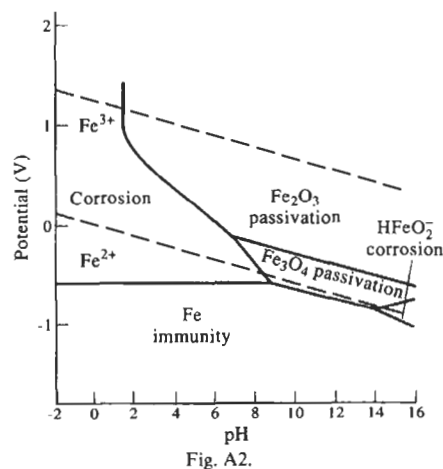
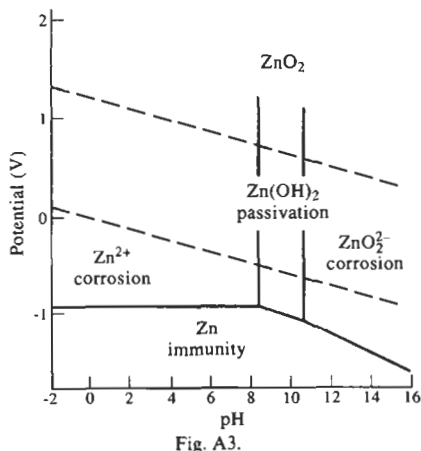
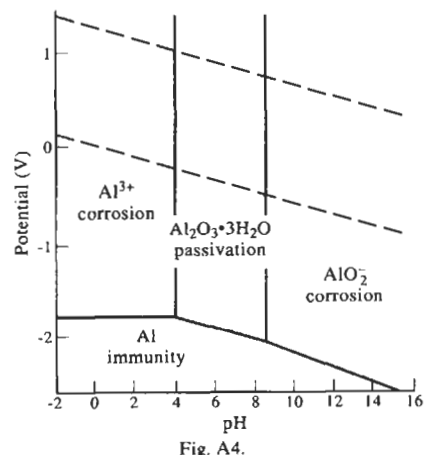
The diagrams give no indication of the rates of corrosion: these can only be found by doing suitable experiments. The diagrams show: (a) where corrosion cannot occur, and (b) where a surface film should form which might prevent or slow down corrosion.

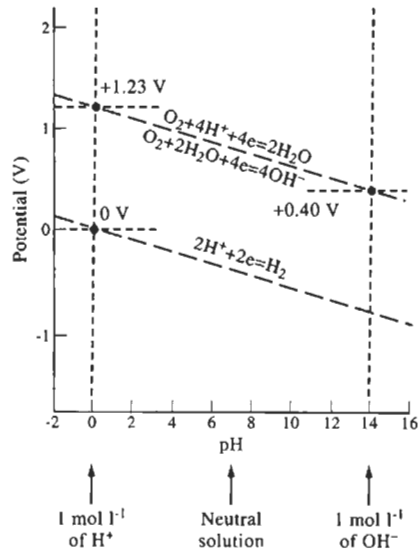
Corrosion cannot occur in practice unless an electron-accepting (cathodic) reaction also takes place. The two most important cathodic reactions (which involve hydrogen and oxygen, respectively) are marked on the diagrams as dashed lines. They are detailed in Fig. A5 [1].

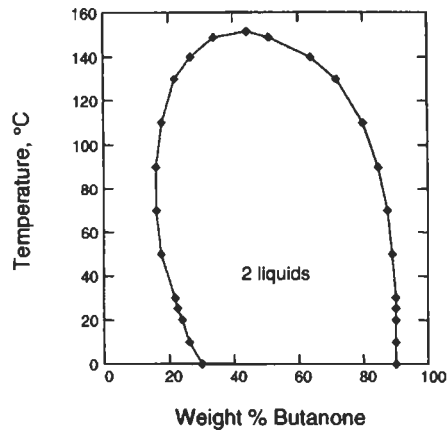
Fig. 1. Water–butanone phase diagram showing single-liquid phases for water- and butanone-rich solutions separated by a two-phase region of liquid immiscibility.

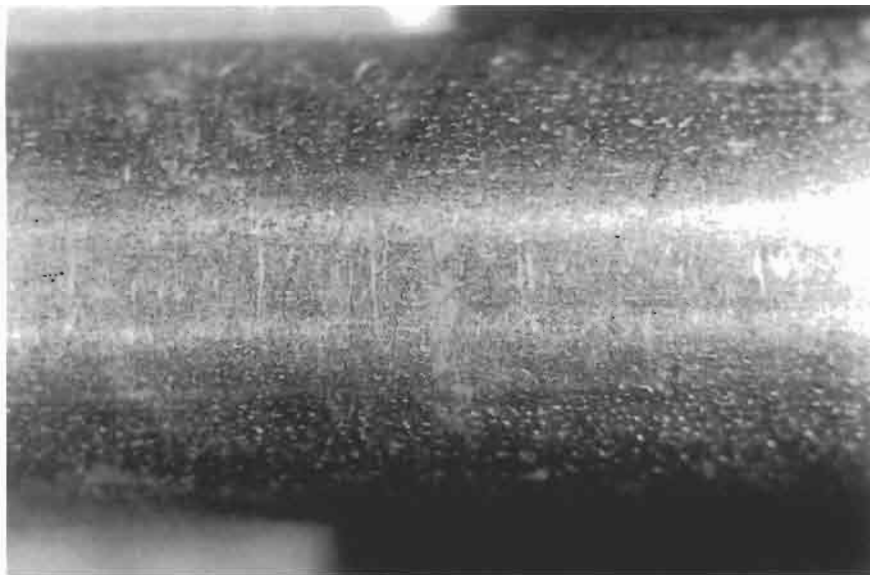
Fig. 3. Light ring of rust which appeared at the o-ring immersed in the water-rich phase after 12 days of exposure at 25 °C ( $\times 16$ )

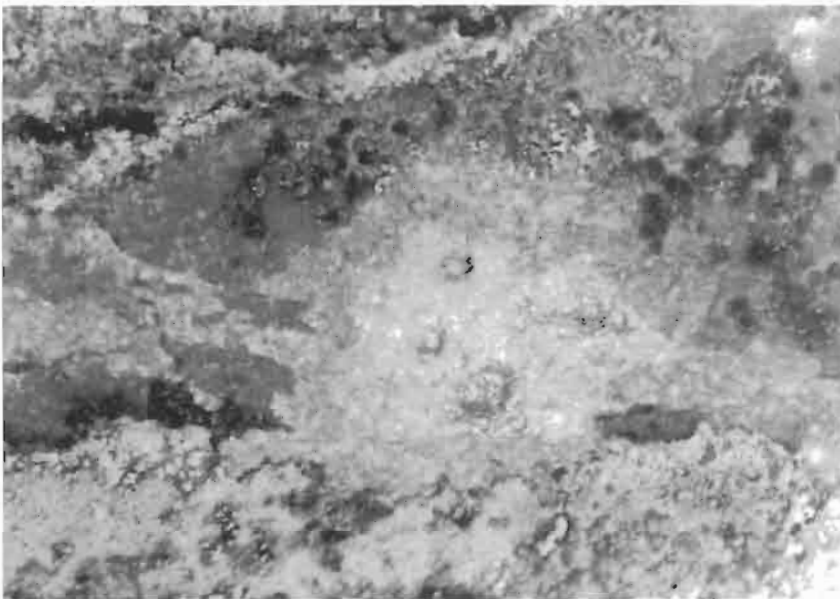
Fig. 2. A high magnification photograph of the region beneath a corrosion tubercle ( $\approx \times 50$ ). Note the presence of the greenish-white scale, the underlying black layer and the corrosion pit.

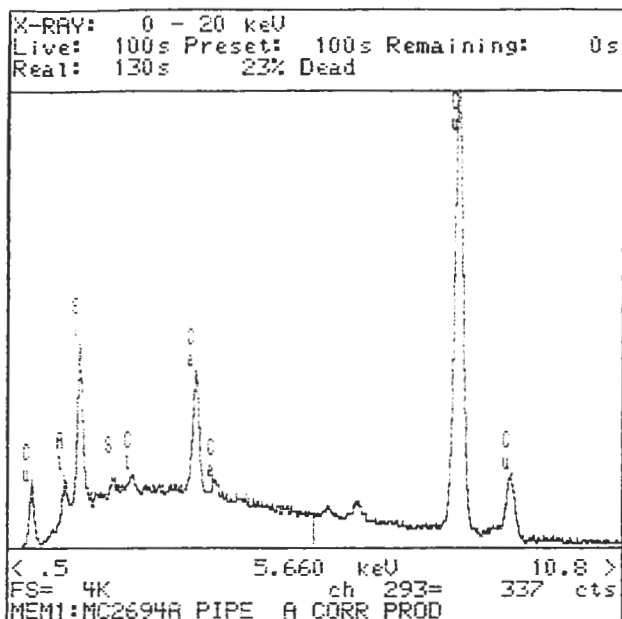
Fig. 4. The EDS results of the greenish-white deposits found on the internal surfaces of the tubes.

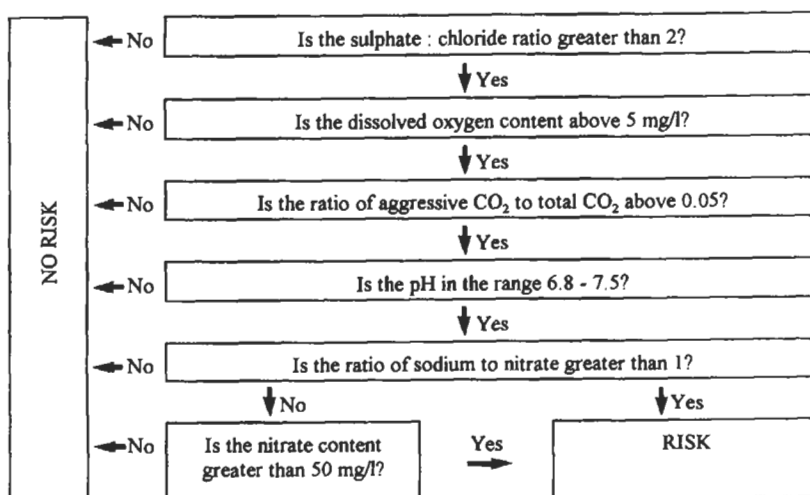
Fig. 5. Evaluation of waters for Type I pitting [2].

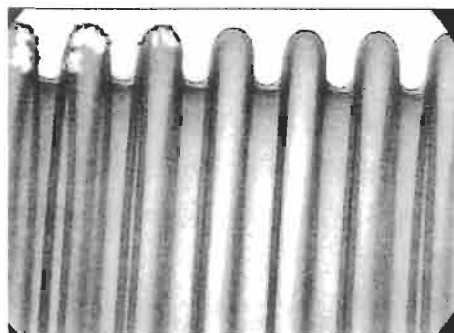
Fig. 1. Profile of waveguide. Dark bands are low points in waveguide or corrugations.

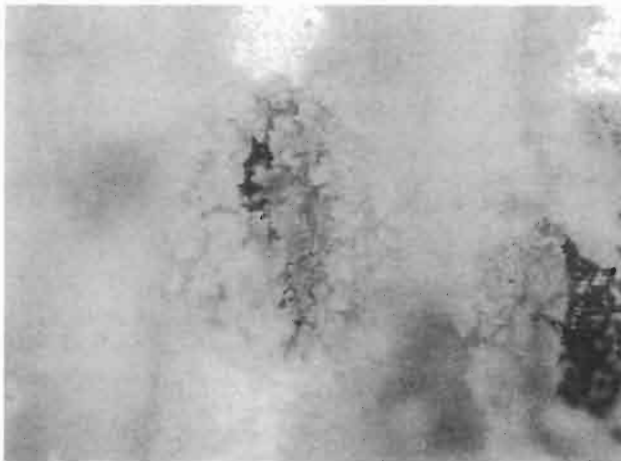
Fig. 3. Debris on waveguide surface. Copper hydroxy nitrate corrosion along corrugations in waveguide.

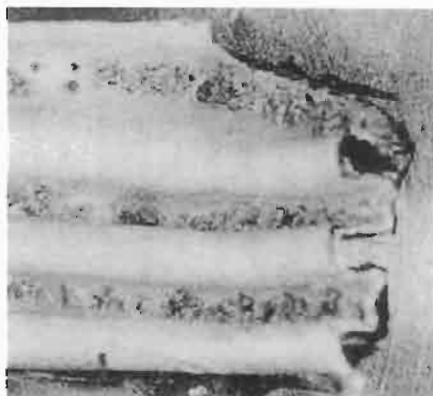
Fig. 4. Corrosion product along corrugations in the waveguide.

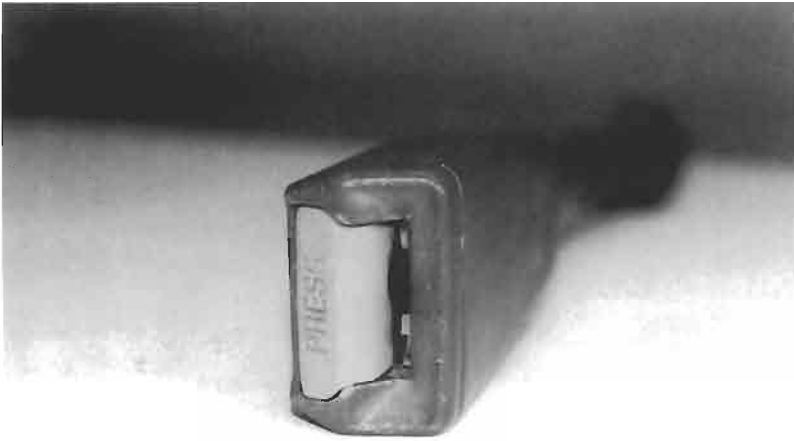
Fig. 1. Typical Takata seat belt receptacle of one of the affected designs. This receptacle was removed from a 1989 Honda Accord. Note impact damage especially to the plastic housing.

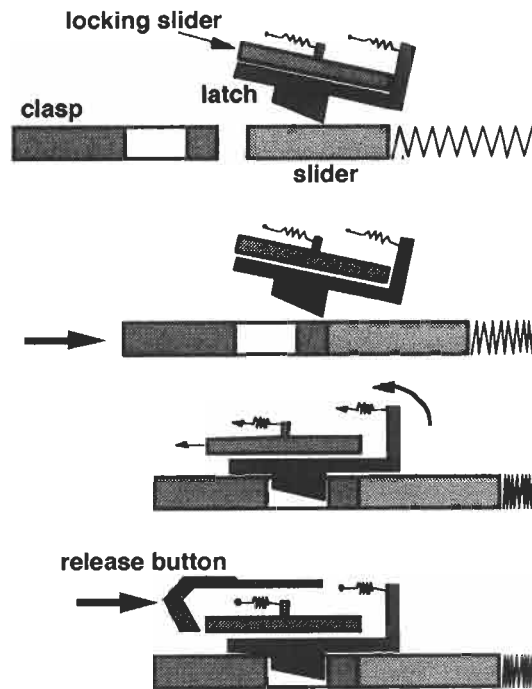
Fig. 2. Schematic side view of the seat belt latching mechanism showing the interactions among the main components, including the release button (bottom).

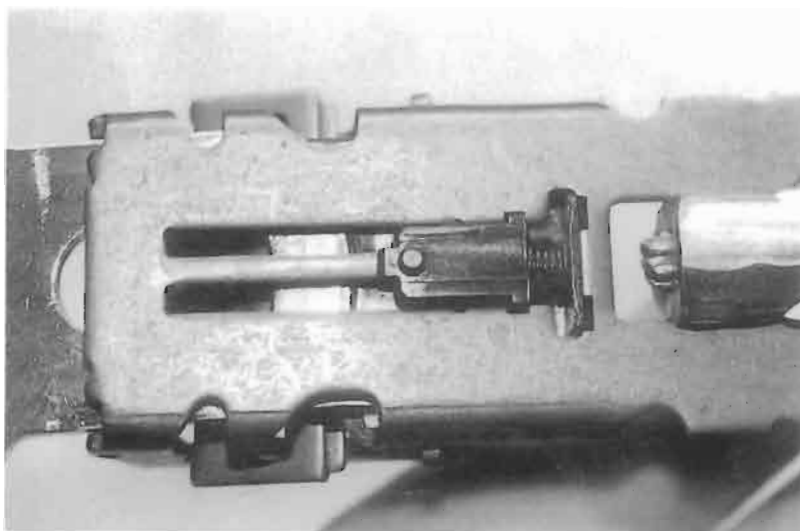
Fig. 5. 'Mode one' failure, showing a bottom view of the receptacle housing. The clasp, at left, is attempting to completely enter the receptacle, but it cannot, because of the button fragment lodged behind the slider.

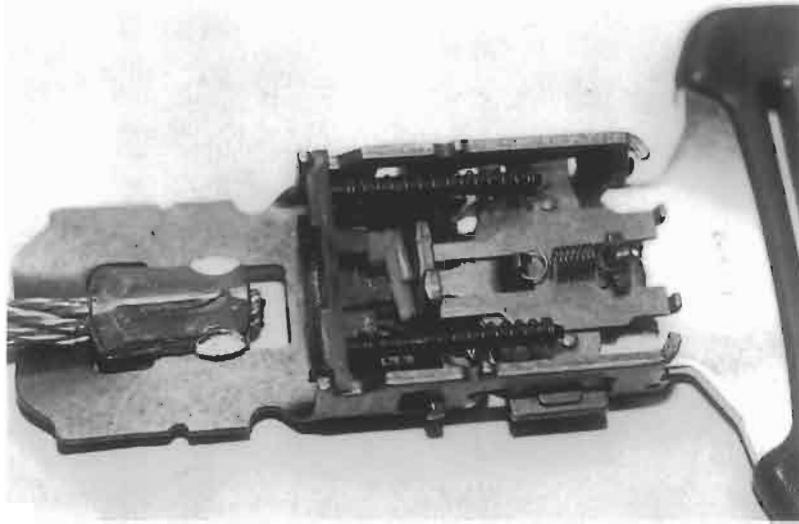
Fig. 6. 'Mode two' failure, showing a fragment of the release button lodged just to the left of the locking slider. In this case, the fragment keeps the locking slider from sliding to the unlocked position when the release button (not shown) is pressed.

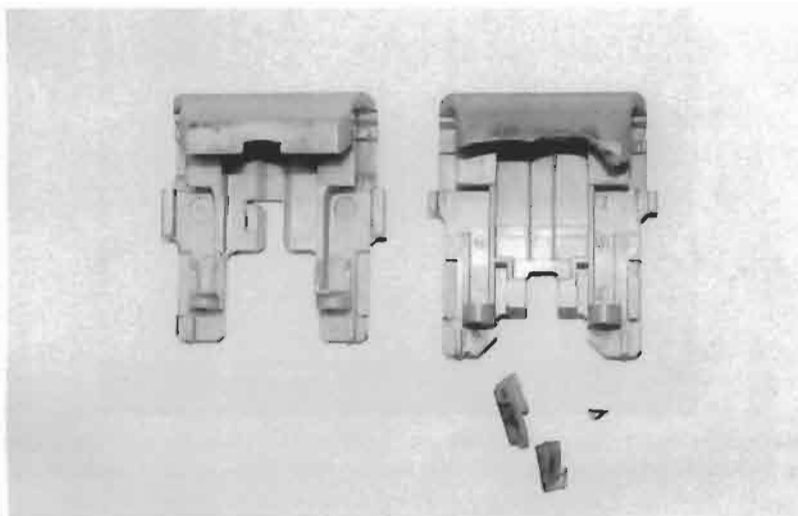
Fig. 8. Two release buttons from Honda Accords. The button at right has degraded and fractured, while the one at left is in better condition.

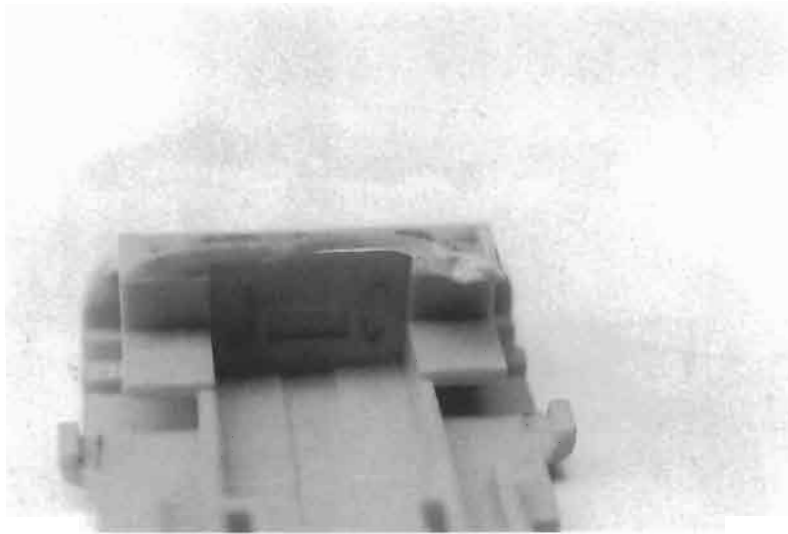
Fig. 9. Close up of the fracture surface of the button on the right in Fig. 8.

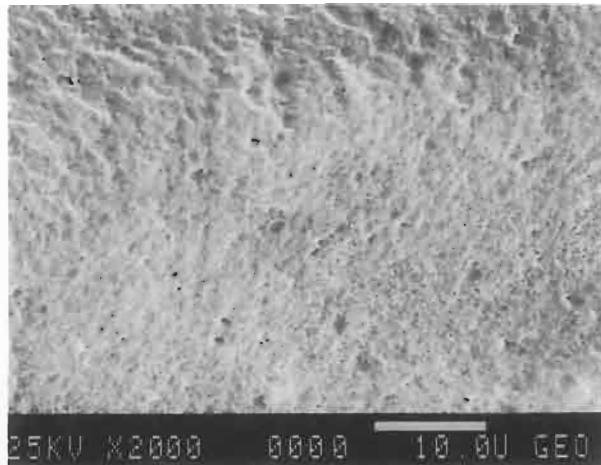
Fig. 10. Scanning electron micrograph of a fracture surface of a degraded release button. The presence of a discontinuous phase (typical of a rubber-modified polymer) is indicated by the round holes on the fracture surface.

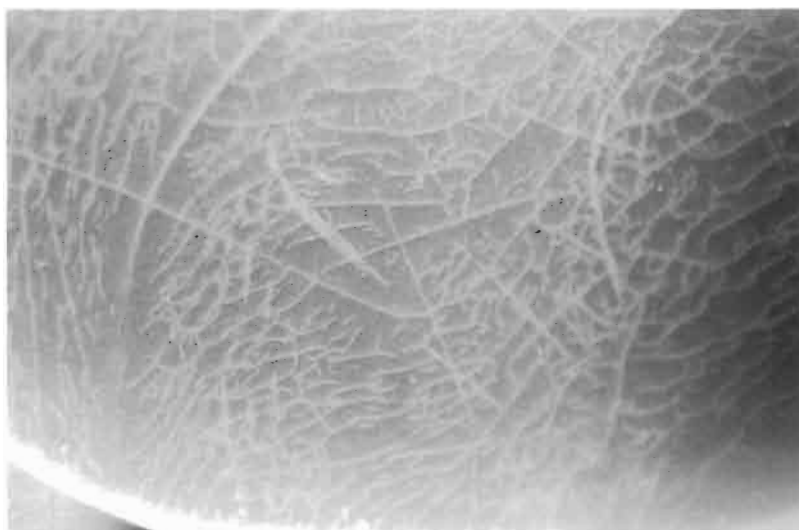
Fig. 12. Light microscope closeup of the button in Fig. 11 showing crazing.

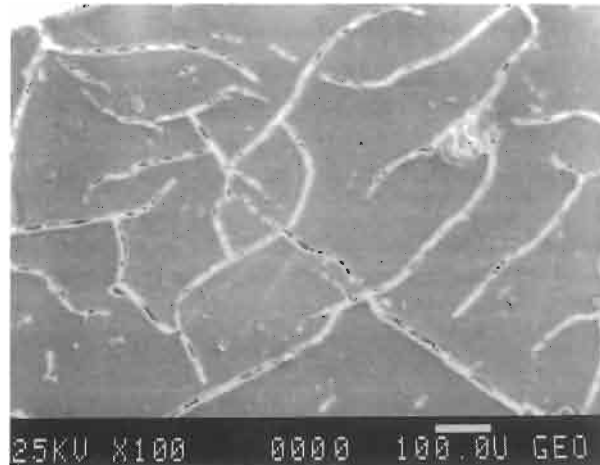
Fig. 13. Scanning electron micrograph of the button in Fig. 12. The crazing cracks are seen to extend through the surface of the material.

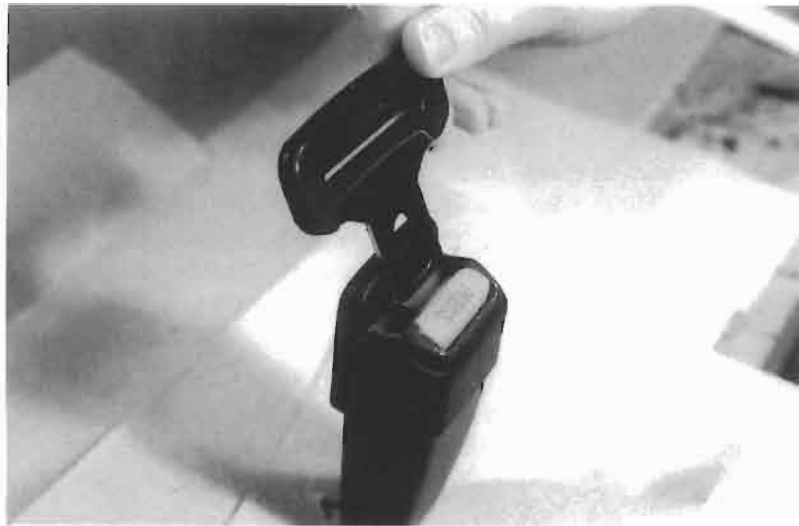
Fig. 14. Short-term solution to the seat belt failure problem. The plastic guard installed on the seat belt receptacle is intended to reduce impact damage to the release button.

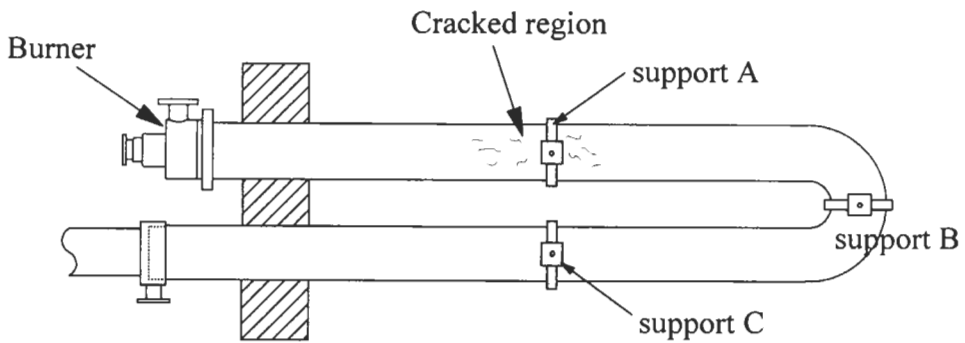
\* Corresponding author.

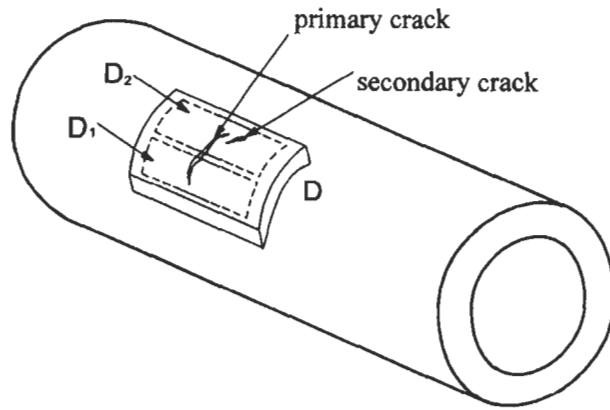
Fig. 2. Samples of a cracked radiant tube for failure analysis.

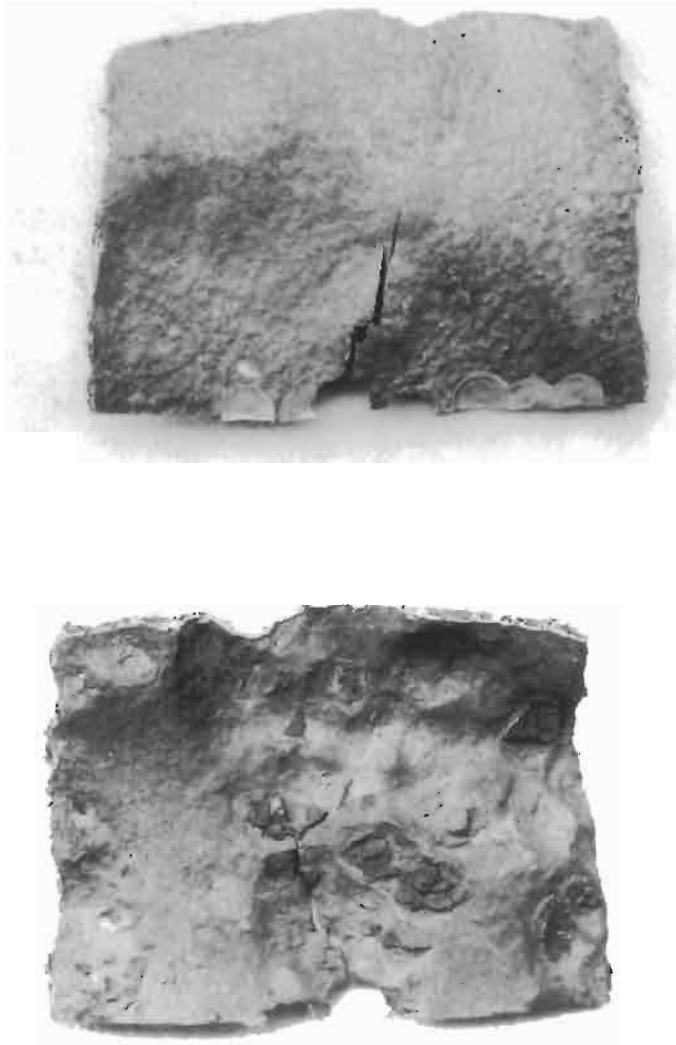
Fig. 3. Appearance of internal and external surfaces of the cracked tube specimen  $D_2$ .

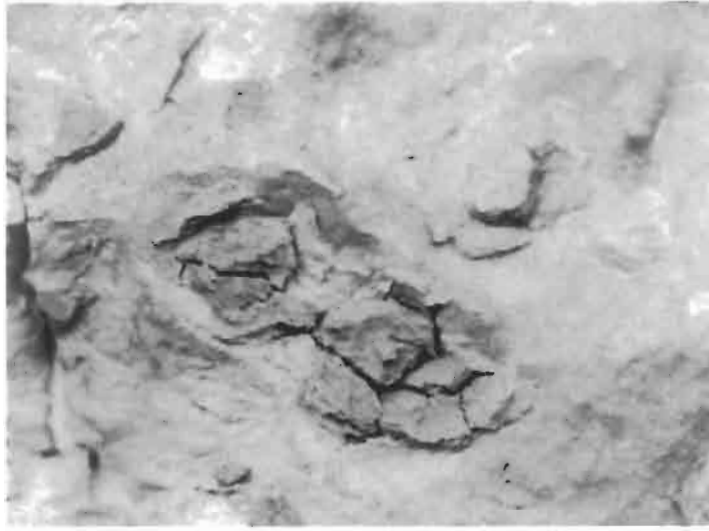
Fig. 4. Enlarged view of a cracked oxide scale located in thinned area.

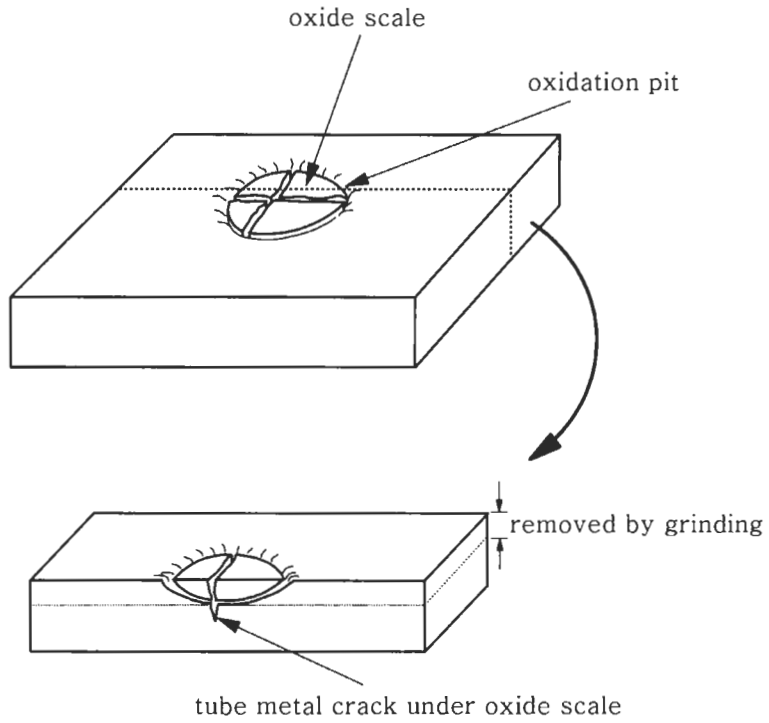
Fig. 5. Preparation of metallographic sample for studying crack initiation mechanism.

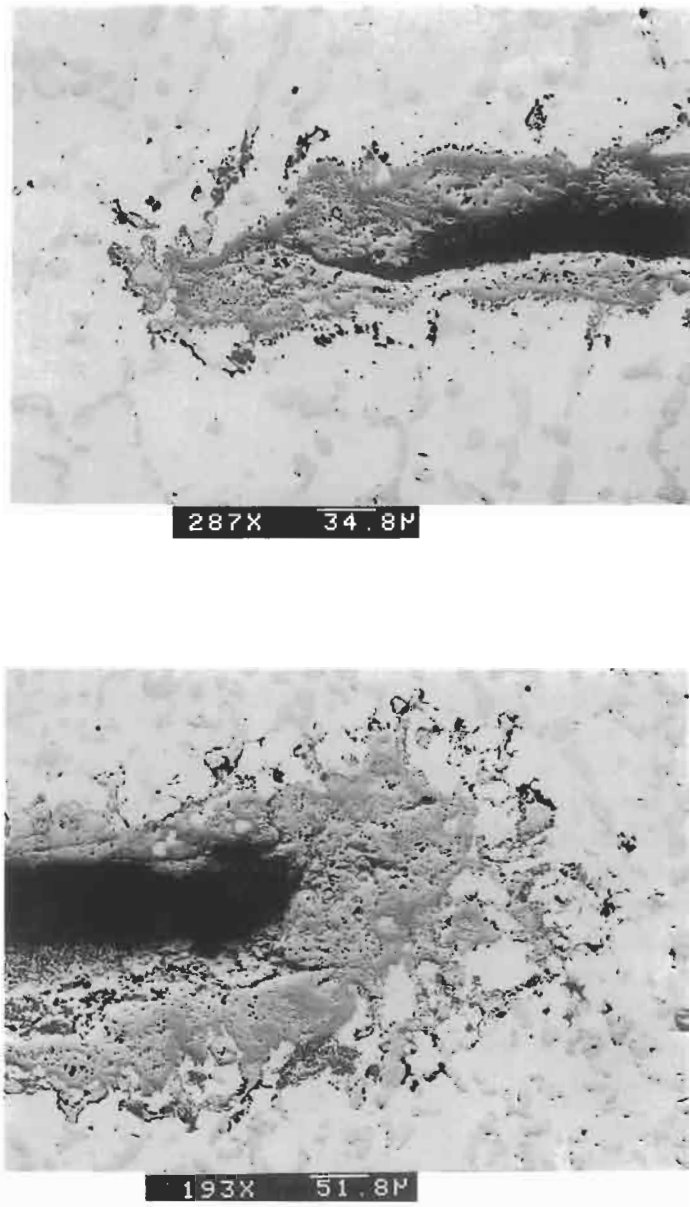
Fig. 6. Crack tip morphology.

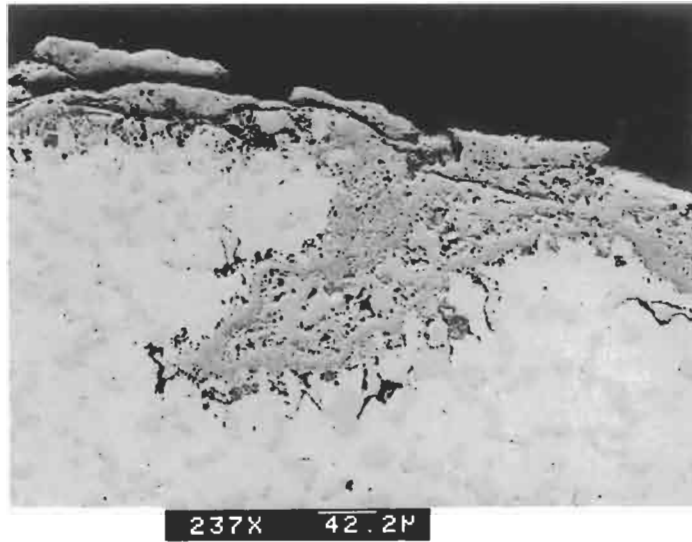
Fig. 7. Oxide spike under the fractured surface of primary crack.

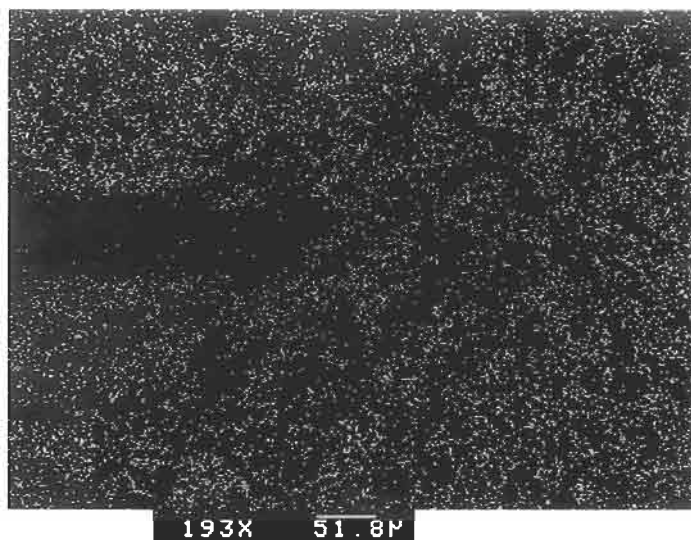
Fig. 8. Ni distribution map of crack tip region (same location as shown in Fig. 6(b))

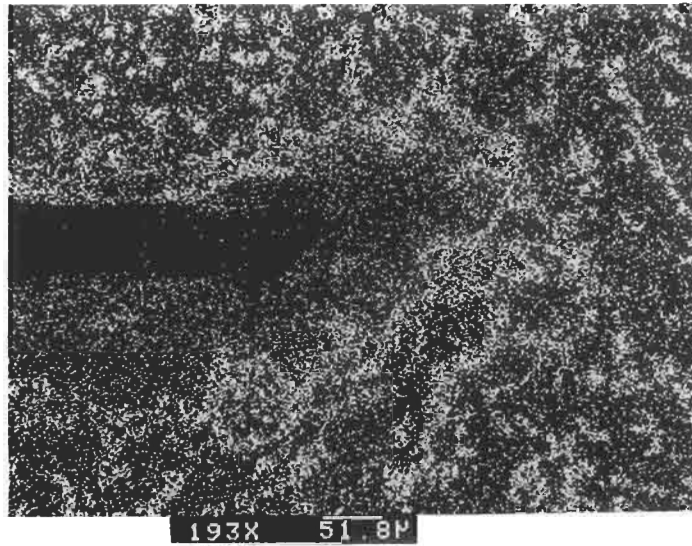
Fig. 9. Cr distribution map of crack tip region (same location as shown in Fig. 6(b))

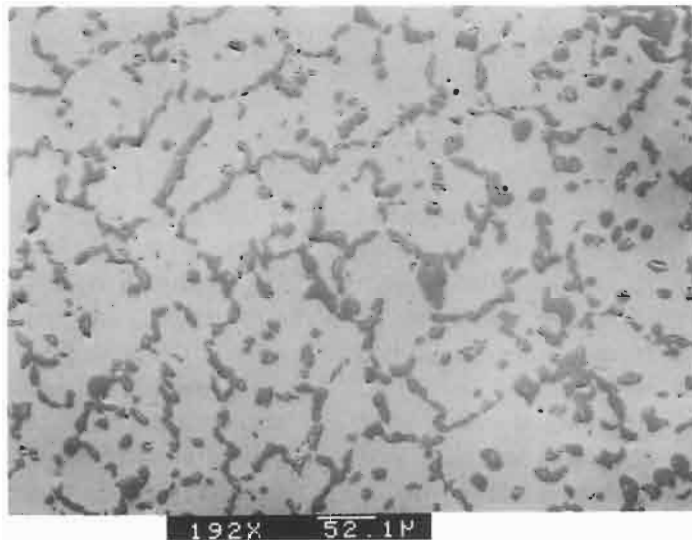
Fig. 10. Microstructure of uncracked region of the tested radiant tube.

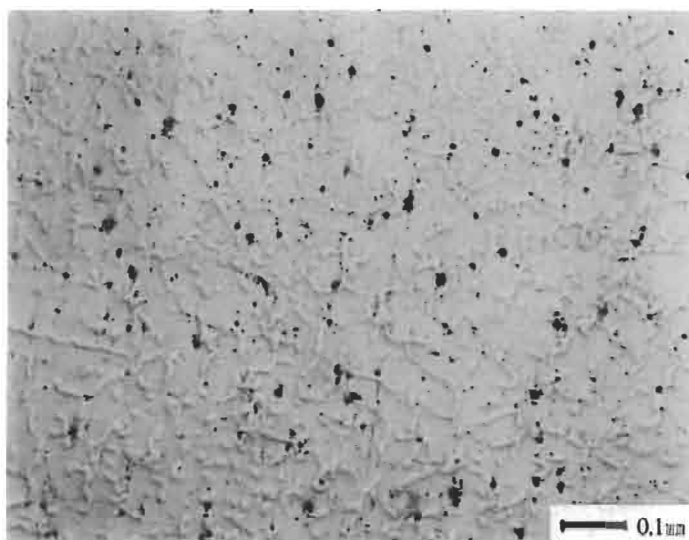
Fig. 11. Microstructure of cracked region of the tested radiant tube showing void formation

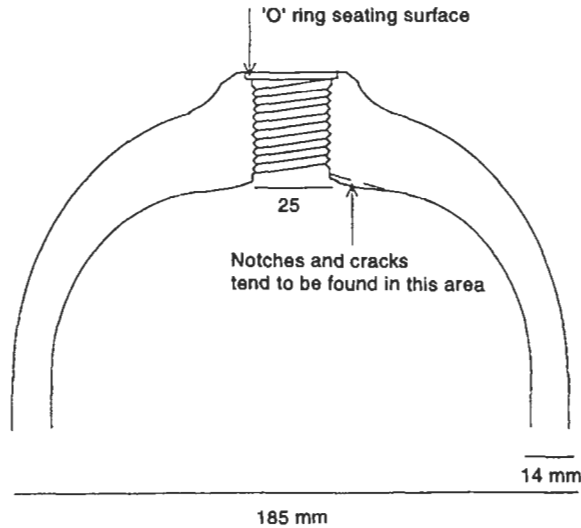
Fig. 1. The top of an aluminium gas cylinder with the area of crack initiation and growth indicated.

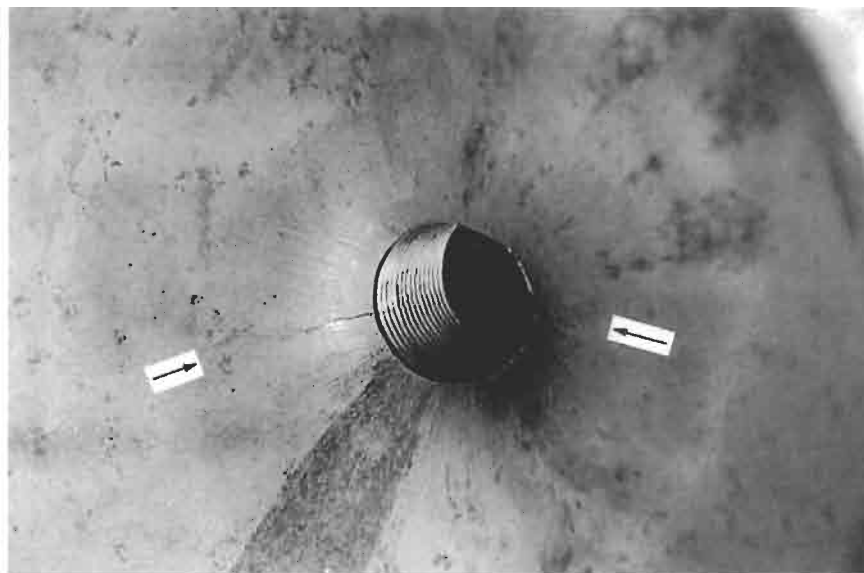
Fig. 2. Inside the top of cylinder A. Two large cracks almost opposite each other are marked. This specimen has been broken open and crack growth was found to proceed under the surface further than detectable using dye penetrant on the surface. The defect appearance conforms to the intergranular growth mechanism.

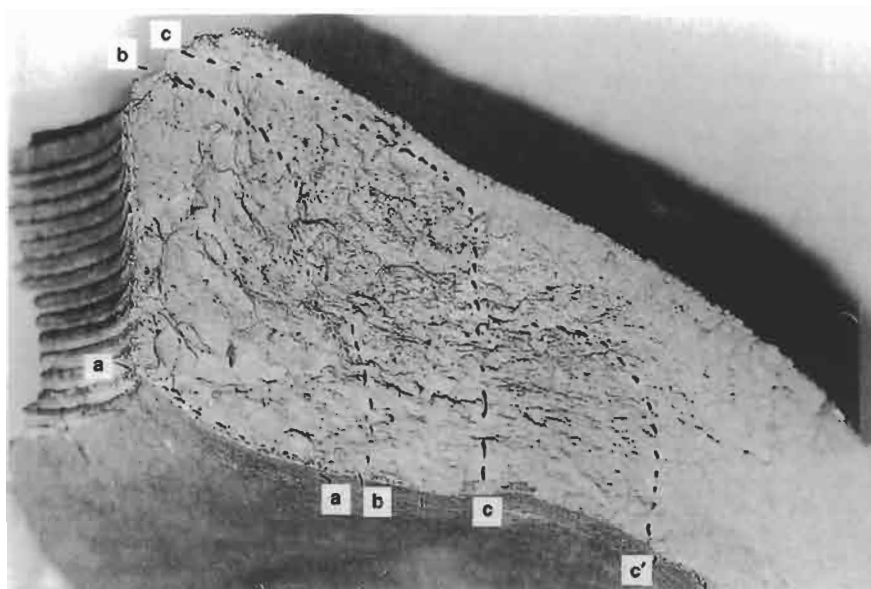
Fig. 3. The fracture surface of one of the four fractures of cylinder B. The photograph has been marked to highlight beachmarks caused either by damage during hydrotests of the cylinder or indicating changes to the crack growth mechanism. Some growth stages might leave no clear beachmark.

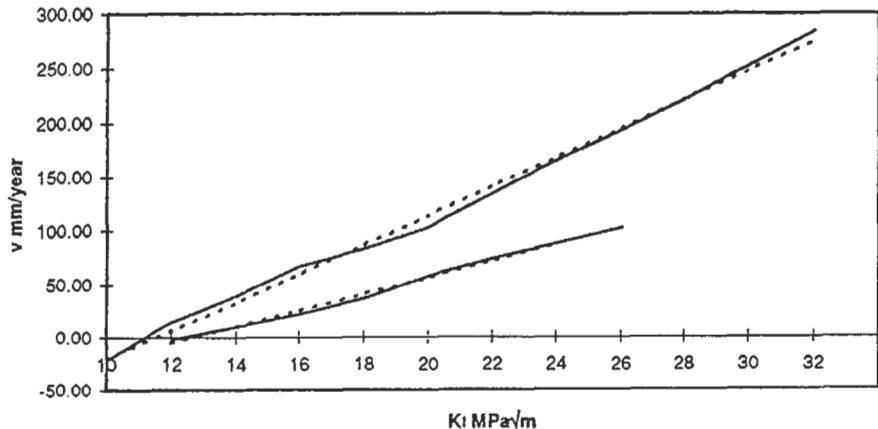
Fig. 4. Data from Lewandowski *et al.* [2] for crack growth at  $30^\circ\text{C}$  (solid lines). The upper data is for 100 ppm Pb and the lower data is for 30 ppm. The data appear to obey a linear relationship (dashed lines). A linear relationship implies there is a threshold below which no growth occurs.

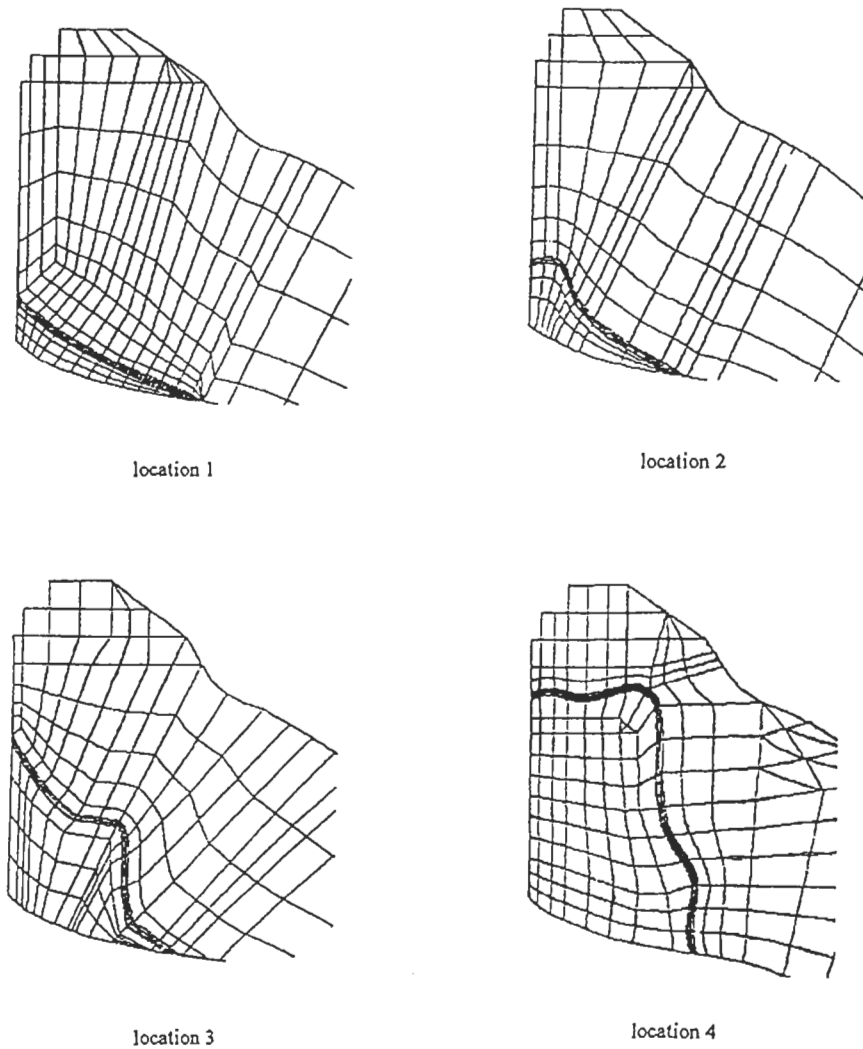
Fig. 5. The finite element mesh for the neck region used to calculate stress around initial and subsequent notches.

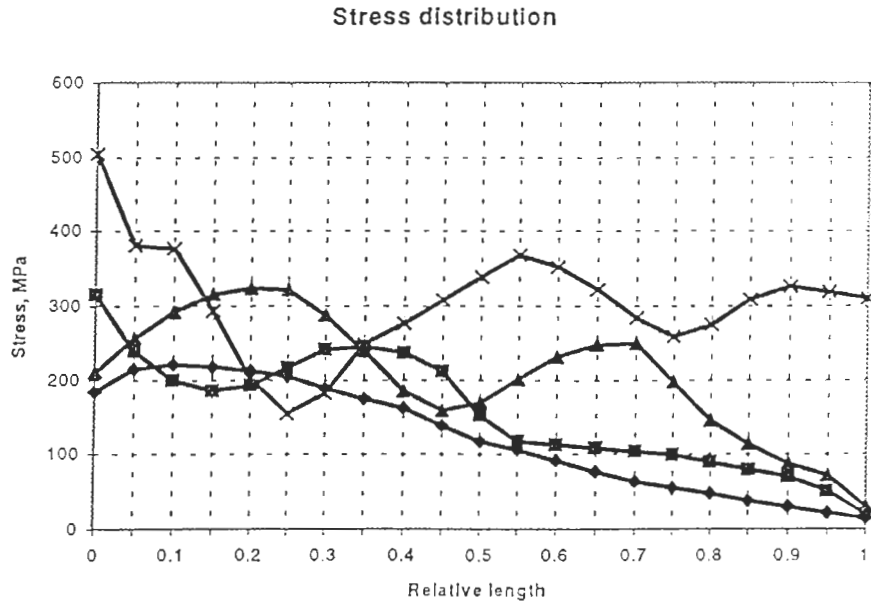
Key: ◆ Defect Location 1, × Location 2, ▲ Location 3, ■ Location 4

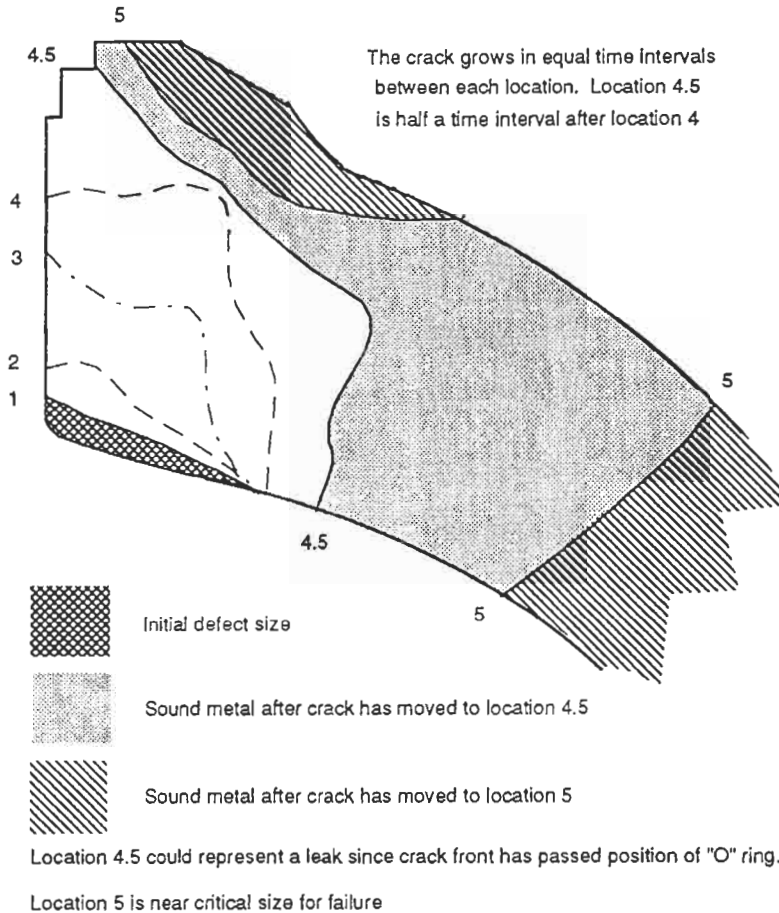
Fig. 7. Theoretically calculated crack positions for the pressurised cylinder over a period of time. These positions are similar to benchmarks such as those seen on Fig. 3. The theoretically determined positions approximate both the shape and the acceleration of the crack growth rate which has occurred in practice. The constants in the growth model were adjusted until the time of growth plausibly fitted the time available for growth in observed cylinders.

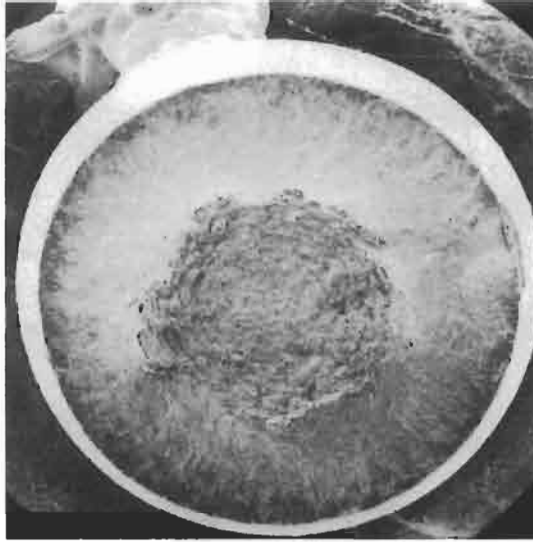
Fig. 4. SEM photograph of the fracture surface of a specimen with Corr. d. = 0.  $\times 13$ .

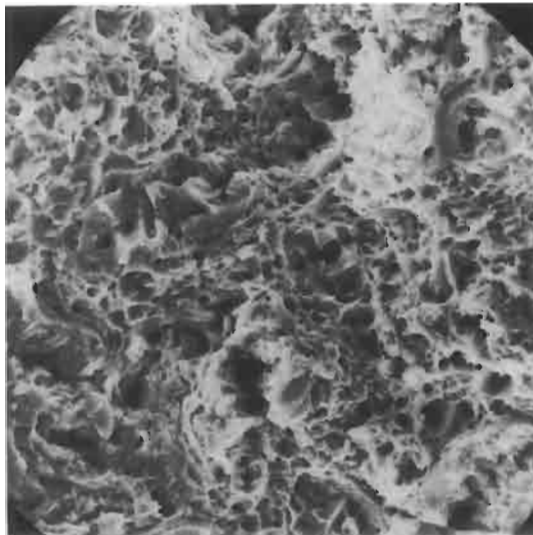
Fig. 5. SEM photograph of a specimen with Corr. d. = 0, showing the tough fibrous zone.  $\times 2000$ .

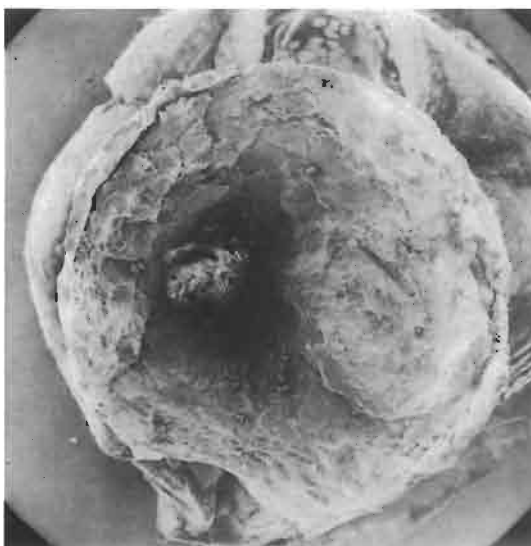
Fig. 7. SEM photograph of a specimen with Corr. d. = 5, showing the very brittle nature of the fracture surface.  $\times 10$ .

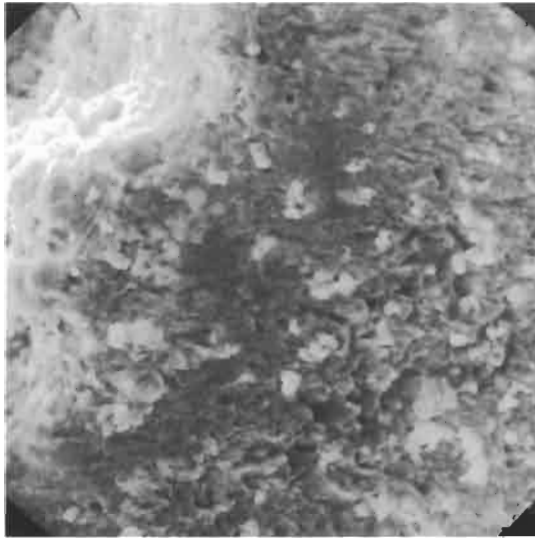
Fig. 8. SEM photograph of a specimen with Corr. d. = 2, showing the shallow dimples.  $\times 1000$ .

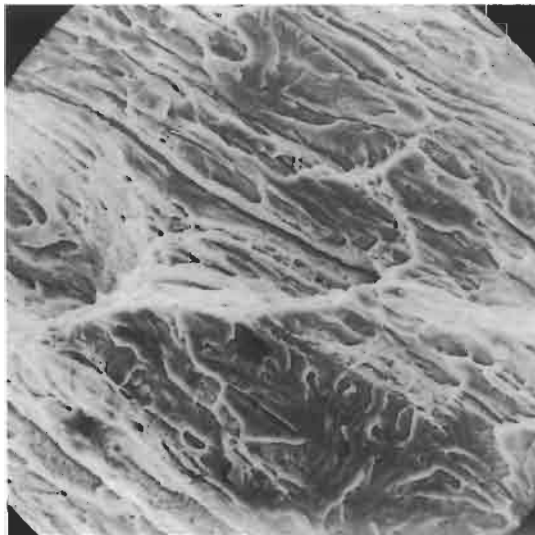
Fig. 9. SEM photograph of a specimen with Corr. d. = 5, showing the brittle nature of the fracture surface.  $\times 1000$ .

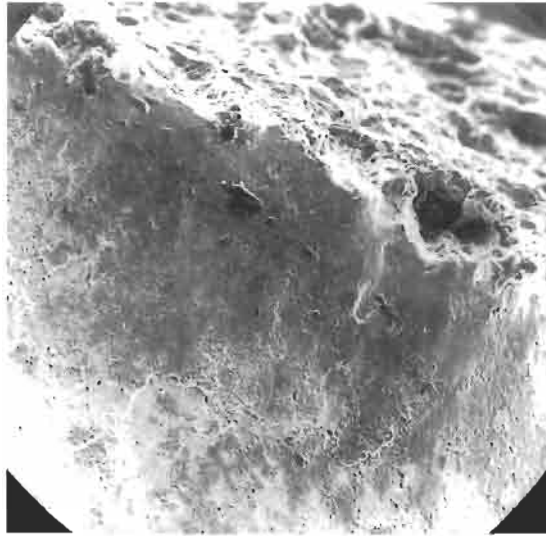
Fig. 10. SEM photograph of a specimen with Corr. d. = 5, with corroded (black) and uncorroded (white) regions.  $\times 100$ .

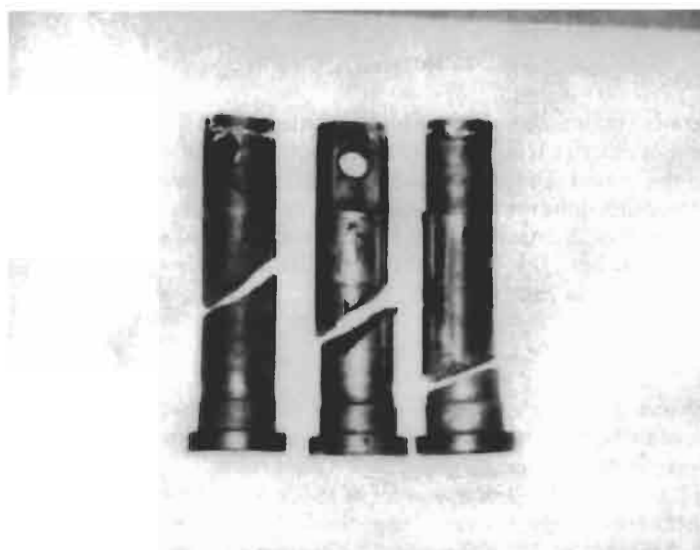
Fig. 1. Three fractured pins showing the position and angle of the fractures.

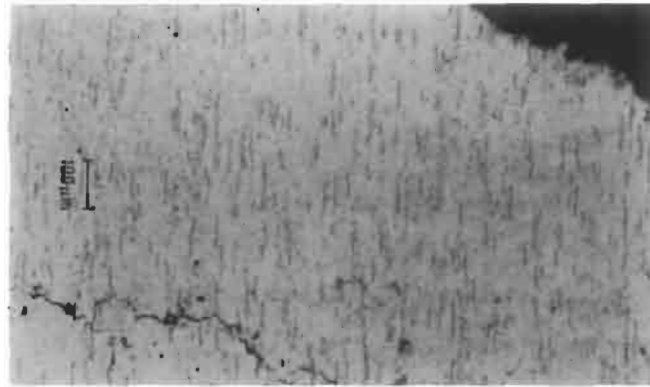
Fig. 2. Fractured pin C. Note the intergranular nature of the fracture surface on the bottom left, and the crack running parallel to the main fracture. The ferrite stringers can also be seen.

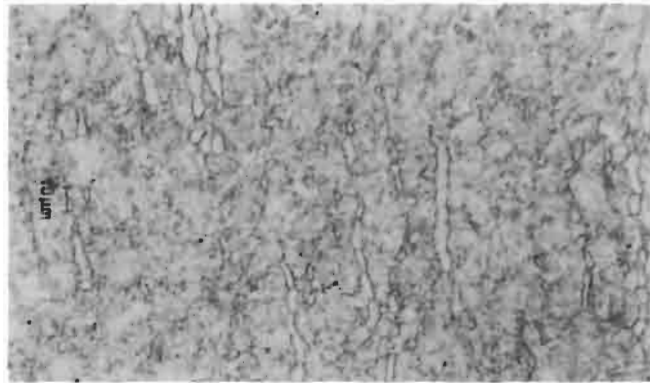
Fig. 3. A high magnification of the structure shown in Fig. 2, showing the tempered martensite and ferrite stringers of pin C.

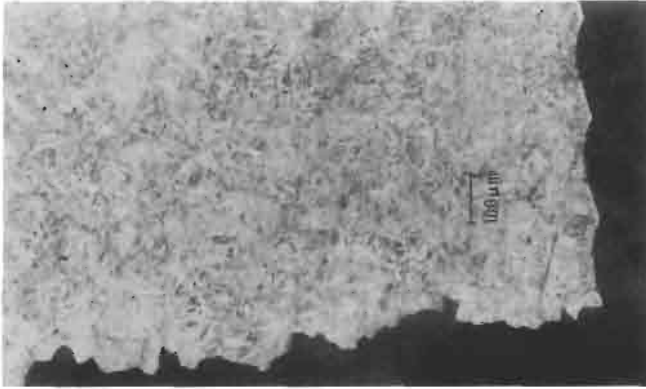
Fig. 4. The tempered martensite matrix as found in all the pins, except pin C, whose structure is shown in Figs 2 and 3. Note the intergranular nature of the fracture surface on the bottom as well as the machining marks on the right.

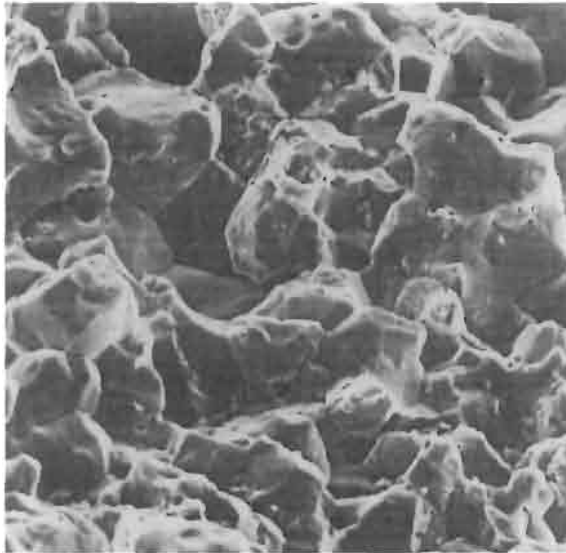
Fig. 5. An SEM picture of the fracture surface of a pin showing the intergranular nature of the fracture. Micropores, yawning grains, and the absence of grain boundary corrosion, characteristic features of HE, are shown.

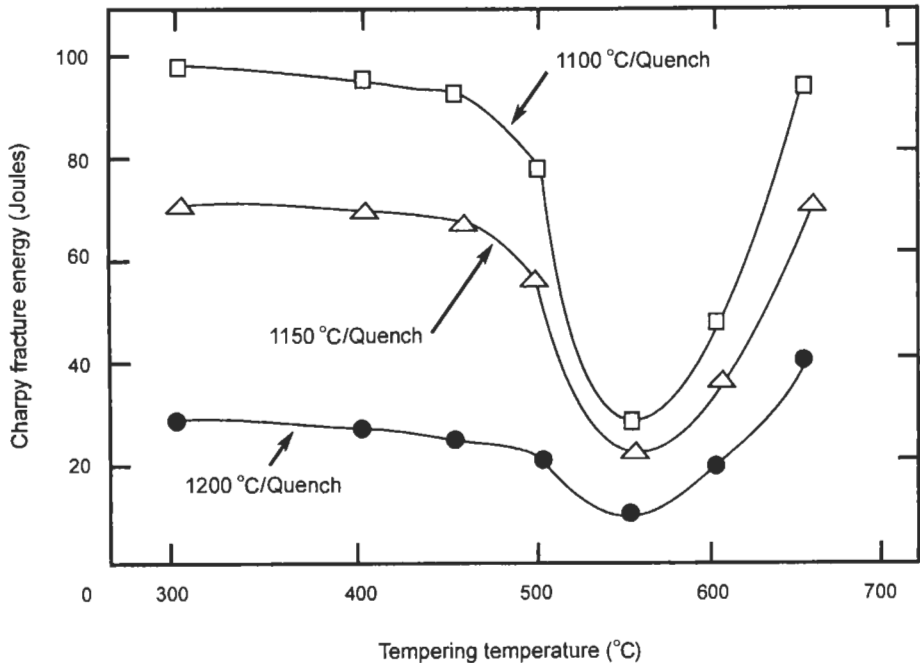
Fig. 6. Charpy impact toughness of either AISI 431 or En 57 as a function of tempering temperature, austenitized at various temperatures and oil quenched.

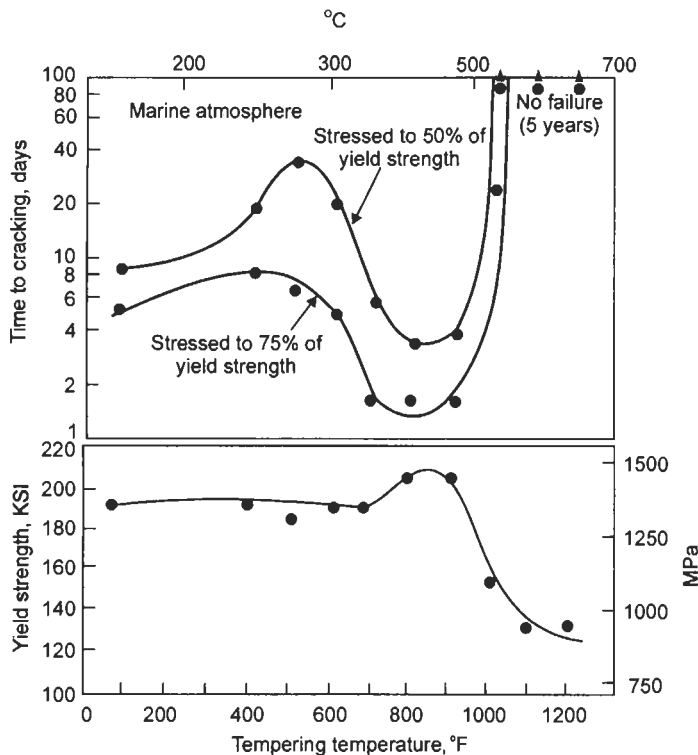
Fig. 7. Effect of tempering temperature on the cracking resistance and yield strength of martensitic stainless steel in a marine atmosphere.

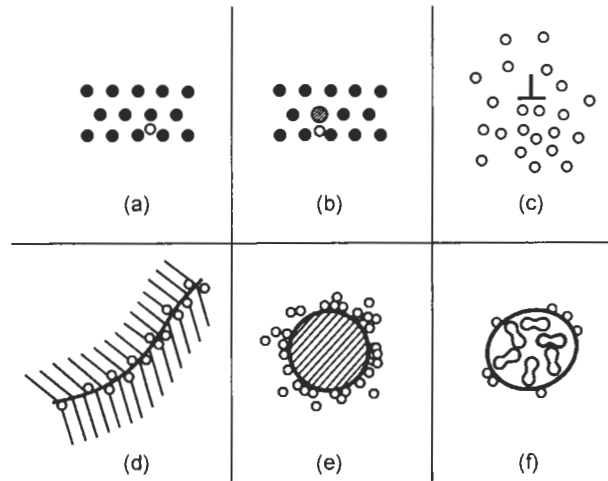
Fig. 8. Schematic view of destinations for hydrogen in a metal microstructure, discussed in the text: (a) solid solution; (b) solute hydrogen pair; (c) dislocation atmosphere; (d) grain boundary accumulation; (e) particle matrix interface accumulation; (f) void containing recombined  $H_2$ .
