***FAILURE  
ANALYSIS  
CASE  
STUDIES II***

Edited by  
**D.R.H. Jones**

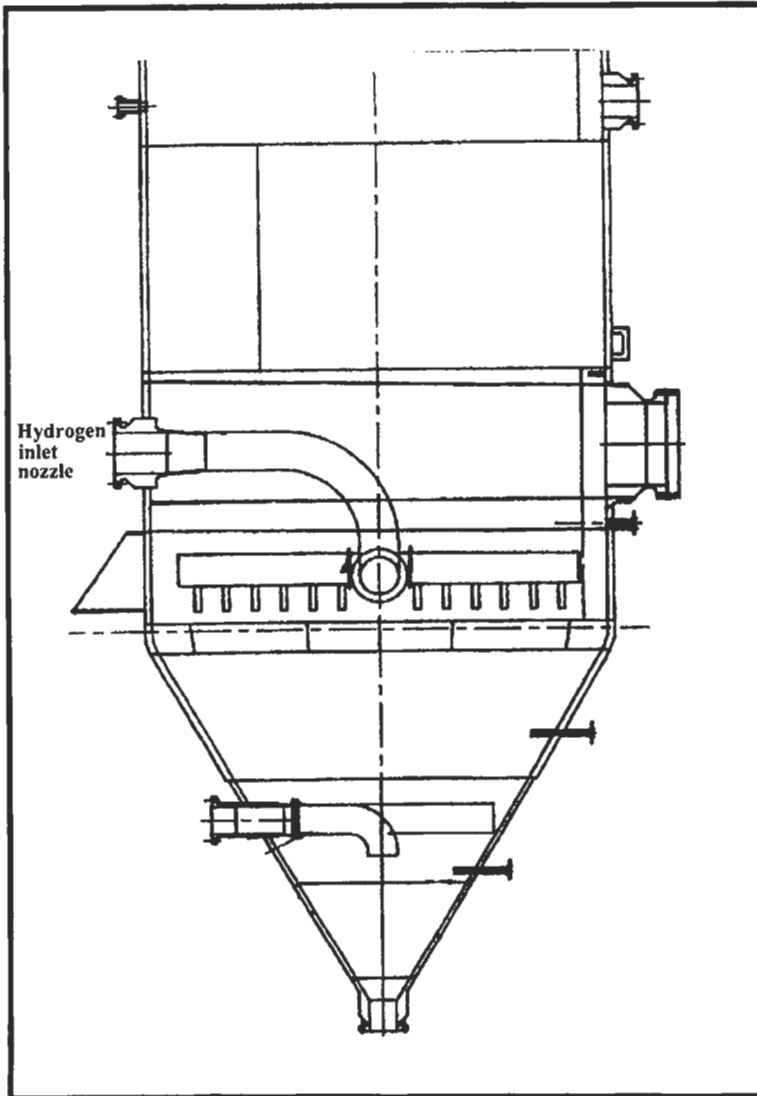
Fig. 1. Schematic view of catalyst reduction reactor (bottom section).

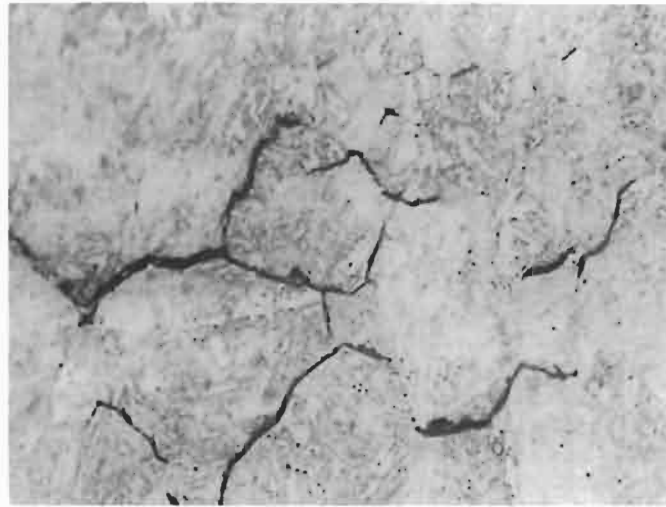
Fig. 2. Replicated micrograph of reheat crack showing bainitic microstructure and crack path following prior austenite grain boundaries (magnification  $\times 100$ ).

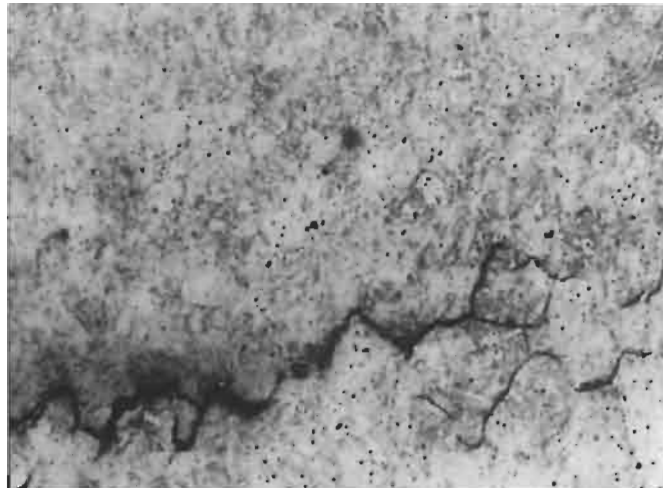
Fig. 3. Replicated micrograph of reheat crack showing bainitic microstructure and crack path following weld heat affected zone (magnification  $\times 50$ ).

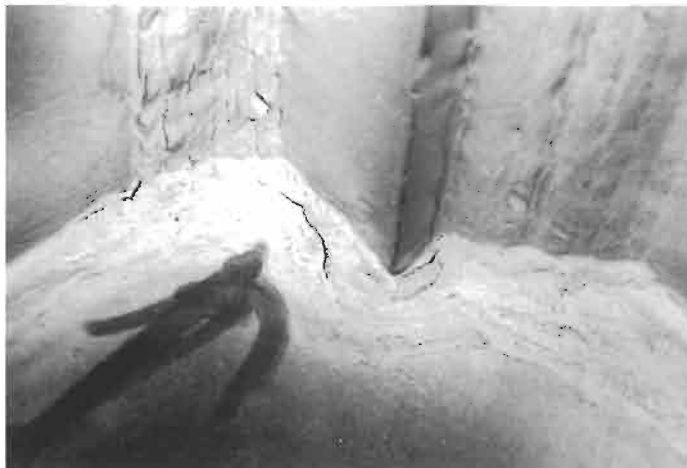
Fig. 4. Typical cracks found at external support welds.

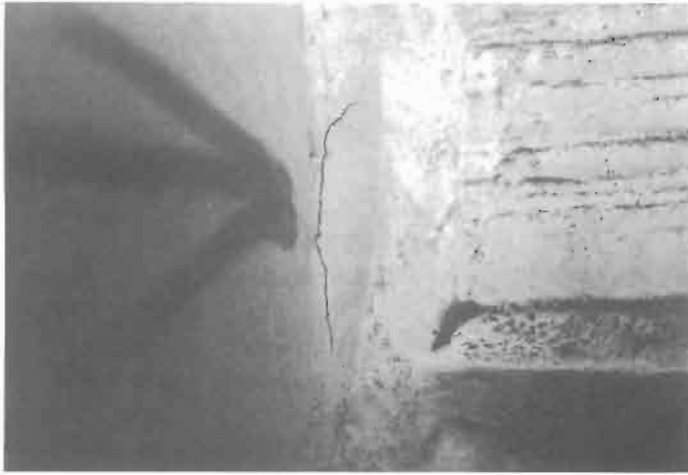
Fig. 5. Typical cracks found at external support welds.

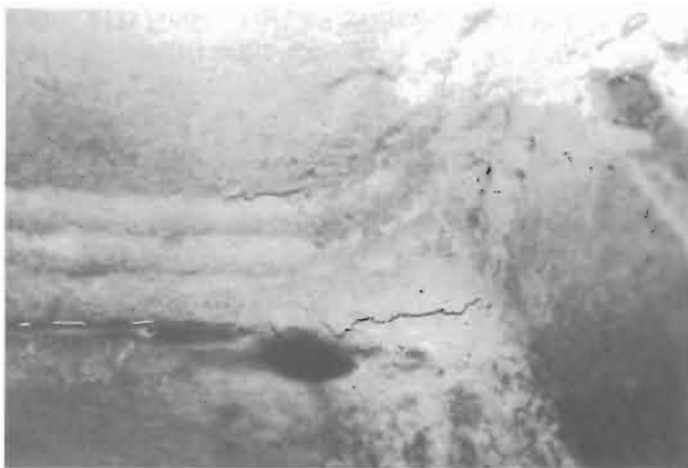
Fig. 6. Typical cracks found at external support welds.

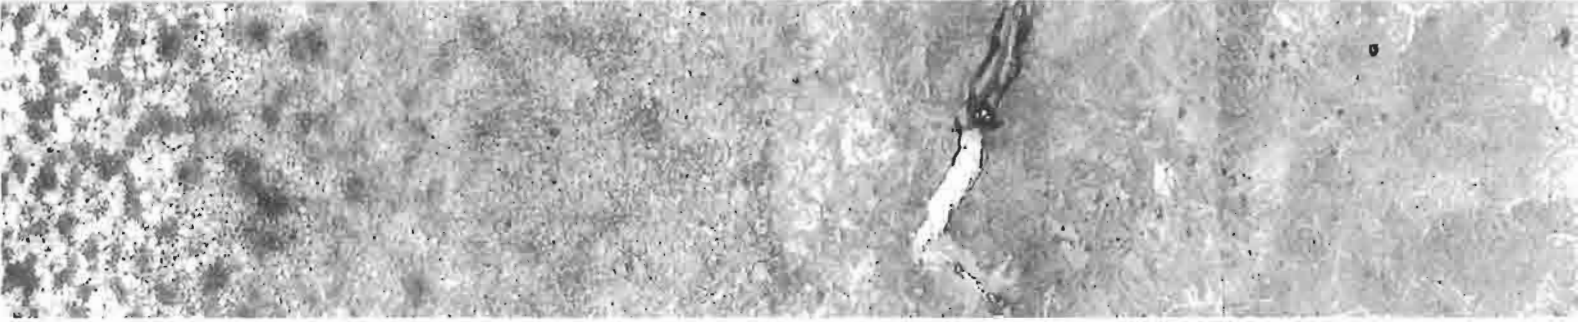
Fig. 8. "Panoramic" section of crack location in support F1 (magnification  $\times 100$ ).

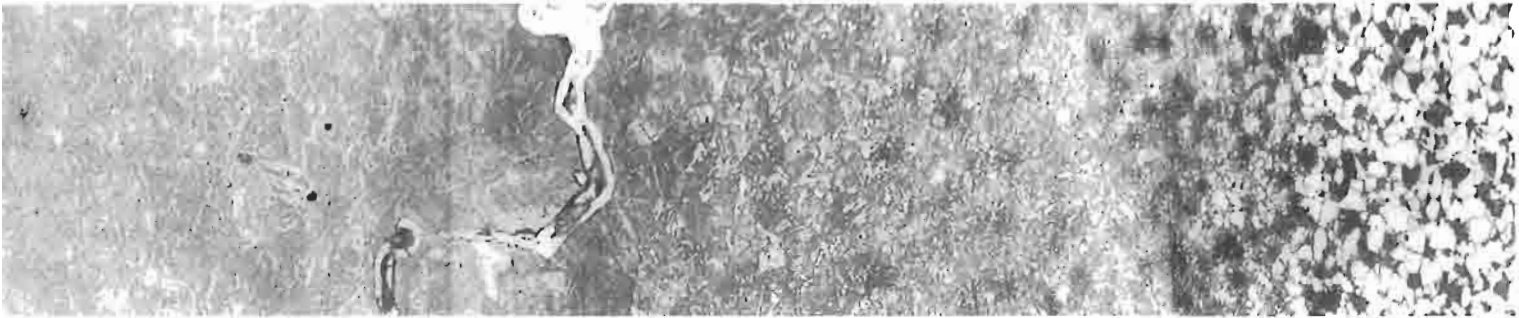
Fig. 9. "Panoramic" section of crack location in support G1 (magnification  $\times 100$ ).

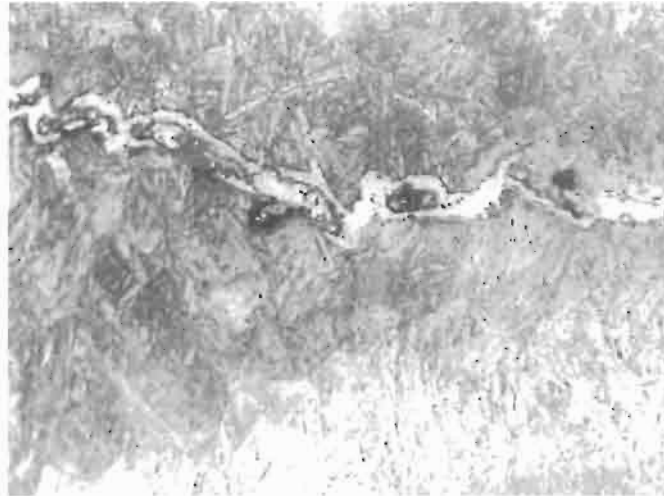
Fig. 10. Detail of oxide filled crack in martensite area of HAZ, support G1 (magnification  $\times 100$ ).

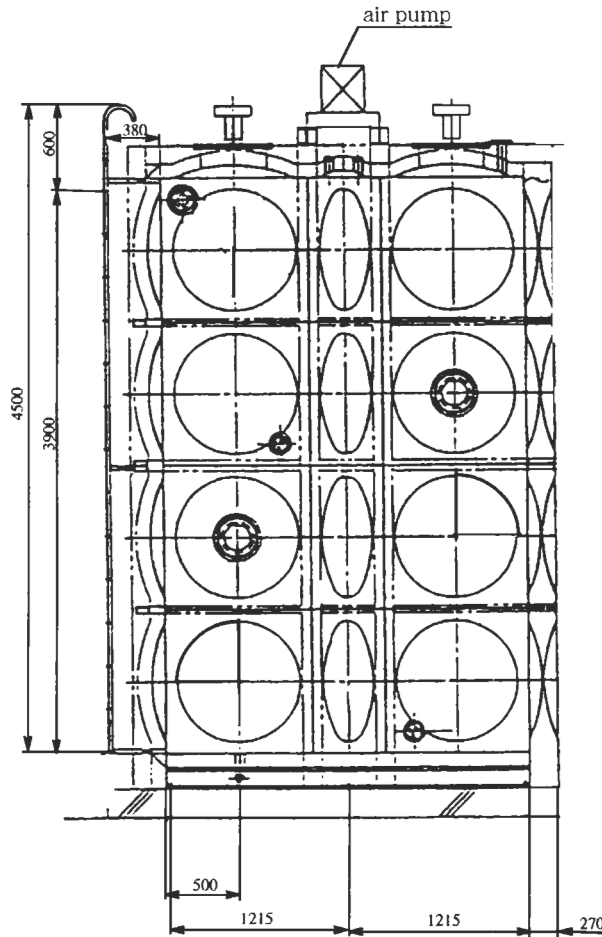
Fig. 1. Schematic diagram of thermal storage tank.

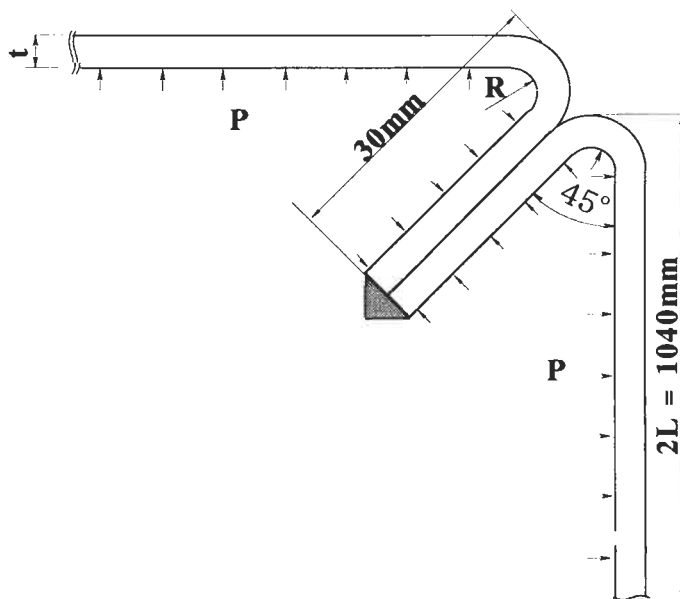
Fig. 2. Enlarged sketch of corner of thermal storage tank panel.

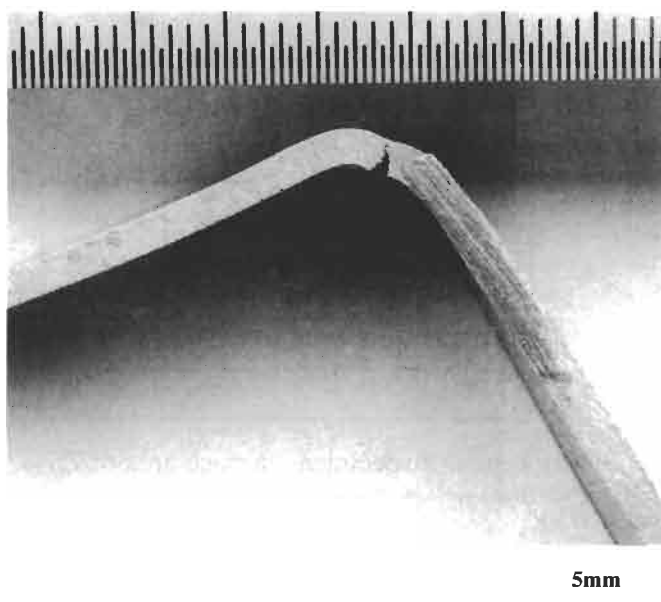
Fig. 3. Cracking in corner.

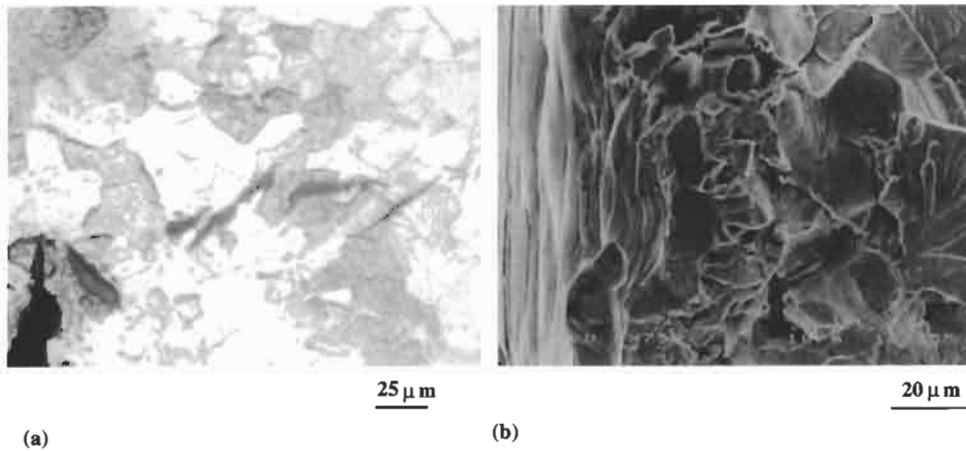
Fig. 4. Microstructure of cracks and SEM micrographs of fracture surface in panel corner.

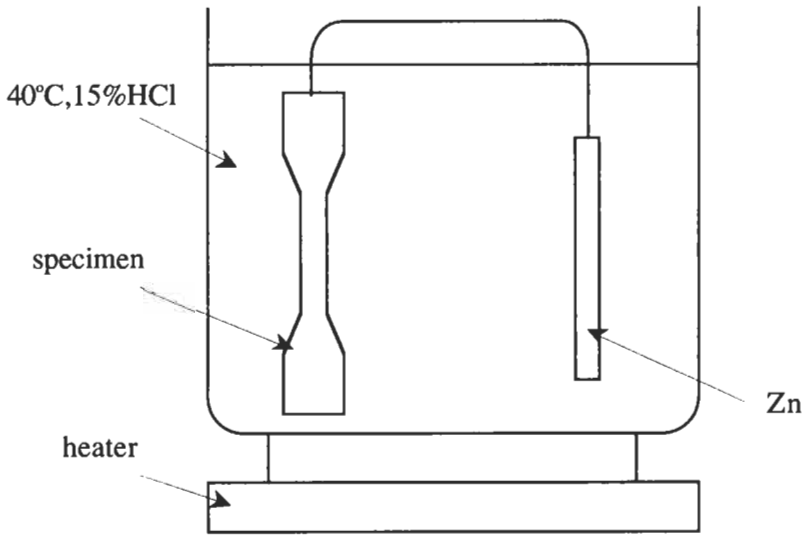
surface area of specimen : surface area of Zn = 2 : 1

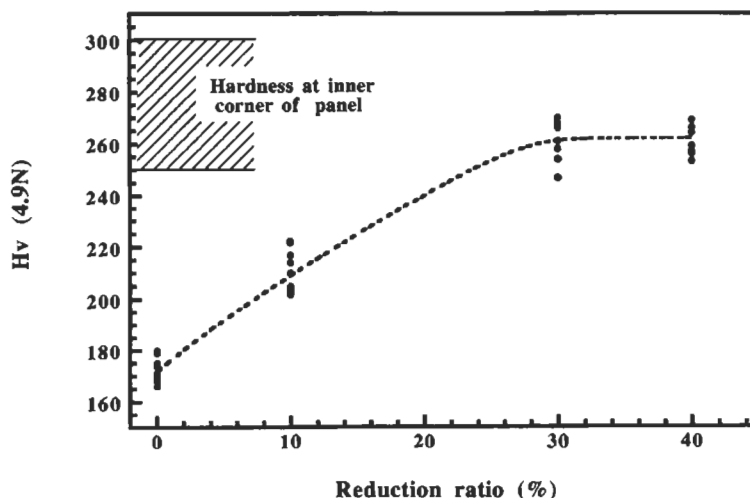
Fig. 6. Relationship between reduction ratio and hardness.

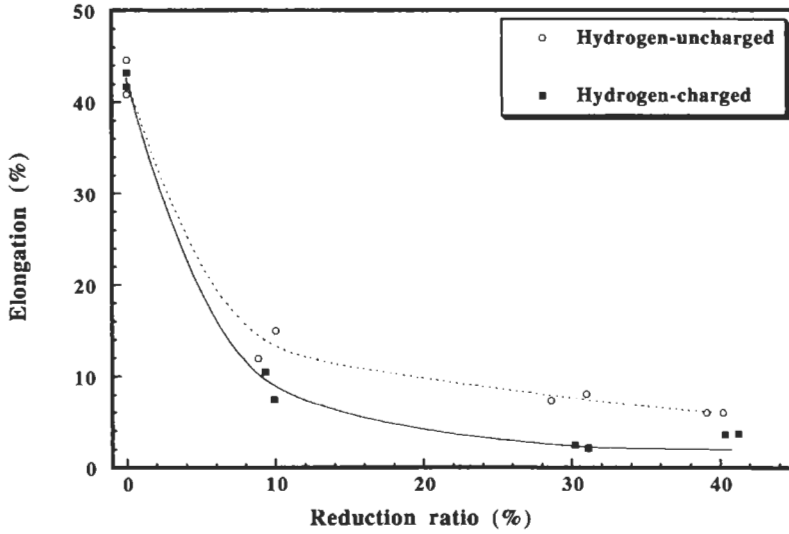
Fig. 7. Influence of reduction ratio on rupture elongation of specimens.

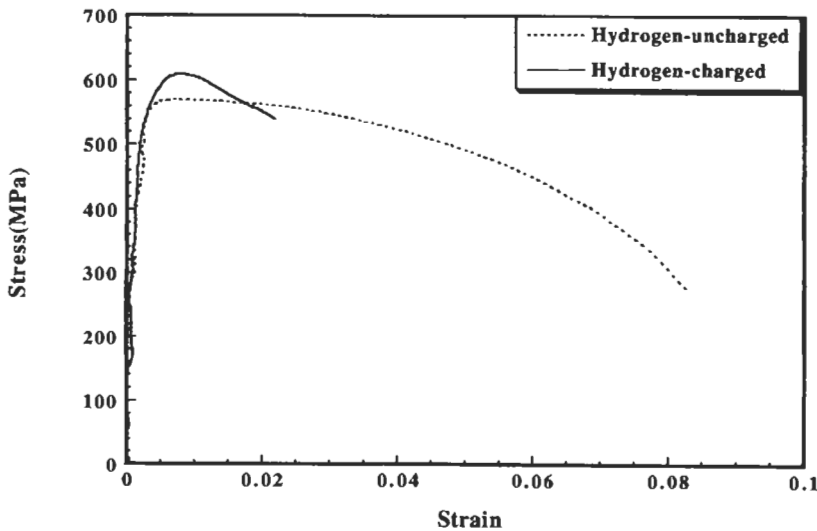
Fig. 8. Stress-strain relation of a tensile test specimen for the case where reduction ratio = 30%.

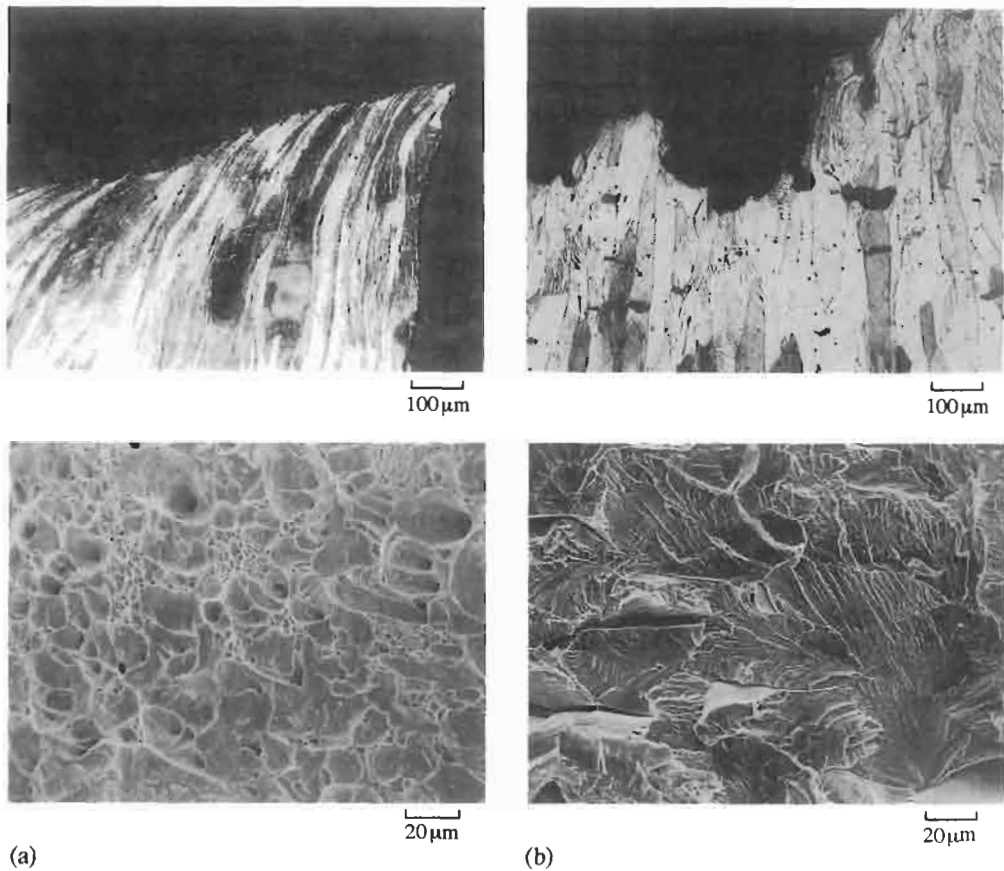
Fig. 9. Microscopic structures and SEM micrographs of fracture surfaces of tensile test specimens for 30% reduction ratio. (a) Hydrogen-uncharged; (b) hydrogen-charged.

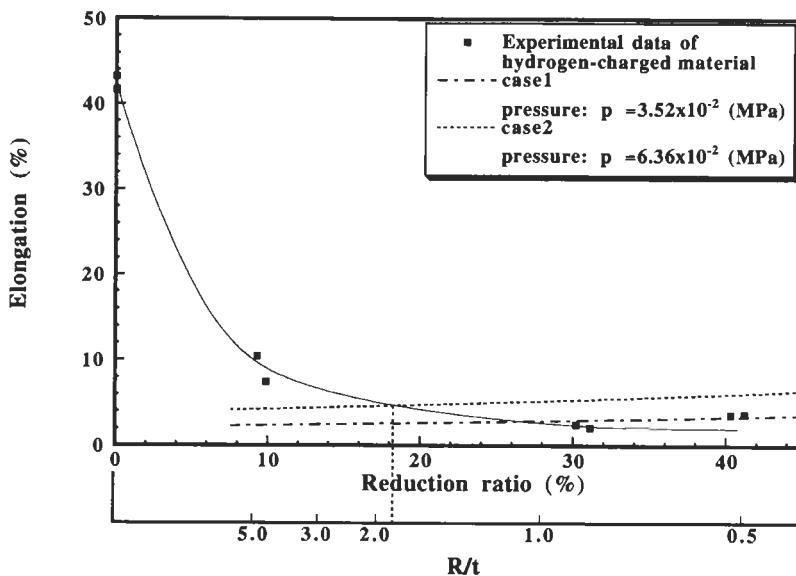
Fig. 11. Conditions for occurrence of hydrogen embrittlement cracking (condition whereby pressure-induced strain at the corner exceeds the rupture elongation of the hydrogen-charged material).

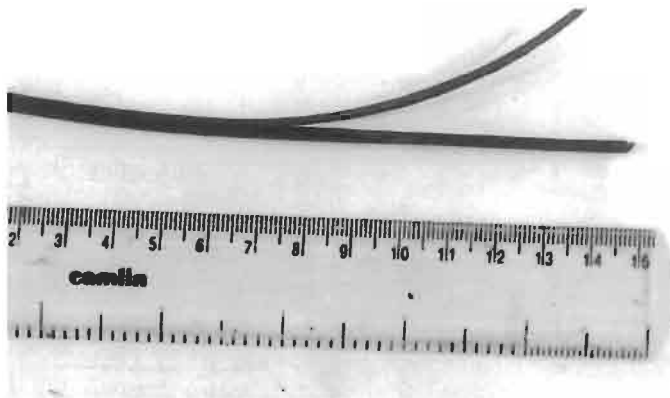
Fig. 1. Wire rod showing a typical split failure.

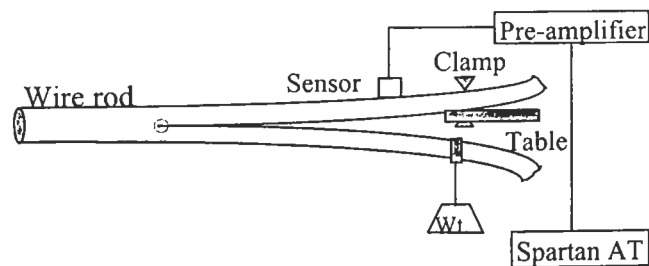
Fig. 2. Schematic view of the experimental set up to study delayed cracking using AE.

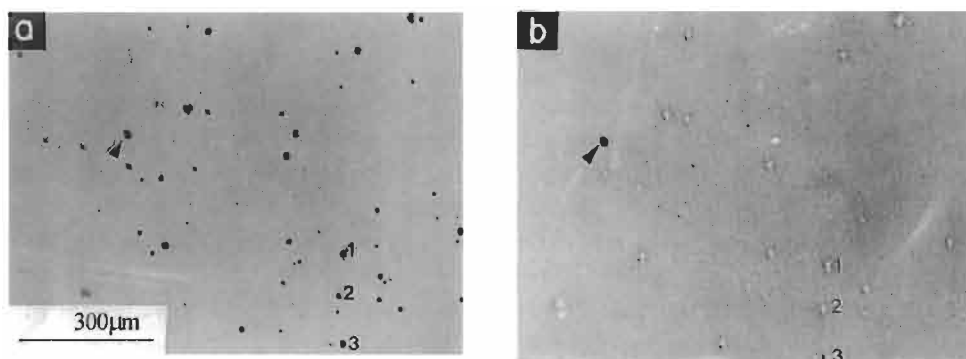
Fig. 3. Optical micrographs of unetched wire drawn sample. (a) Transverse section shows abundance of pores in focused condition. (b) Over-focused condition showing pores as illuminated spots and inclusions as dark spots. The correspondence between (a) and (b) can be noted.

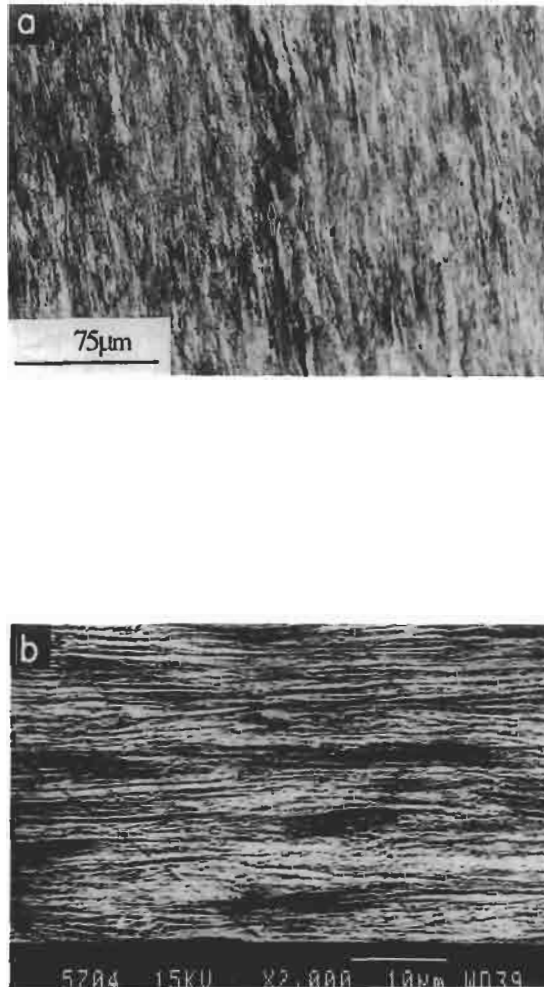
Fig. 4. (a) Optical micrograph and (b) SEM photograph showing microstructures featuring typical fibrous nature comprising elongated ferrite and cementite lamella. The cracks along the drawing direction can be observed in (a).

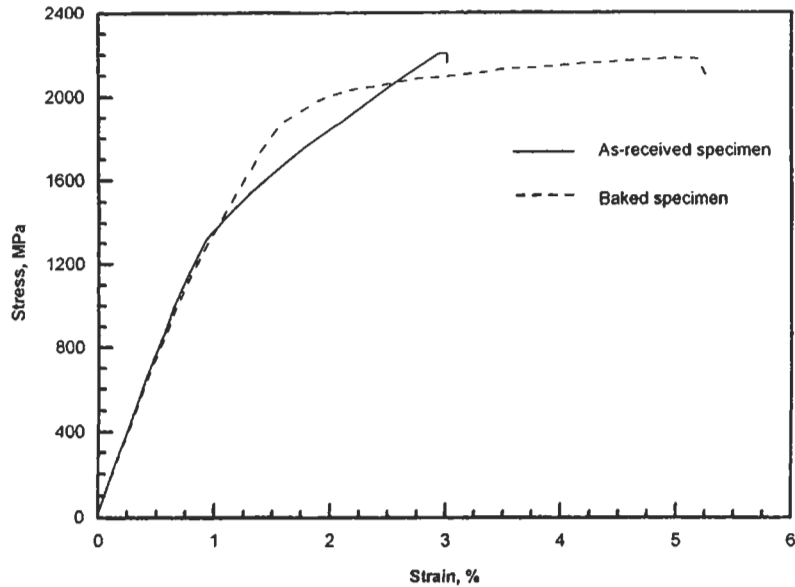
Fig. 6. Tensile behaviour of high tensile wires in as-received and baked condition. Significant improvement in elongation of the baked specimen can be noted.

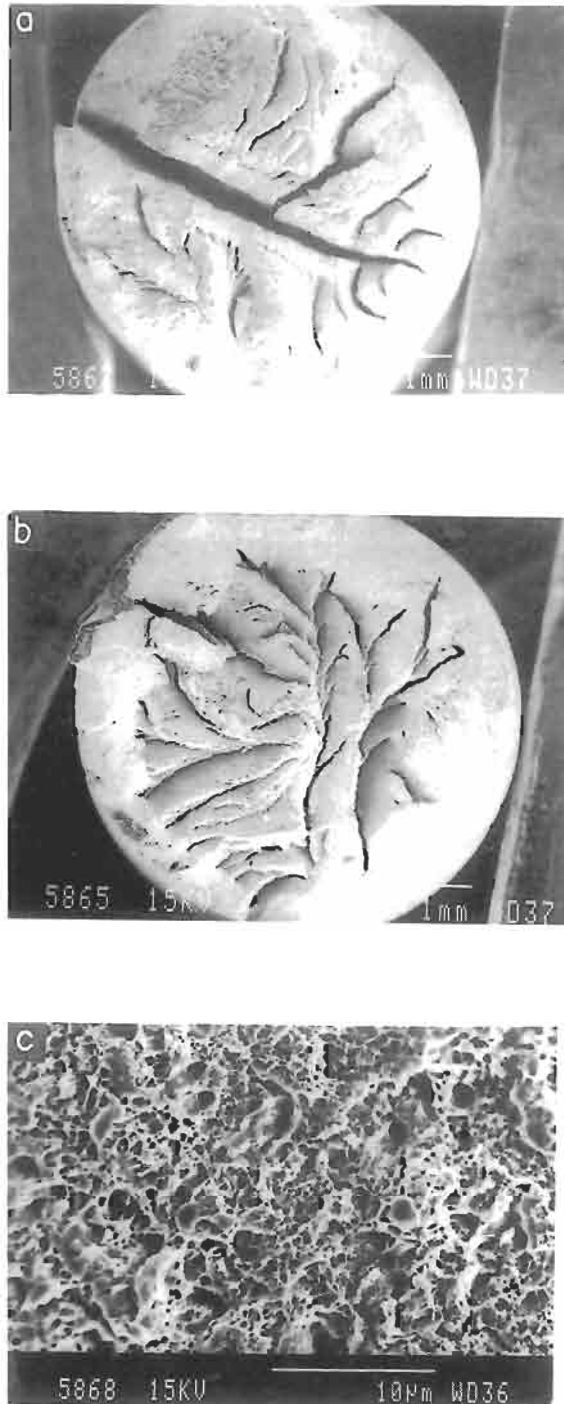
Fig. 7. SEM fractographs of (a) as-received specimen; (b) baked specimen; (c) dimple fracture observed at higher magnification, location as at (a).

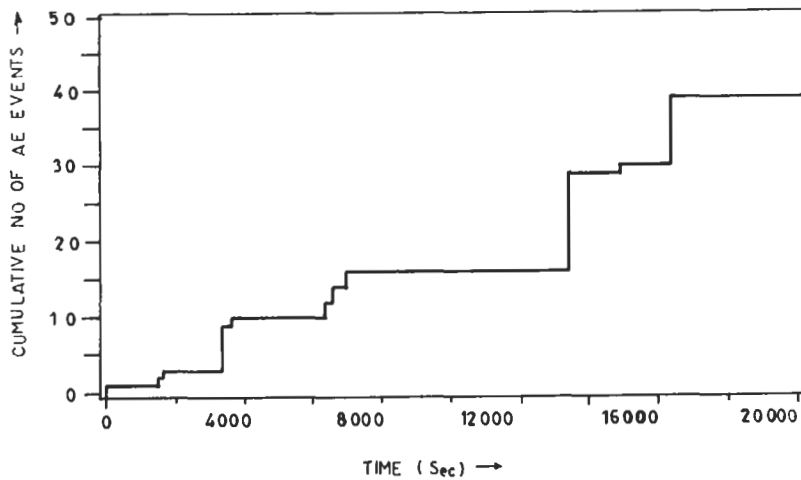
Fig. 8. Cumulative number of AE events generated during delayed cracking test of the wire.

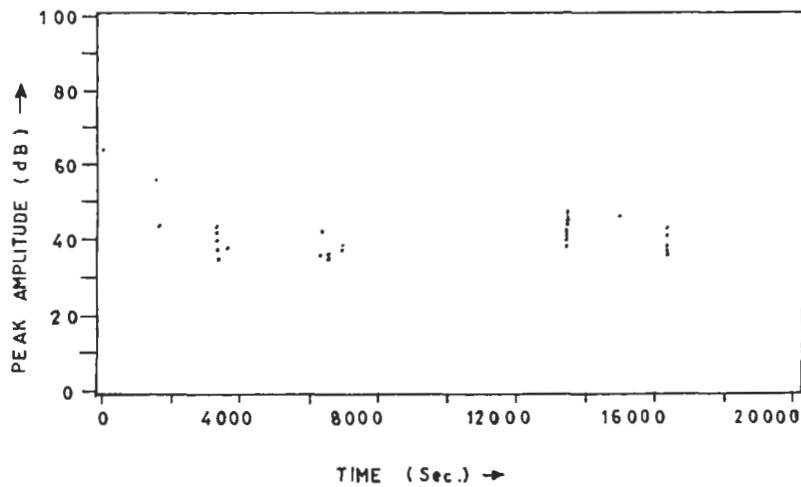
Fig. 9. Peak amplitude of AE events generated during delayed cracking test of the wire showing intermittent nature of the events.

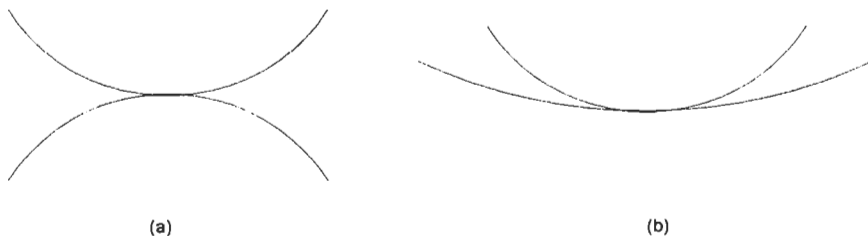
Fig. 1. Schematic illustration of counterformal (a) and conformal (b) surfaces in contact.

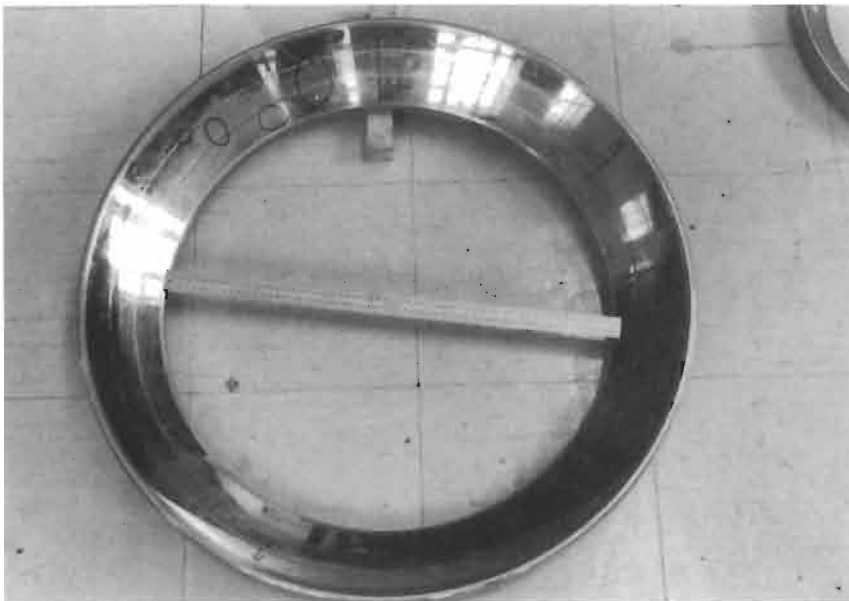
Fig. 2. Thrust bearing cup showing highly polished surfaces typical of the initial stages of rolling contact fatigue.

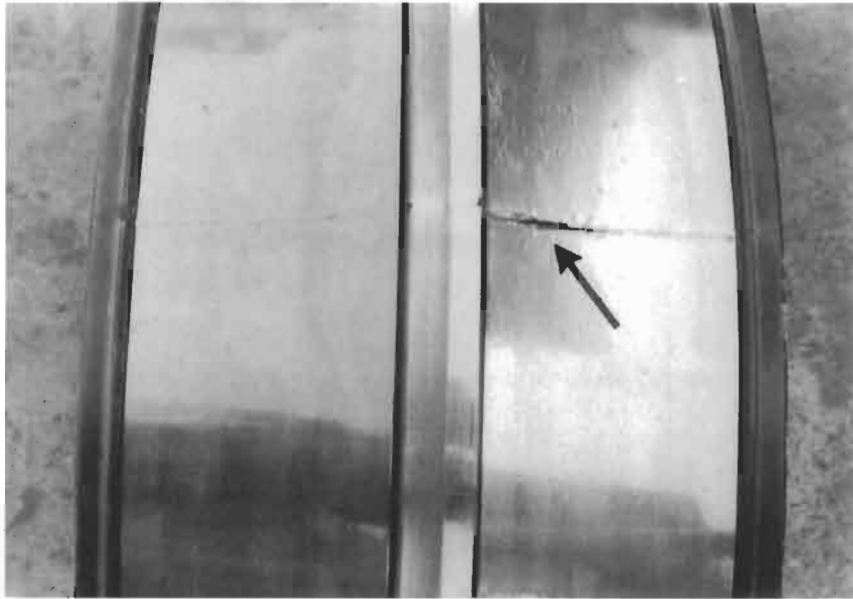
Fig. 3. Inner ring of a thrust bearing showing extensive surface damage on one raceway, and through-cracking of the bearing ring.

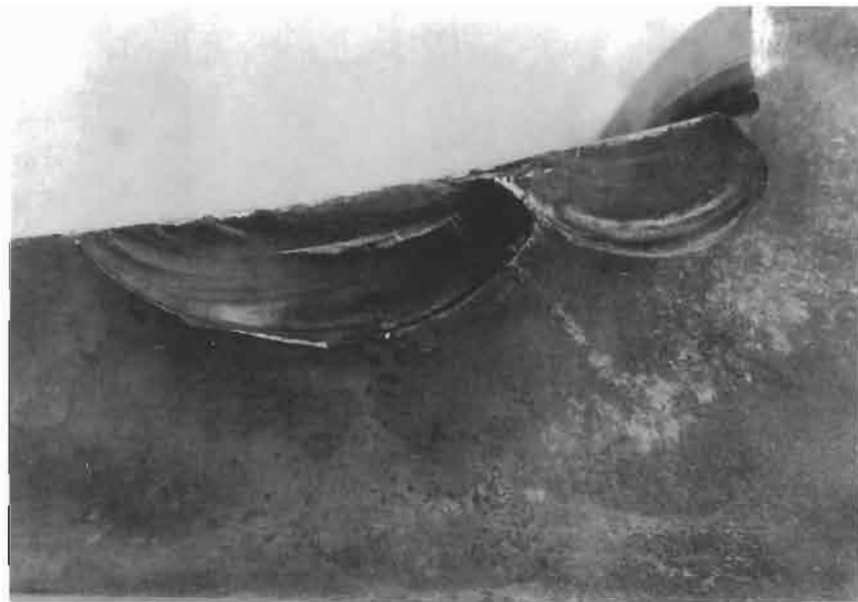
Fig. 4. Crack face in the vicinity of the region marked with an arrow in Fig. 3.

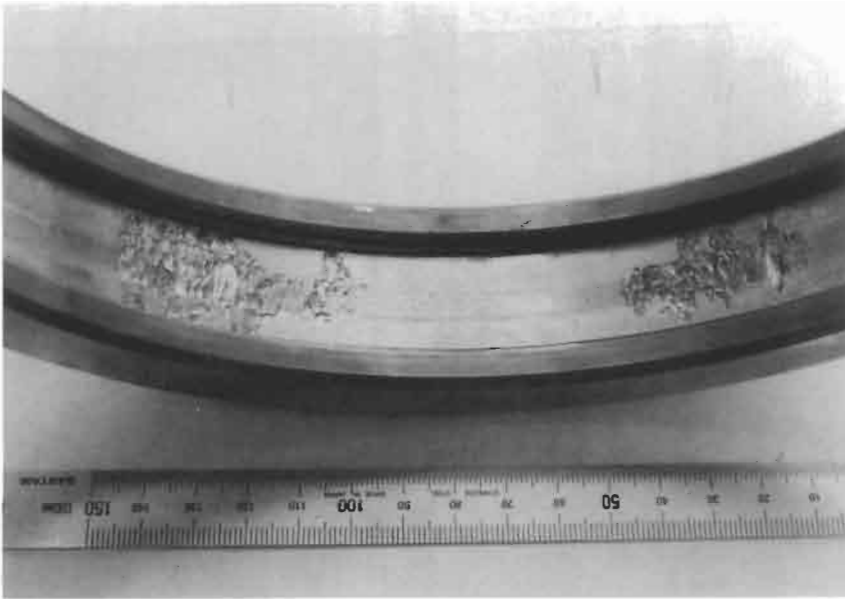
Fig. 5. Flaking damage on the outer raceway of a roller bearing.

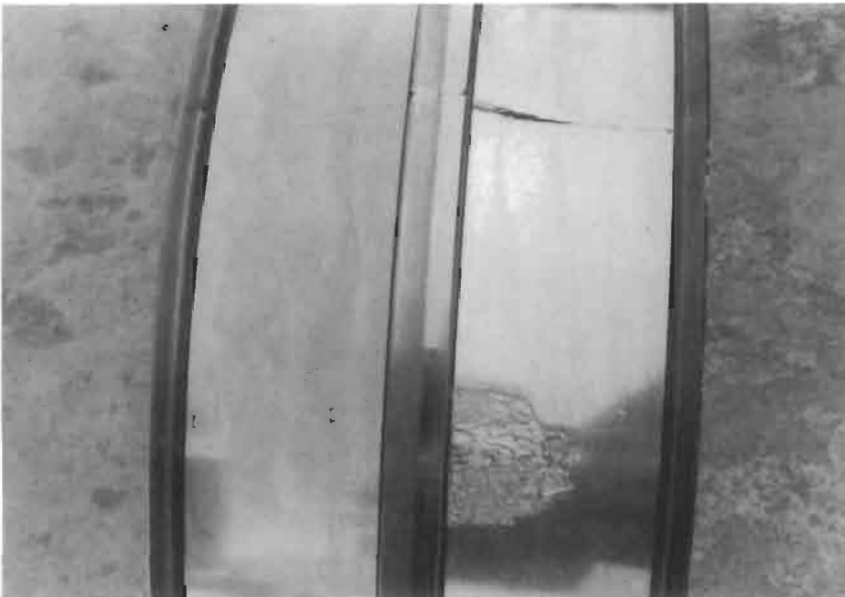
Fig. 6. Localized flaking damage on the inner ring of a thrust bearing.

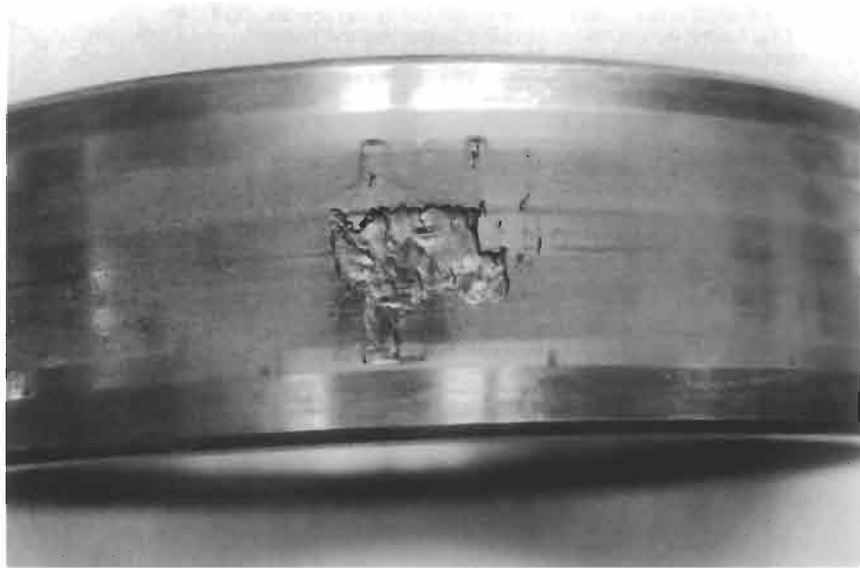
Fig. 7. Severe spalling on the inner ring of a thrust bearing.

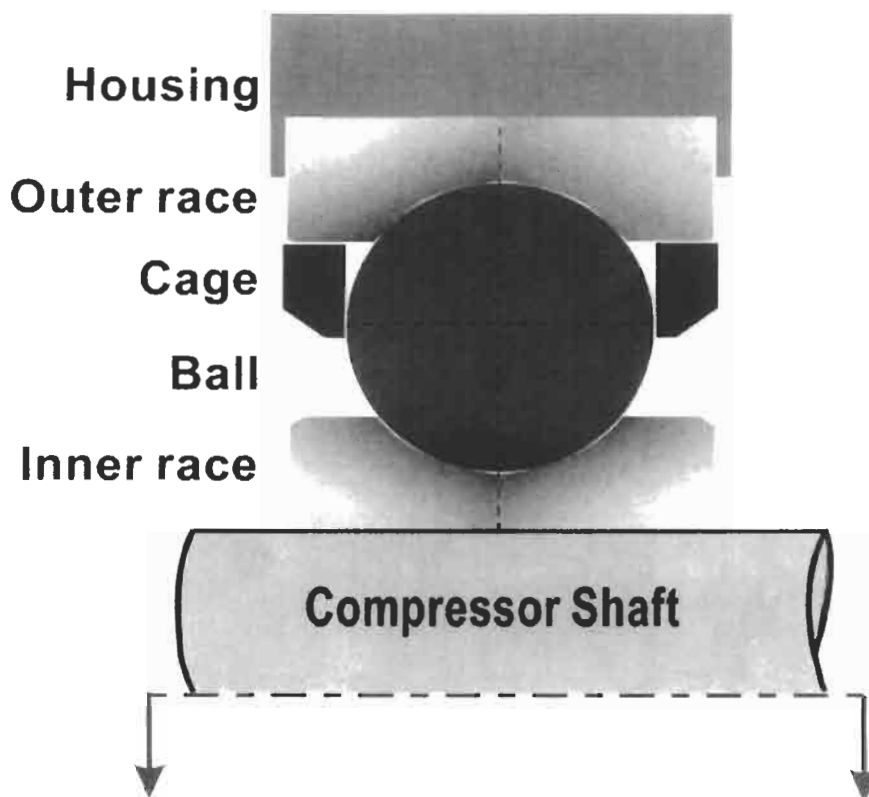
Fig. 2. Sketch of the bearing assembly.

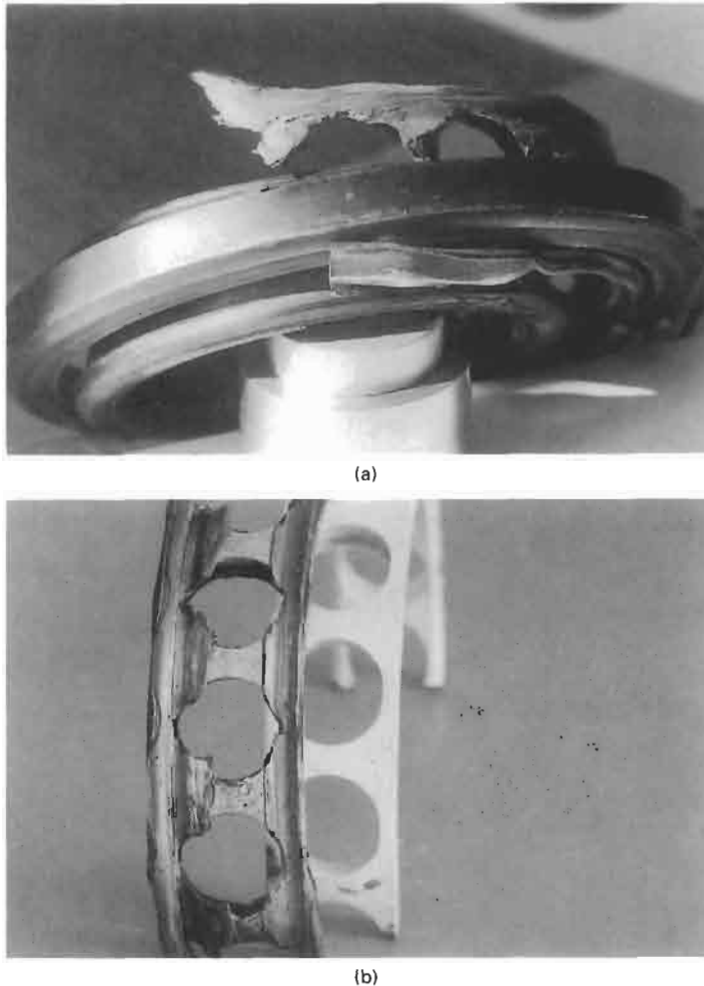
Fig. 3. (a) Probable configuration of bearing components after mishap. (b) Retrieved cage compared with the new one.

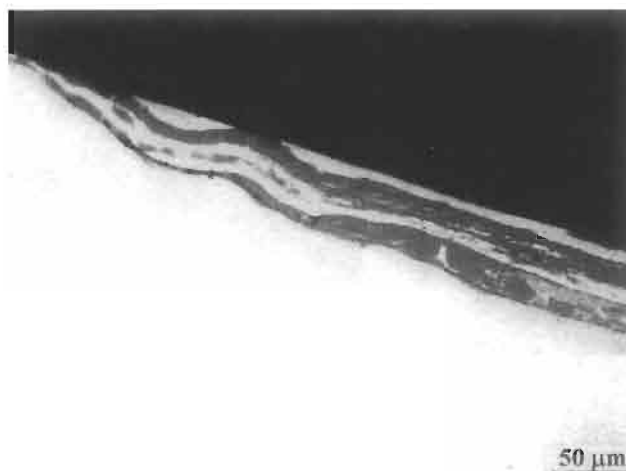
Fig. 6. Deformation bands near the surface of the retrieved outer race.

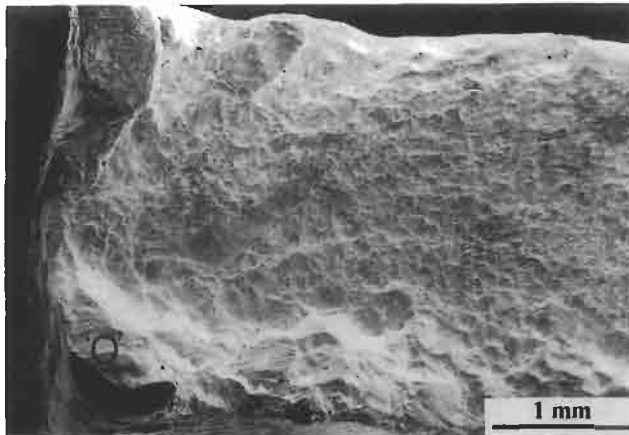
Before the accident excessive wear of the bearing components took place in a short time of approximately 5 h. Cage material was stuck between the ball and the race producing severe

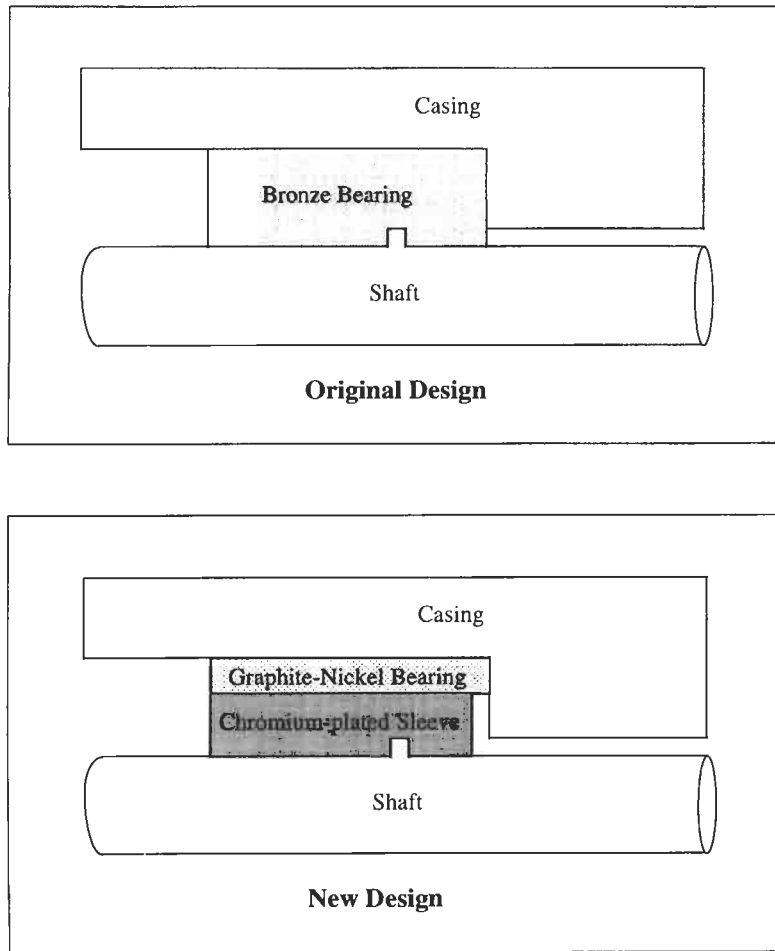
Fig. 1. Original and new design of the first stage sealed area.

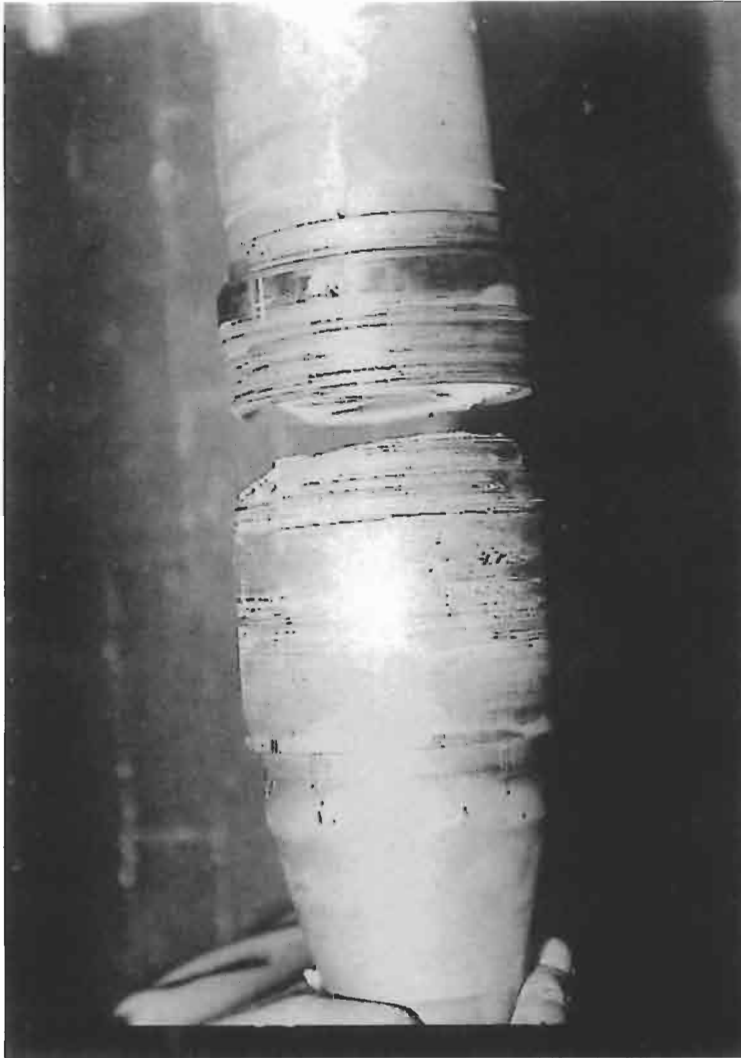
Fig. 2. Photograph of the failed shaft and chromium-plated sleeve.

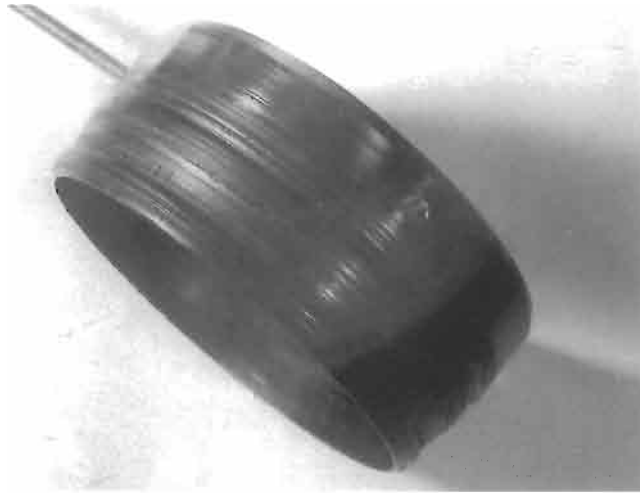
Also seen in Fig. 2 is the irregular shape of the fracture surface in the lower sleeve part, this fracture surface being located in some areas below the fracture surface of the shaft. In contrast, in the upper sleeve part, the fracture surface of the shaft is totally obscured by the sleeve. In addition, in this part, the sleeve does not show the typical and irregular appearance of a fracture surface. Its edge is completely regular and homogeneous, as if machined. These facts may indicate that after the failure the fracture surface of the upper part of the sleeve was rubbing against the casing while

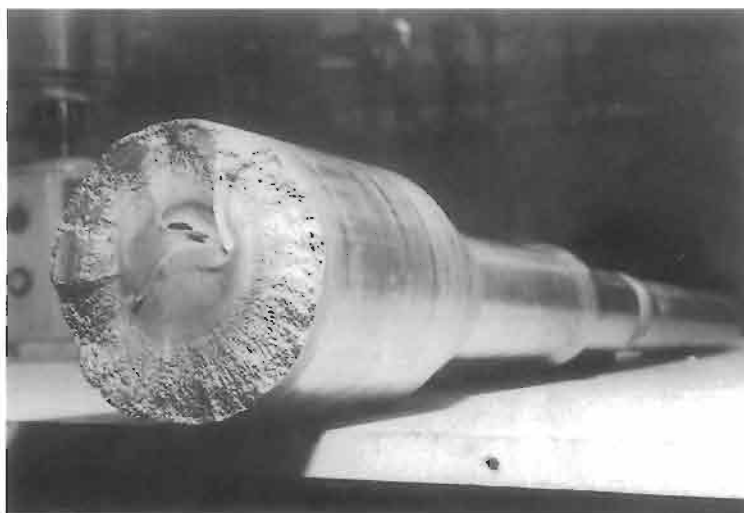
Figure 4 shows the fracture surface of the shaft. The appearance and topography is different in the outer part and in the inner part. In the outer part, the fracture is rough and bright, and it becomes smoother and more matte towards the center of the shaft. It is possible to differentiate

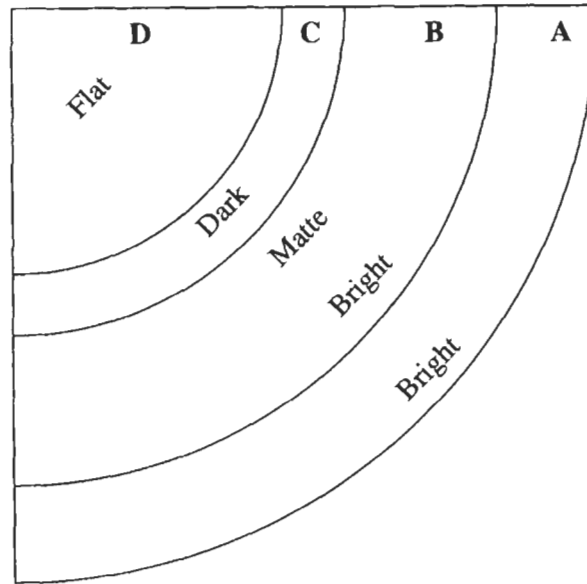
Fig. 5. Schematic illustration of the shaft fracture surface.

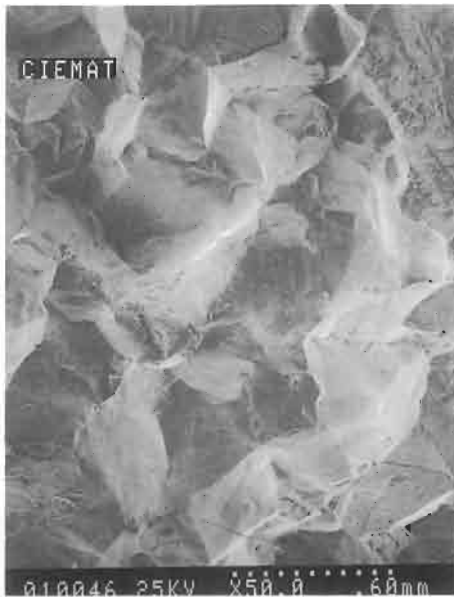
Two different metallographic sections can be seen in Figs 7 and 8. Figure 7 shows a macro-

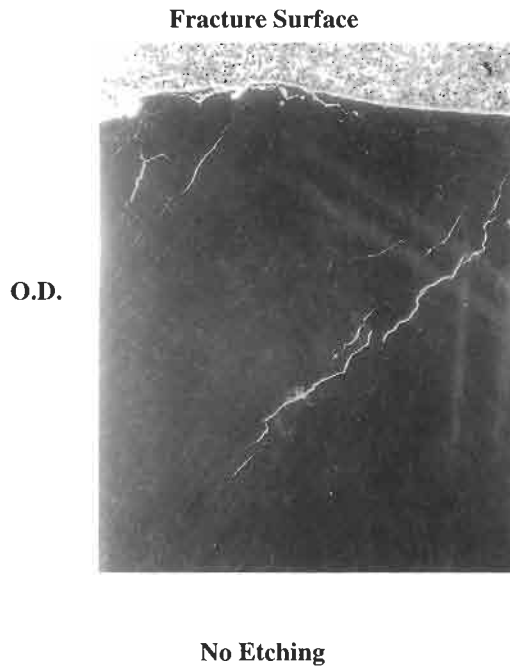
Fig. 7. Metallographic section close to shaft fracture surface.

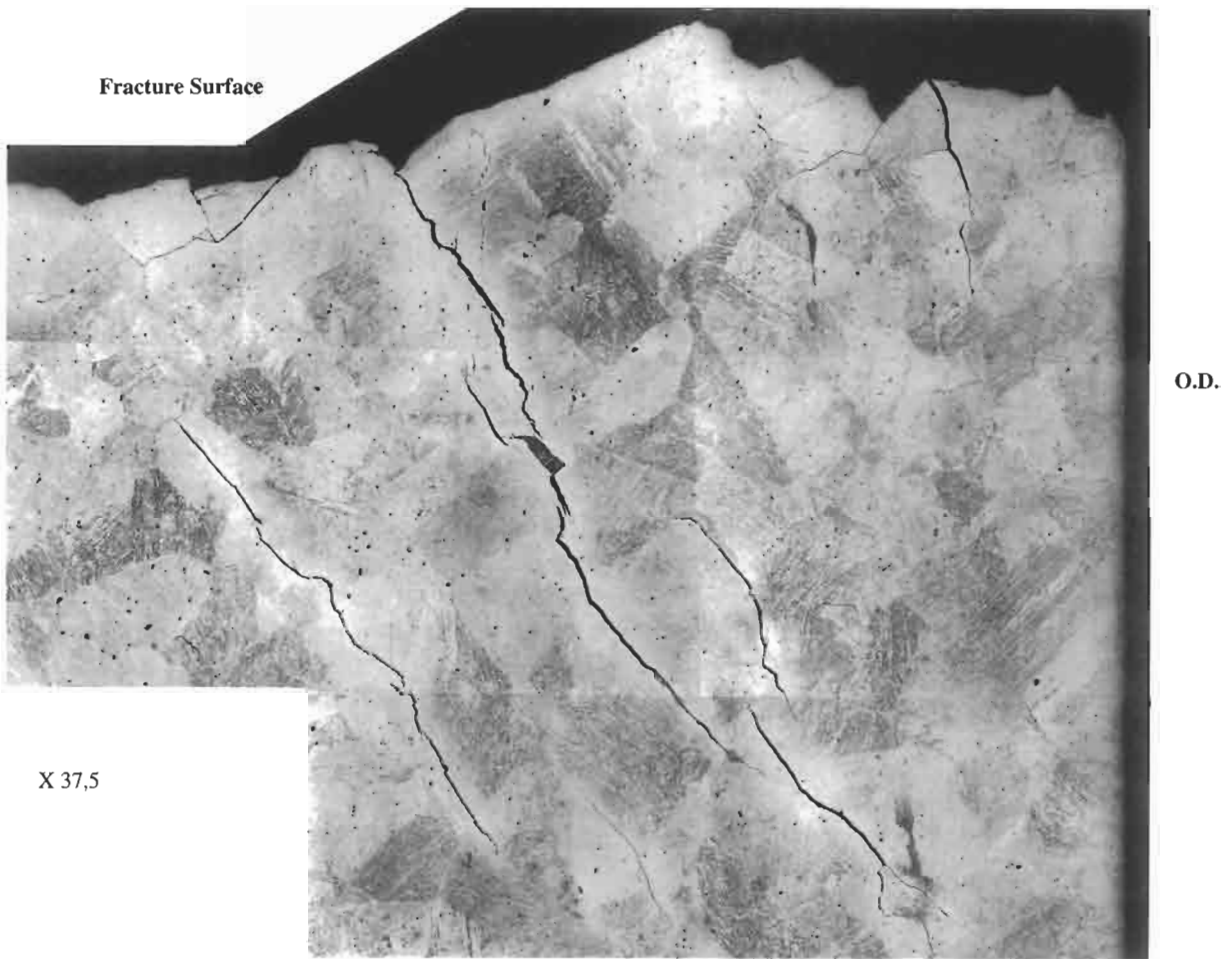
Fig. 8. Detailed metallographic section close to shaft fracture surface.
