***FAILURE  
ANALYSIS  
CASE  
STUDIES II***

Edited by  
**D.R.H. Jones**

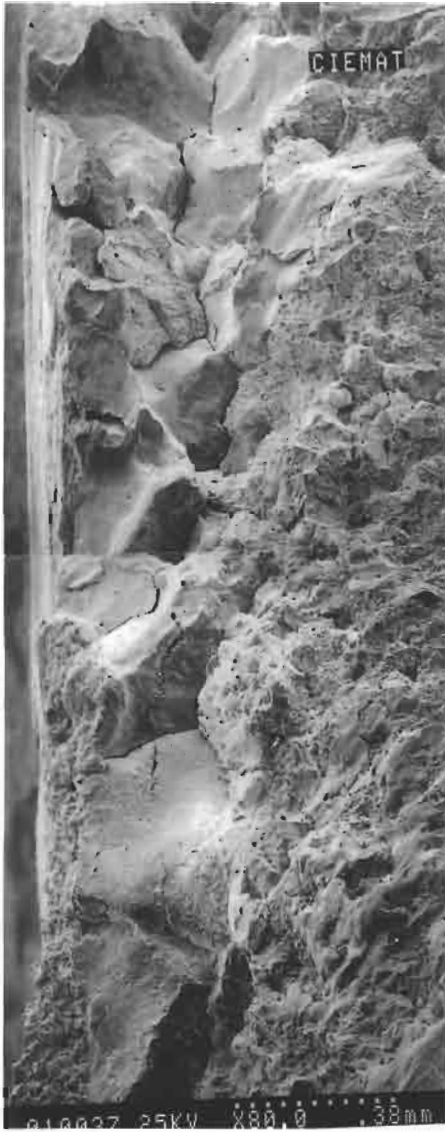
Vickers microhardness with a load of 200 g were measured in zones close to the fracture surface and in zones 30 mm from the fracture. In the last case the average value obtained was 325 HV, in accordance with the hardness of this material. However in areas close to the fracture, the average value at the center of the sleeve thickness was 420 HV while at the O.D., where different microstructural characteristics were observed, microhardness values from 250 to 375 HV were measured.

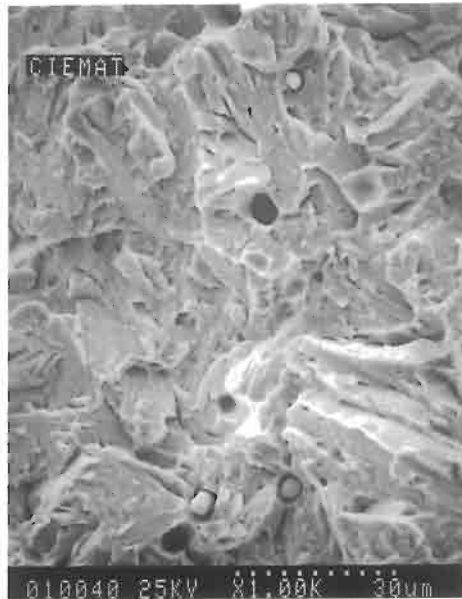
Fig. 10. Fracture surface of the failed chromium-plated sleeve (center).

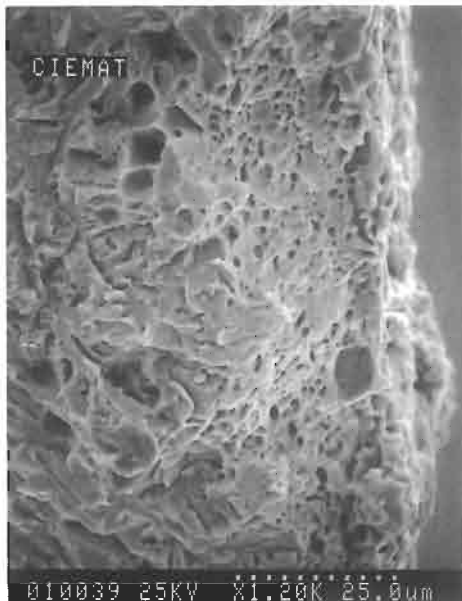
Fig. 11. Fracture surface of the failed chromium-plated sleeve (I.D.).

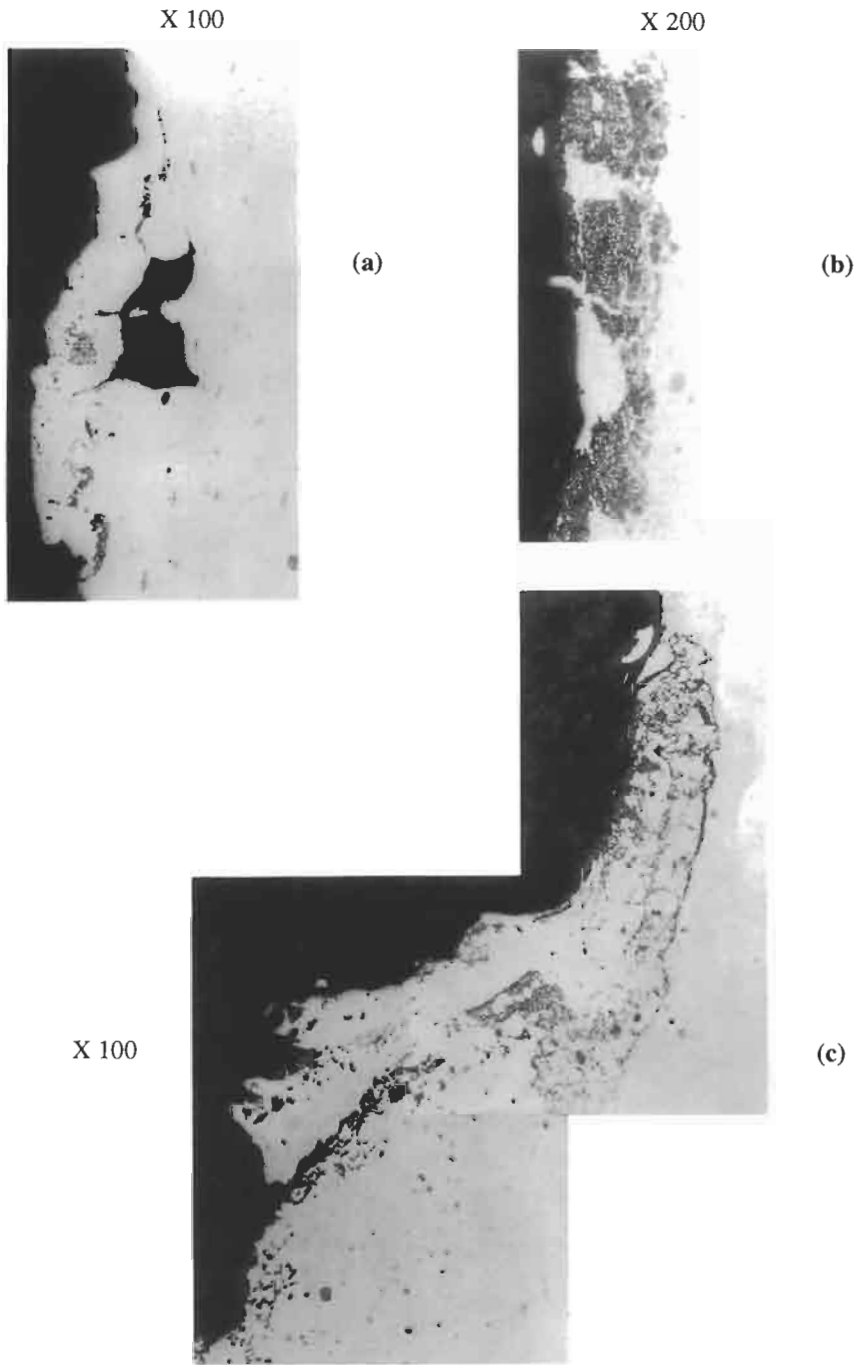
Fig. 12. Metallographic sections, not etched, close to the fracture surface of the chromium-plated sleeve (OD).

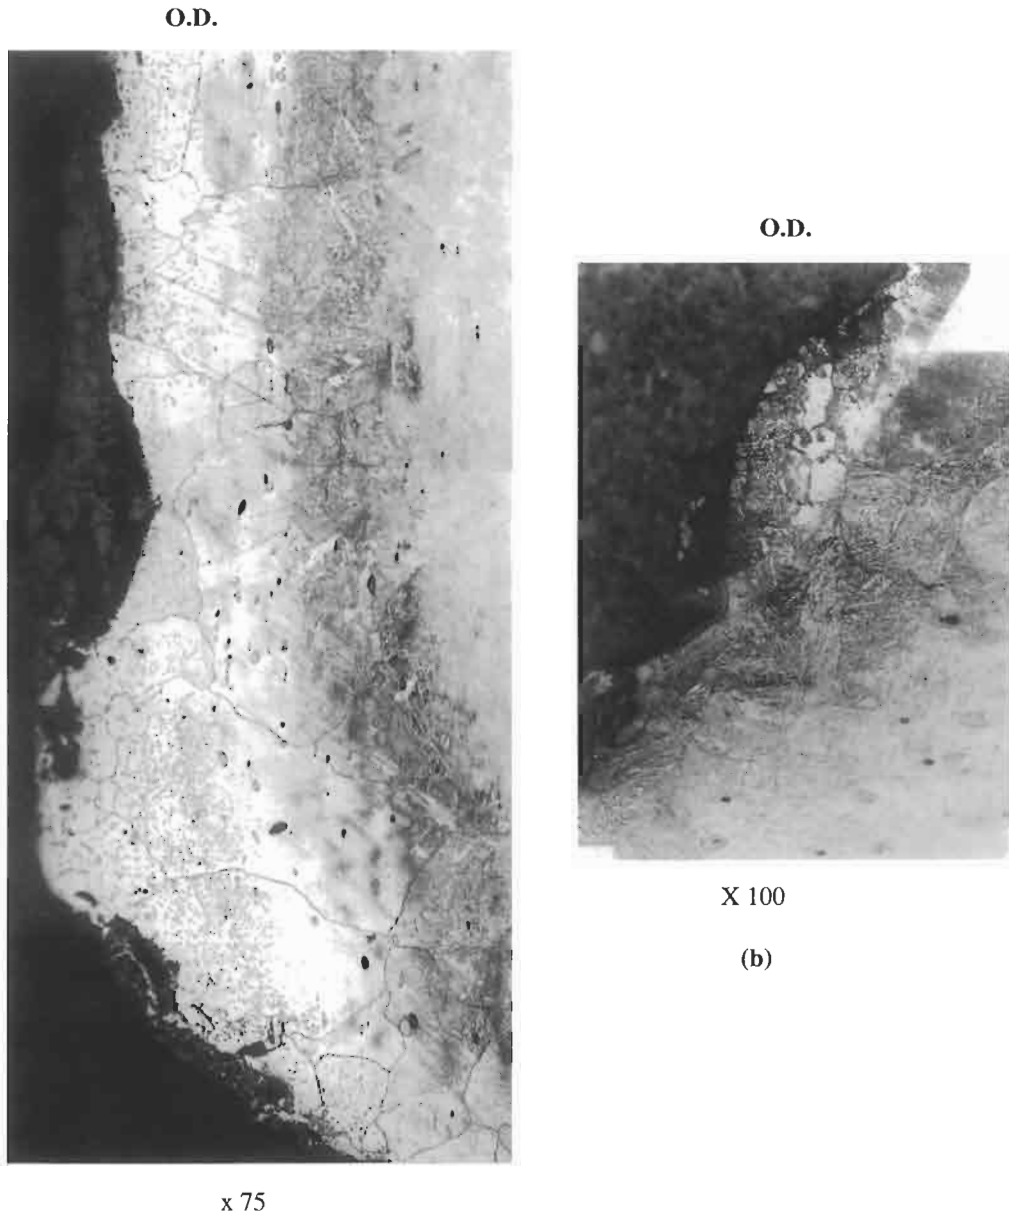
Fig. 13. Metallographic sections, after etching, close to the fracture surface of the chromium-plated sleeve (OD).

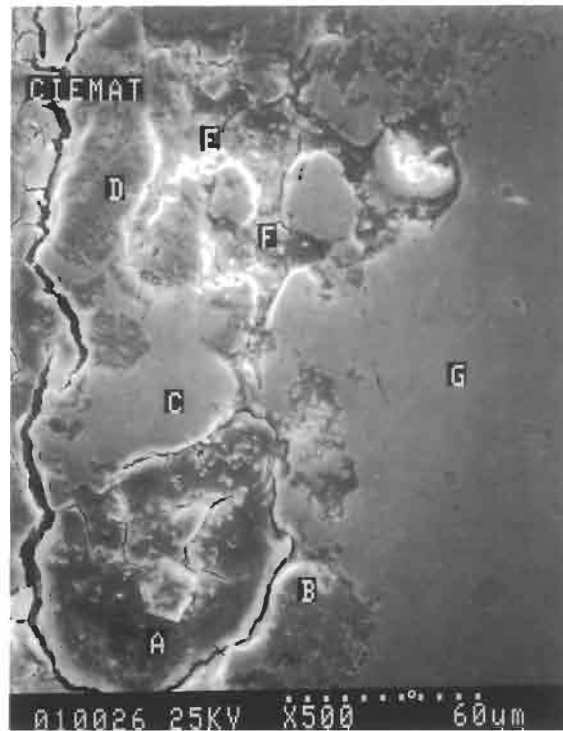
Al	Si	Ca	Cr	Mn	Fe	Ni	Cu	Pb	
A	2.44	2.01	3.80	17.90	---	50.22	16.27	5.84	1.52	% wt
	1.16	1.00	2.70	16.47	---	49.63	16.91	6.57	5.56	% ato.
B	---	2.47	---	74.19	7.24	2.76	---	9.94	3.40	% wt
	---	1.19	---	66.35	6.84	2.65	---	10.86	12.11	% ato.
C	13.13	1.85	---	53.36	18.18	9.91	---	0.15	3.41	% wt
	6.50	0.96	---	50.92	18.33	10.16	---	0.17	12.97	% ato.
D	---	6.33	---	79.77	4.63	1.98	---	4.85	2.44	% wt
	---	3.23	---	75.37	4.62	2.01	---	5.60	9.17	% ato.
E	0.75	4.68	---	76.76	4.92	5.92	---	6.11	0.86	% wt
	0.38	2.48	---	75.16	5.09	6.22	---	7.31	3.36	% ato.
F	---	12.74	1.86	36.42	---	35.69	7.20	5.33	0.85	% wt
	---	6.76	1.42	36.04	---	37.93	8.04	6.44	3.37	% ato.
G	---	---	---	9.74	---	88.75	---	1.51	---	% wt
	---	---	---	9.11	---	89.17	---	1.73	---	% ato.
