Property address

Date of inspection

26th June 2017

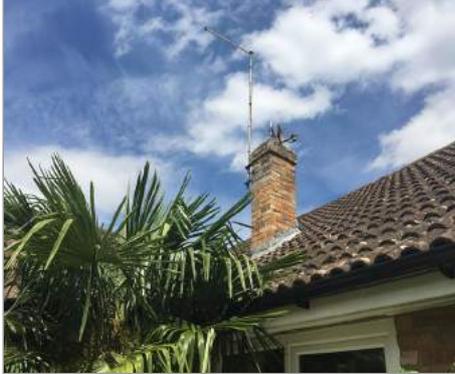
Photo - 3

The roof is covered with concrete tiles and appears to be in acceptable condition.

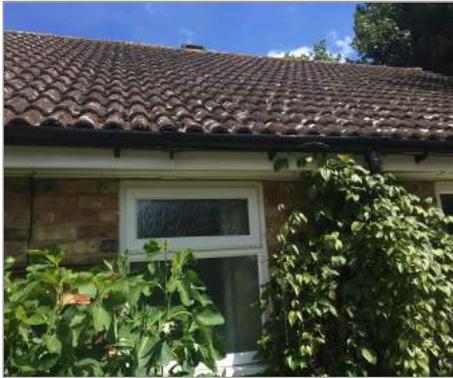
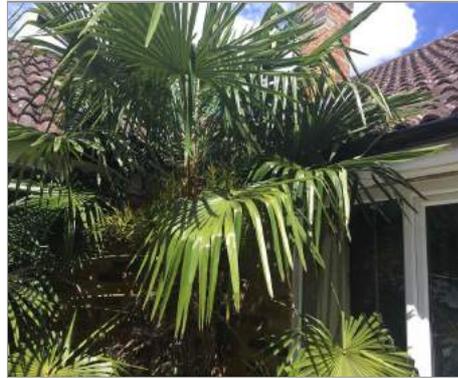
The rainwater goods are UPVC and appear to be in acceptable condition.

As it was not raining at the time of the inspection it was not possible to determine if there any areas which are leaking.

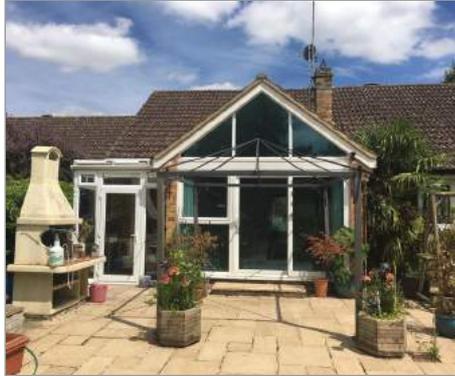
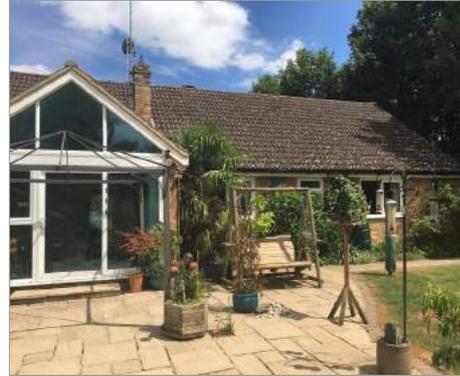
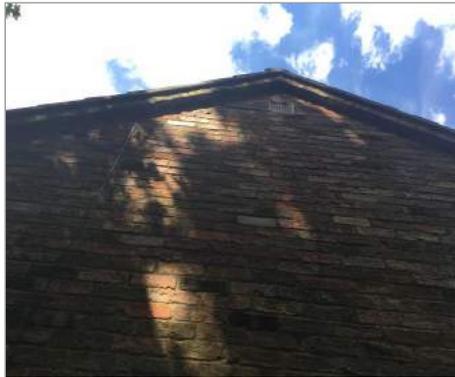
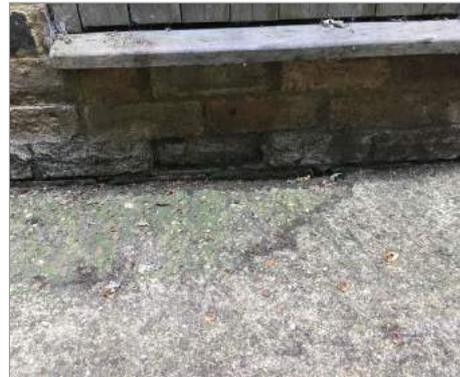
The condition of the walls could not be fully ascertained due to the amount of shrubbery growing around the property. It is suggested that the shrubbery be cut back to prevent any damp being trapped between the wall and shrubbery and penetrating the wall.

The main gable where the boiler room is located has worn brickwork at low level, however, this is not considered to be of concern nor is hairline cracking to projecting gable sections.

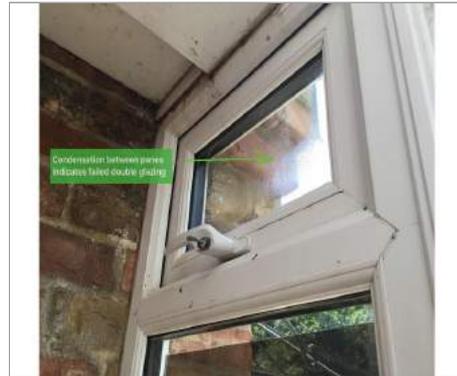
Photo - 12

One of the top panes of the conservatory requires replacement as the seal has gone.

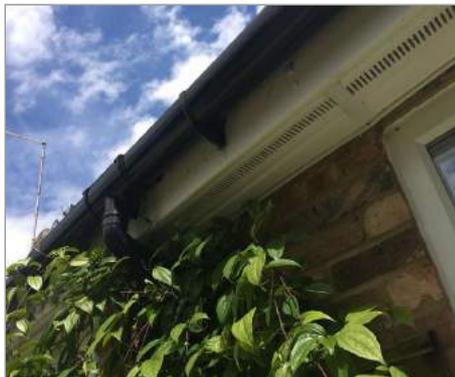
Photo - 13

The property has vented UPVC soffits and fascias which appear to be in acceptable condition. 1

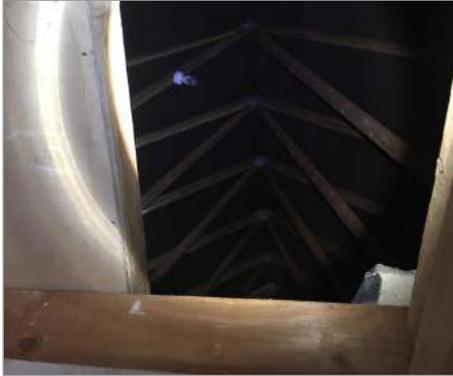
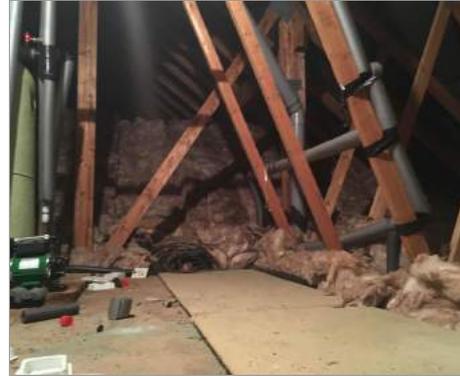
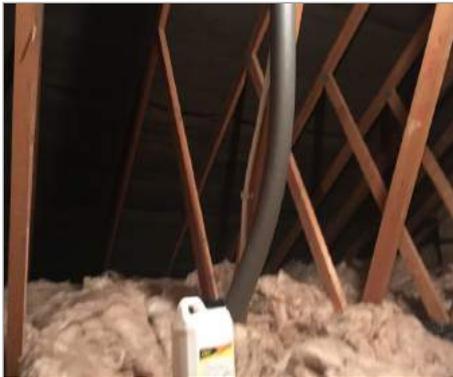
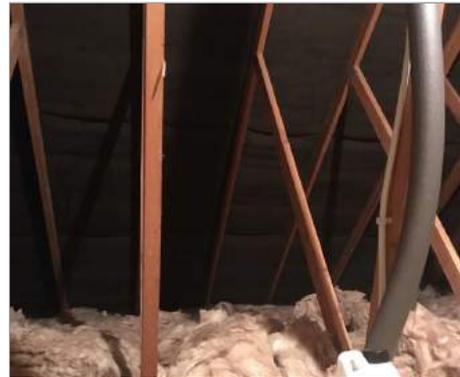
All timbers and fixings appeared to be in acceptable condition. The main roof is insulated at ceiling joist level with loose fill insulation, it should be ensured that the insulation does not block the soffit vents.

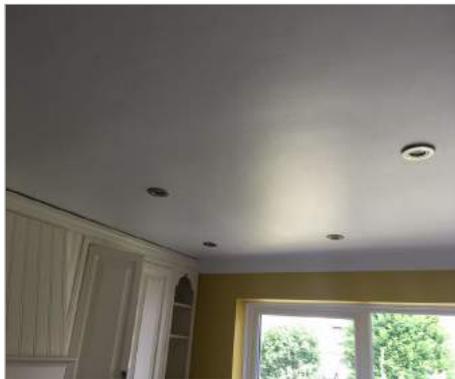
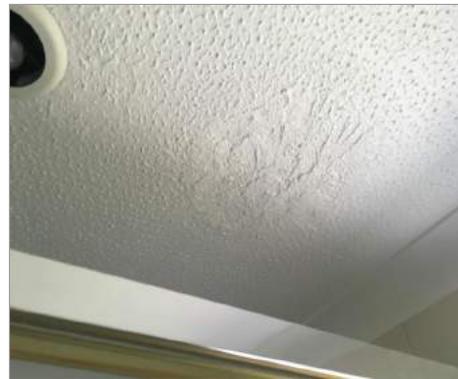
The ceilings are a mixture of plaster skim and artex. In the front storage cupboard there is a crack and dark staining to the ceiling, however, no dampness registered to these areas on the damp meter. 2

In the rear end bedroom with the built in wardrobes there was evidence of a patched up crack with bulging. The crack appears to be straight and is believed to be due to poor fixing of boards or contraction and expansion at board edges. There is a water tank and cylinder in the loft so it is possible that they or possessions in the roof space have overloaded this area of ceiling.

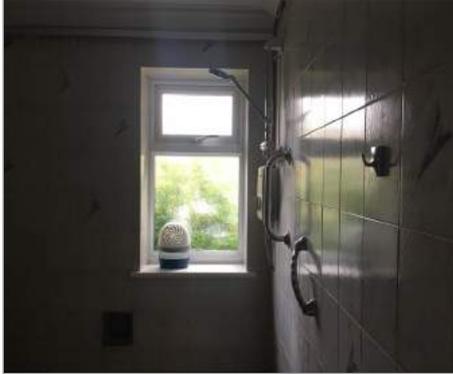
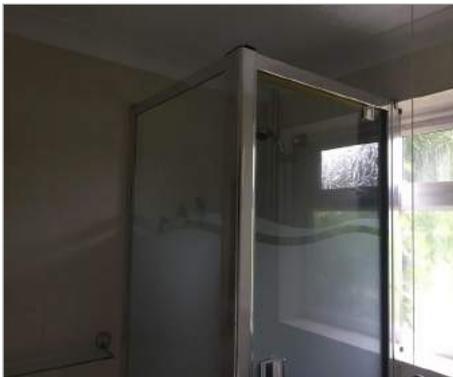
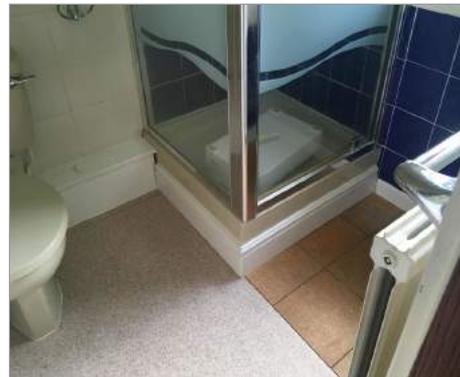
The rear ensuite comprises WC, handbasin and shower cubicle. The front en suite is a wet room with shower, handbasin and wc. 1

Both appear to be in ok condition with modernisation required in the rear en suite.

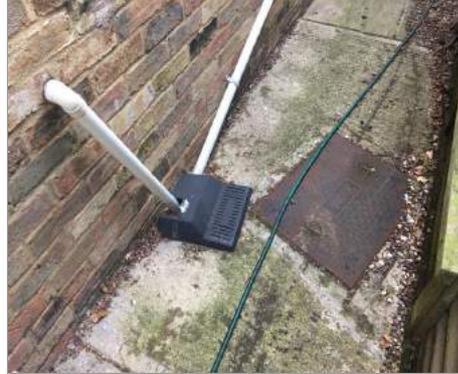
Photo - 58

Adjacent to this gully is an inspection chamber, the lid was not openable as it may have been concrete in places. The other side of the gate is another chamber, this lid was liftable with the condition of the lid and chamber being in acceptable condition.

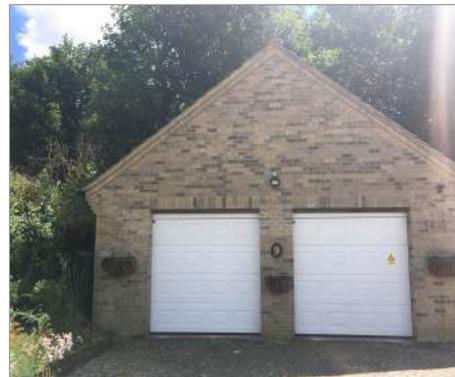
Photo - 64

The garage appears to be in fair condition with all rainwater goods, soffits and fascias being UPVC however, repointing is required to the roof verge in places. The rear and side on the boundary could not be inspected.

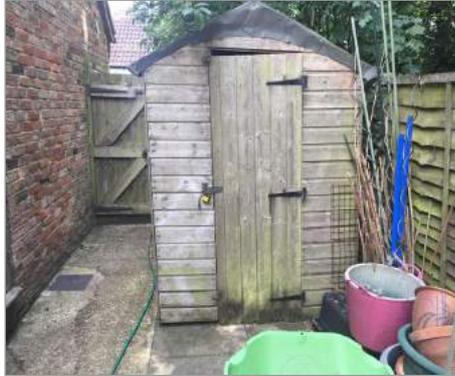
Photo - 71

To the rear of the property there is a timber shed and greenhouse which are in fair condition. The greenhouse is safety glazed.

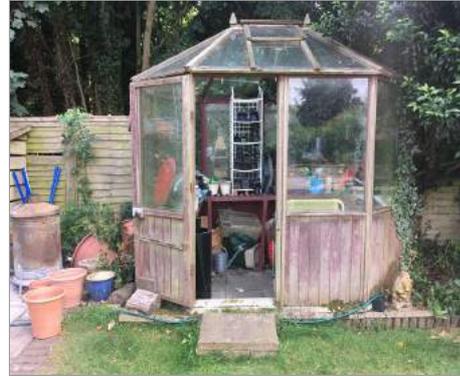
Photo - 72

There is a timber glazed store which has ivy growing through it, evidence of rot to timbers and glazing that is not safety glazing.

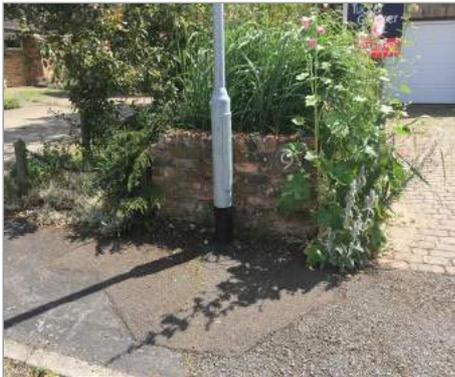
Photo - 77

The boundary fencing is largely obstructed by vegetation. The fencing that was visible appeared to be old and will require replacement in due course.
