Building Surveys and Reports

Edward A. Noy FASI, ARSH

James Douglas BSc, MRICS

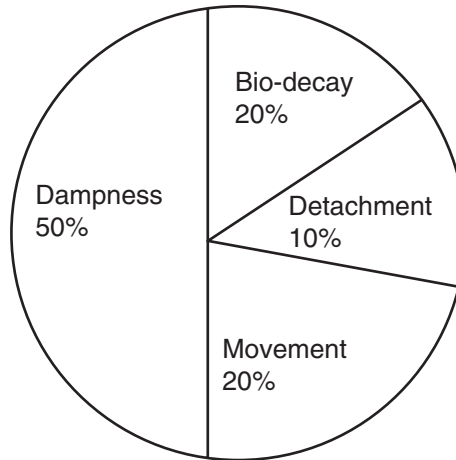
Figure 2.2 Analysis of building defects (Ransom 1987).

All buildings to a greater or lesser degree are exposed to these major influences (see Fig. 2.2). Within each of these three basic causes, however, are numerous agencies or sources such as condensation (i.e. dampness), dry rot (i.e. timber decay) and subsidence (i.e. movement). As pointed out by

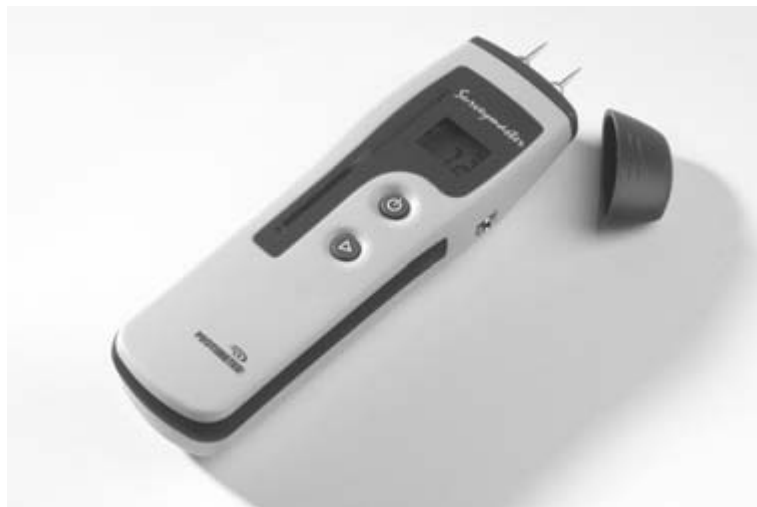
Figure 2.3 'Surveymaster SM' moisture-reading meter (courtesy of Protimeter Ltd).

- (1) Electronic moisture-reading meter (around £350 at 2004 prices) (see Fig. 2.3). There are two main types currently in use, the conductiv-

ity and the capacitance type. These instruments measure conductivity and do not actually measure content.

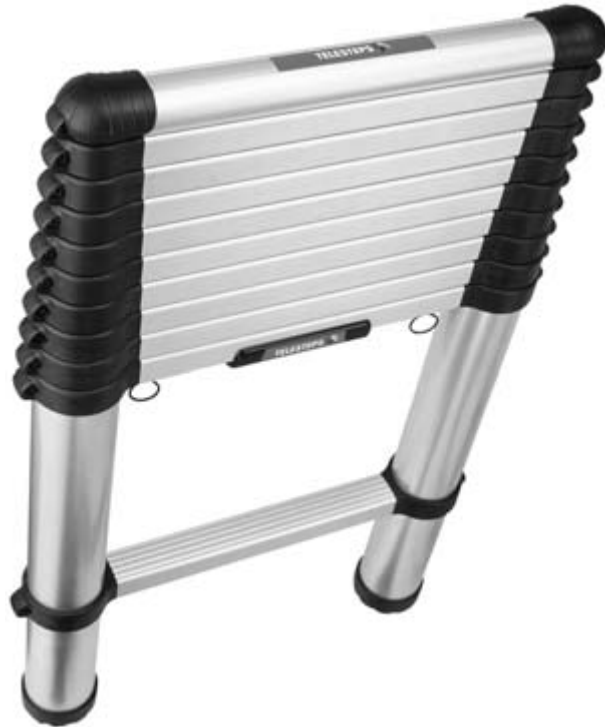
Figure 2.4 Telesteps® telescopic ladder (courtesy of The Telescopic Ladder Company Ltd).

- When no builder is involved it is often necessary to gain access to high ceilings and roof spaces. A telescopic aluminium ladder capable of extending to about 3 m will meet this need, and will be found useful for most surveys. This type of ladder is usually about 1 m long when retracted and can easily fit into a car (see Fig. 2.4).

- (2) Telescopic ladder (around £250 at 2004 prices) (see Fig. 2.4) A fairly recent innovation is the use of a telescopic ladder for building inspection purposes. The ladder is only 78cm when closed, and 3.3m when fully extended, locking at ten different intermittent heights in between.
- (3) A bradawl, pocket knife, cold chisel, small hammer and pliers are necessary for exploring on a limited scale. The bradawl and pocket knife have many uses, such as testing timber for rot and mortar joints for sulphate attack.
- (4) A vernier scale is useful for measuring the width of joints or cracks, frames and pipes etc.
- (5) An adhesive material such as Blu-Tack™ can be most useful as a temporary fixing for measuring tapes etc.
- (6) For recording the movement of cracks various methods have been tried out over the years. Strips of glass bedded in cement fixed across

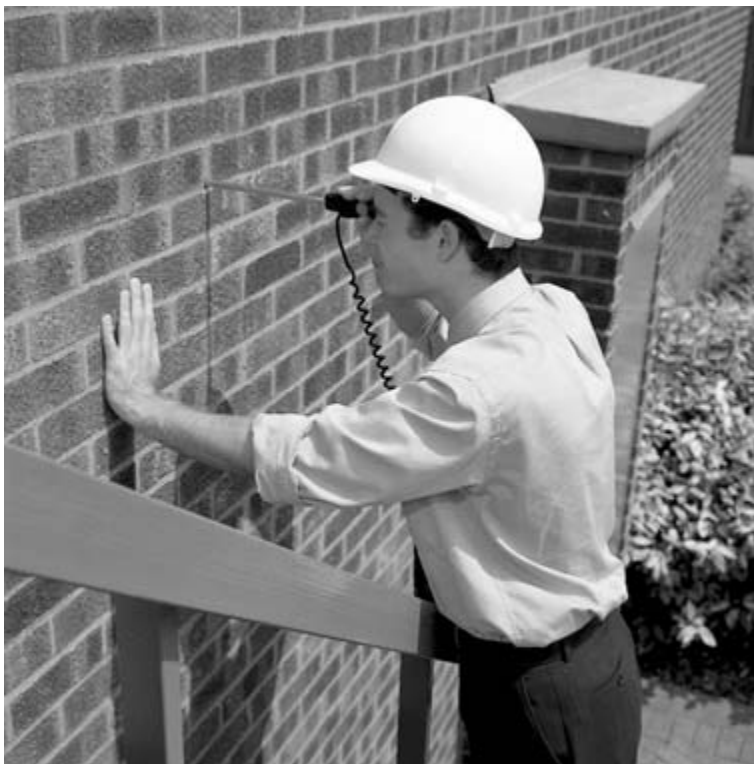
Figure 2.5 Surveyor using a borescope (courtesy of Olympus Industrial).

- (1) Endoscopy: A fibre optic borescope (shown in Fig. 2.5) is a useful tool with which building surveyors can inspect hidden voids and cavities for problems such as bridging, wall-tie corrosion and fungal attack (Hollis 2000) (Around £1,000–£3,000 at 2004 prices).
- (2) Electric drill: A power drill is useful for removing small cores of plaster or brick for moisture determination.
- (3) Electronic hygrometer: The humidity and temperature of a building fabric can be measured with an electronic hygrometer. This instrument is essential for investigating condensation dampness (around £300 at 2004 prices) (see Fig. 2.6).

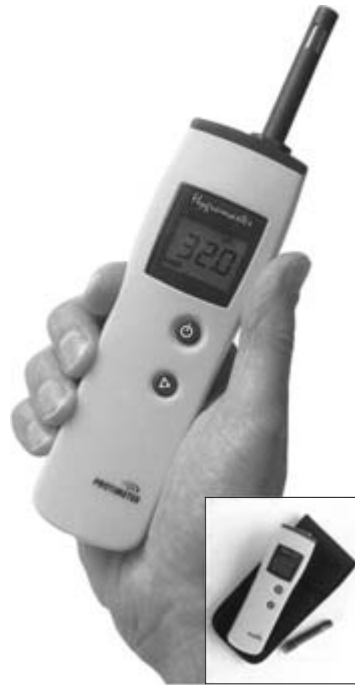
Figure 2.6 Electronic hygrometer (courtesy of Protimeter Ltd).

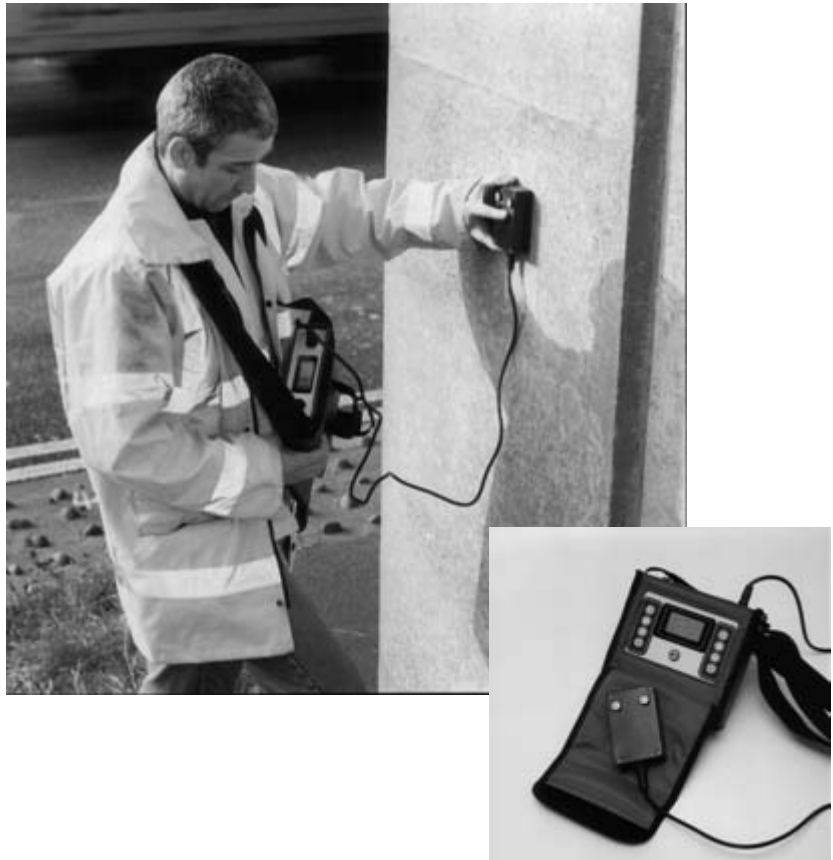
Figure 2.7 Reinforcement cover meter (courtesy of CMT Instruments).

- (4) Cover meter: Engineers and surveyors use this inspection tool to detect the presence and depth of steel bars in reinforced concrete (around £1,500 at 2004 prices) (see Fig. 2.7).
- (5) Calcium carbide ('Speedy') moisture meter: This instrument is used to ascertain on site the moisture content of particulate building materials such as mortar, brick, stone and concrete (around £700 at 2004 prices) (see Fig. 2.8). These meters have certain advantages over electrical moisture meters. They actually measure the water content of a sample. However, they do not automatically provide the source of that moisture.
- (6) Plastic sample bags: These are useful for collecting samples of mortar, brick and other materials for laboratory tests. Ideally they should be clear plastic bags about 100 × 100 mm in size with a seal-

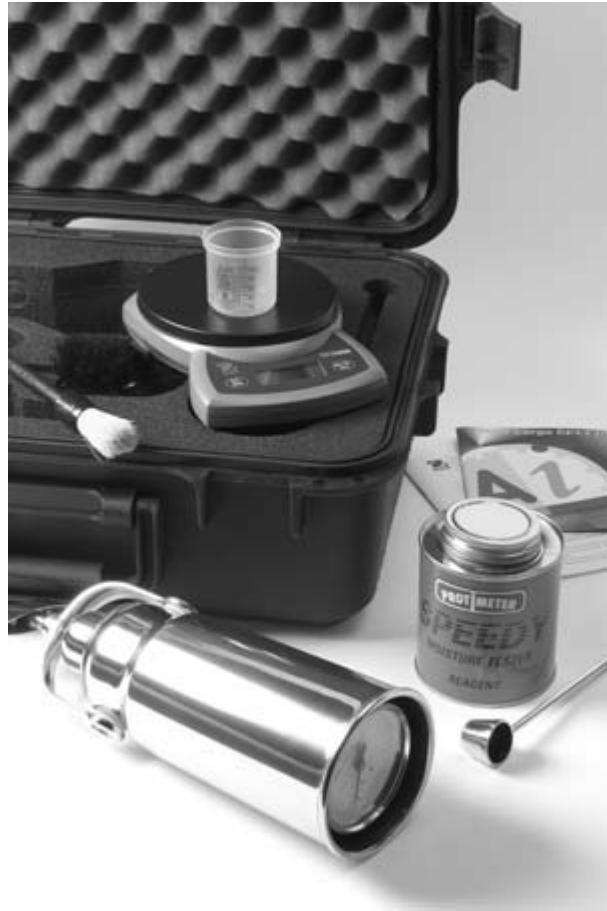
Figure 2.8 'Speedy' calcium carbide moisture meter (courtesy of Protimeter Ltd).

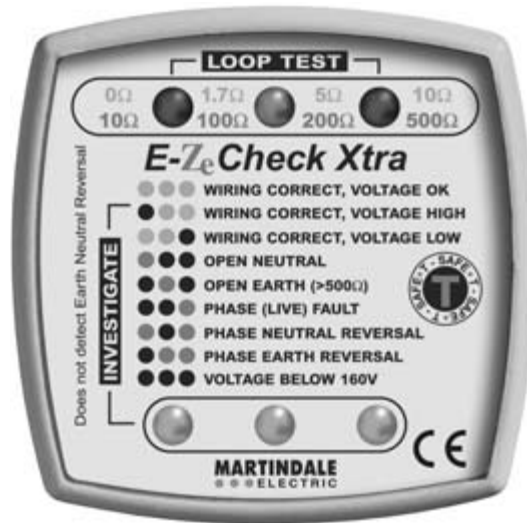
Figure 2.9 Earth loop impedance socket tester (courtesy of Martindale-Electric).

- (7) Socket tester: For use in undertaking earth safety test, voltage and wiring checks (around £50 at 2004 prices) (see Fig. 2.9).
- (8) Micro-drilling: This is a very effective tool to determine the presence of decay in structural timbers using a special low-voltage hand-held

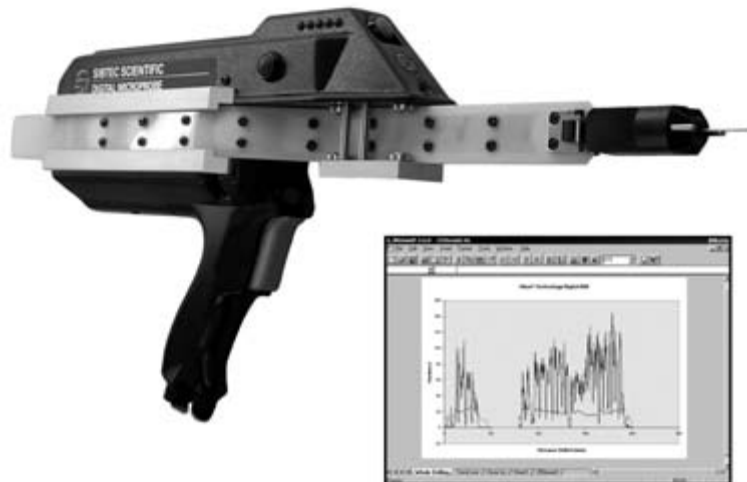
Figure 2.10 Digital microprobe wood-decay-detecting drill (courtesy of Sibert Technology Ltd).

drill. It gives digital results which can be printed or viewed in a spreadsheet program such as Microsoft ExcelTM. (around £3,500 at 2004 prices). Sibert Technology Ltd (<http://www.sibtec.com/>) is the major supplier of this instrument (see Fig. 2.10).

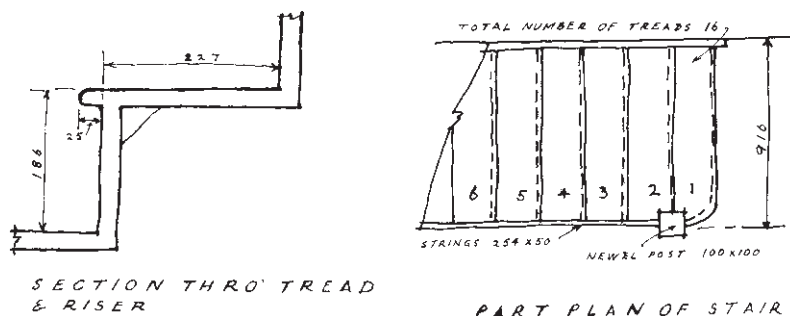
Figure 3.3 Sketch of stair details.

projecting beyond the face of the riser. As the total of the sums of the width of the treads will be greater than the total 'going' of the stairs, it is usual to measure the treads from the face of the lower riser to the face of the top riser. Enter this dimension with the number of treads on the survey sketch. The risers are similarly measured from tread to tread (see Fig. 3.3). The plan and the section shown should be sufficient for a 1:50 or 1:100 scale, but details of newel posts and balustrade will probably require a larger scale.

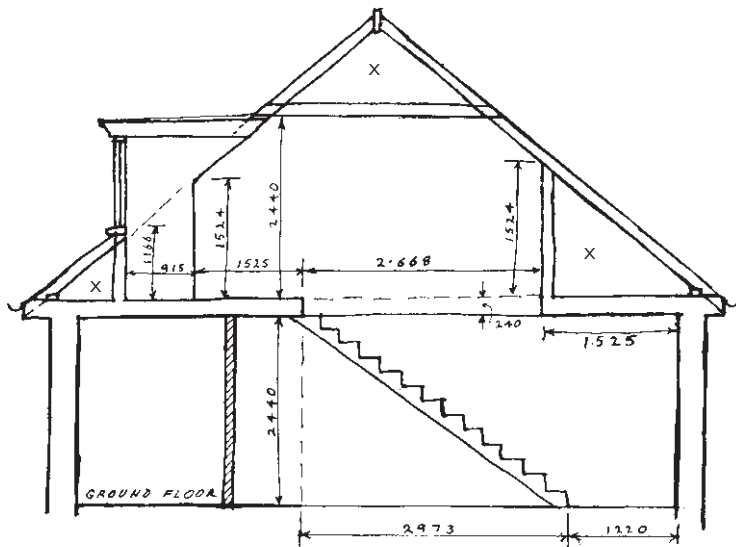
SECTION THRO' ROOF SPACE & GROUND FLOOR. (X=VOID SPACES, WHICH SHOULD BE VENTILATED).

Figure 3.4 Section through roof space and ground floor.

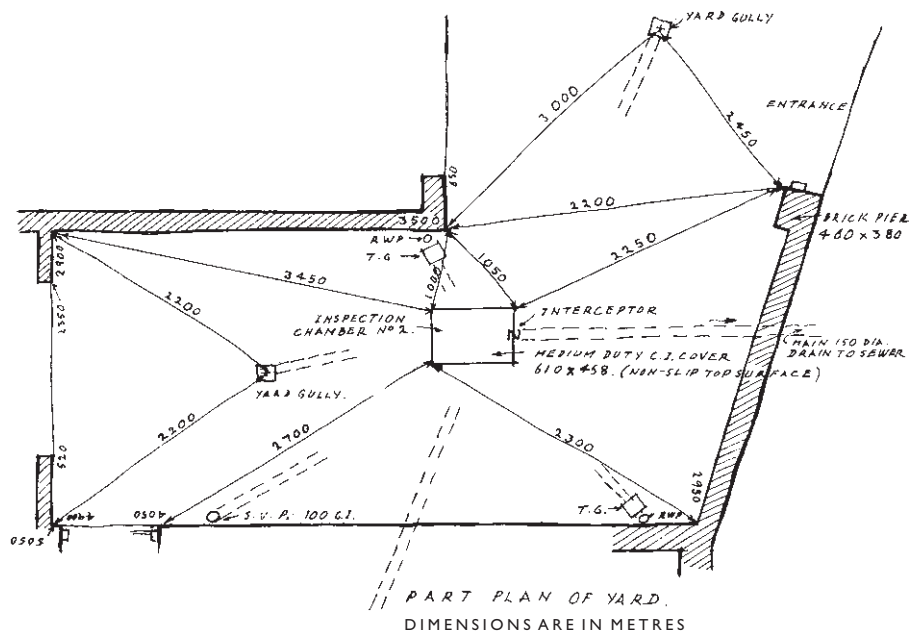
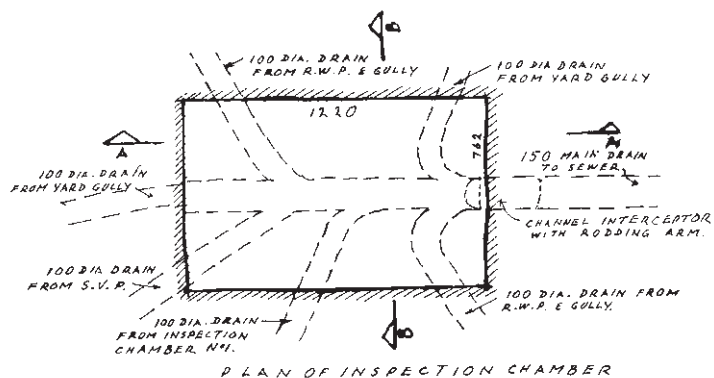
Figure 3.6 Drainage details.

Inspection chamber positions can be established by taking measurements to suitable points on the external or boundary walls of the building. Figure 3.6 shows an enlarged survey sketch of the drainage system taken from the yard survey in Fig. 3.1. The inspection chamber cover should be removed and the internal measurements of the chamber taken, together with the depth from cover to invert and the position and size of all pipe runs. Do not assume that the inspection chamber is the same size as the cover, as large inspection chambers are often corbelled over at the

top and fitted with a small cover as shown in Fig. 3.6. Trace all the drain branches by flushing WCs and running taps in basins and sinks so that every run is accounted for and at the same time note the condition of the installation.

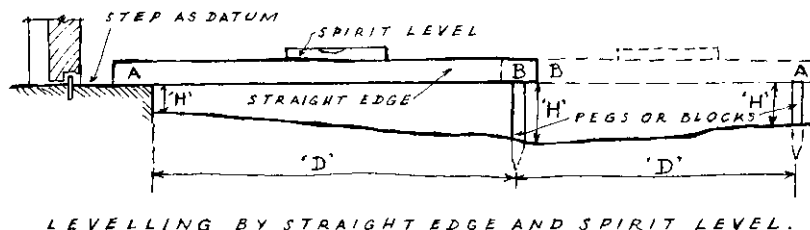
Figure 3.7 Levelling by straight edge and spirit level.

straight edge cut from a board approximately 150 mm \times 25 mm \times 3 m long. The board is used in conjunction with a spirit level as shown in Fig. 3.7 using a series of pegs or small blocks of timber on a flat base board. The spirit level should be checked for accuracy by reversing it on the straight edge. The bubble should come to rest in the same position. When levelling, the board and level should be reversed at each move as indicated by the letters 'A' and 'B' at each end of the board. By reversing the board and level any error will be minimised. The distance between the pegs or block and their height can then be measured, as indicated by the letters 'D' and 'H' on the sketch.

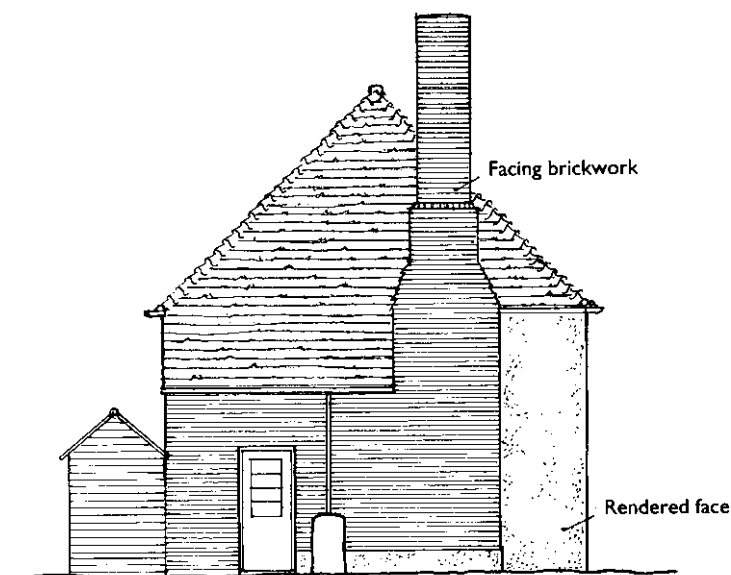
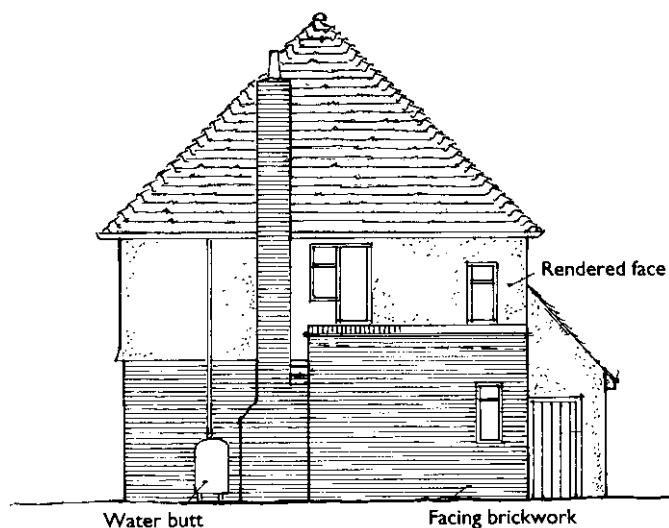
Side elevation (south)

Side elevation (north)

Figure 4.2 Side Elevations.

Figures 4.1, 4.2 and 4.3 show the elevations, plans and notes of an 18th-century listed country farmhouse and cottage in Kent. This information is sufficient for a superficial layout as described above. Surveys of historic buildings for repair or restoration purposes will require more detailed information (Dallas 2003). The primary object of this type of survey is to assist accurate diagnosis as a basis for a specification. All available evidence must be collected together and critically examined before conclusions are reached. Measured plans, elevations and sections will be required including all the items mentioned above.

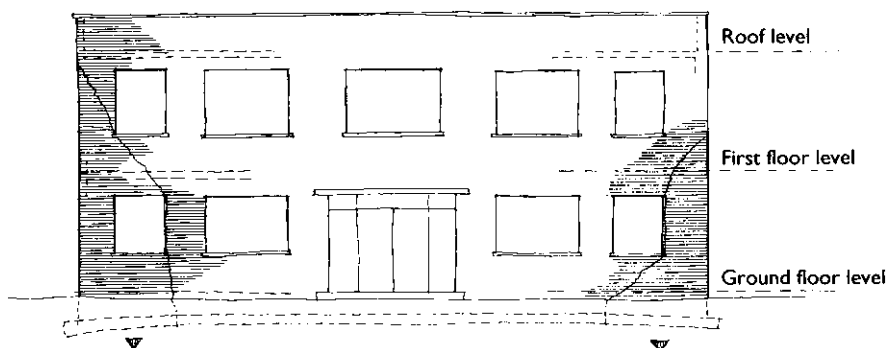
Figure 5.1 Example of differential settlement. Settlement in end walls with centre portion stable. Cracks increase in width with height, and appear to be interrupted by the windows, but in fact extend round the openings forming a gap between window frame and brickwork. The movement is at its maximum at roof level and could cause loss of bearing in the roof slab.

Excavating the ground and placing substantial loads on it is sufficient to cause a slight movement as the ground below is compressed to resist the load. Provided the settlement is uniform over the building area the movement does little damage. Alternatively, it may be differential movement where part of the foundation remains stable while the remainder moves (Richardson 2000). A typical example of differential movement is shown in Fig. 5.1 where settlement occurred in the end walls with the centre portion stable. The cracks are usually vertical or diagonal and are often interrupted by window or door openings. In such cases a gap is formed between the frame and brickwork. The movement is at its maximum at roof level and could cause loss of bearing in the roof slab.

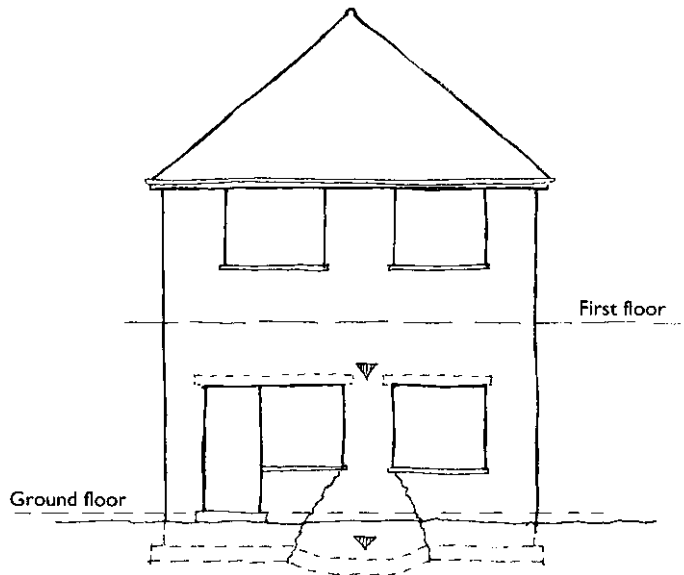
Figure 5.2 Example of overloading. Settlement in the centre of a wall with ends stable. Heavy loads from first floor, roofs and walls above are transferred to a narrow pier of brickwork causing cracks in the wall and foundation settlement. With this type of settlement cracks decrease in width with height.

Every building has its own pattern of loading. Where internal alterations have taken place in the original building or additional loads have been applied due to a change of use, then the loads placed on the subsoils are greater than was originally allowed for. Overloading can also occur where door or window openings have been enlarged which may result in a heavier load being transferred to an adjacent section of brickwork consisting of a narrow pier. Again, the load imposed upon the subsoil is greater than originally allowed for causing the pier to settle (see Fig. 5.2).

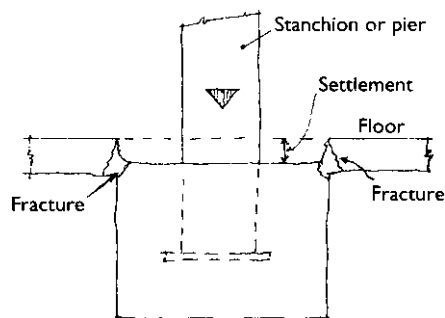
Figure 5.3 Differential settlement under the point load of a stanchion.

Under concentrated loads such an overloaded pier or stanchion on shallow foundations will often show movement cracks between floor and foundation where the foundation has been 'punched' downwards sometimes several centimetres (see Fig. 5.3).

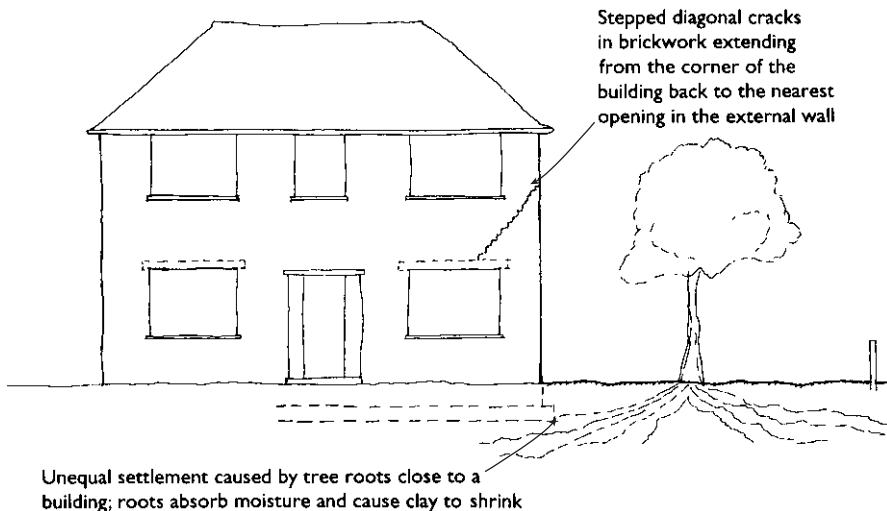
Figure 5.4 Unequal settlement caused by tree roots.

Fast growing trees close to buildings can cause unequal settlement when active tree roots dry out the soil causing differential soil shrinkage (BRE Digest 298 1999). Shrinking clays affect the bearing capacity and lead to movement in the building, especially in shallow foundations. Tree roots can extend over a considerable distance and can extract moisture from as deep as 6 m below the surface. It is, therefore, necessary to make an accurate survey of their position and obtain details of the type of tree, and at the same time establish that the tree is the cause of the damage (see Fig. 5.4). Poplars and elms with fast growing root systems can be expected to cause serious seasonal movements.

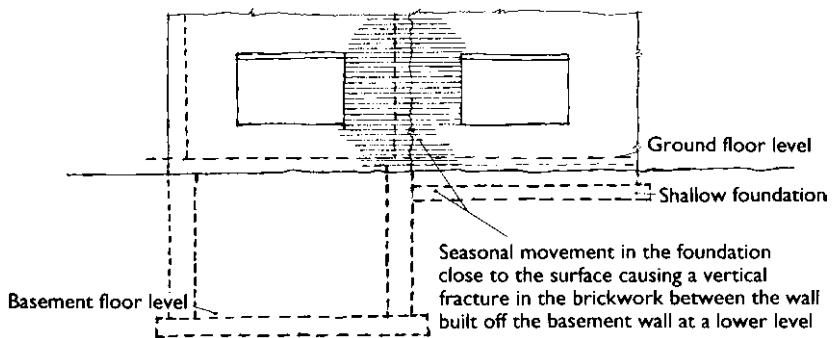
Figure 5.6 Unequal settlement between basement and ground floor walls.

Another common example is when part of a building has a basement with foundations set in deep geological beds. Seasonal movement will often take place in the foundations close to the surface causing a vertical fracture at the junction between the walls built off the basement wall and the ground floor. The heavier walls to the basement area will settle relatively more causing movement cracks between the light and heavily loaded walls as shown in Fig. 5.6. This is more noticeable when the ground floor structure is built on shallow foundations in a clay subsoil.

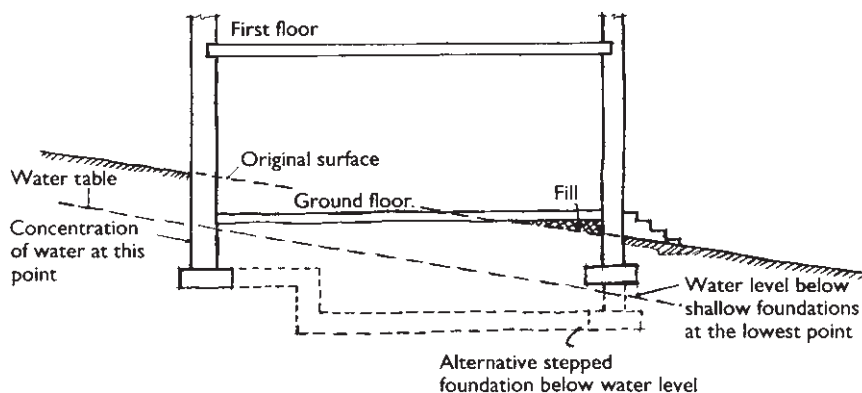
Figure 5.7 Building on sloping clay site.

Buildings on sloping clay sites can often present difficulties (IStructE 2000). The water table on sloping sites tends to follow the topography of the surface and if the natural contours of the site change it does not necessarily alter this line. Where the foundations have been set at a constant depth from the stepped level surface the concentrations of water may affect the foundations at the lowest point causing differential settlement. Figure 5.7 shows such a case where the water table is above the foundation at the highest point and beneath a shallow foundation at the lowest point. In such cases it would have been advisable to form stepped foundations as shown in the sketch in order to be below the water level.

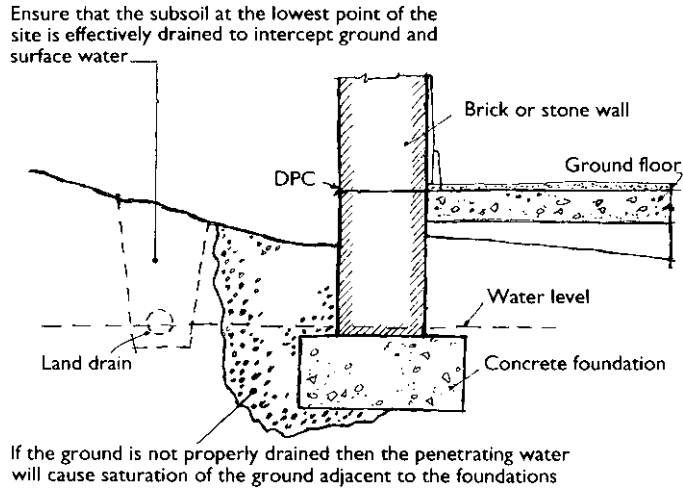
Figure 5.8 Building at the lowest point of a sloping site.

If a building is erected at the lowest point of a sloping site, natural drainage of the water to the lower points can cause saturation of the ground around the base of the wall and foundations thus lowering the bearing capacity (see Fig. 5.8). In both the above cases it is advisable to check that the subsoil is effectively drained at the highest level in order to protect the building against damage by water penetration. The surveyor will often find that surface water drainage has been omitted especially in ancient buildings.

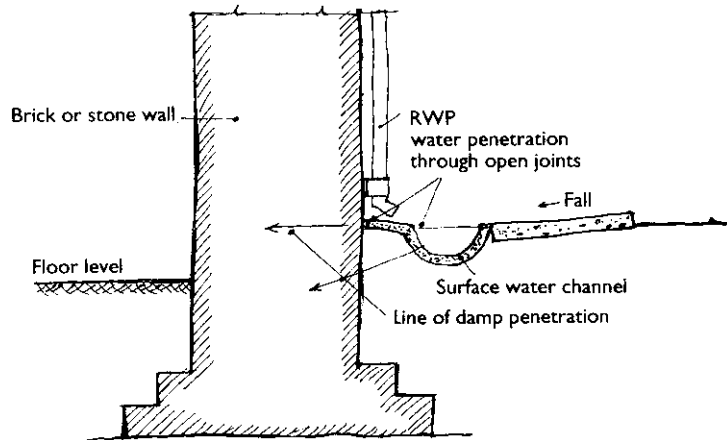
Figure 5.9 Water penetration around base of external walls where the ground floor level is below the ground level.

A similar case of water penetration often occurs around the base of the external walls of old buildings where the ground floor level is below the ground level. The surveyor will probably notice that clayware or concrete channels have been inserted around the base of the wall to collect rain-water from the roofs and a certain amount of surface water from paved areas around the building. The channels tend to move with the seasonal changes in the subsoil causing the joints to open, thus allowing water to percolate through to the subsoil and the base of the wall. In such cases

there is a risk of uneven movement in the subsoil leading to settlement cracks (see Fig. 5.9).

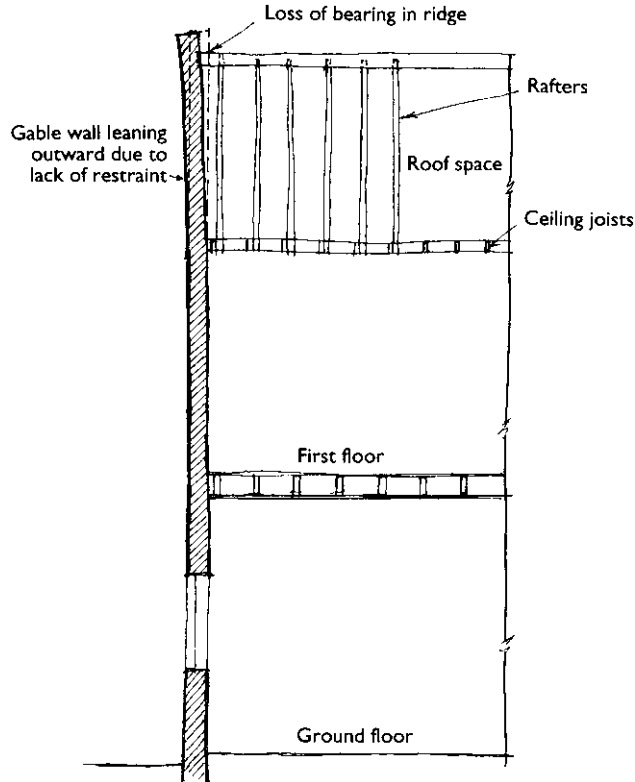
Figure 6.2 Unrestrained flank gable wall.

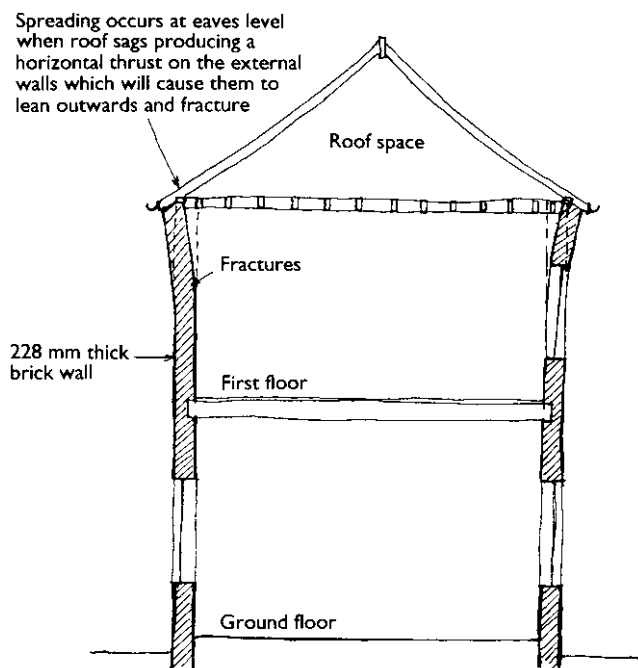
Figure 6.3 Untied roof causing rafters to spread.

Figure 6.3 is an example of an untied roof causing the roof to sag. The sagging produces a horizontal thrust on the external walls which may cause them to lean and fracture. With all bulging and leaning defects evidence can also be seen internally by way of cracks in the ceilings, particularly at the junction of wall and ceiling, and where the partitions meet at right angles to the external wall.

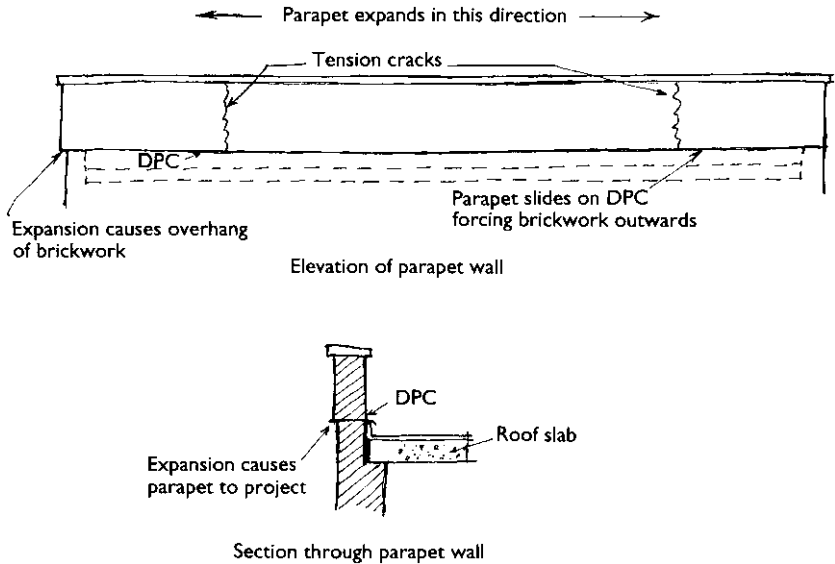
Figure 6.5 Thermal movement of brickwork.

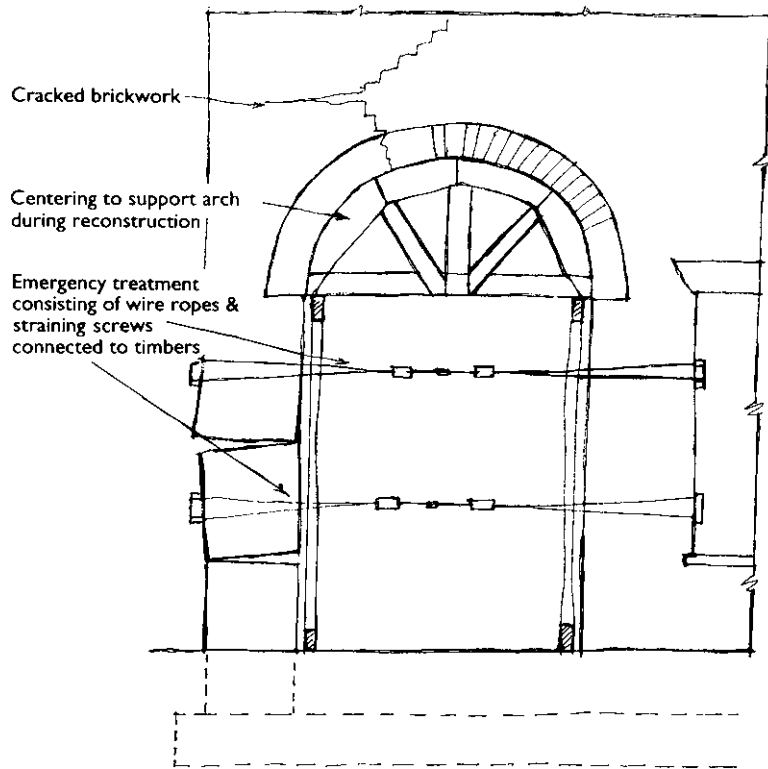
Figure 6.6 Damage to abutments due to inadequacy of the pier.

Settlement cracks usually arise from the inadequacy in size of the abutments causing the brickwork to thrust outwards as shown in Fig. 6.6 where the opening is too near the corner of the building. If the surveyor considers the fractures to be serious and requiring emergency treatment then the first step is to tie the abutments together by using two or three wire ropes and straining screws connected to timbers through the nearest opening. The arch will also require support by erecting centring similar to that used in the construction of new arches. This will relieve the arch of its load and enable the necessary repairs to be carried out. Alternatively, a raking shore should be erected against the fractured abutment to resist any further movement. A similar problem can arise from the excessive deflection of a lintel, causing converging cracks to run upwards as shown in Fig. 6.7.

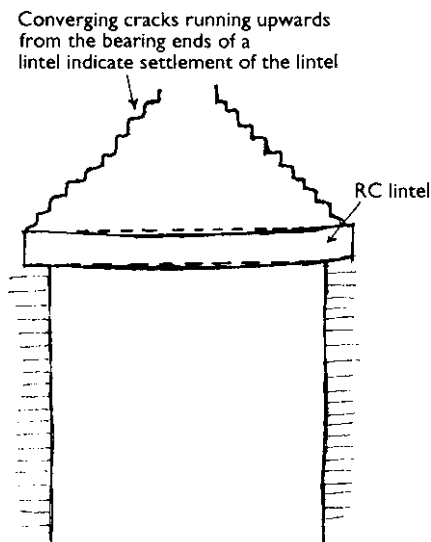
Figure 6.7 Cracked brickwork due to lintel failure.

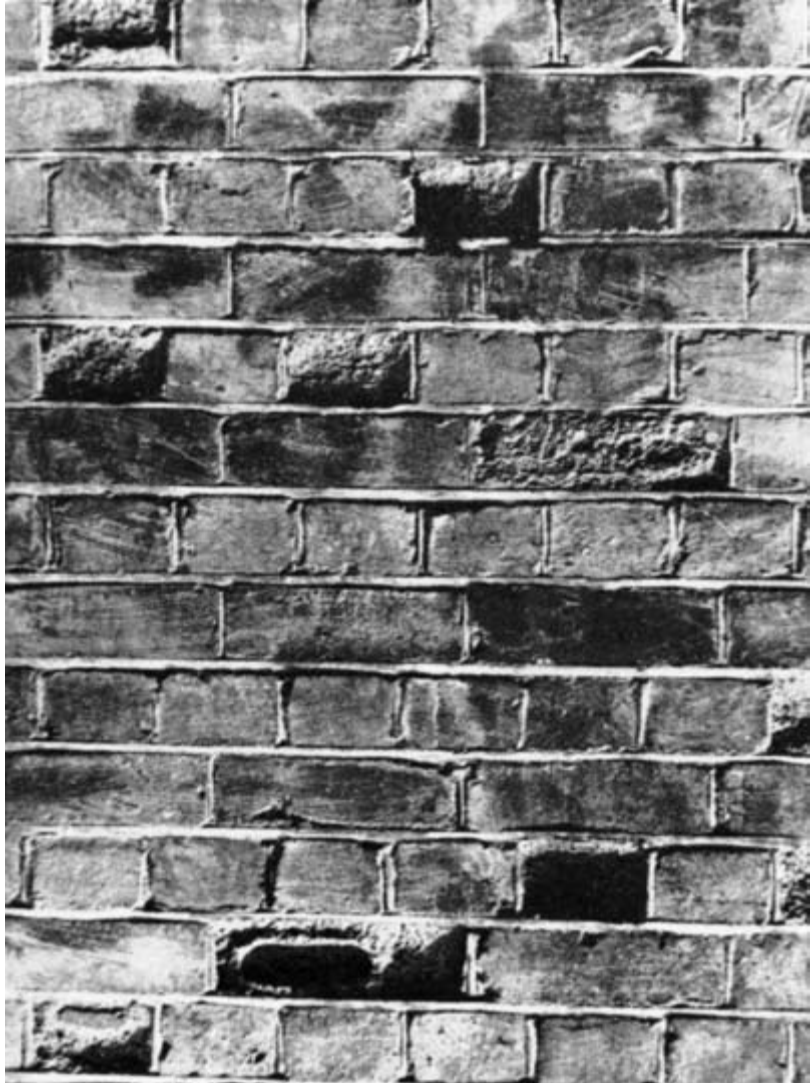
Figure 6.8 Surface decay of brickwork due to crystallisation of salts.

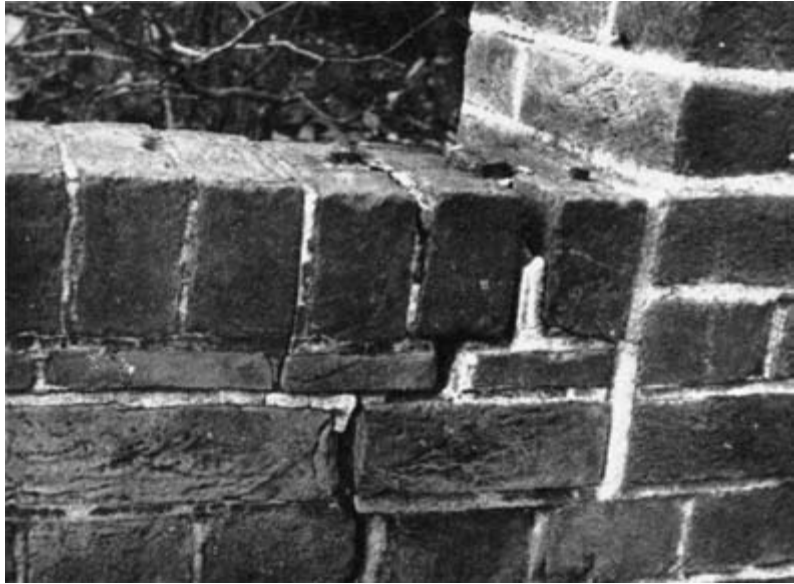
Figure 6.10 Cracking of brickwork due to corrosion of embedded steel.

Iron and steel members embedded in brickwork can well be affected by corrosion causing the surrounding brickwork to fracture and loosen. In order to diagnose the full extent of the problem, the surveyor will usually find it necessary to remove the surrounding brickwork in order to gain access to the metalwork. Figure 6.10 shows a typical example. Rusting steel stanchions encased in brick cladding may produce vertical cracks.

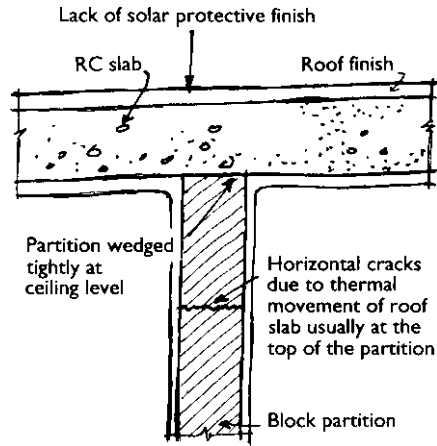
Figure 6.11 Partition failure due to thermal expansion of roof slab.

Another type of failure is associated with the thermal expansion of a concrete roof slab to which the flat roof system is prone. This occurs where the partition has been wedged tightly at ceiling level without allowance in the design for the differential movement between the roof slab and partition. The thermal movements of the slab produce horizontal cracks near the top of the partition as shown in Fig. 6.11. This failure is also due to the lack of solar-protective finish on the roof covering in order to reduce the amount of heat absorbed by the roof slab.

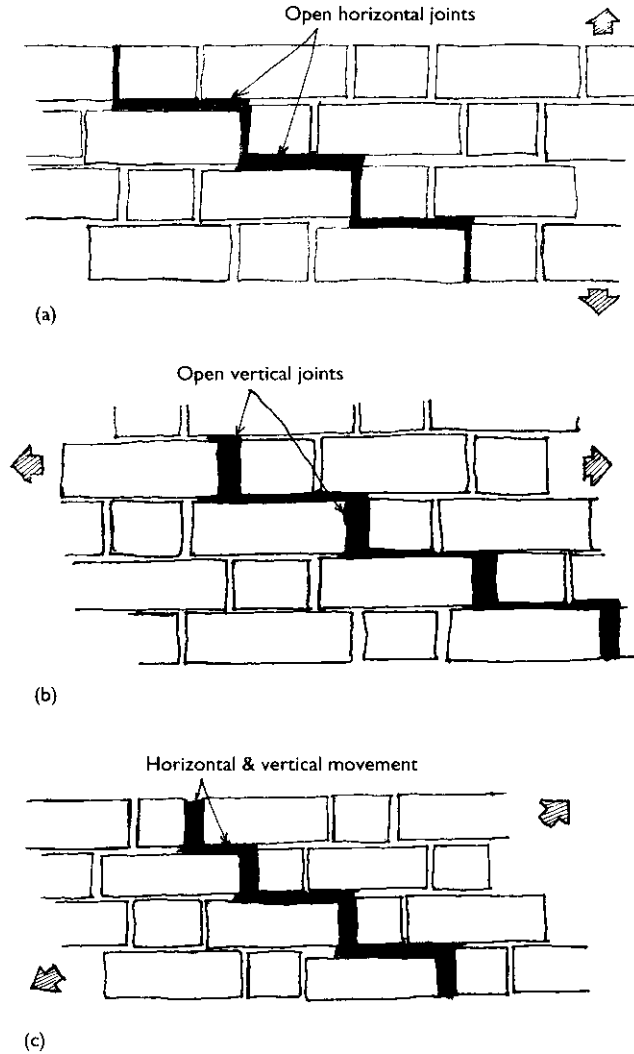
Figure 6.12 Assessment of cracks. (a) Vertical settlement (b) horizontal movement and (c) transverse failure.

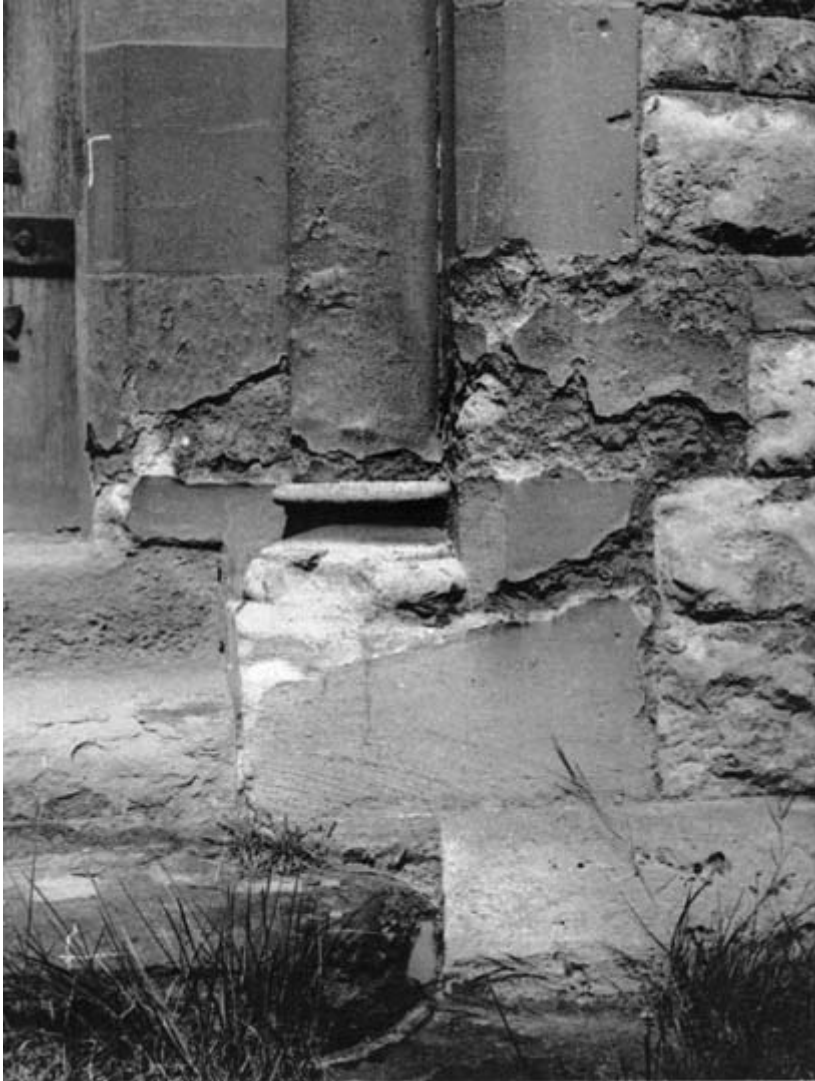
Figure 6.13 Surface blistering of bath stone and Kentish rag stone due to atmospheric pollution.

Atmospheric pollution is the principal cause of deterioration of limestone and sandstones (Richardson 2001). Air usually contains impurities of sulphur and carbon. Sulphuric gases in the atmosphere dissolve in rainwater to form acid solutions and when not freely washed away by rain form a hard skin on the limestone eventually causing surface blistering, scaling and the formation of cracks at arrises (Cook and Gibbs 1993). When the surface blistering breaks off, it pulls away some of the limestone with it. Sulphur gases can also attack calcareous sandstone in a similar manner. Pollution deposits are widely dispersed and travel with the wind and rain, although the effect is more noticeable in urban and industrial districts. Figure 6.13 shows an example of surface blistering of Bath stone and Kentish rag stone due to atmospheric pollution.

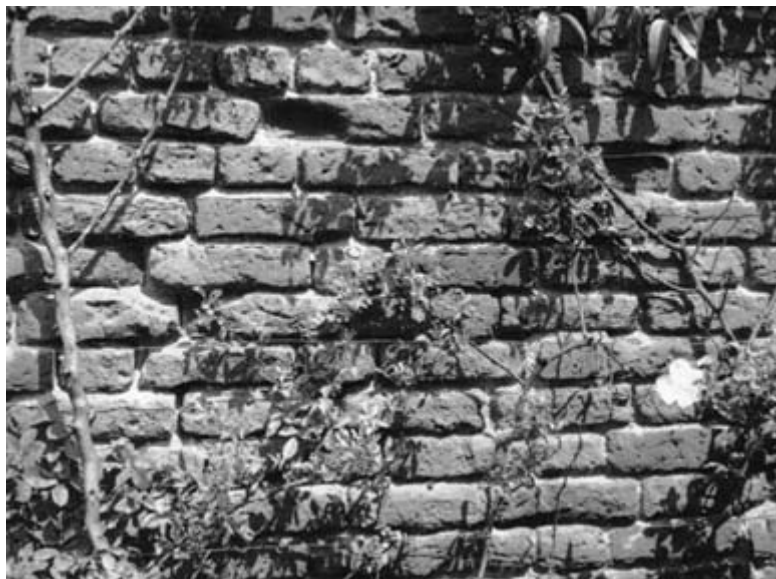
Figure 6.14 A fairly common defect caused by shrubs sending their roots into brick joints.

Ivy, honeysuckle and wisteria can cause severe damage. They keep the wall damp, and joints are forced apart by the expanding roots which eventually dislodge the stones. Some clinging creepers such as Virginia creeper attach themselves to stonework by suckers, but in many cases are harmless though they do keep the wall damp. In general, most plant growths should be discouraged for if they are allowed to cover a whole wall surface, they are apt to reach the roofs, the most vulnerable part of the building, and lead to blockage of gutters and downpipes. Figure 6.14 shows a fairly common defect caused by shrubs sending their roots into brick joints.

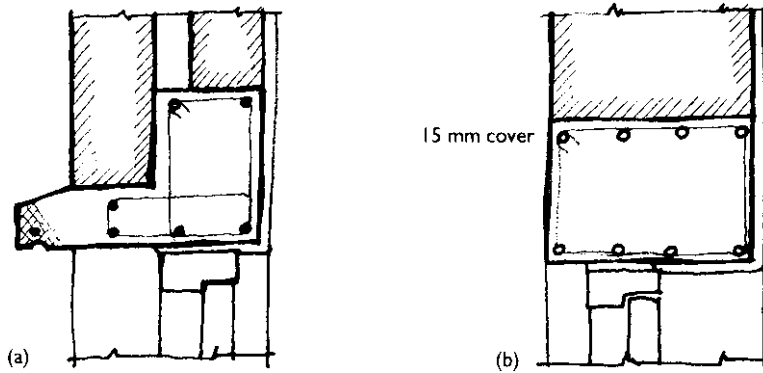
Figure 7.1 (a) Cracking of concrete in projecting nib of lintel. Reinforcement not required to projecting nib. Damp penetration will cause corrosion and spalling of concrete; (b) Reinforcing bars too near the surface causing concrete to crack and bars to corrode. In both cases cracking of the concrete will occur allowing moisture to penetrate and concrete to spall off.

It is important that the surveyor checks the depth of the cover, especially in small members such as window sills, string courses and projecting nibs to RC lintels as shown in Fig. 7.1a. If the reinforcing bars are too near the surface the concrete will crack and the bars corrode. Loose portions of concrete can be removed fairly easily and should not present the surveyor with any difficulty. When dealing with cracks it is often necessary to enlarge the crack to gain access to the steelwork before a correct diagnosis can be obtained.

In some cases it may be found that the reinforcing bars are too close together to allow the aggregate to pass freely between the bars and formwork as shown in Fig. 7.1b. Figure 7.2 shows an example of reinforcement corrosion causing cracks to appear in the concrete cover. Cracks can also be caused by structural movement or defects in the foundations; if the cracks continue down below the ground this would suggest some defect in the foundations, possibly due to settlement.

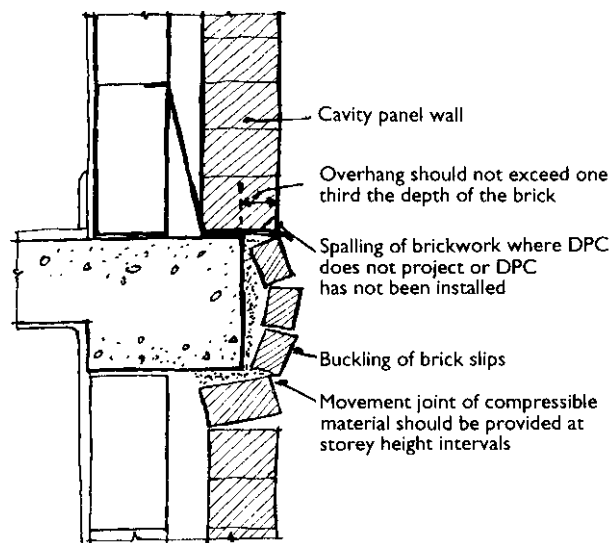
Figure 7.3 Movement in concrete structure due to creep of concrete frame and expansion of brick panel walls.

Where brickwork is supported on reinforced concrete beams or 'nibs', brick slips are often used to cover the edge of the beam. In recent years there have been a number of failures due to the brick slips buckling. It is usually attributed to the expansion of the brickwork or 'creep' of the concrete frame (see Fig. 7.3). Conventional mortars and adhesive have proved inadequate for fixing the brick slips. A considerable amount of research has been carried out in this field by the Brick Development

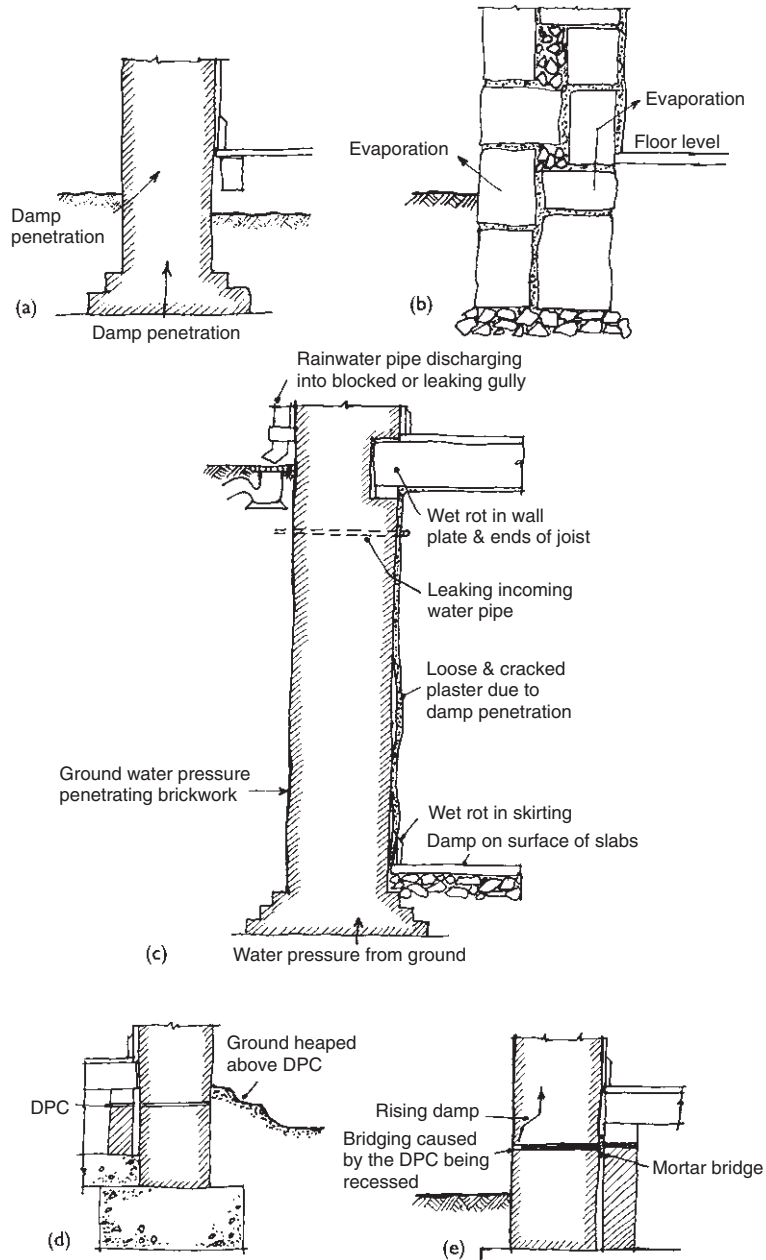
Figure 8.1 (a) Typical early 19th century external wall construction with no DPC (b) Traditional solid stone wall. No DPC. (c) Typical damp problems in old basement walls. (d) Damp course covered by earth. (e) Defects caused by bridging DPC.

Figure 8.1a shows a typical early nineteenth century external wall construction with no DPC and no foundation concrete. Care must be exercised when checking for rising damp due to a defective DPC. The cracks usually pass through the horizontal joint with a semicircular damp patch internally spreading up from the line of the DPC. The damp course line should be checked for continuity especially where it is stepped due to changes in floor levels or external pavings. At the same time the condition of the pointing to the damp course should be noted.

The important point for the surveyor to remember is that any treatment which prevents evaporation such as waterproof rendering internally or externally, will only cause the damp to rise higher before it can evaporate causing more problems! Any treatment recommended is a matter requiring careful judgement (see Fig. 8.1b).

Flag stones or brick floors were usually laid on the bare earth and moisture rising from the ground is common. The surveyor will often find an impervious finish has been laid over the solid floor which has become very wet underneath, and probably affected by rot. Figure 8.1c shows typical problems in an old basement wall.

A common defect is where the horizontal DPC is placed nearer the ground than the 150mm clearance required by the Building Regulations, and becomes ineffective through being bridged by earth or paving slabs laid at a higher level. In wet weather moisture may be drawn into the wall from the soil above the DPC. Where dampness appears on the interior face near the floor the ground level in relation to the DPC should be examined (see Fig. 8.1d).

Rendered plinths were common during the early part of the twentieth century, often in speculative built houses. In many cases the plinths were applied to buildings with solid walls and they invariably bridged the DPC causing rising damp to penetrate through to the wall plaster and skirtings. Bridging can also be caused by the DPC being slightly recessed and the joint filled with pointing mortar as shown in Fig. 8.1e.
