Building Surveys and Reports

Edward A. Noy FASI, ARSH

James Douglas BSc, MRICS

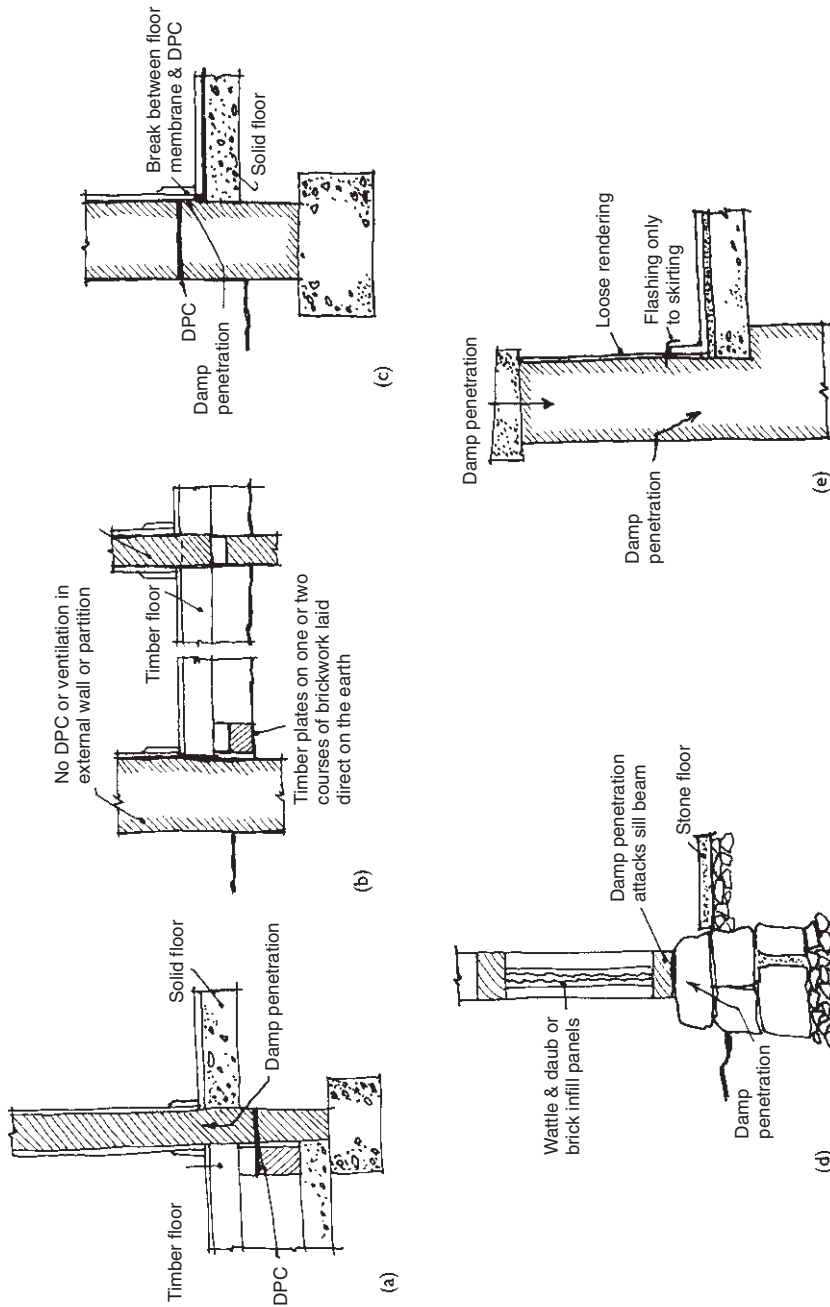
Figure 8.2 (a) Incorrect DPC insertion in partition wall. (b) Typical early 19th century timber floor construction. (c) Inadequate jointing between floor membrane and DPC. (d) Typical base detail of timber framed building. (e) Defects caused by the absence of DPCs in parapet wall.

a few millimeters below the concrete floor then damp can rise through the unprotected gap (see Fig. 8.2a)

The ventilators were often small and insufficient in number, but they did allow a certain amount of air to circulate around the joists. Damp-proof courses consisting of slates are likely to be found below the wall plates of sleeper walls during this period. In both the above categories very few will be found to have been provided with site concrete (see Fig. 8.2b).

internal face of the wall. If moisture can be found to have affected the walling behind the skirting the cause can only be due to inadequate jointing between the floor membrane and the DPC in the external wall (see Fig. 8.2c). An important point to check is the air space and ventilation to the ground floor. This space must be properly ventilated to protect the joists and wall plates against dry rot. Air is induced from outside by the insertion of air vents at frequent intervals immediately under the damp course level (giving at least 1500 mm² fresh air inlet per lineal metre of external wall). The air vents are usually constructed of cast-iron or terracotta (size 230 mm × 75 mm) although tile slips are often used in good quality work. It is not unusual to find that the air vents have been covered with perforated zinc or even solid metal plates in order to discourage insects or mice. When carrying out the examination it is important to ensure that the air vents are free from obstruction. If close to garden planting or shrubs the apertures are often found to be filled with earth.

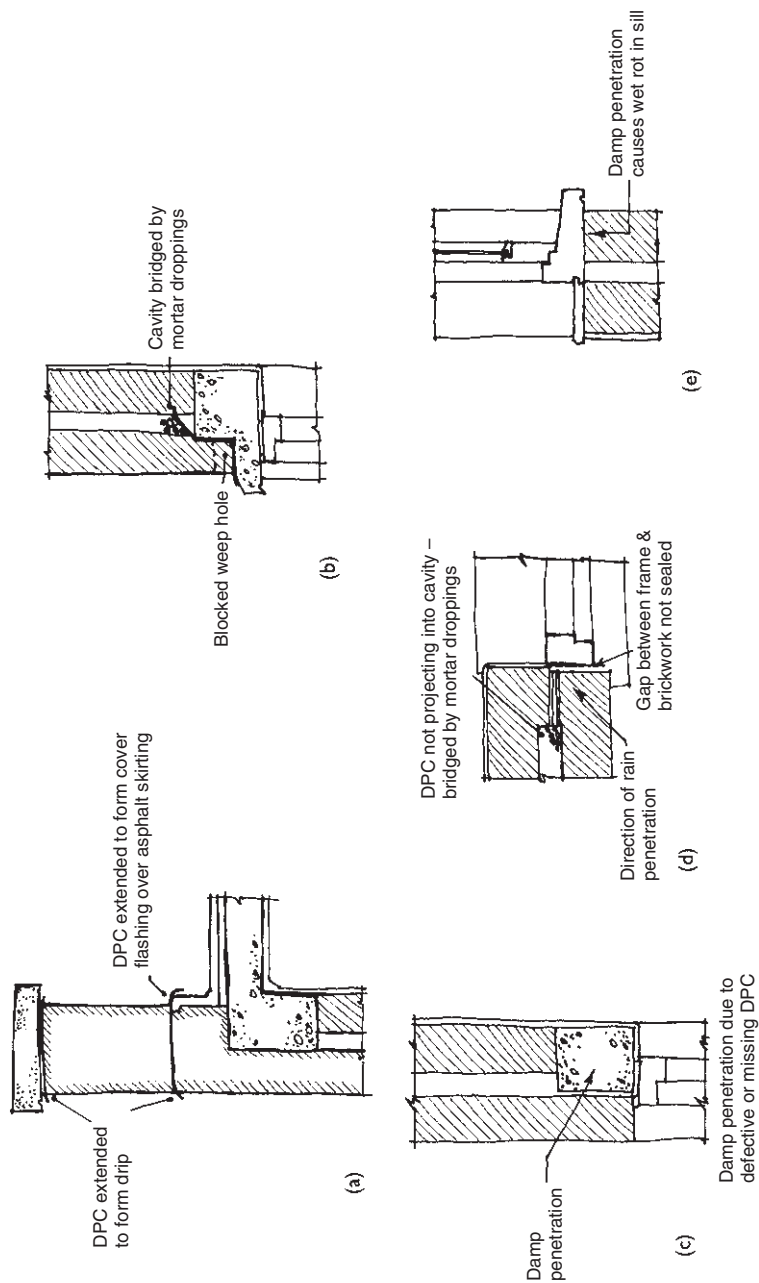
Figure 8.4 (a) Correct detail for DPCs in solid parapet wall. (b) Bridging of DPC over opening. (c) Damp penetration due to defective or missing DPC. (d) Damp penetration due to poor detailing of DPCs and jointing to reveal opening. (e) Damp penetration due to omission of DPC under sill.

The reveal to a window opening seems the obvious place to expect the entry of water particularly if the jointing between wall and frame is in poor condition. Rainwater penetration at this point is often due to poor detailing of the DPC. Semicircular damp patches at the junction of the window frame and plaster indicate a defective or missing vertical DPC which can also cause wet rot in the frame. The vertical DPC should project into the cavity to prevent 'bridging' by mortar droppings (see Fig. 8.4d). Another common danger point is the sill. All sills should be provided with a DPC for their whole length and width, and turned up at the ends.

Where a flexible DPC crosses the cavity the underside should be supported on an asbestos or slate sheet. Figure 8.4e shows the line of damp penetration due to omission of the DPC under the sill. In recent years the cavities of cavity walls have often been filled with plastic foam to increase the thermal insulation value of the wall. The foam usually consists of urea-formaldehyde and is injected into the cavity by drilling holes through the mortar joints. In view of the fact that the main purpose of a cavity is to prevent damp penetration, a filling material, in principle, increases the risk.

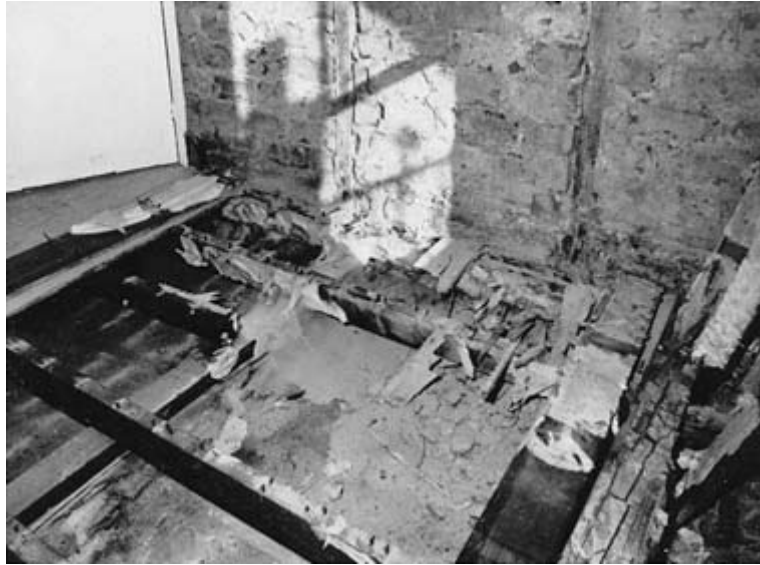
Figure 9.1 Dry rot spore dust in floor joists and partition (courtesy of SGB Group Publicity).

In the first case described above the ground floor construction is the most likely place for dry rot to appear. The construction consists of timber joists supported on sleeper walls built of the site concrete. If the sleeper walls are well provided with honeycomb openings, and the external walls have enough air vents, the circulation of air may be sufficient to carry away the moisture and so prevent the fungus starting. However, it often happens in course of time the air vents become clogged or covered with earth (see Chapter 8). Pockets of stagnant air and rising damp through poor quality site concrete or brickwork are the primary contributory causes of fungal decay. The timber will absorb the moisture and so produce the fungi which decompose the wood. Figure 9.1 shows ground floor joists badly affected by dry rot attack.

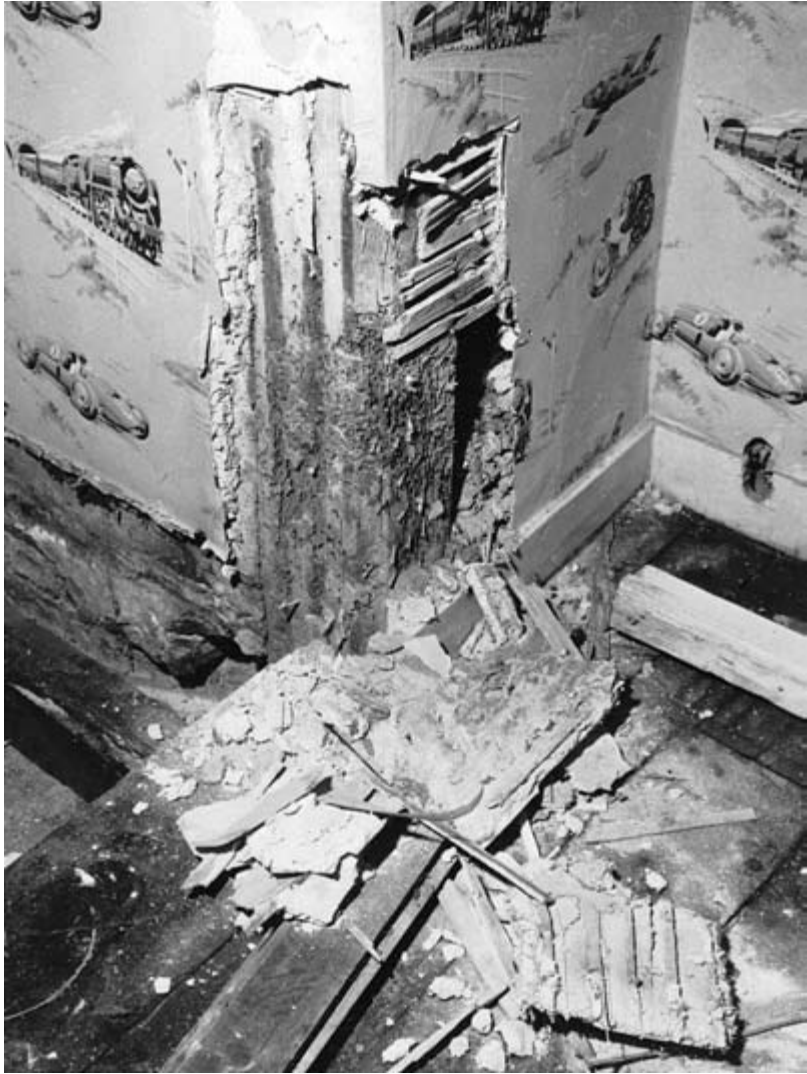
Figure 9.2 Effects of Death Watch beetle (courtesy of SGB Group Publicity).

The Death Watch beetle derives its name from the tapping sound both sexes make during the mating season. This is a larger beetle, about 6 to 8 mm long, chocolate brown in colour, spotted with thick patches of short yellowish grey hairs. The life cycle is one to eleven years. The flight holes are circular, about 3 mm in diameter. They lay their eggs in crevices or knots or old flight holes and the eggs hatch in two to eight weeks. The grubs wander over the surface before tunnelling. The bore dust contains coarse bun-shaped pellets. The beetle is often found in old hardwoods, usually oak and chestnut, and most damage occurs in built-in parts of a structure such as end beams, wall plates and poorly ventilated places (see Fig. 9.2).

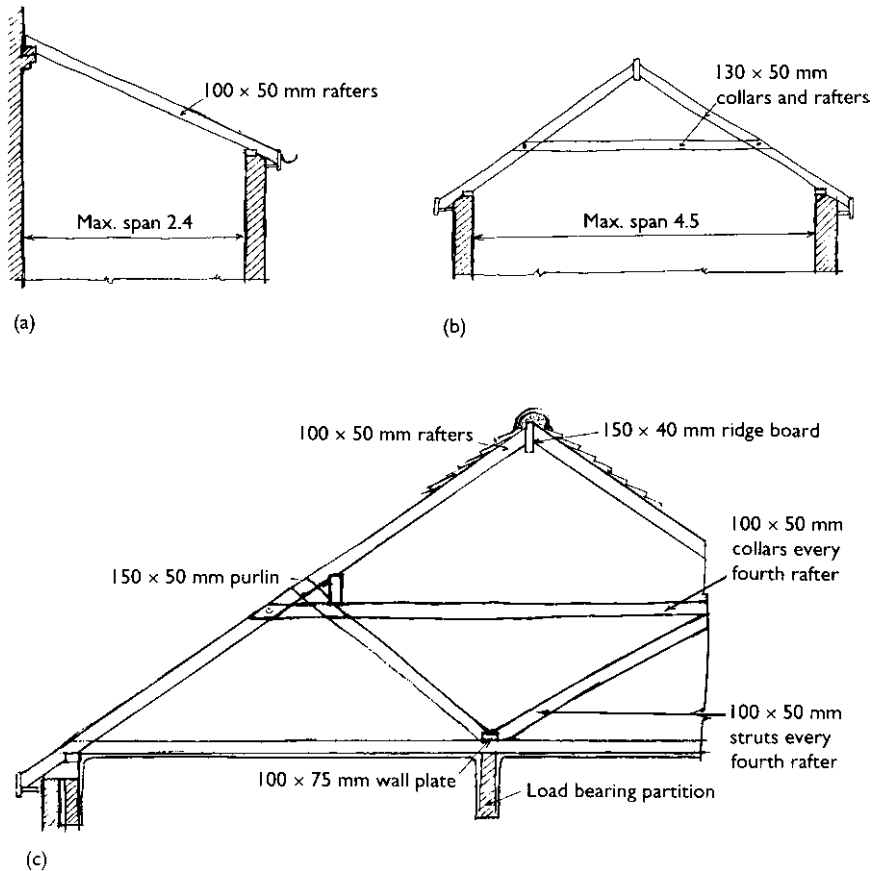
Figure 10.1 (a) Lean-to roof, (b) collar roof and (c) double or purlin roof.

The timber lean-to and collar roofs are the simplest type of roofs for short spans and are often found on back additions or on outbuildings to older domestic properties (see Figs. 10.1a and 10.1b).

Figure 10.1c shows a typical purlin roof found in many domestic properties erected during the first half of the twentieth century and consists of a ridge piece, rafters, purlins, collars and struts. The purlins are fixed under the rafters to provide intermediate support and are secured to struts which bear on an internal load bearing partition. It was also common practice to stiffen the roof by providing collars at every fourth pair of rafters. The size of the various members is important as it is essential to use economical sizes governed by the span of the roof and the load it supports.

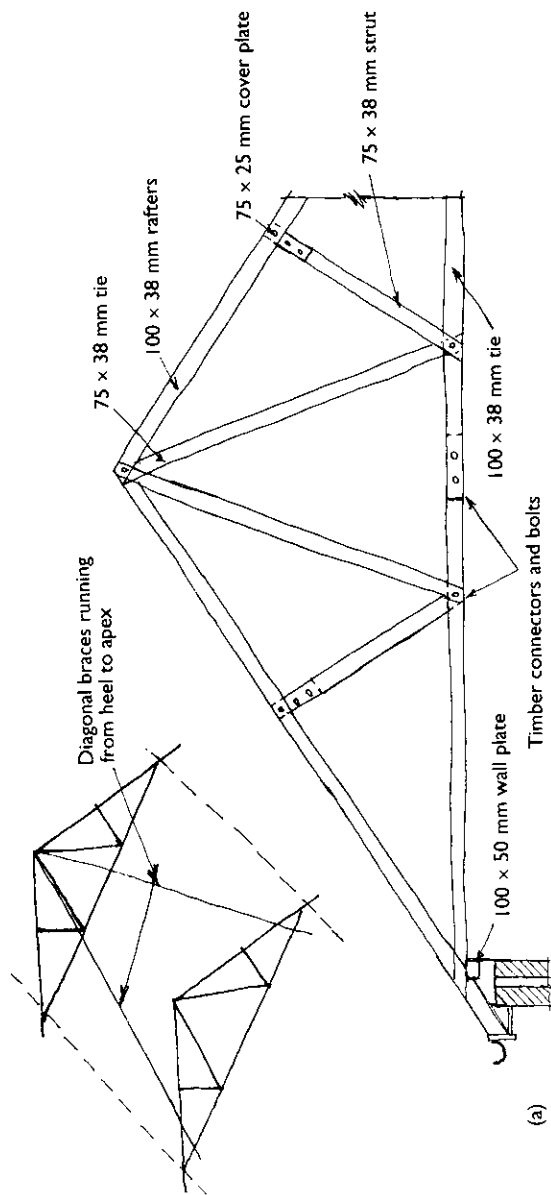
Figure 10.2 (a) Trussed rafters,

due to badly made joints or the omission of diagonal bracing, causing the trusses to move laterally. If not corrected, these defects can cause the roof tiles to lift and rainwater to penetrate the roof space. Care should be taken to ensure that the fasteners and diagonal braces have been properly installed and if they are not provided or are defective, a definite recommendation should be made for their provision (see Fig. 10.2a).

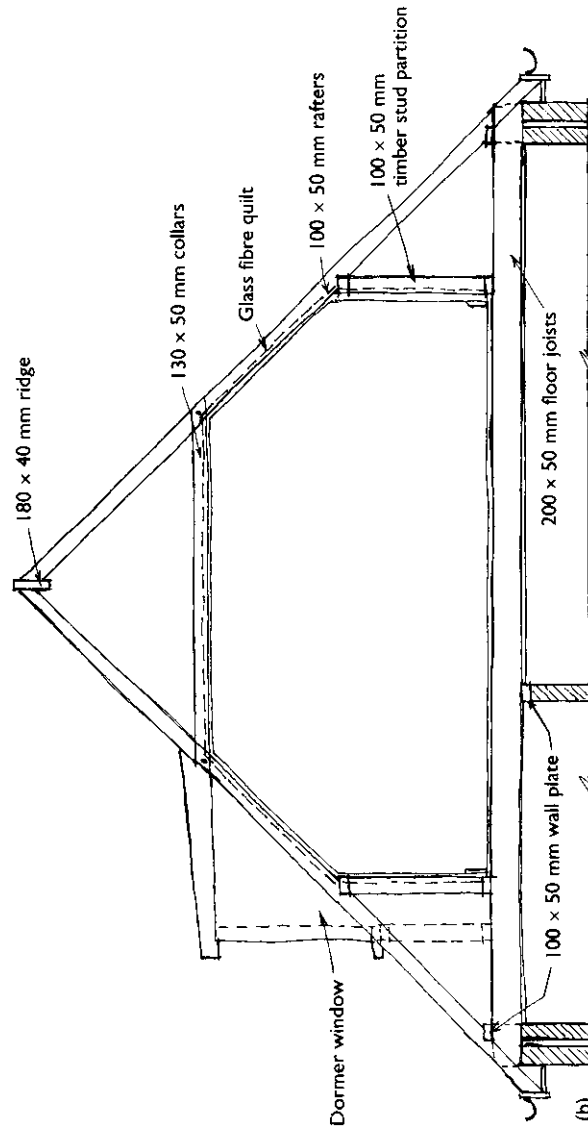
Figure 10.2 (b) room in roof space.

late the triangular space and ceiling (see Fig. 10.2b). The mansard roof is of similar construction, but without the sloping ceilings.

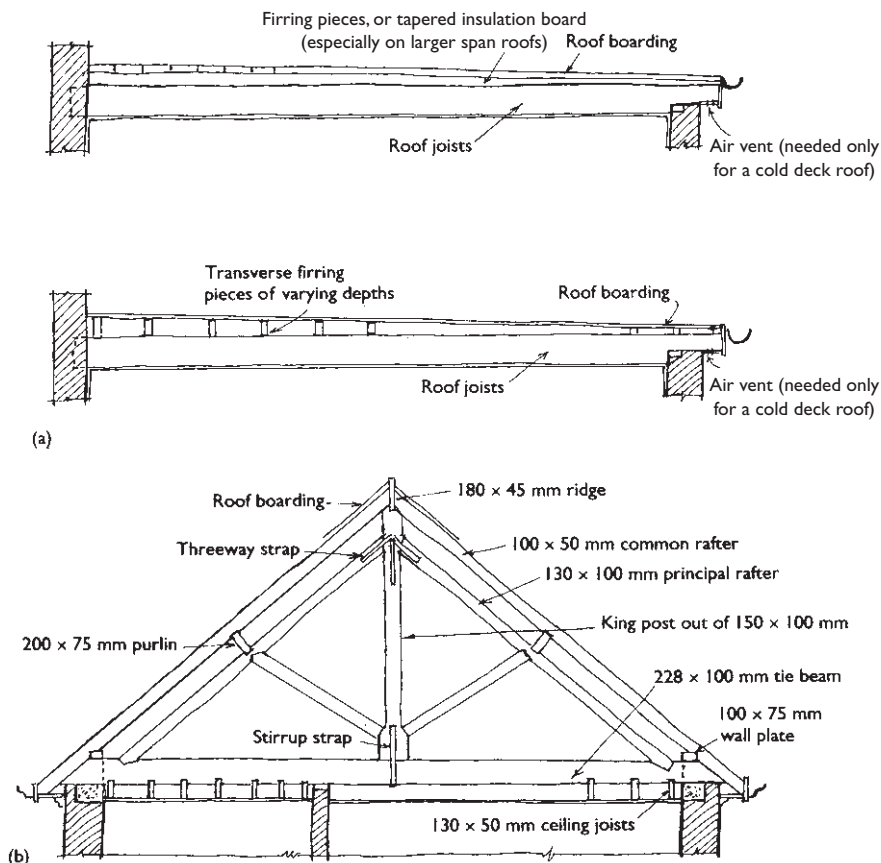
Figure 10.3 (a) Flat roof construction and (b) King Post roof.

examine and old building where this type of construction is met with. The example shown is a King Post truss, but there were many variations and this type together with the Queen Post reached their ultimate design during the mid nineteenth century. The truss supports the purlins which in turn support the common rafters. The roofs were usually close boarded and covered with slates making a sound insulated loft. In all cases the joints were strengthened with iron straps and bolts.

Flat roofs for medium spans say from 6 to 7.5 m are usually constructed of timber joists which are freely adaptable and are particularly suitable for domestic roofing (see Fig. 10.3a).

During the eighteenth and nineteenth centuries larger span roof trusses followed the pattern shown in Fig. 10.3b for the majority of the larger domestic dwellings, light industrial and commercial buildings. This type of roof has been included because surveyors are often called upon to

Where flat roofs are provided it is usually impossible to inspect the timbers for defects. If the defects are due to water penetration a damp patch or water mark will be seen on the ceiling. If the problem is serious it is likely to be indicated by deflection in the roof timbers, coupled with depressions in the roof covering and cracked or loose ceiling plaster. If the roof covering is seriously defective and will obviously require renewing then it is often possible for the surveyor to arrange for a portion of the roof covering to be removed allowing access to the boarding and joists. As mentioned in Chapter 2, fibre-optic probes and boroscope systems have come to the surveyor's rescue and it is now possible to introduce a 600mm long boroscope into the roof structure via a small drill hole in order to view the condition of the joists etc. A polaroid camera and attachment can be fitted to this instrument to record the information. Flat roofs need to be laid to adequate falls and to incorporate a vapour barrier. The fall is achieved by either using tapered furring pieces secured to the joists or tapered insulation board on a vapour control layer on the warm side of the timber deck. Various types of boarding are used to support the roof covering e.g. rough boarding, T and G boarding, blockboard and chip-board may be used. Care should be taken to examine the method of ventilation of the timbers if it is a cold deck flat roof, as shown in Fig. 10.3a.

The internal examination of a large roof of an eighteenth or nineteenth century building (see Fig. 10.3b) can be a very long and costly operation. If the roof is of the open type with no ceiling then a long extension ladder or tower scaffold is usually required. An inspection of this type of roof will reveal that the greatest number of failures are due to decay of the timbers, often resulting from the deterioration of the roof covering. It is, therefore, necessary to check carefully for evidence of wet rot and wood boring insects. (All these defects have been dealt with in Chapter 9.)

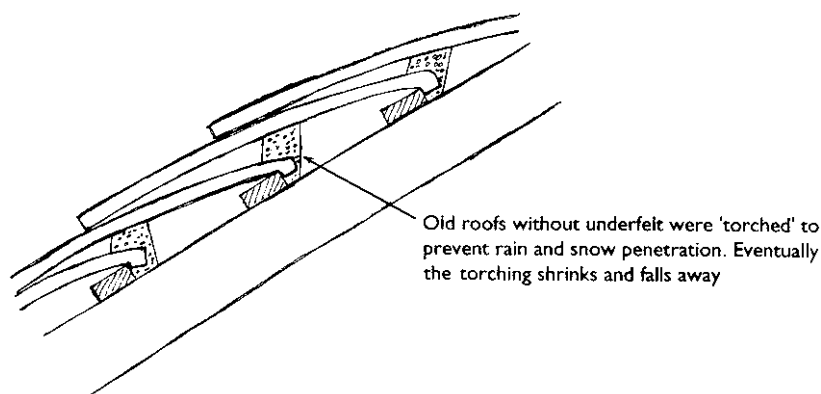
Figure 10.6 Method of 'torching' to underside of roof tiling.

- A great number of domestic buildings built before 1940 have roofs without either underfelt or boarding. To prevent rain or snow penetration 'torching' has been used on the underside of the tiles and consists of a mixture of lime mortar and cow hair. The mixture was spread behind each batten to fill the space between the tiles. The disadvantage with 'torching' is that it tends to shrink and fall away. The torching should be carefully examined and commented on (see Fig. 10.6).

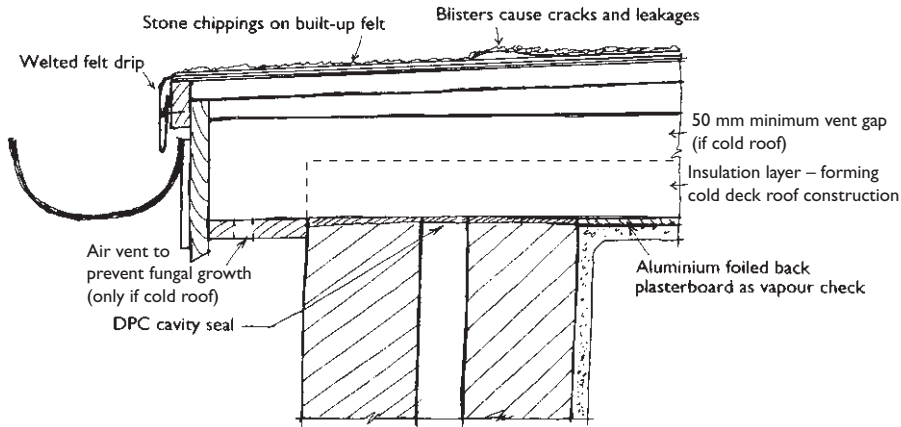
Figure 10.7 Built-up roofing – eaves detail.

- (2) As mentioned earlier in Chapter 8, condensation can present serious problems in roofs of this type. Moisture can be prevented from entering the roof by the provision of a vapour barrier such as plaster board and ventilation in the roof void to prevent fungal growth. The entrapped air or moisture between the layers of felt or between the felt and the substructure will cause the felt to lift in the form of 'blisters'. The blisters are not necessarily a sign of failure, but should be carefully examined to see whether any foot pressure has been applied to cause the blister to crack and form a passage for water penetration. One of the most common defects is to find that no provision has been made for ventilation and a vapour barrier. It is, therefore, important that the surveyor endeavours to ascertain the nature of the original construction (see Fig. 10.7).

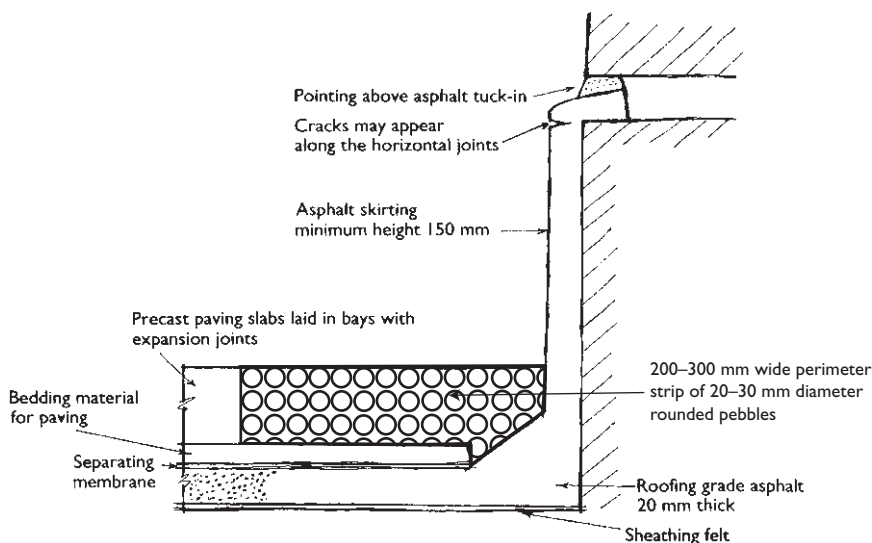
Figure 10.8 Mastic asphalt to roof garden or car park roof.

The recognition during the past fifty years of the value of flat roofs as a means of providing car parking, roof gardens and playgrounds etc., has created a demand for roof coverings which combine water resisting qualities with an attractive finish such as precast paving slabs preferably with solar reflective properties. The pavings should be laid in bays with expansion joints where necessary and a separating membrane should be provided beneath the paving as shown in Fig. 10.8. The durability of asphalt can be affected in several ways and the most common defects the surveyor will have to investigate are described below:

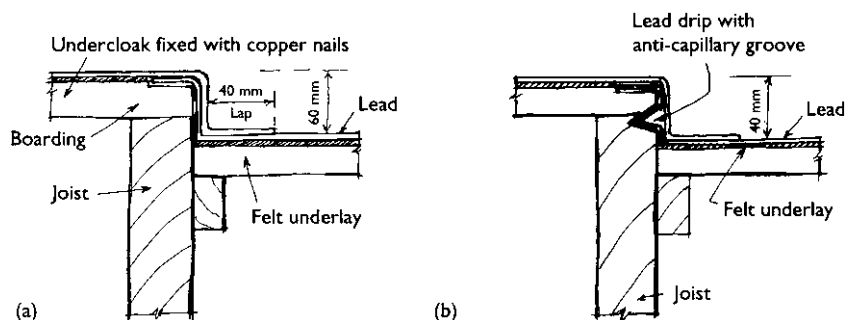
Figure 10.9 (a) Lead drip. (b) Lead drip with anti-capillary groove.

- (1) If the joints of the boarding show on the upper surface of the lead it usually means that the underlay is missing.
- (2) If thermal expansion occurs the sheets will tend to lift in folds and not return to their natural position. The lead will eventually become brittle and crack allowing rainwater to penetrate through to the sub-structure. The sheets should be carefully examined for such defects.
- (3) One of the most common faults is due to inadequate drips. They are normally 60mm deep as shown in Fig. 10.9a but a minimum depth of 40mm is permissible if an anti-capillary groove is provided in the vertical face of the drip. This groove prevents rainwater rising and penetrating through to the timber as shown in Fig. 10.9.

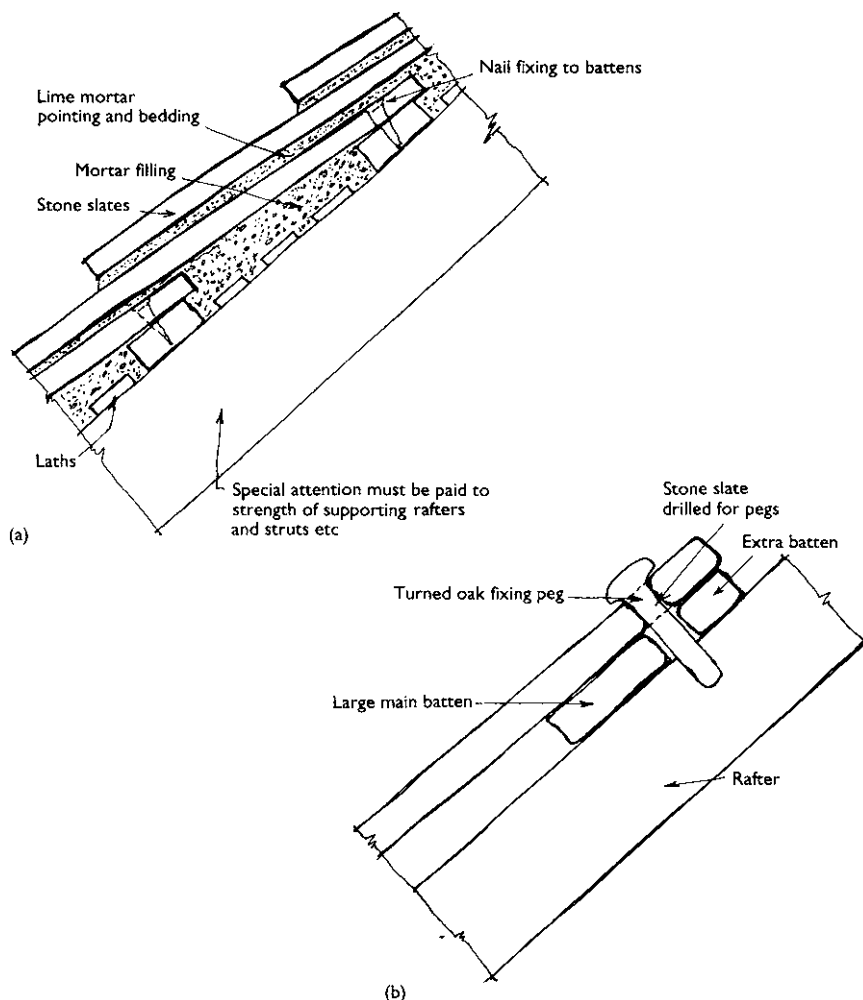
Figure 10.10 (a) Stone slates sealed by bedding. (b) Tarred oak peg fixing.

- Slates laid on a bed of lime mortar should be carefully checked. Moisture may have penetrated through to the laths and battens causing wet rot and the mortar bedding to become damp and loose. If these defects are far advanced then the surveyor may well consider stripping and renewing all the fixings.
- Externally, the very old slates may well be seriously damaged by frost or have become worn and fractured and require complete renewal.

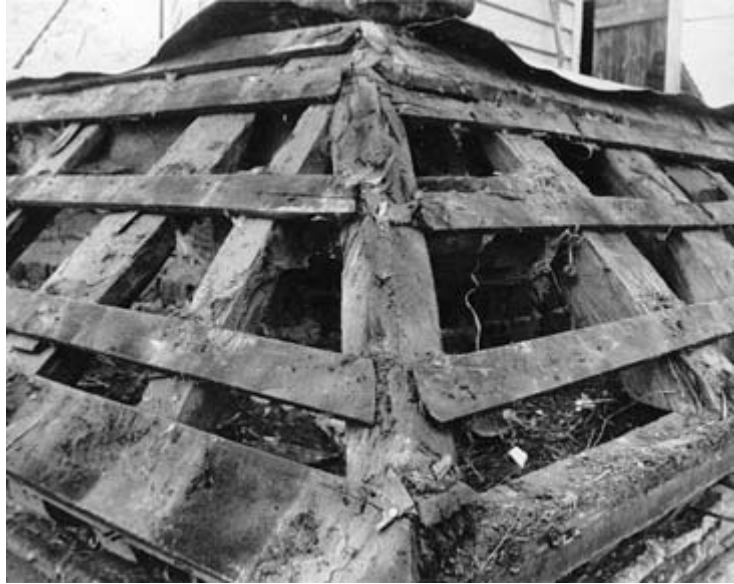
Figure 10.11 Timber roof structure after worn stone slates have been removed.

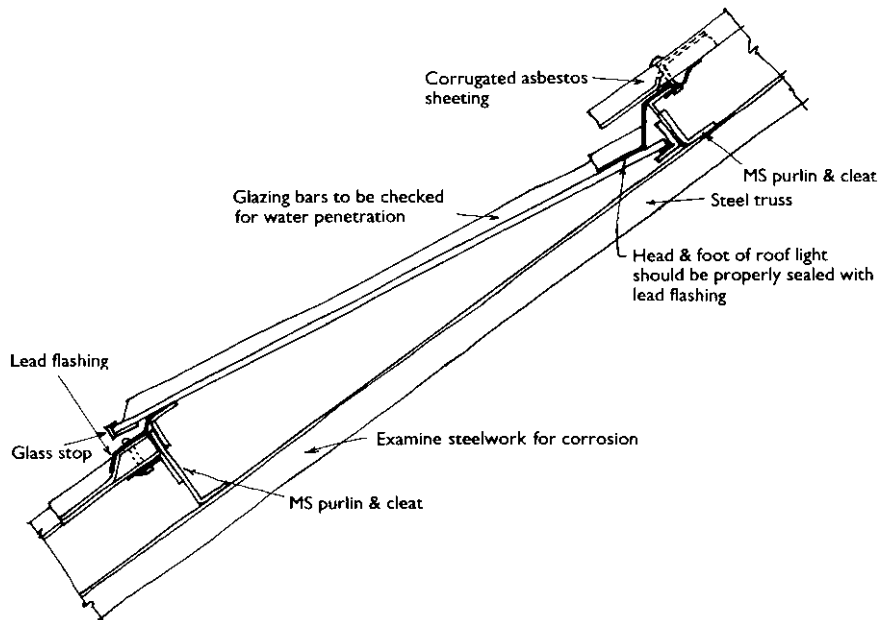
Figure 10.12 Fixed roof glazing.

- Fixed roof glazing to pitched roofs is used in conjunction with asbestos sheeting or other types of covering and usually consists of patent glazing bars designed to accommodate single or double glazing secured to the roof purlins (see Fig. 10.12).

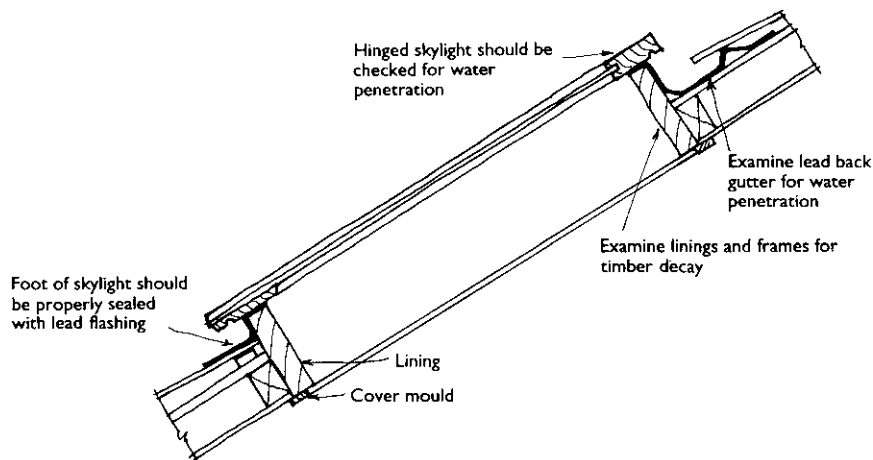
Figure 10.13 Skylight detail.

- Skylights may be provided in pitched roofs to light a staircase, landing or attic. The skylight may be hinged or fixed (see Fig. 10.13).
- The traditional form of timber lantern light is still efficient and is found on the flat roofs of many old buildings (see Fig. 10.14). During the last forty years they have largely been superseded by dome lights which are manufactured by specialist firms and consist of a combined curb mounted ventilator and roof light unit. The units are constructed throughout in extruded aluminium and are corrosion resistant. The domes are available in glass, acrylic and wire laminated PVC. The aluminium construction reduces roof loading and obviates maintenance. All that is required is an occasional cleaning.

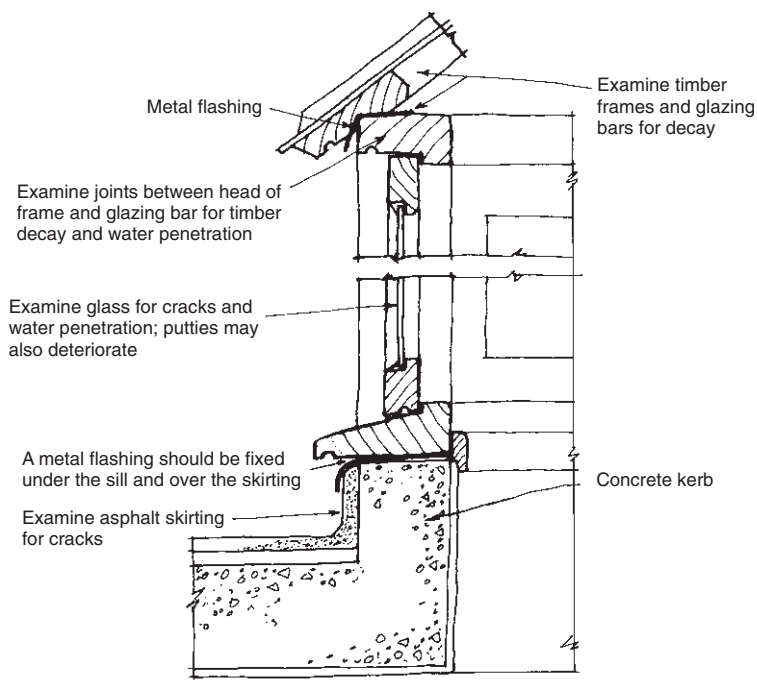
Figure 10.14 Lantern light.

- Skylights may be hinged or fixed, but if the light is hinged penetration of rainwater is likely.
- All forms of upstands to the lantern lights must be in sound condition and should have an angle fillet between roof and upstand. A metal flashing should be fixed under the sill and over the upstand covering as shown in Fig. 10.14. Poor detailing in this area is a common cause of water penetration.

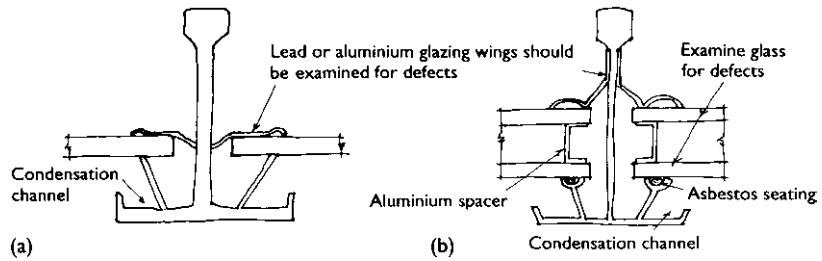
Figure 10.15 (a) Aluminium glazing bar. (b) Aluminium double glazing bar.

glazing bars can be made of softwood or hardwood. They are liable to decay and regular maintenance is necessary especially in very exposed positions. There are several proprietary glazing bars in the form of metal T-sections consisting of steel or aluminium alloy sheathed in lead or PVC. The bars incorporate condensation channels and the glass is secured with aluminium spring cover strips or lead wings. The bars are normally trouble free and produce a durable watertight roof light. Figures 10.15a and 10.15b show examples of single and double glazing bars. The various items affecting the durability of the roof lights and requiring examination may now be considered:

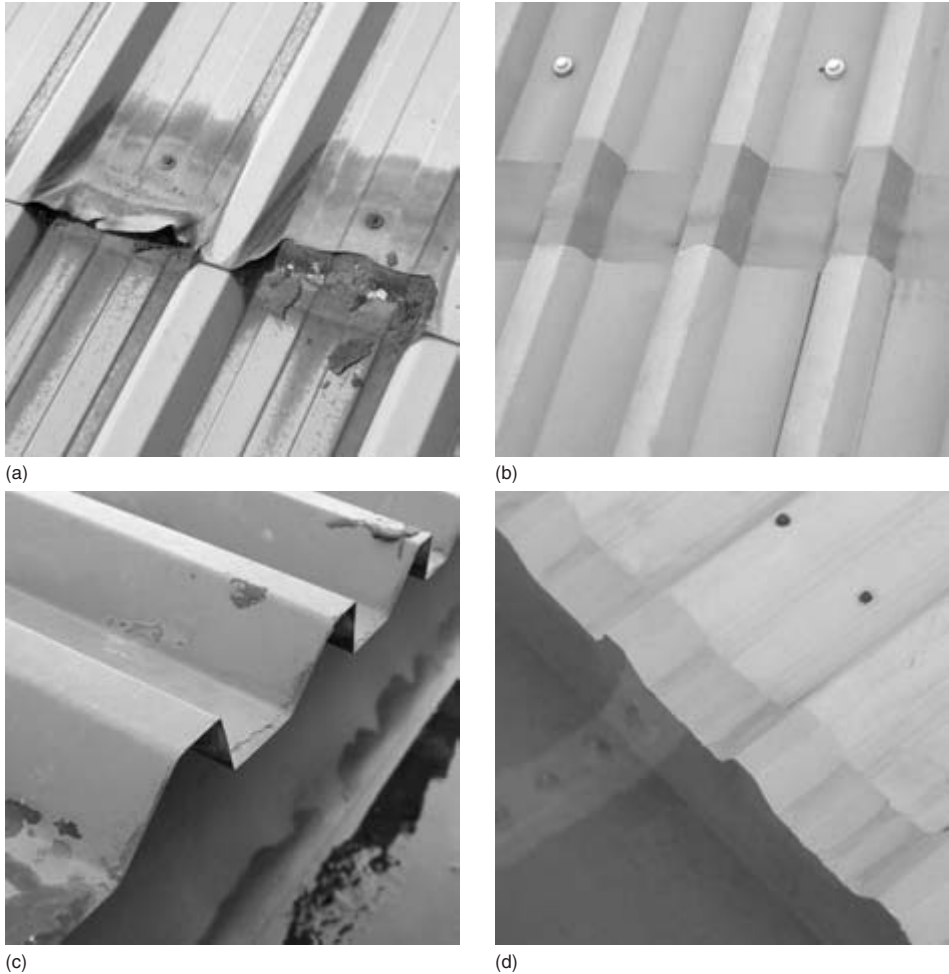
Figure 10.16 (a) Lap Joint Before Treatment; (b) Seamsil® Treated Lap Joint; (c) Gutter Overhang Before Treatment; (d) Seamsil® Treated Gutter Overhang (courtesy of Delvemade Ltd).

There are now a number of proprietary treatments of edge corrosion available (see Fig. 10.16). Delvemade Ltd (www.delvemade.co.uk) is one such system which uses a silicone (non-acidic) sealer application. It can be used in conjunction with a recoating scheme for the whole external surface of the cladding using a more durable paint system such as PVDF. Consult also technical guides by Weatherproofing Advisers (see website address in bibliography).

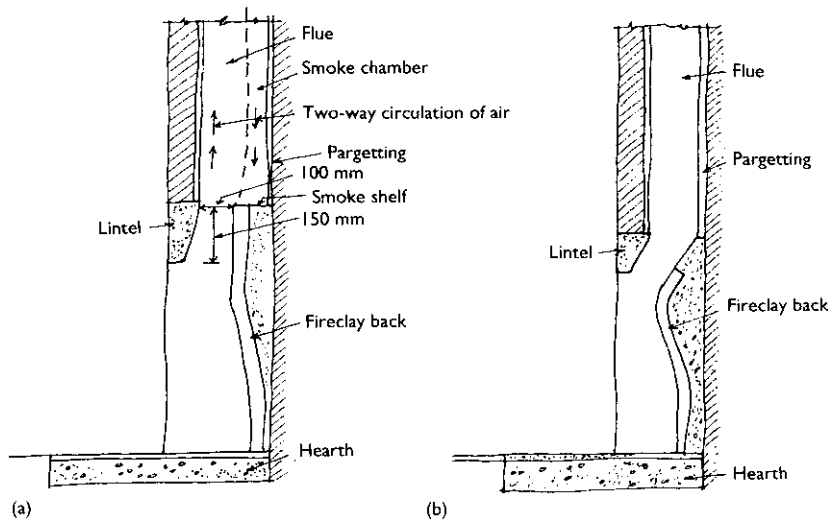
Figure 11.1 (a) Section through fireplace designed on the principles of Count Rumford. (b) Fireplace design commonly adopted in modern work.

In practice of course, the surveyor will often find that these ideal conditions may not always occur. The fireplace and flue entry shown in Fig. 11.1a has been designed on the Rumford principles (see Billington and Roberts 1982) and Fig. 11.1b shows a section commonly adopted in modern work which is usually successful. The surveyor will often find that dwellings erected in the past forty years have been fitted with precast throat units which ensure that the throat is formed to the correct dimensions.

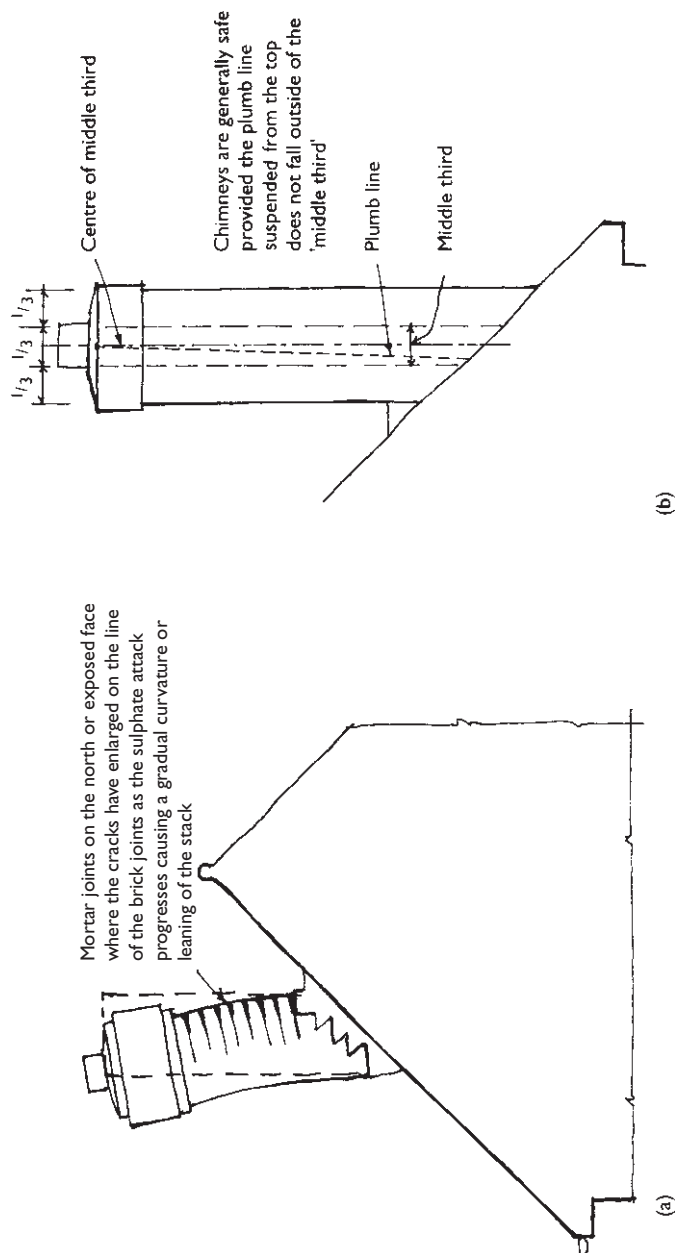
Figure 11.4 (a) Sulphate attack on a typical kitchen boiler flue. (b) Middle third rule.

- (1) As already mentioned, sulphate attack causes the mortar to expand and this leads to a gradual curvature or leaning of the stack which can be extensive on rendered stacks. The lining or pargetting can also be attacked by the products of combustion as they rise up the flue. Sulphate attack on a typical kitchen boiler flue is shown in Fig. 11.4a where the shrinkage cracks have enlarged on the horizontal brick joints as the sulphate attack progresses.

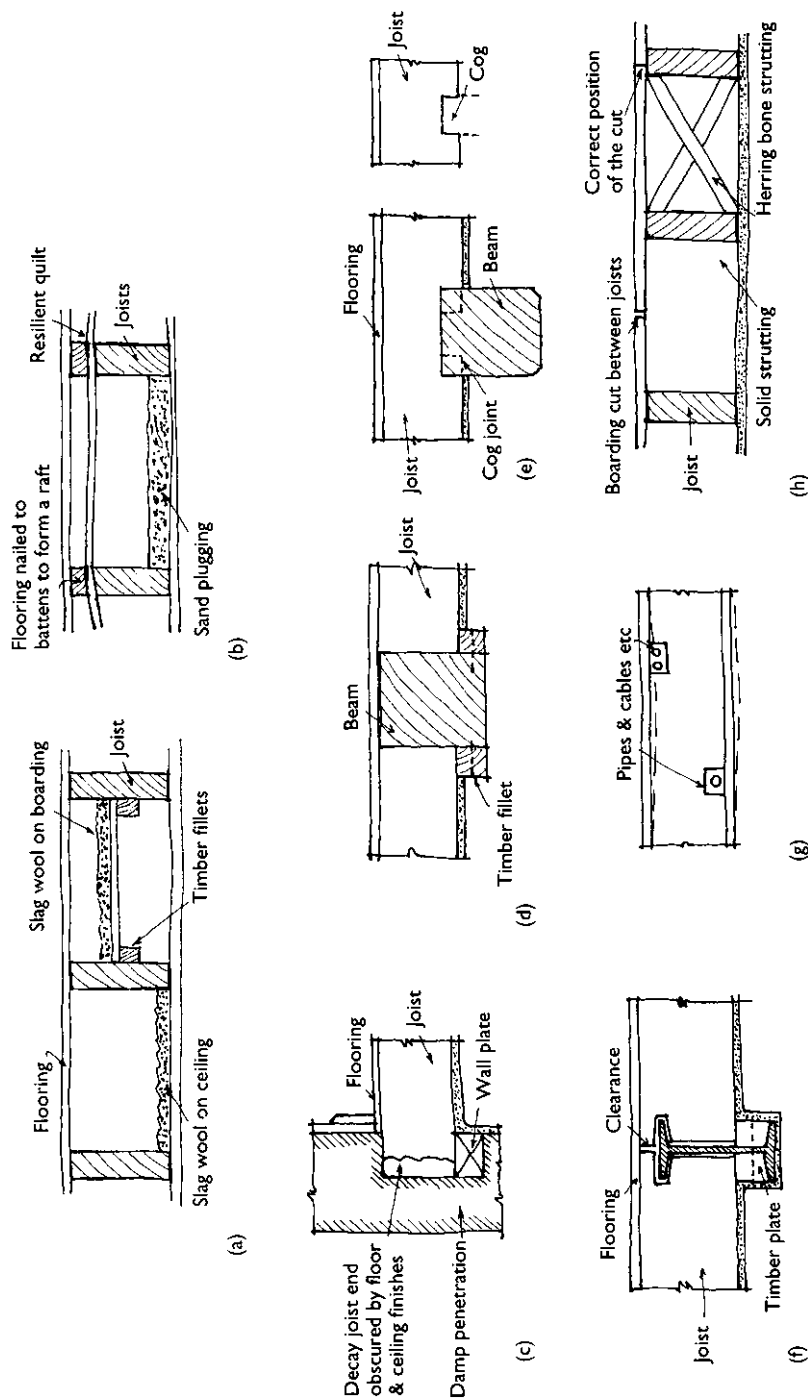
Figure 12.1 (a) Two methods of sound insulation between floors. (b) 'Floating floor' for sound insulation. (c) Joists built into solid wall without an air space. (d) Joist resting on fillets nailed to bottom edge of beam. (e) Method of cogging joists over timber beam. (f) Typical notching when RSJs are used. (g) Deflection due to excessive notching. (h) Floorboard jointing and strutting details.

in older buildings is a fillet nailed along the bottom edge of the beam with the joist resting on the fillet as shown in Fig. 12.1d. In such cases the nails in the fillets are supporting the joists and if they should fail the joists would collapse. When carrying out an investigation to such a floor, it may be found that the nails have given a little, but not necessarily caused a dangerous condition. If this is so the floor can be strengthened. It is better practice to cog the floor joists over the beam as shown in Fig. 12.1e. Figure 12.1f shows a typical notching where the beam consists of a rolled steel joist. The timber joists are supported on timber plates secured to the web of the RSJ, but are kept clear of the rest of the RSJ to allow for expansion and contraction of the timber. In some cases the top of the joists are flush with the top of the RSJ causing the floorboard situated over the top flange to curl due to the fact that the only fixing is the tongue and groove in the jointing of the floorboard.

- (5) The centre of the span should be checked for some form of strutting. Although strutting is usually fitted between joists, it may happen that in very old timber floors it has been omitted, in which case undue vibration will occur. This is due to the joist tending to tip sideways under movement, especially if the floorboards have not been nailed to every joist. Also the end wedges between the wall and the last joist may have been omitted or have fallen out. If this is the case, considerable improvement can be effected by taking up the flooring and inserting a row of solid strutting down the centre of the span (see Fig. 12.1h).

- (6) Another problem which could be attributed to deflection in old floor joists is that excessive notching of the joists may have been made to accommodate gas pipes, electrical cables or water pipes (see Fig. 12.1g). If the surveyor feels uncertain on this point it is well to consult the British Standard Code of Practice BS 5268-2:2002 which sets out rules concerning safe notching in joists.

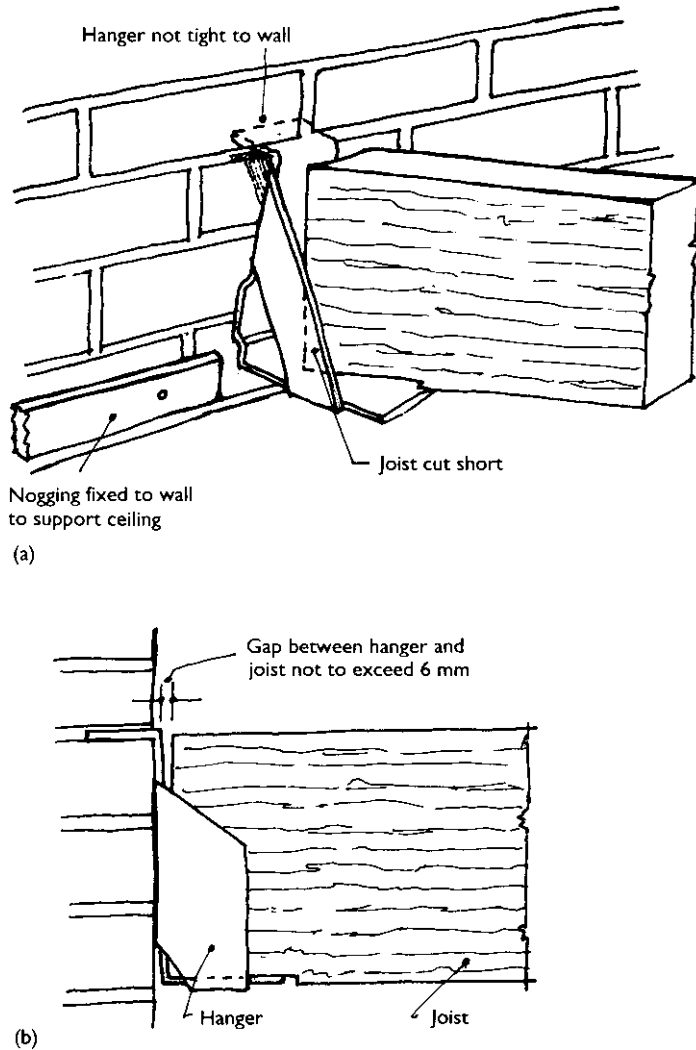
Figure 12.2 Use of metal joist hangers: (a) incorrectly positioned; (b) correct positioning.

- (8) In modern properties metal joist hangers have been used extensively. Unfortunately, recent surveys have found instances where the hangers or joists have failed due to one or more of the following causes (see Fig. 12.2a and b).

- Sometimes joists are cut short leaving a large gap between joists and back plate of hanger. This may cause hangers to move and the floor to settle.
 - Check to ensure that no damaged or corroded hangers have been used.

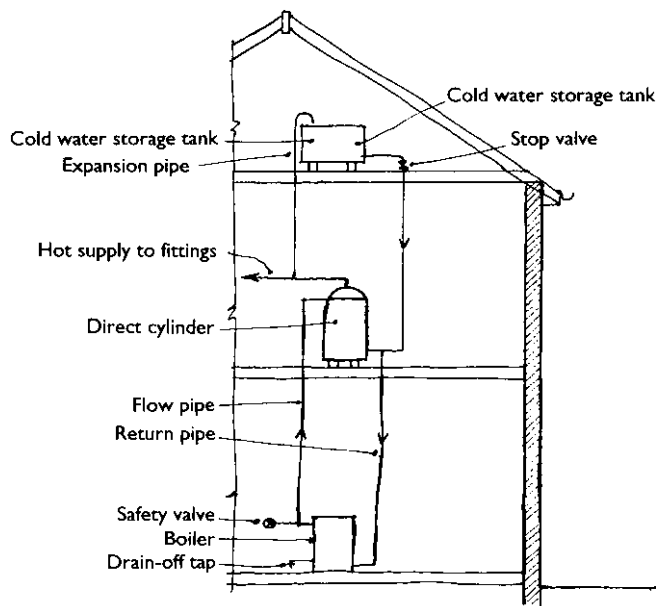
Figure 14.2 Layout of direct heating system.

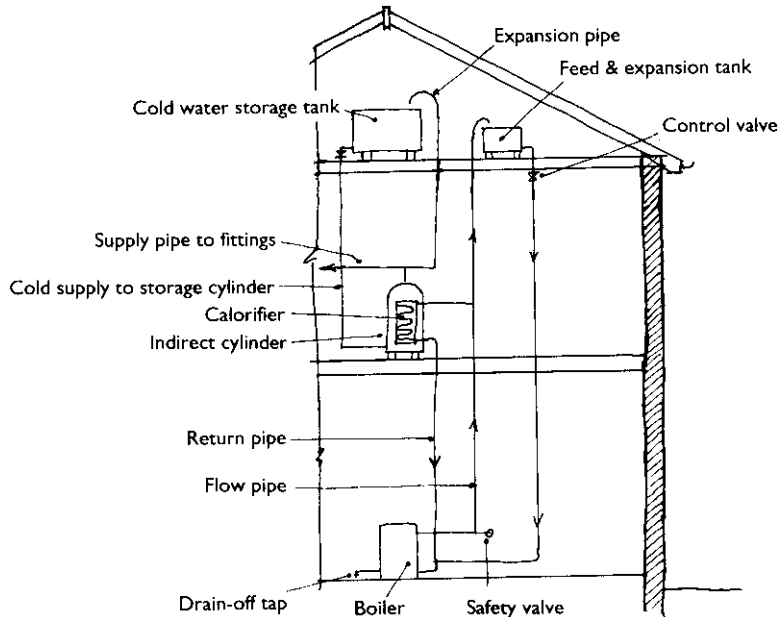
Figure 14.3 Layout of indirect heating system.

An indirect system of hot water supply is one in which the water used is heated indirectly by hot water in a calorifier placed in the hot water vessel. In this system the hot water to the fittings does not pass through the boiler. Two separate cisterns are necessary. One is the feed and expansion cistern and the other is the cold water storage cistern for the building. Both act as expansion cisterns. The advantages of the system are that only one boiler is necessary for both installations and after the initial deposit has taken place in the boiler the water constantly recirculates between boiler and calorifier. The water in the calorifier is hardly ever replaced, thus there is very little furring of pipes (see Fig. 14.3).

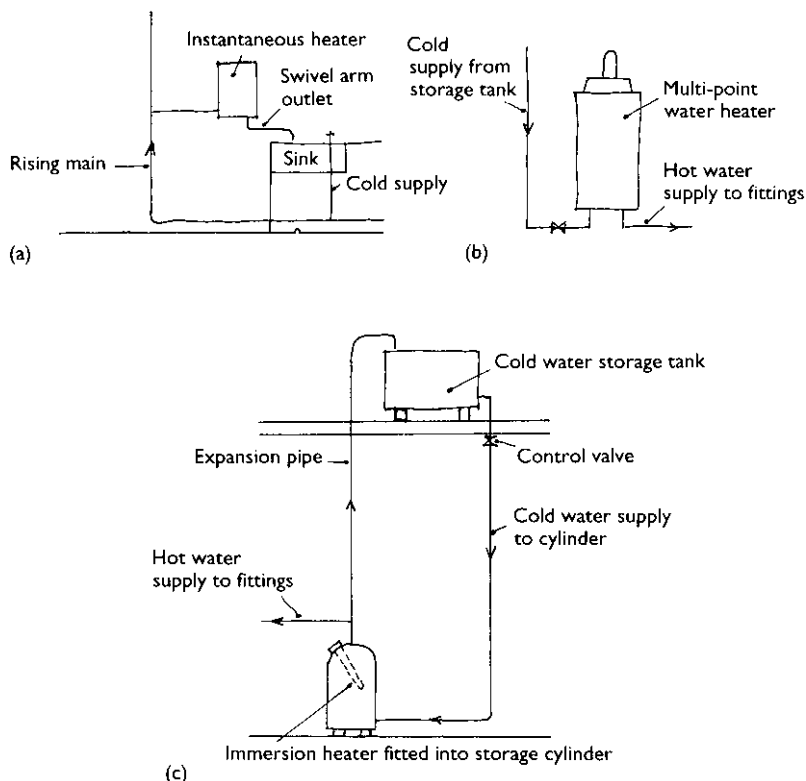
Figure 14.4 (a) Wall mounted instantaneous heater. (b) Wall mounted multi-point heater. (c) Heating water by electric immersion heater.

water storage tank which then supplies hot water to several fittings (see Fig. 14.4b).

In modern buildings the surveyor will often find that the cylinders are coated with sprayed on foam insulation in lieu of jackets. This type of insulation is very efficient and has a neat appearance. All pipes connected to the cylinder should also be insulated (see Fig. 14.4c).
