Building Surveys and Reports

Edward A. Noy FASI, ARSH

James Douglas BSc, MRICS

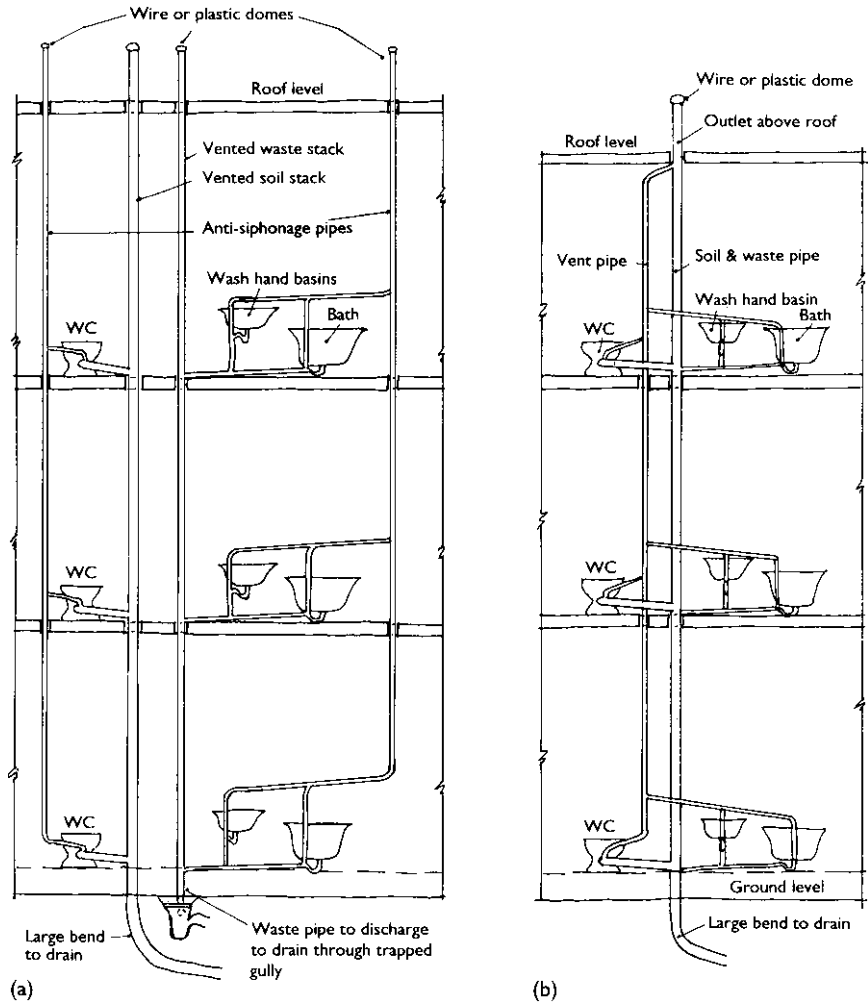
Figure 14.5 (a) Two pipe system for block of flats. (b) One pipe system.

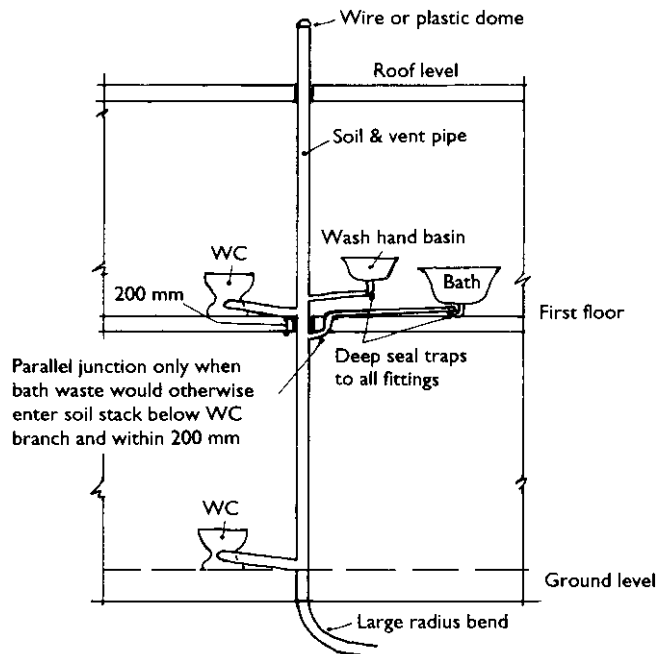
Figure 14.6 Single stack system.

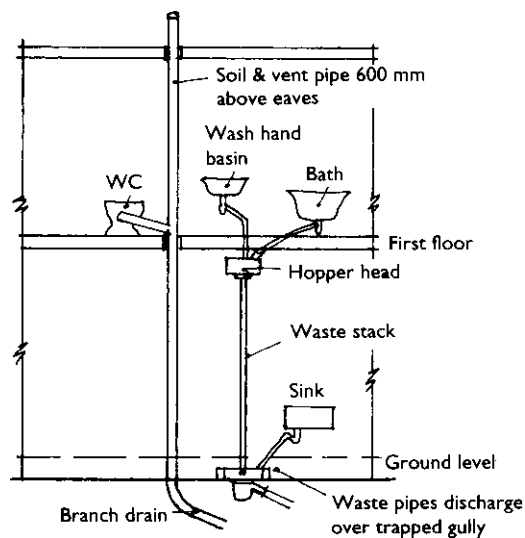
Figure 14.7 Disposal of soil and waste water in older domestic properties.

In many domestic properties built before the Second World War the surveyor will find that the waste pipes from fittings above ground level, such as baths, basins and showers, will discharge into hopper heads and the sinks at ground level discharging over a trapped gully. The WC is usually connected to a ventilated soil pipe. The waste pipe and hopper are not a satisfactory method and will often be found to be partially blocked with slimy soap and hair etc., and in very cold weather the waste water will freeze and possibly fracture the pipes (see Fig. 14.7).

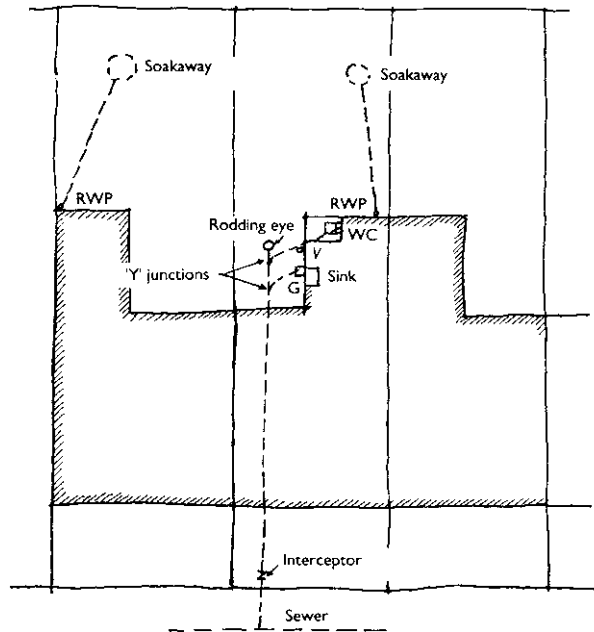
Figure 15.1 Soil drainage system to terraced housing erected before 1900.

If inspection chambers are not visible on site, the possibility that they may have been covered up by raised flower beds, pavings or rubbish should not be ruled out. If, however, inspection chambers cannot be located, there is a strong possibility that the building is still equipped with the original system which was probably installed some time between 1850 and 1880. Such a system was usually laid in four- or six-inch salt glazed pipes with clay joints and without any form of concrete bed. In the case of terraced houses, the most common layout was a straight run under the house from the outside WC to the sewer. This meant that the soil branch drain connected to the WC outlet and vented to the open air and went directly to the main drain while a second pipe took the waste water from the kitchen sink to an outside trapped gulley. Sometimes the WC connection entered the main run with a 'Y' junction, the main run then being extended via an easy-bend up to yard level where it was capped off with a rodding eye. However, it was fairly common practice to form a junction by cementing the end of a 4" branch pipe into a hole cut into a 6" main drain (see Fig. 15.1).

It may well be found that the surface water drainage is on a 'separate system' either to a surface water sewer or to a soakaway within the curtilage of the site as shown in Figs 15.1, 15.2 and 15.3. Care must be taken not to get the systems inadvertently interconnected. 'Separate systems' were adopted by many local authorities in large towns in order to avoid overloading the sewage treatment plant. They will not allow rainwater pipes or yard drainage to be connected to the foul sewer. However, some local authorities allow the soil and surface water to discharge into the same sewer as shown in Fig. 15.4.

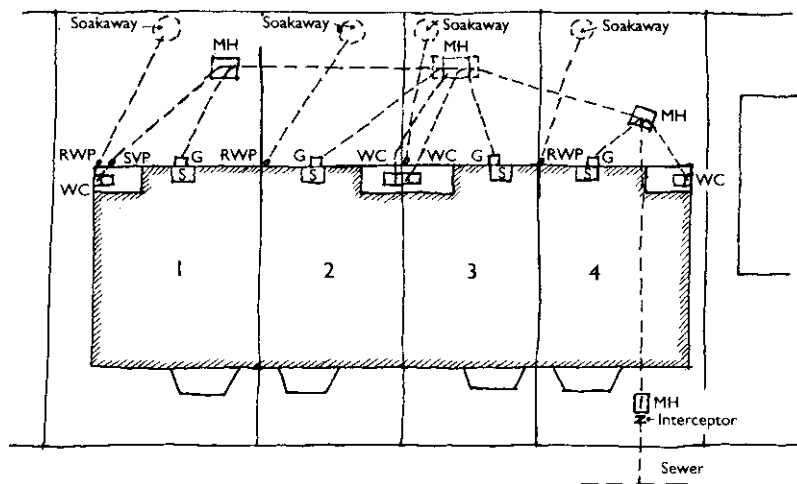
Figure 15.2 Soil and surface water system to terraced housing erected after 1900.

In some cases it will be found that, although there is no inspection chamber on the property, the drains are in fact connected into an inspection chamber in an adjoining property, as shown in houses 2 and 3 in

Fig. 15.2. No particular problems should arise from this unless the properties belong to different owners. Should this be the case a 'drainage agreement' will have to be entered into by the various owners, whereby joint responsibility is accepted for the repair of common sections of the drain. It is advisable to check this point with the owner when carrying out a drainage survey.

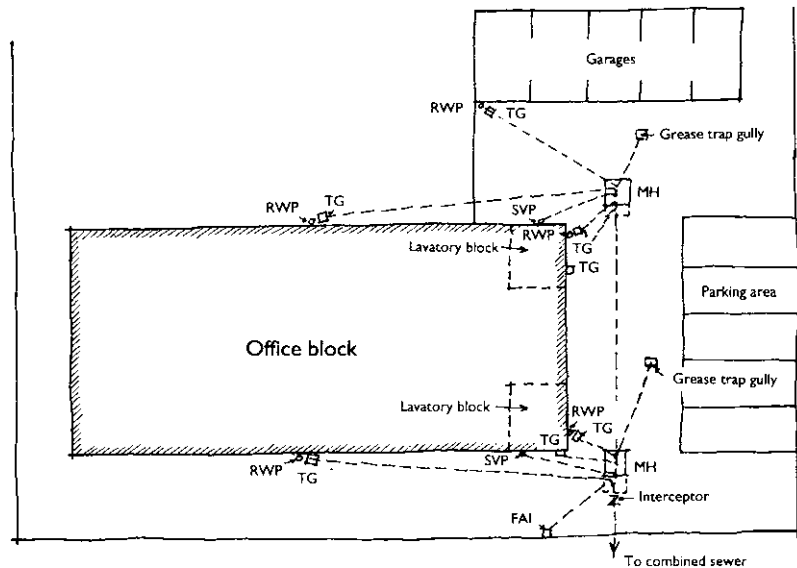
Figure 15.4 Typical combined system for small commercial building.

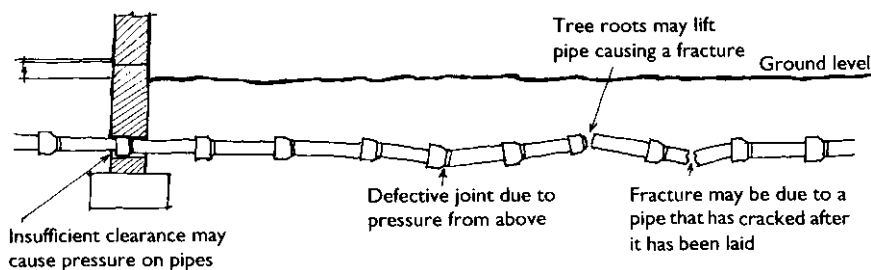
Figure 15.5 Defects due to movement of ground through settlement, shrinkage or tree roots.

- Leaky pipe joints which may require rejoining. Old drains are almost certain to have leaky joints. Cement joints often shrink and crack.
- Movement of the ground through settlement or shrinkage may disturb the pipes and often the joints. This type of defect is illustrated in Fig. 15.5.
- Cement and debris left in pipes causing obstruction.
- Obstruction due to solid matter being washed down the drains.
- Lack of proper ventilation causing bad smells in the system.
- Bad smells through leaks, faulty fittings, or blocked traps.

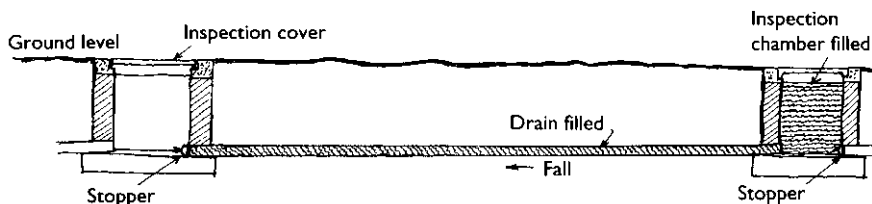
Figure 15.6 Water test applied to section of drain between two inspection chambers.

ping the inlet with an expanding stopper. Another stopper should be fitted to the inlet (or to each inlet if there are more than one) at the next inspection chamber higher up. These positions are shown in Fig. 15.6 which is a section through a drain being tested. The higher inspection chamber is then filled with water and the distance from the top of the cover frame to the top of the water carefully measured and then left for about an hour and a half to two hours. If the water level in the chamber goes down to any appreciable extent a leakage is indicated. There will be a slight lowering of the water level even if the drains are watertight due to absorption and possibly to some evaporation. If there is any doubt as to the leakage the drain must be emptied by removing the lower stopper and the test repeated. At the second test there should be practically no loss of water caused by absorption.

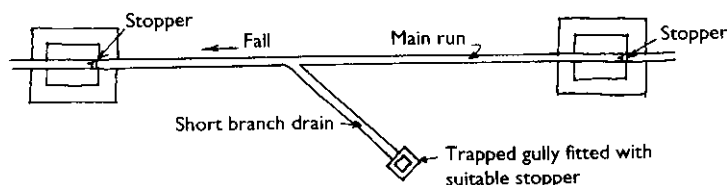
Figure 15.7 Water test applied to main and branch drain.

Short branches connected to a main drain between inspection chambers as shown in Fig. 15.7 should be tested with the main drain. The gully should be fitted with a suitable stopper and any confined air in the gully should be drawn off as the pipe fills with water, using a rubber tube passed through the seal of the gully. The shorter the lengths tested at one time the better, as the job of opening the ground and searching for defects can be confined to those sections in which defects are indicated by test.

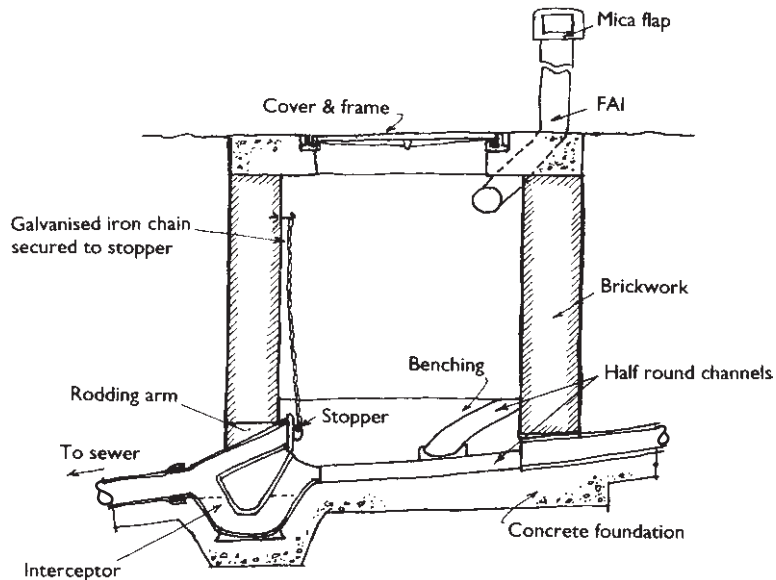
Figure 15.8 Section through interceptor and inspection chamber.

The interior of each inspection chamber should be carefully examined and the construction and condition of the following parts noted (see Fig. 15.8).

It is advisable to recommend that a galvanised iron chain is provided and secured to the chamber wall as shown in Fig. 15.8. Where an interceptor is provided, a fresh air inlet with a mica-flap is theoretically necessary as shown in Fig. 15.8. It should be located away from windows and doors and sited where the front will not be accidentally damaged. The mica-flaps should be closely examined. They may cause a nuisance by acting as a foul air outlet if the flaps are damaged.

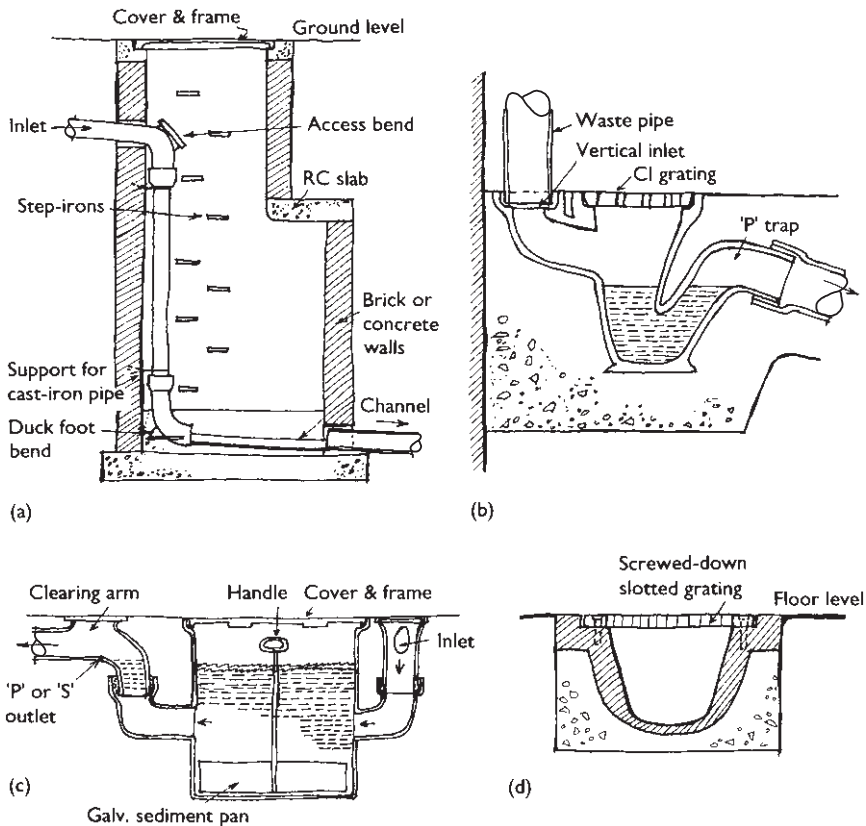
Figure 15.9 (a) Section through back-drop inspection chamber. (b) Back inlet gully. (c) Grease trap. (d) Drainage channel.

No difficulties should be found in locating drain runs, inspection chambers and interceptors etc. During this period more reliance can be placed on the deposited plans and the date of construction can be verified. However, it will often be found that unauthorised additions have taken place since the plans were deposited. Since about 1950 drainage installations have been of the 'one-pipe' system as described in Section 14.25. An important feature of this system is that waste pipes must discharge below the level of the gulley grille thus avoiding blocked gulleys as shown in Fig. 15.9b.

An inspection chamber incorporating a vertical drop for the purpose of connecting to a sewer or drain at high level to one at a lower level is known as a back-drop inspection chamber, or tumbling bay. The vertical drop is usually constructed outside the chamber, but may be constructed inside provided there is sufficient space in the chamber as shown in Fig. 15.9a. If the vertical drop is constructed outside the chamber an access branch should be provided through the inspection chamber wall. If the vertical drop is constructed inside the chamber then a cast-iron access bend should be provided at the top of the vertical pipe. When dealing with both deep

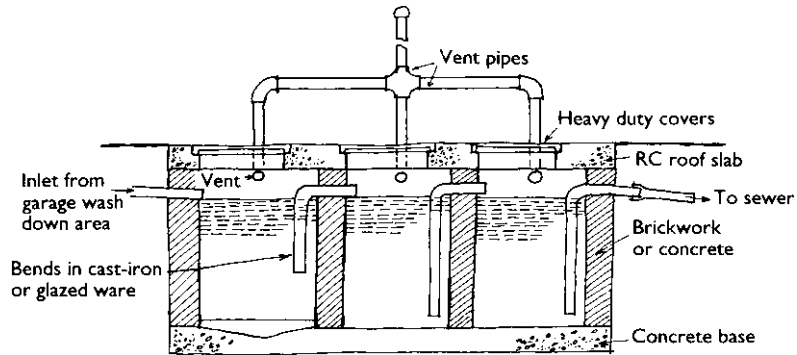
Figure 15.10 Petrol interceptor.

- The first chamber should contain a shorter bend as shown in Fig. 15.10. The purpose of the shorter bend is to allow for the accumulation of grit etc. without blocking the end of the pipe.

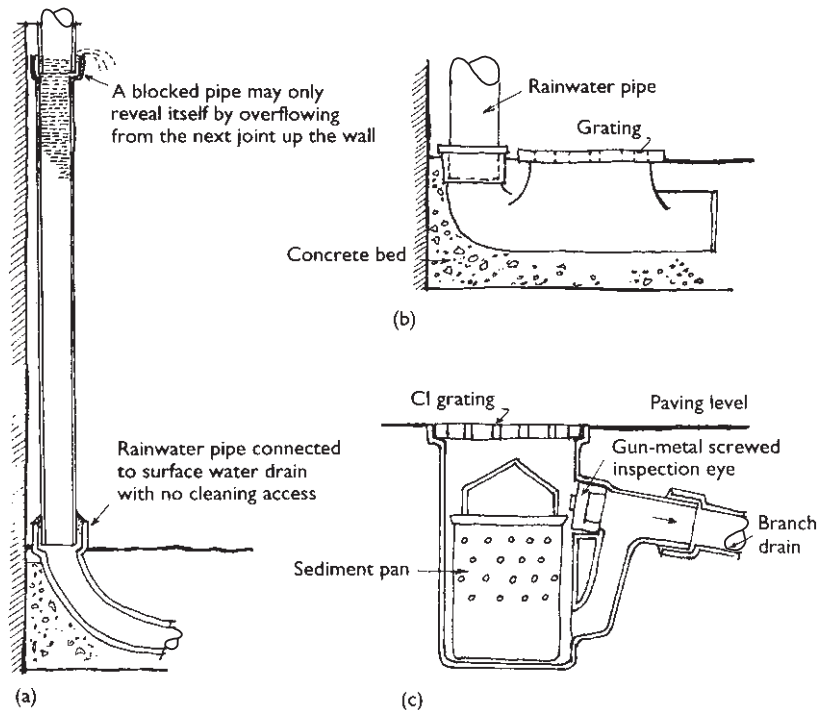
Figure 15.11 (a) Rainwater pipe connected direct to surface water drain. (b) Rainwater shoe. (c) Yard gulley.

less gulleys, may be used. However, in many domestic properties the bottom of the rainwater pipe is jointed direct to the socket of the surface water drain as shown in Fig. 15.11a. This method has several disadvantages because the state of the drain is unknown, and having no cleaning access the silt will gradually build up in the rainwater pipe and drain. This build up will not be noticed until the rainwater overflows from the next joint up the wall.

The type of gully illustrated in Fig. 15.11c is designed to take surface water from yards, pavings and garage wash down areas. There are several variations some of which are fitted with a perforated sediment pan to facilitate the removal of grit and mud. The pans should be periodically emptied, but in the writer's experience this operation is seldom carried out. If there is a build up of silt or other matter, this should be noted. In

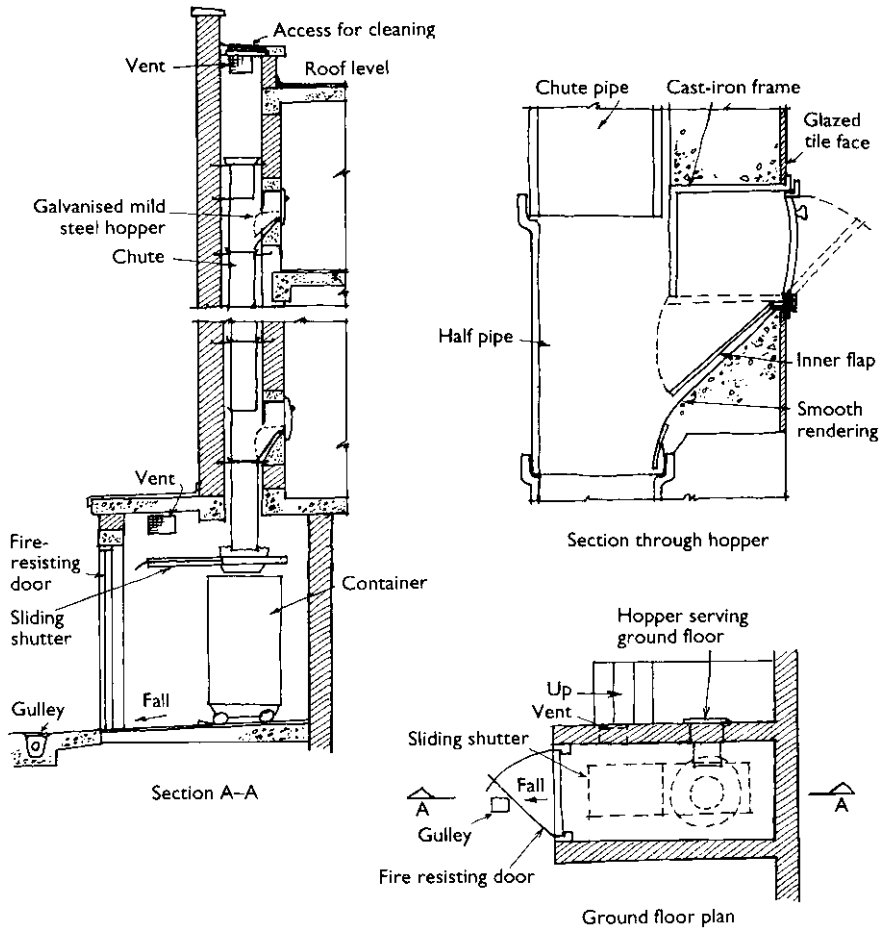
Figure 15.13 Typical refuse chute.

The problem of refuse disposal in large blocks of flats and in some commercial buildings is usually overcome by refuse chutes. Figure 15.13 shows many of the standard features of a refuse chute and storage chamber which are required by the Building Regulations. The chute consists of a vertical pipe with a minimum diameter of 457mm although some older types will be approximately 375mm. The pipes must be constructed of non-combustible impervious materials such as salt glazed ware or vitreous enamelled iron, though in modern buildings spun concrete is used. The chute runs from top to bottom of the building and has an inlet hopper on each floor. At ground floor level the chutes discharge into a wheeled container in a specially constructed chamber consisting of a brick structure with a concrete roof slab and floor fitted with a fire-resisting door. Adequate ventilation is a necessity and both chamber and chute must be ventilated as shown in Fig. 15.13.

- The chute must be ventilated at the top and so positioned as not to transmit foul air in such a manner as to become prejudicial to health.
- A hinged cover for access at the top of the chute for cleaning is desirable, as shown in Fig. 15.13.
