# BUILDING SURVEYS

**Sixth edition**

**Peter Glover**

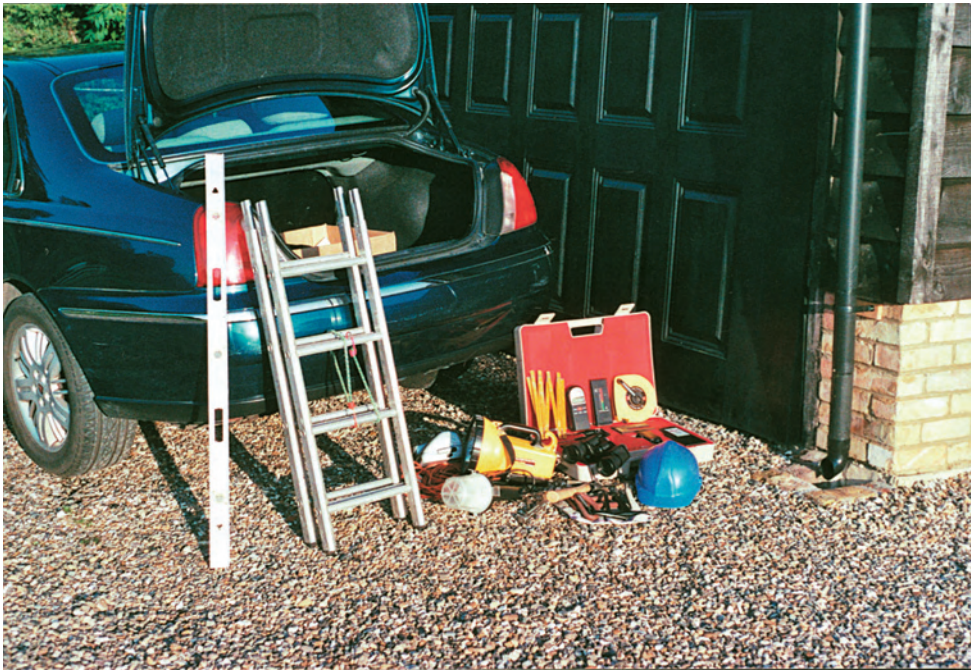
**Fig. 1.1** Equipment for a Building Survey of a simple low rise structure.

1. A4 clipboard with pro forma site notes, field sheets and checklists.
2. Folding or sectional ‘surveyors’ ladder.
3. Laser measuring device, linen and steel tapes and wooden rule.
4. Mains powered light and extension lead plus rechargeable torch.
5. Moisture meters.
6. Binoculars.
7. Spirit level and plumb line.
8. Selection of manhole keys, claw hammer and bolster.
9. Mirrors.
10. Identity documents.
11. Selection of tools including meter box keys, screwdrivers and wood probes.
12. Protective gloves and face masks.
13. Digital camera.

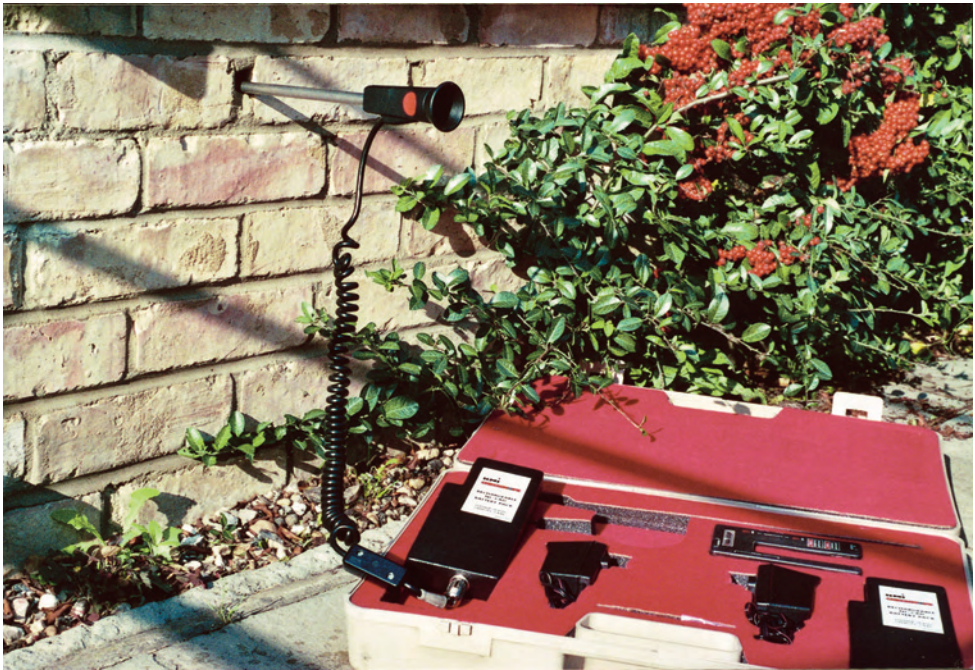
**Fig. 1.2** Borescope for inspecting inside wall cavities, sub-floor voids and other areas. The wide-angle lens provides good depth of field.

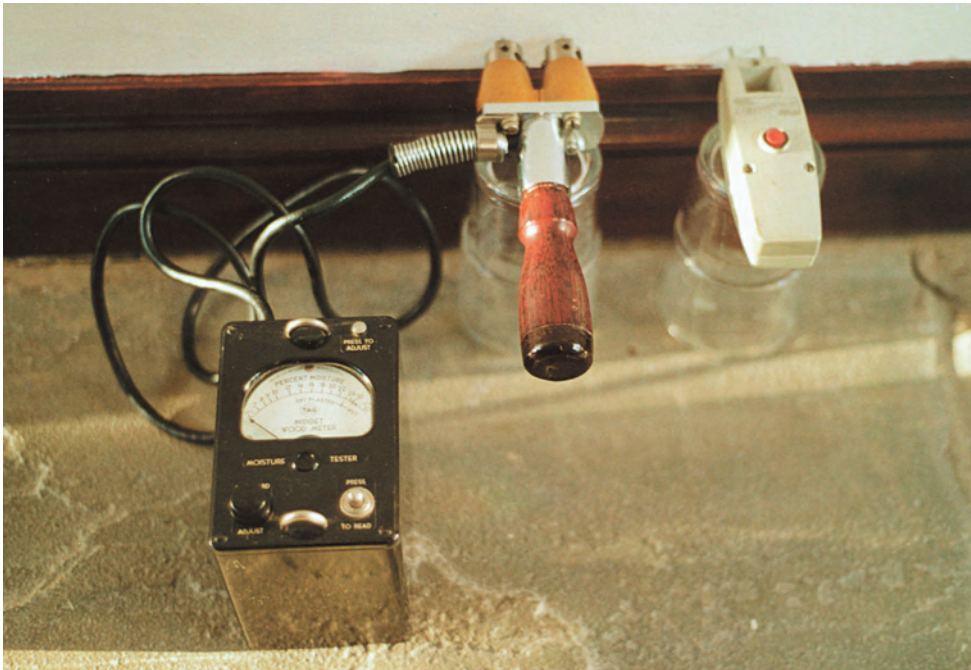
**Fig. 1.4** Moisture meters are not a new invention. On the left a Weston Moisture Meter manufactured by the Weston Electrical Instrument Corp in the USA in the 1930s. Principally designed to check moisture levels in timber but also having a scale to measure dampness in plaster. On the right an Aquatrace made in England in the 1960s – you press the red button and a flashing light indicates damp. The faster it flashes the damper the wall.

- 1.3 Environmental issues should be covered in the report but the client must decide whether a problem such as aircraft noise is acceptable or not.
- 1.4 Moisture meters are not a new invention. On the left a Weston Moisture Meter manufactured by the Weston Electrical Instrument Corp in the USA in the 1930s. Principally designed to check moisture levels in timber but also having a scale to measure dampness in plaster. On the right an Aquatrace made in England in the 1960s – you press the red button and a flashing light indicates damp. The faster it flashes the damper the wall.

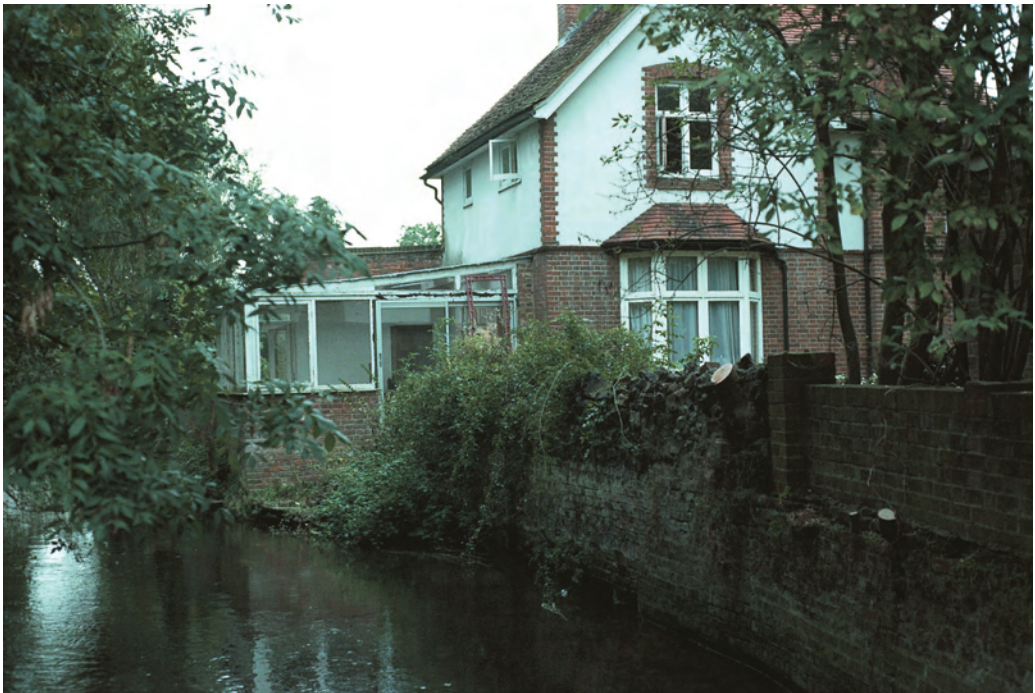
**Fig. 2.1** This house is built directly on the riverbank. Issues arising include foundations, potential riparian liabilities and flood risk.

- 2.1 This house is built directly on the riverbank. Issues arising include foundations, potential riparian liabilities and flood risk.
- 2.2 The huge oak tree almost touches the garage wing to this house and there are a pylon and overhead power lines close by, both matters to be reflected in the report.

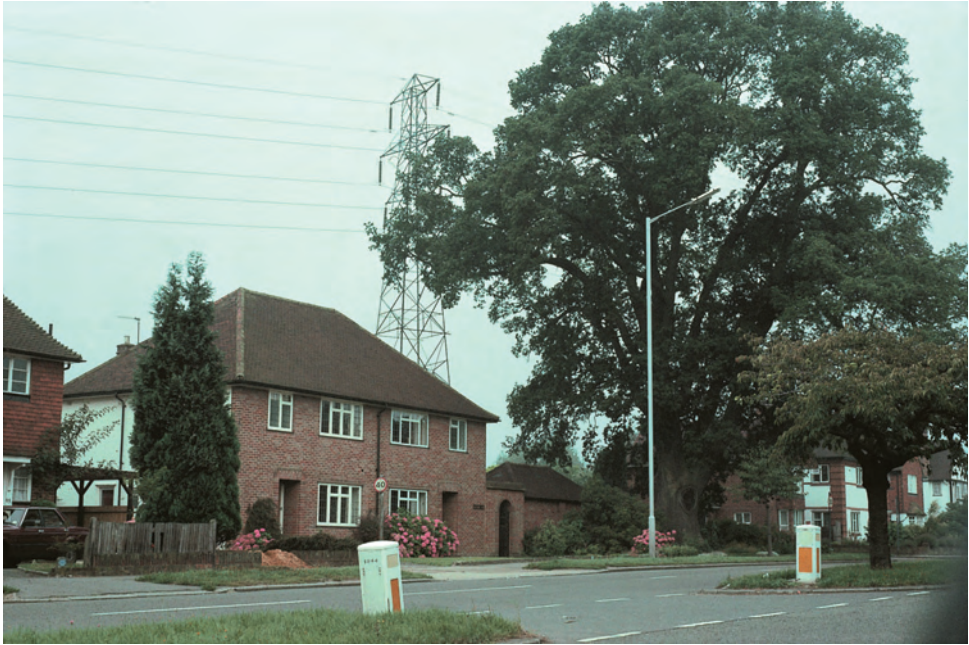
**Fig. 2.2** The huge oak tree almost touches the garage wing to this house and there are a pylon and overhead power lines close by, both matters to be reflected in the report.

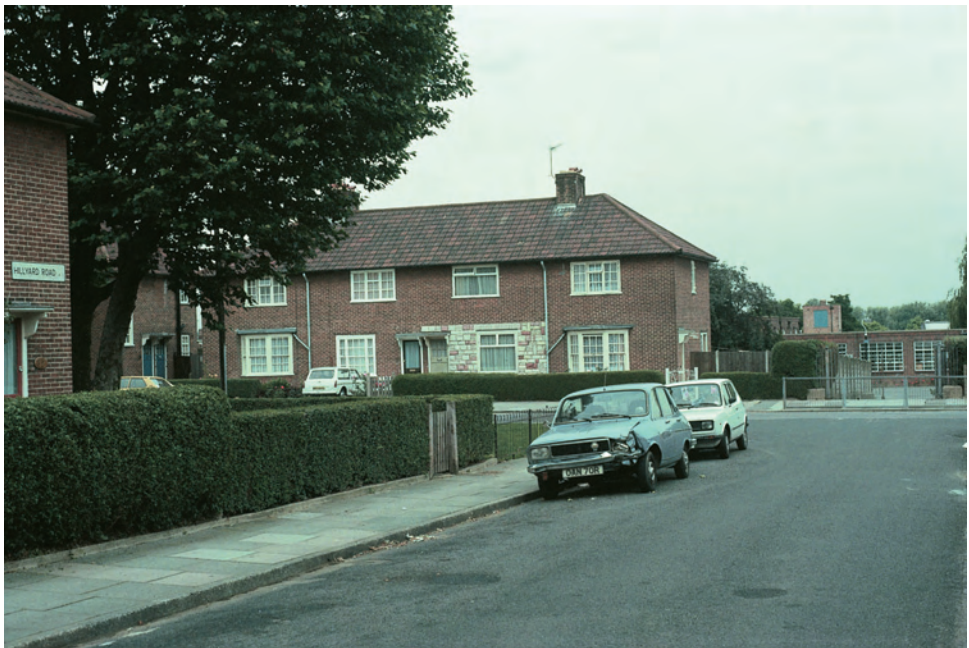
**Fig. 2.3** Artificial stone cladding generally reduces the value of the property to which it is applied, and in this case by cladding only at ground floor level the owner has left a ledge for driving rain to penetrate behind the cladding resulting in a damp problem inside.

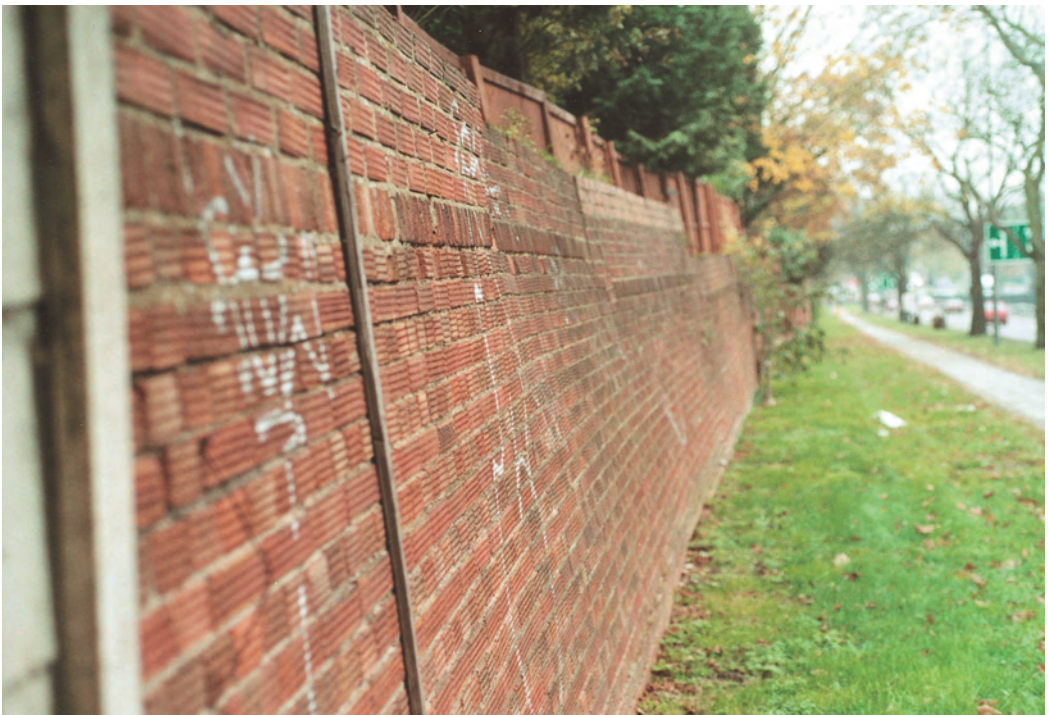
**Fig. 2.4** If leaning boundary walls have to be rebuilt this can be very expensive.

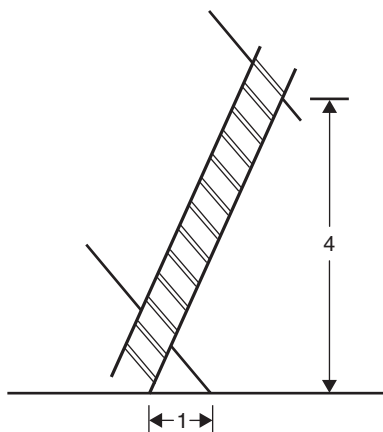
**Fig. 2.5** During the survey any ladders used must be properly angled and grounded. A 4 to 1 ratio of height to distance is best. Steeper and the user may topple backwards; shallower and the ladder may slide from beneath.

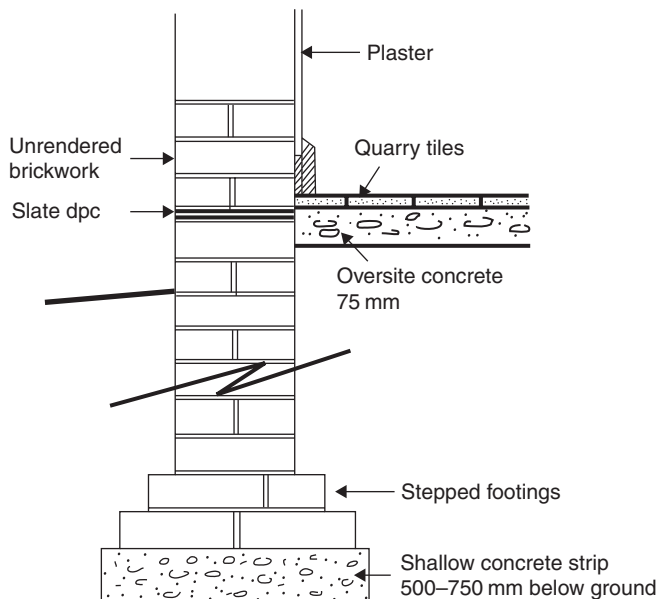
**Fig. 3.1** Late Victorian foundation, circa 1900.

- 3.1 Late Victorian foundation, circa 1900.
- 3.2 Typical 1930 domestic foundation.
- 3.3 Modern short-bored pile foundation for domestic and other buildings. Common 1990 foundation.

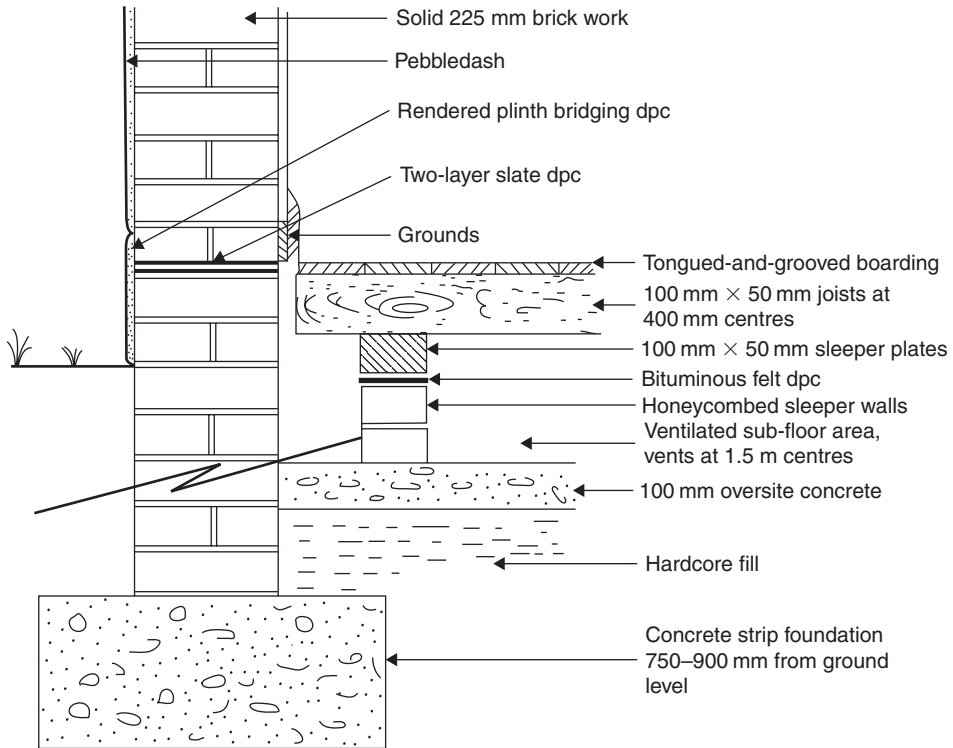
**Fig. 3.2** Typical 1930 domestic foundation.

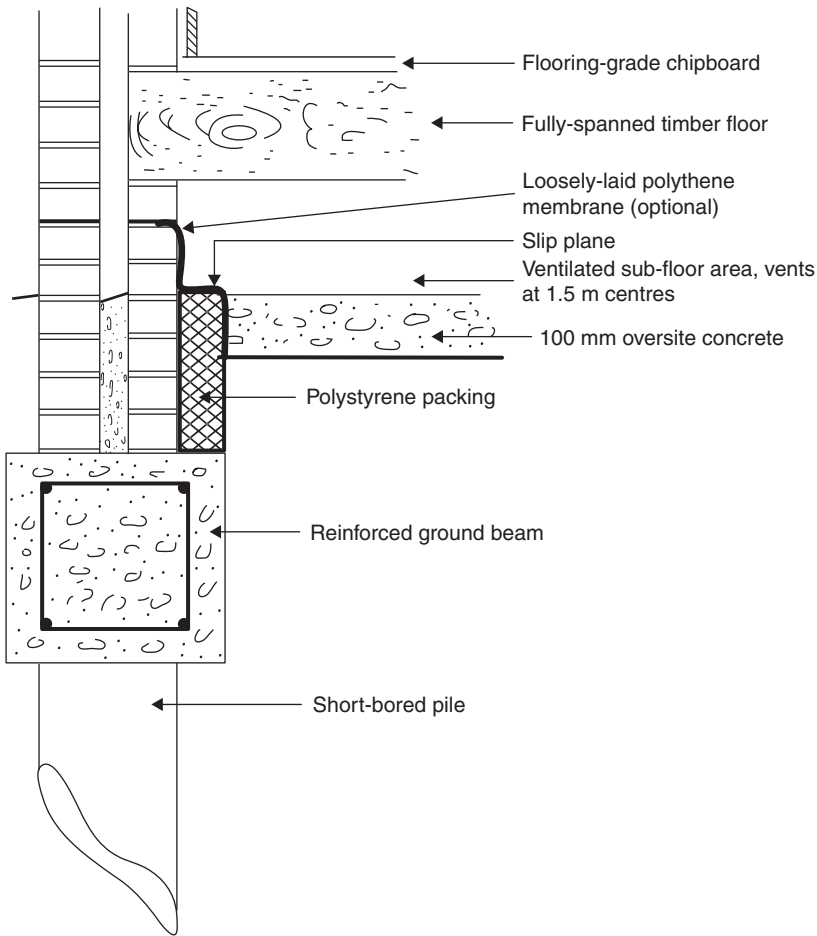
**Fig. 3.3** Modern short-bored pile foundation for domestic and other buildings. Common 1990 foundation.

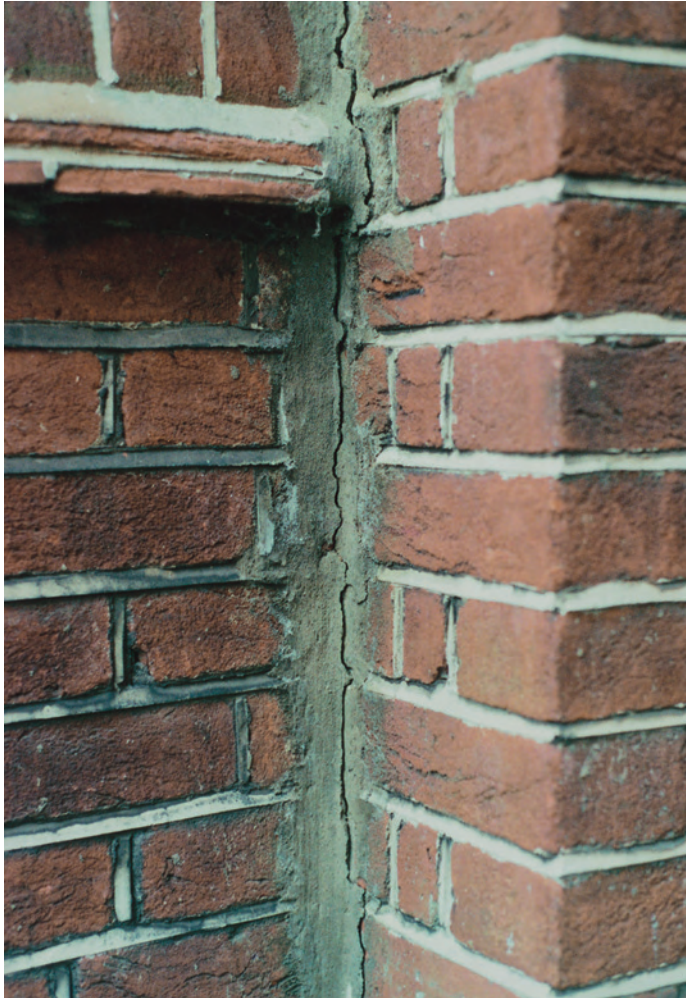
**Fig. 3.4** This settlement fracture has been poorly repaired and opened up again indicating continuing movement.

- 3.4 This settlement fracture has been poorly repaired and opened up again indicating continuing movement.
- 3.5 A bulge fracture due to compression not related to foundations.

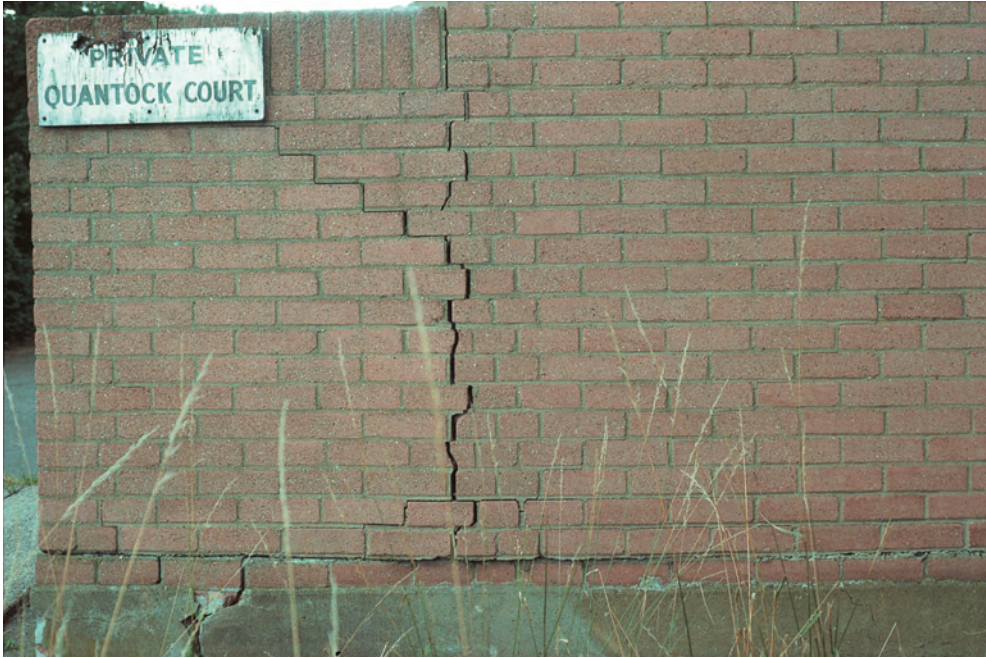
**Fig. 3.5** A bulge fracture due to compression not related to foundations.

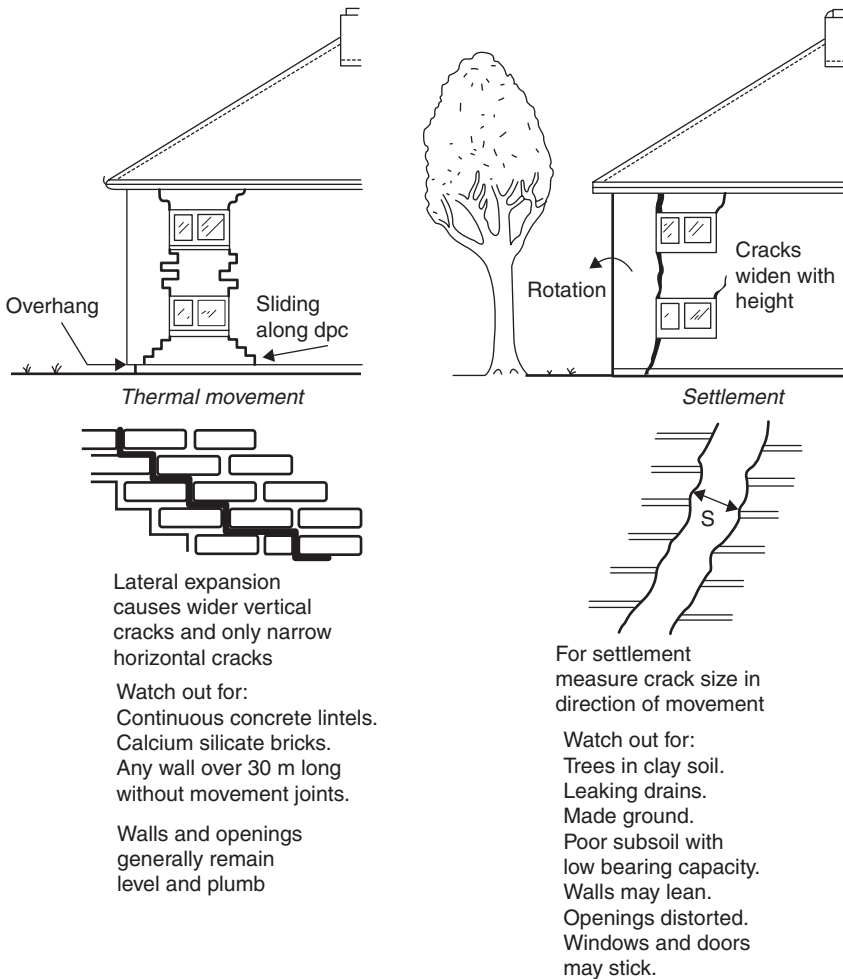
Fig. 3.6 Assessing crack damage – 1.

**Category 3** Degree: Moderate

Cracks between 5 and 15 mm wide, or a number of cracks up to 3 mm wide.

Cracks require opening up and stitch bonding by a mason, with repointing to exterior brickwork. Doors and windows sticking. Service pipes may fracture. Weather-tightness often impaired.

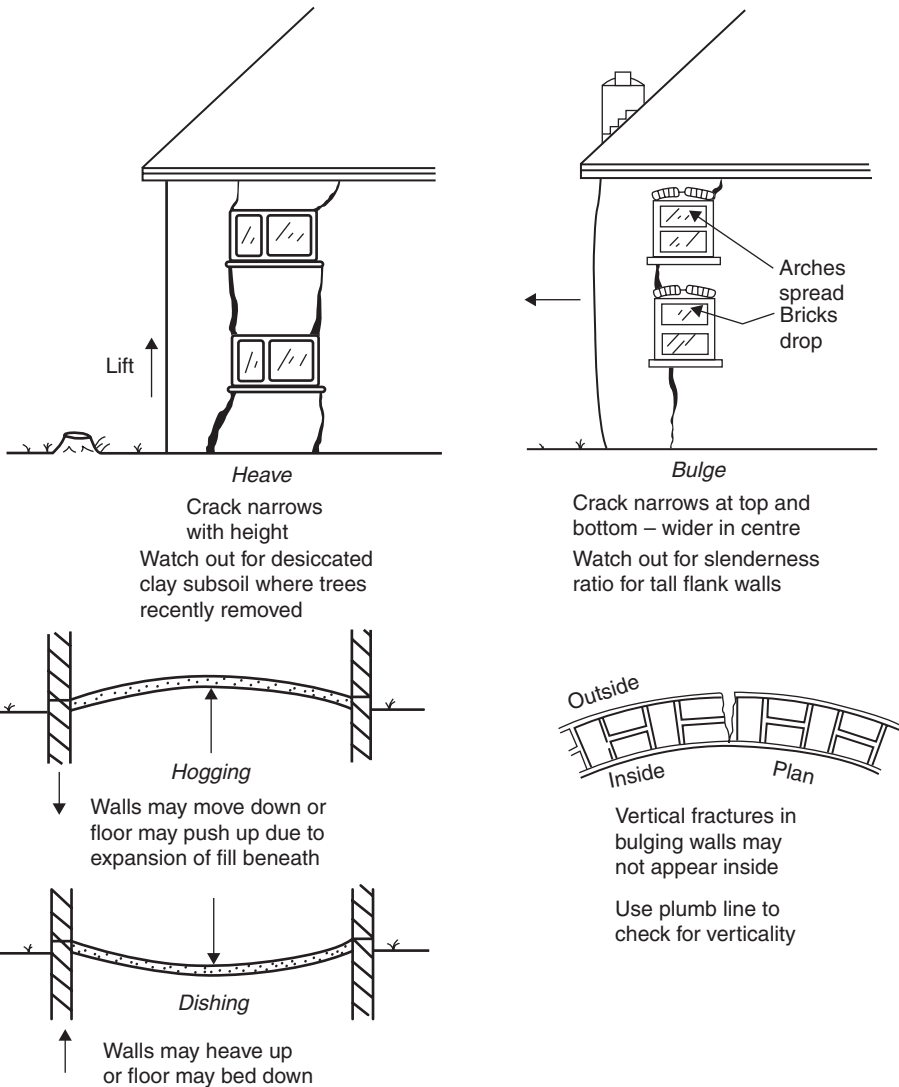
Fig. 3.7 Assessing crack damage – 2.

Damage of Categories 1 and 2 proportions would not generally of itself justify any specific remedy, and a cosmetic repair should be sufficient. Categories 1 and 2 damage in circumstances where other adverse features of the structure or site exist may, however, be a foretaste of more serious problems to come. Most major structural fractures start with a hairline crack.

Category 3 damage could require a specific remedy depending upon the circumstances. Certainly such damage would require periodic monitoring in order to confirm whether or not the structural movement is continuous and worsening.

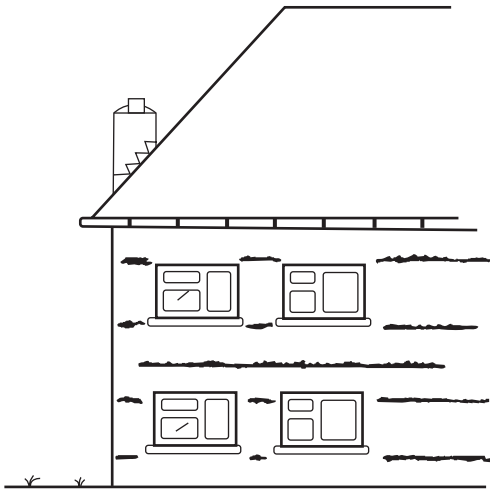
*Rusting wall ties*

Pattern of horizontal cracking to mortar joints in cavity wall. There may be bulging and separation of two skins of brickwork.

Watch out for:  
Any pre-war cavity walls.  
Black ash mortar.  
High exposure for driving rain.  
1950s Finlock gutters with leaking joints.

Cracks tend to appear every six courses, this being typical wall tie spacing.

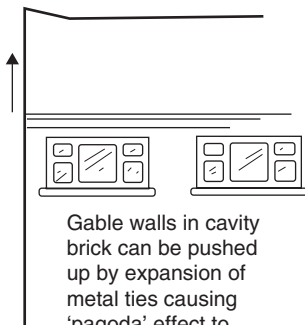
Gable walls in cavity brick can be pushed up by expansion of metal ties causing 'pagoda' effect to verge tiles.

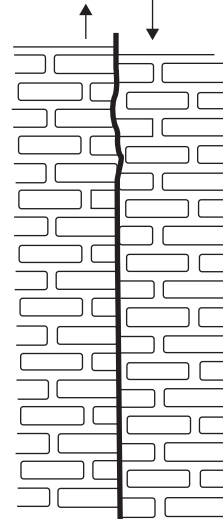
**Fig. 3.8** Assessing crack damage – 3.

*Shear failure*

Often to bonding between new and pre-existing construction.

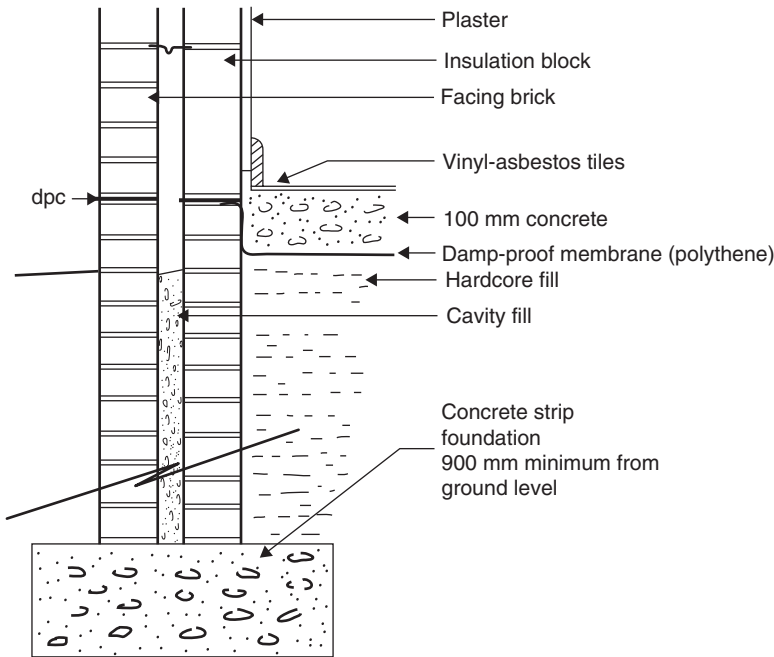
**Fig. 3.9** Typical 1970 domestic foundation.

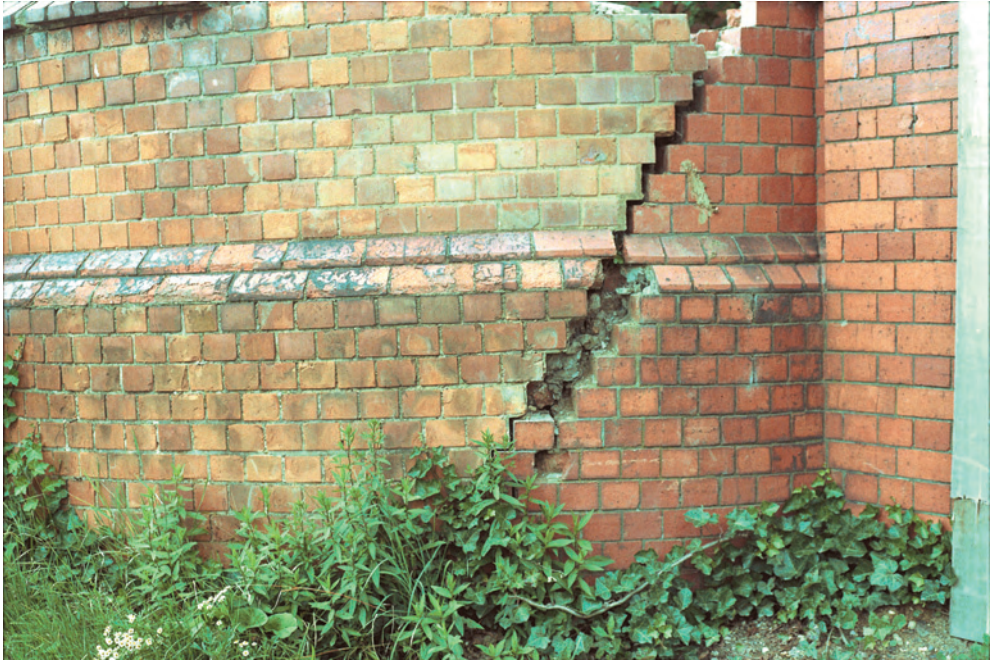
**Fig. 3.10** Settlement or subsidence. The crack widens with height.

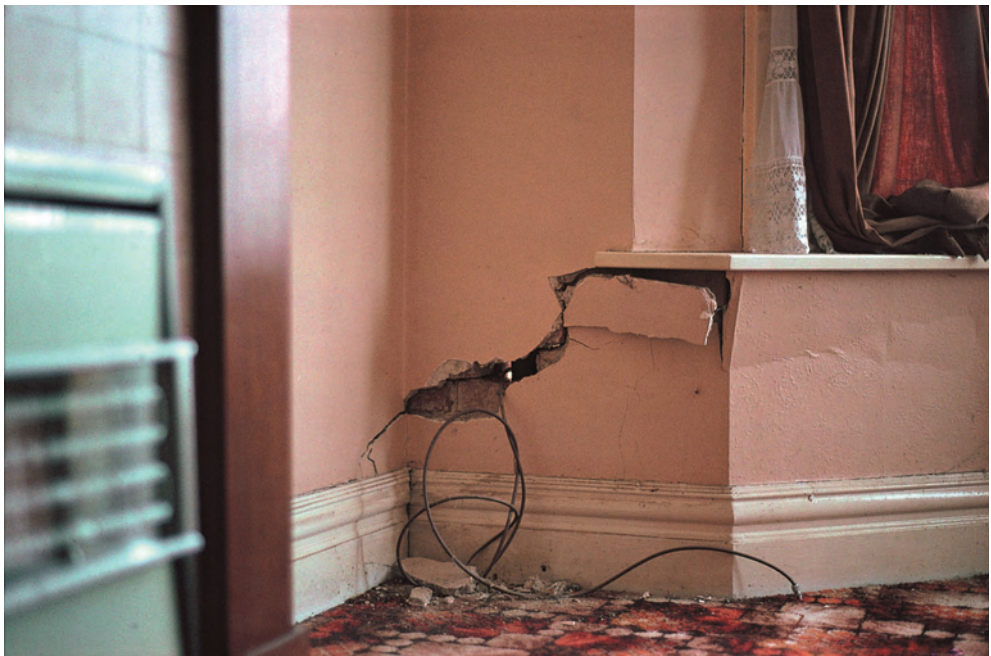
**Fig. 3.11** Subsidence damage inside house.

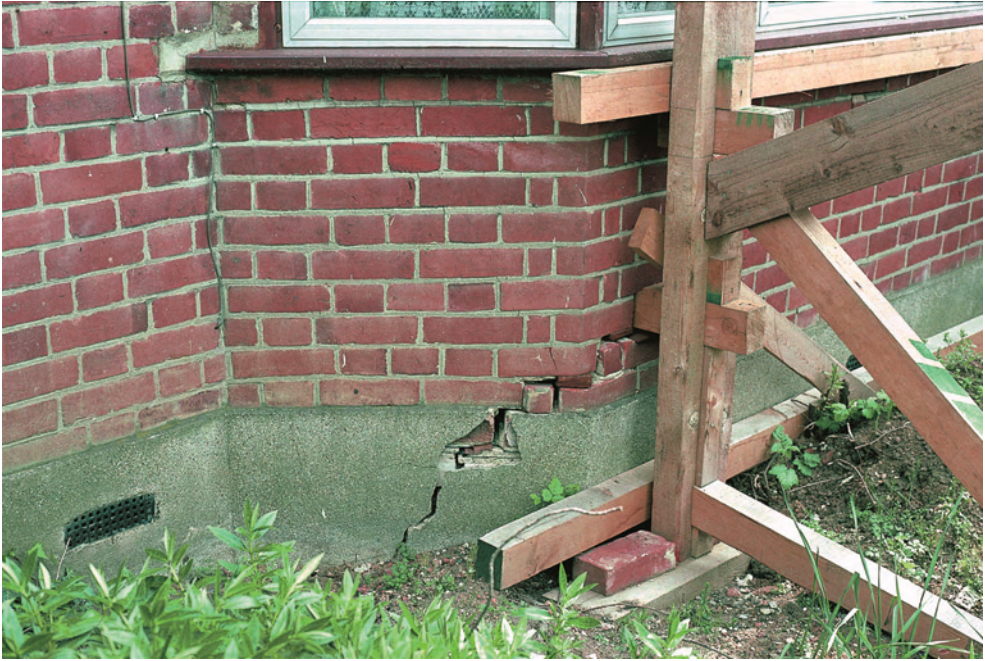
**Fig. 3.12** Subsidence damage outside house.

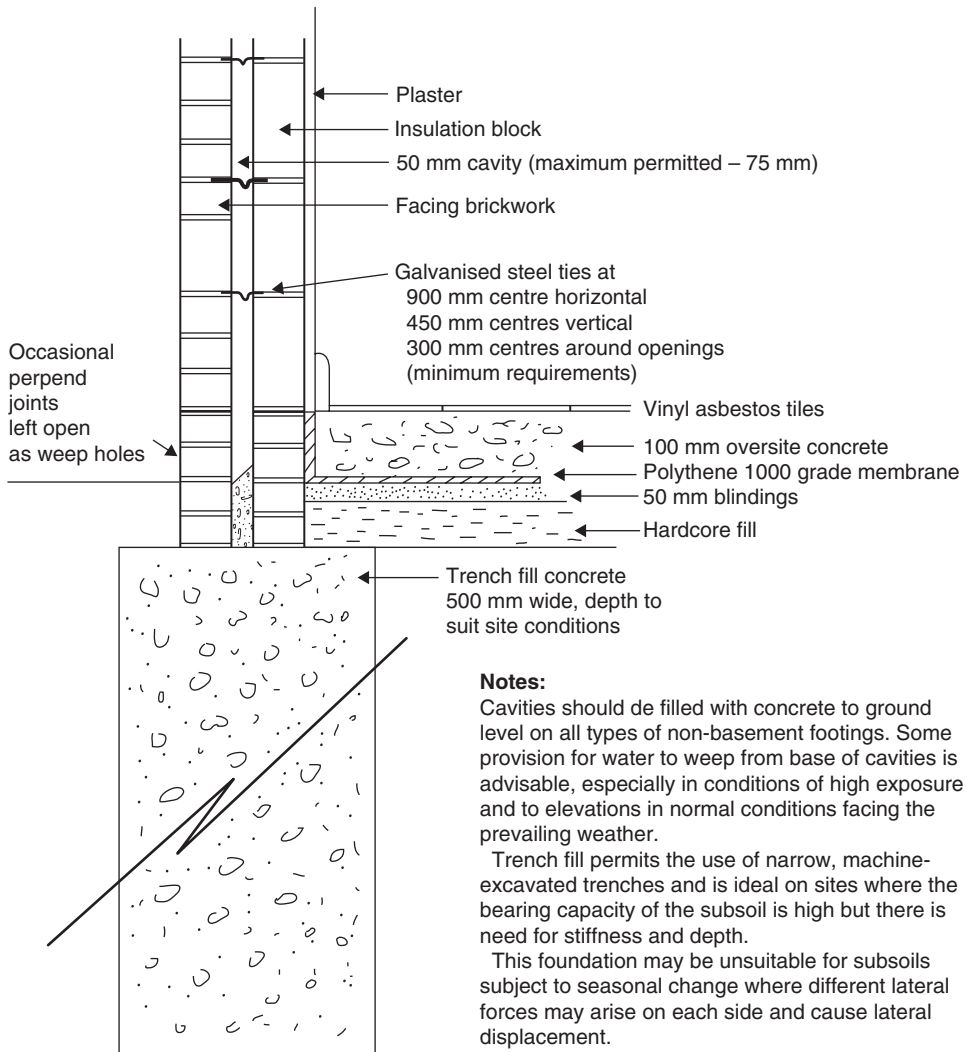
**Fig. 3.13** Modern deep strip or trench-fill foundation.

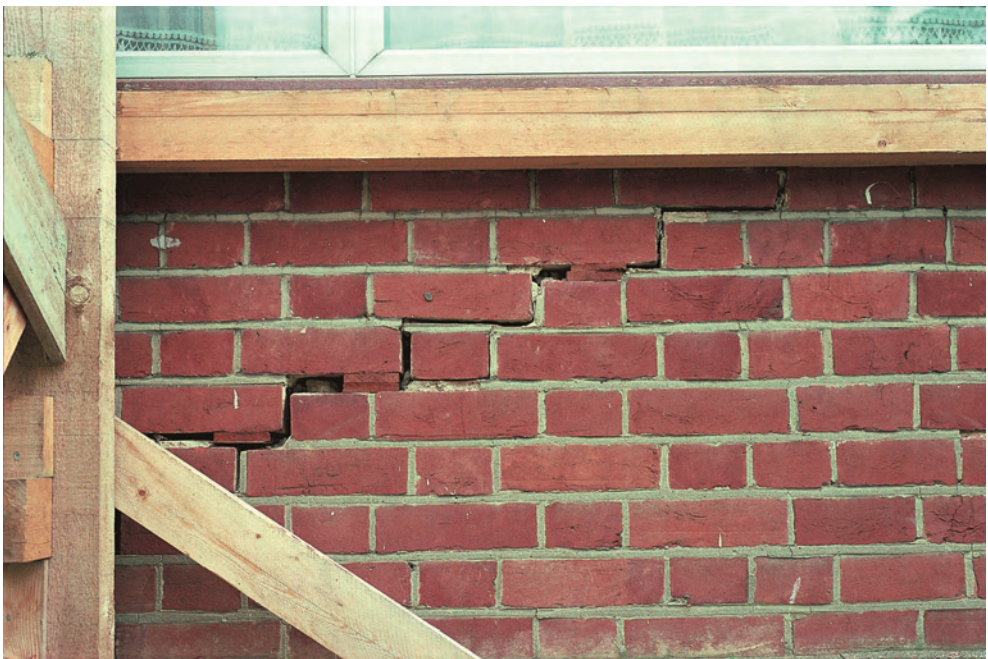
**Fig. 3.14** Subsidence has affected the lower part of this wall. As a temporary measure raking shores have been placed against the wall and hardwood wedges driven into the open bed joints to prevent further movement of the construction above.

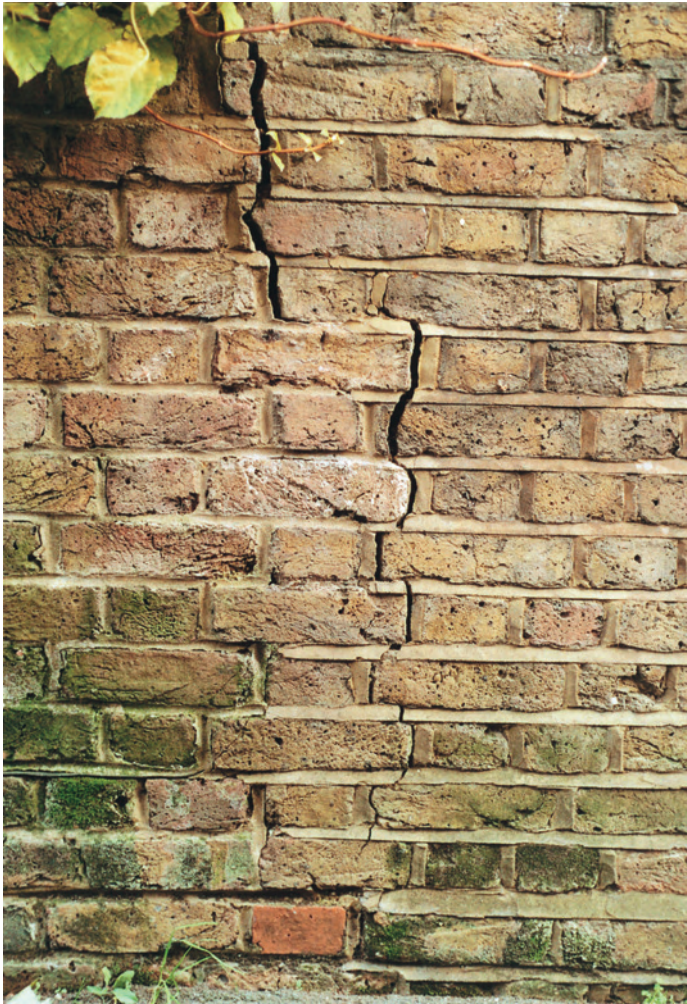
**Fig. 3.15** Settlement or subsidence again with the crack widening with height.

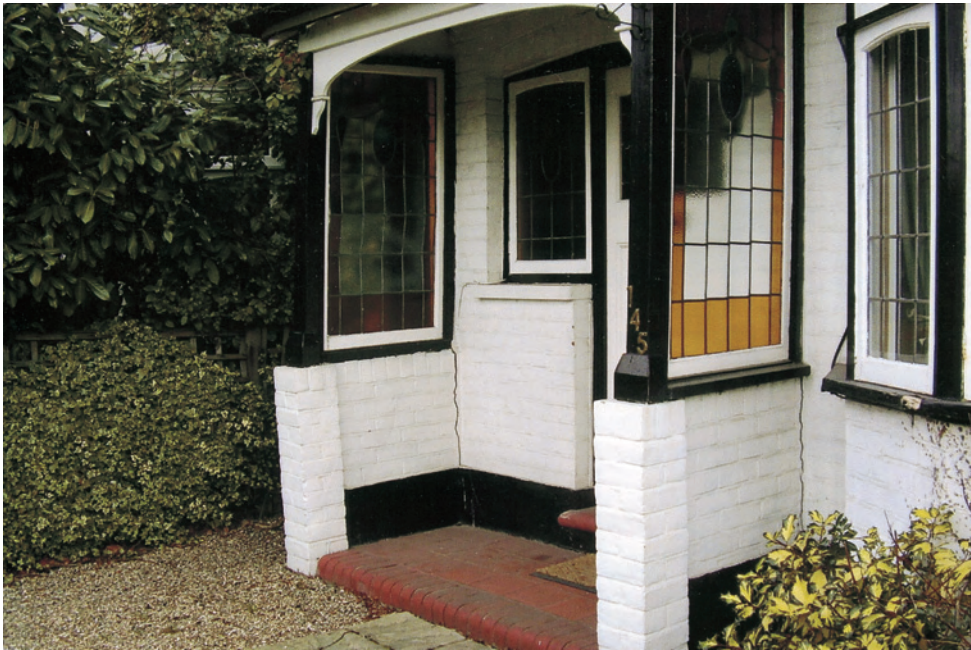
**Fig. 3.16** Builders will often use a very shallow foundation for a porch thinking that because the weight is low they do not need to excavate as deeply as for the main house; this is not so and the porch in this case will need to be rebuilt on deeper footings.

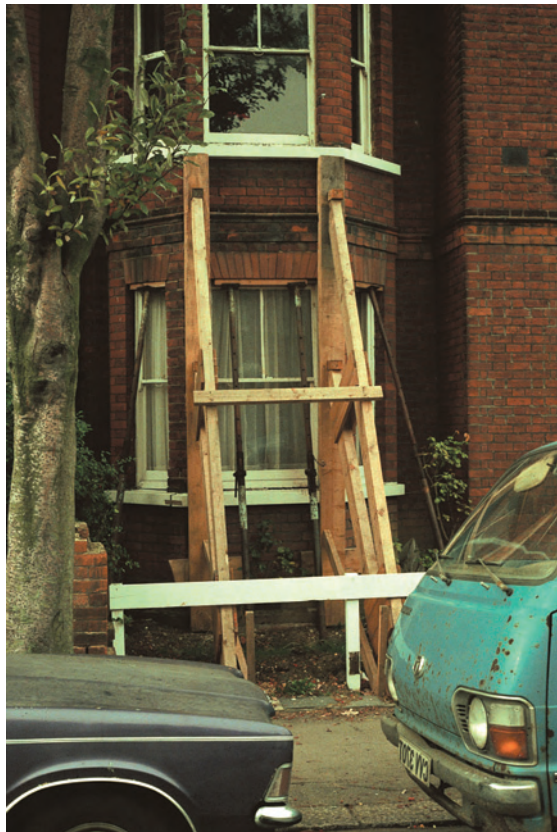
**Fig. 4.1** Raking shores used to support bay suffering from subsidence pending repair. Note the tree.

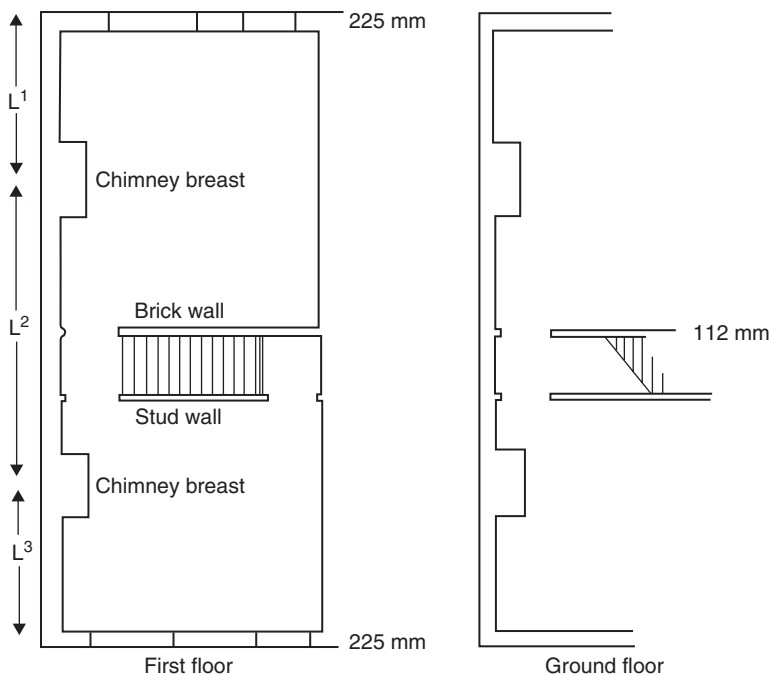
Fig. 4.2 Ground and first floor plans of end-of-terrace Victorian cottage.

Figure 4.2 shows part of an end-of-terrace Victorian cottage. Note that the brick cross-wall construction is separated from the flank wall on both levels by door openings so that little or no effective cross-wall bonding exists. The stud cross-wall is of no benefit to the stiffness of the flank wall either. The flank wall is 225-mm thick and divided into three lengths, these being 3, 5 and 3 m, respectively, this flank wall being carried up to form a gable-end with an effective height exceeding 3.6 m.

If the chimney breasts are removed a single length of 11 m of wall exceeding 3.6-m high results which should be a minimum of 300-mm thick at ground floor level. Since this is not so, the removal of the chimney breasts is not recommended; they add essential stiffness to the flank wall construction. If soft lime mortars are used, the removal of buttressing from the flank wall may still be ill-advised, even if a check by reference to Rule 7 raises no technical objection, because the SR by reference to CP 111 is excessive.

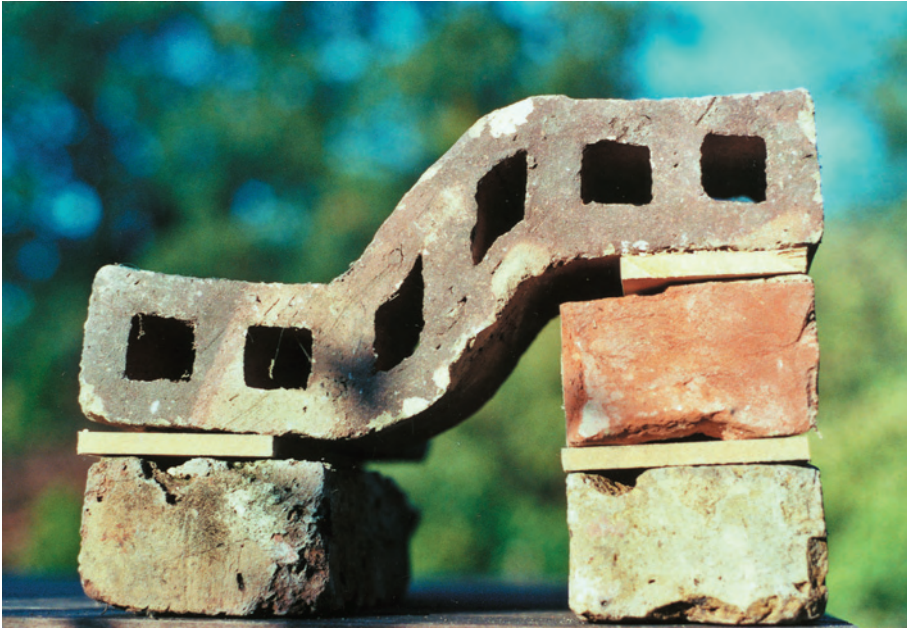
**Fig. 4.3** The Victorians used special-shaped bricks as wall ties in their cavity walls.

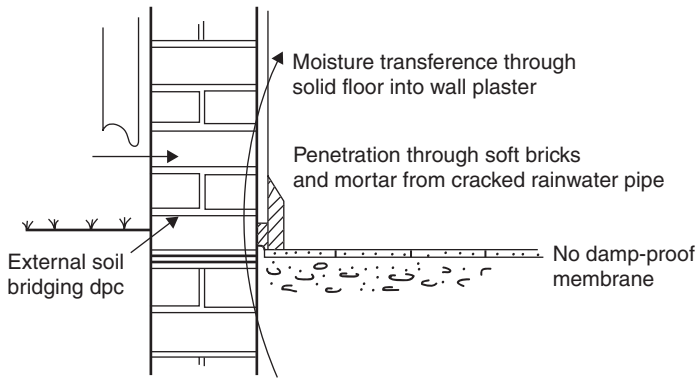
**Fig. 4.4** Bridging of slate damp-proof course in unrendered, solid brick wall.

Figure 4.4 shows a sketch section through an unrendered solid brick wall of a type commonly encountered in Victorian and Edwardian construction having a solid internal floor covered with quarry tiles and no effective damp-proof membrane. A risk of damp penetration through the wall and dampness rising by capillary action via bridging arises with this type of construction. Wet- or dry-rot to grounds and skirting boards in such a location is likely if dampness is present. Simple remedies such as dealing with defective rainwater equipment and lowering ground levels may suffice but it will not be possible to confirm whether the slate damp-proof courses are effective or not since they cannot function properly anyway until the obvious problems are dealt with. Floors may be re-surfaced with a new covering of two good coats of 'Synthaprufe' or similar bituminous coating, taking care to cut back old tiles, to expose the damp-proof courses and to finish the bituminous backing against the slates to ensure a continuous damp-proof course and membrane. Pointing and soft brickwork should also be attended to as required.

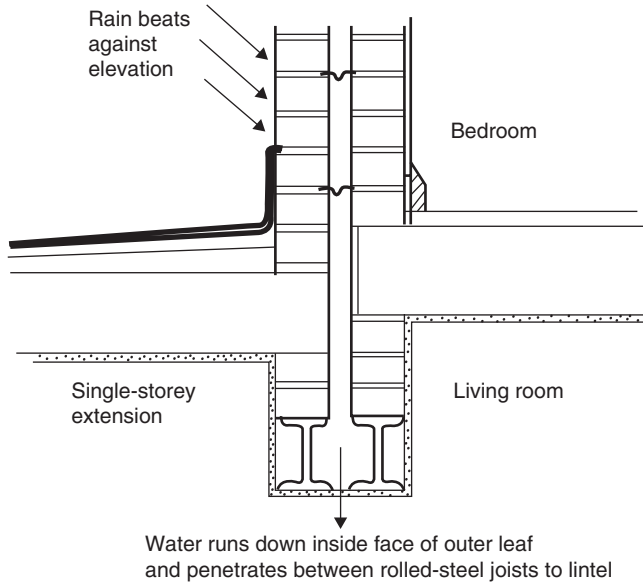
**Fig. 4.5** Lack of damp-proof cavity tray to cavity wall over opening for living-room extension.

Figure 4.5 shows a sketch section through a cavity wall where a living room has been extended and two small rolled-steel joists inserted. In such a location, especially in conditions of high exposure or normal exposure facing the prevailing weather (usually south west), a damp-proof cavity tray should be provided, lapped over the exterior roof flashing and a few open perpend or weepholes allowed for so that any water running down the inside face of the outer skin is picked up and taken to the outside over the roof line. Similar provision is required in a cavity wall where a subsidiary pitched roof joins the outer skin using a conventional flashing and where the cavity continues downwards to terminate at lintels over rooms below.

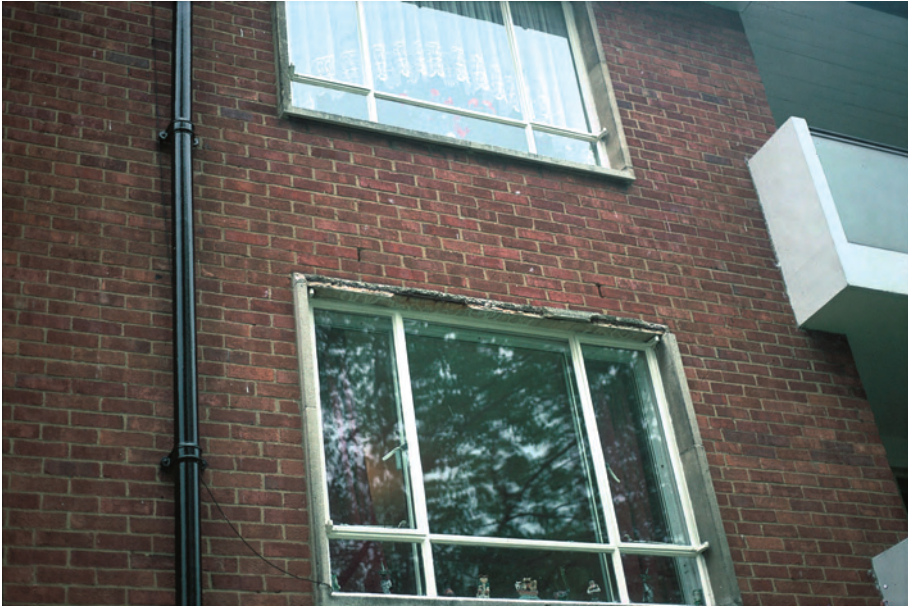
**Fig. 4.6** Inadequate cover for steel reinforcement in concrete lintel. Rust can take up to seven times the space of the steel it replaces causing bursting to the concrete surface.

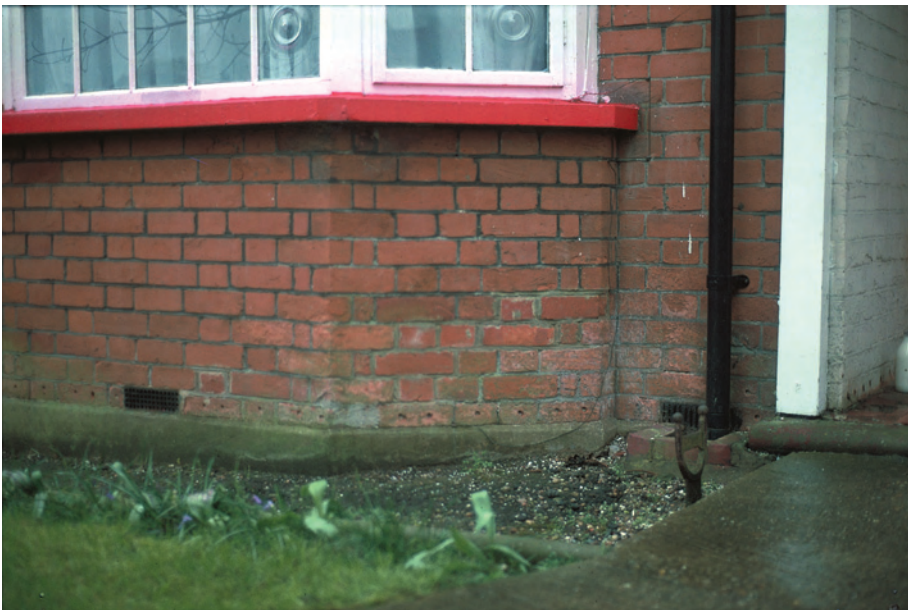
**Fig. 4.7** Drill holes at the base of the wall indicate that a chemical injection damp-proof course has been added.

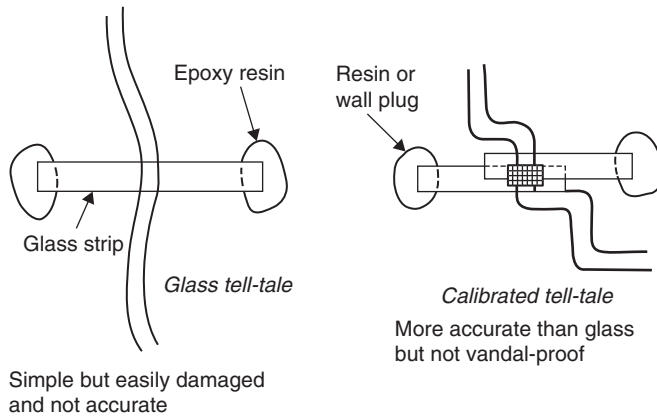
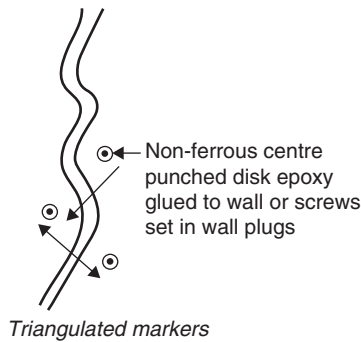
Robust, cheap and accurate.  
Use vernier calipers to check horizontal and vertical movement.

**Fig. 4.8** Crack monitoring.

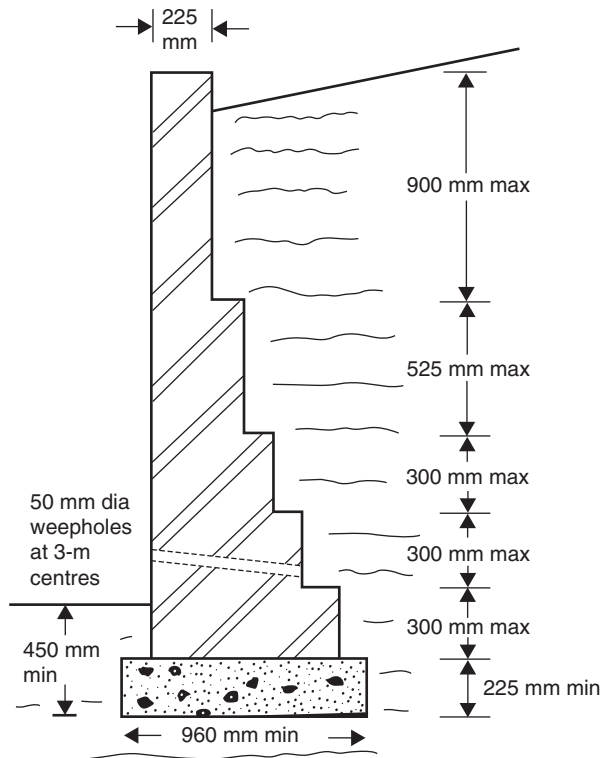
**Fig. 4.9** Typical design for all-brick retaining wall, using special-quality brickwork which does not require tanking or weathering. The wall is stepped back in half-brick increments. Backward-sloping drain-holes prevent staining down the face of the wall from very small quantities of groundwater discharging over a long period. Note that ordinary-quality brickwork requires special tanking, damp-proof courses and weathering, otherwise frost damage will result.

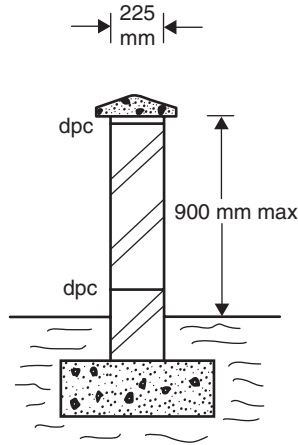
**Fig. 4.10** Freestanding wall construction. Throated weathering projecting at least 45 mm, plus damp-proof courses at top and bottom, allow ordinary-quality brickwork to be used for normal exposure conditions, but special-quality bricks are necessary for footings below damp-proof course, (dpc).
