# BUILDING SURVEYS

**Sixth edition**

**Peter Glover**

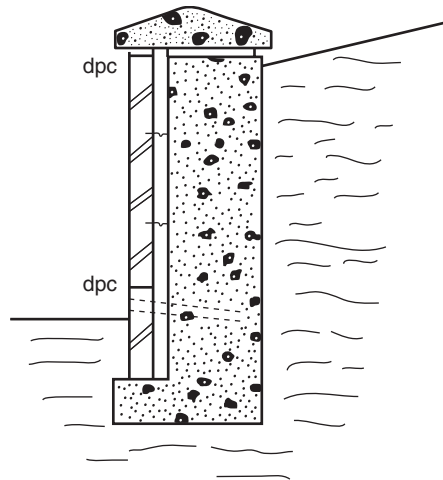
**Fig. 4.11** Mass concrete retaining wall with brick face.

behind the wall. In Figure 4.11 a cross-section of a brick retaining wall is shown. It will be noted that 225-mm brickwork should be used only for retained heights up to 900 mm, and that progressively thicker wall construction is required as the height of the wall increases. Regard should be given to the bearing pressure values of the retained ground, which may require special consideration. Figure 4.10 shows a typical freestanding wall. It should be noted that 225-mm brickwork is a minimum thickness and that piers or buttresses or, alternatively, thicker overall construction is required for heights greater than 900 mm. A check on the SR is recommended in doubtful cases, paying particular regard to the strength of the mortar, which is often poor, exterior brickwork and stonework, especially if this is old.

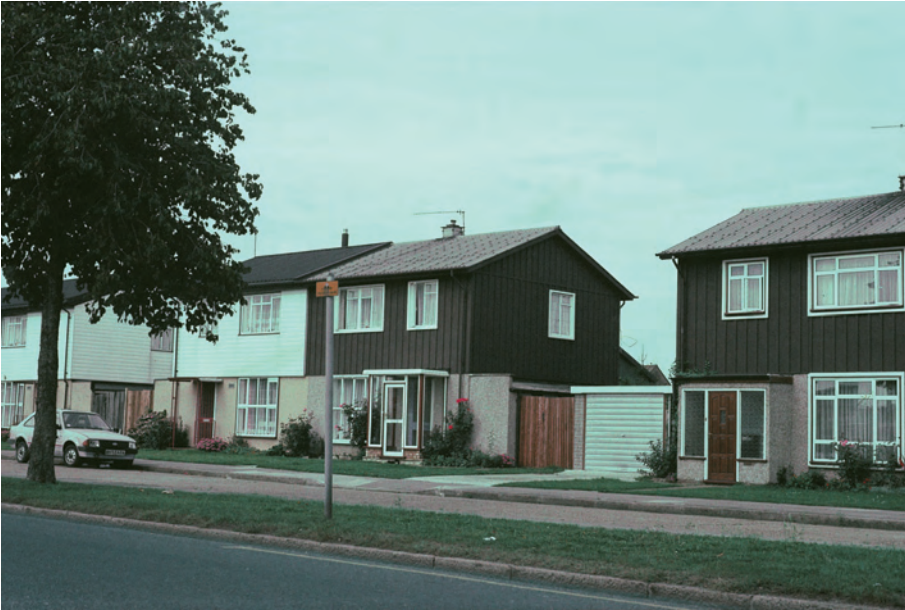
**Fig. 4.12** BISF (British Iron and Steel Federation) Houses.

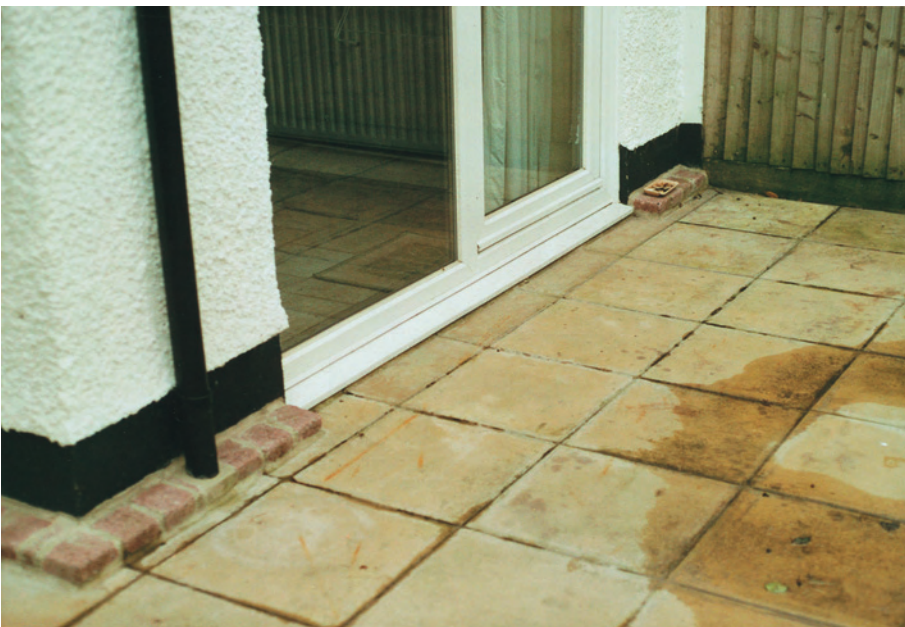
**Fig. 4.13** The paving is too high. It should be lowered to at least 150 mm (2 brick courses) below the damp-proof course or internal floor level whichever is the lower, with a slope away from the wall.

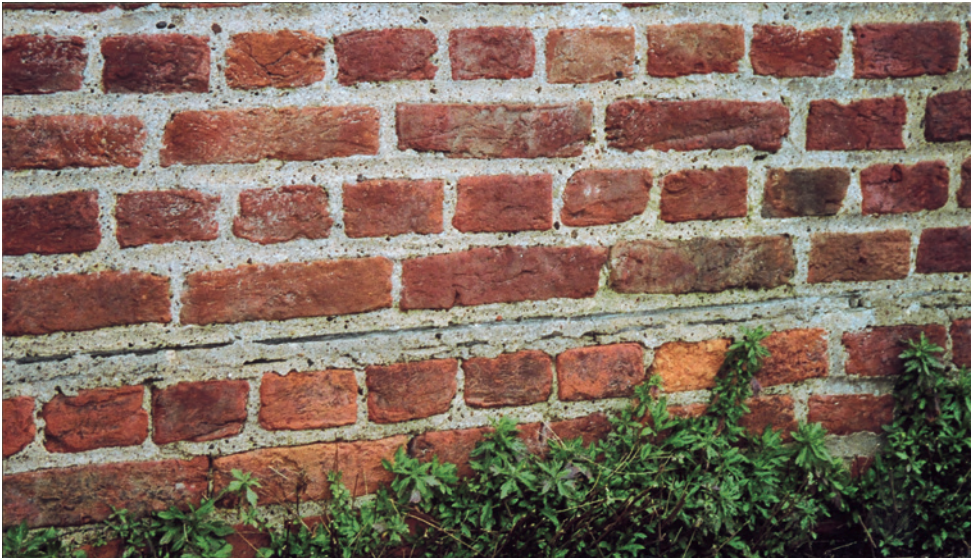
**Fig. 4.14** Hand made red facing bricks set in lime mortar to English Bond with a two-course slate damp proof course. Good ground clearance below the damp proof course.

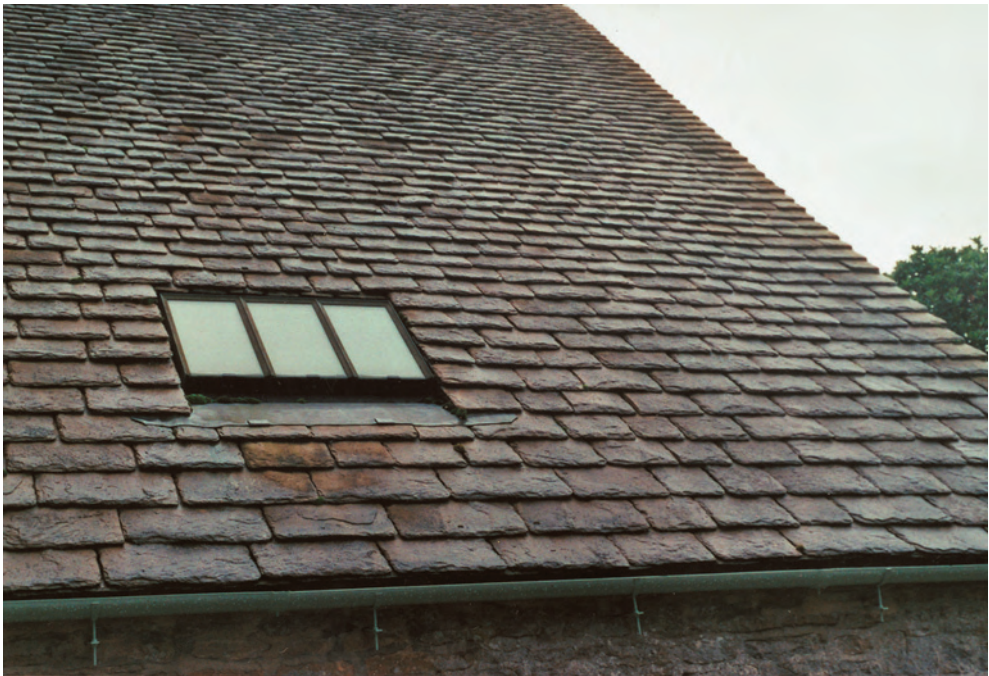
**Fig. 6.1** Cotswold stone roof with skylight and lead apron. Careful attention to detail is needed if leakage around skylights is to be avoided.

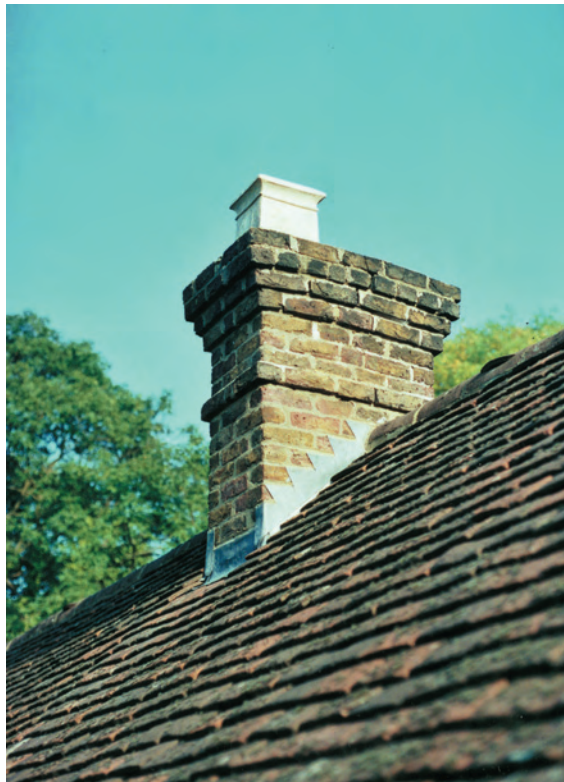
**Fig. 6.2** Traditional lead flashings are fixed by plumbers, not roofing contractors, this being part of the plumber's trade.

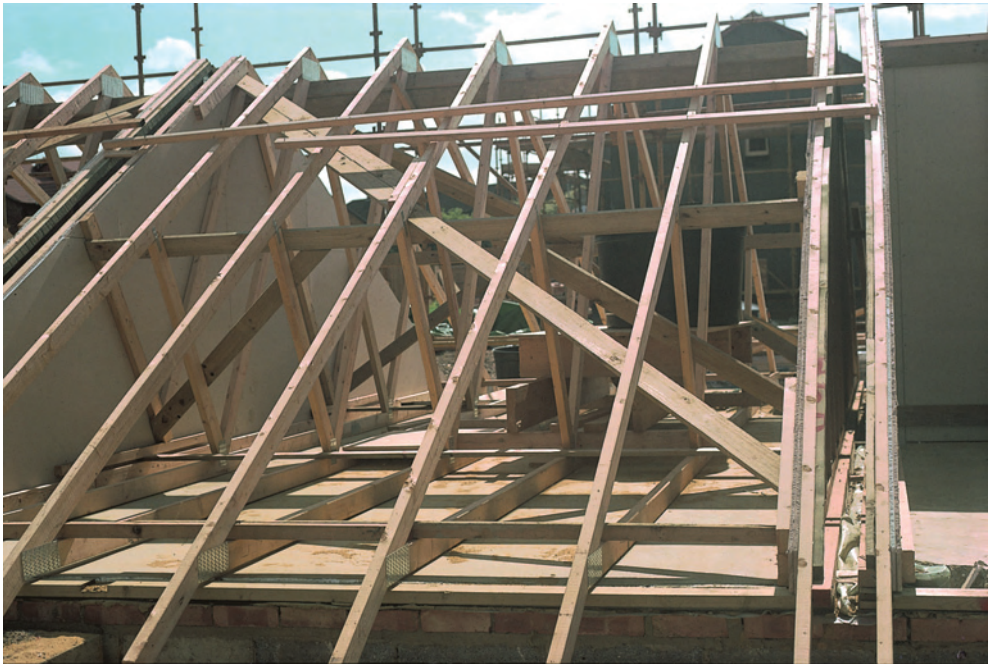
**Fig. 6.3** Modern gang-nailed trussed rafter roofs require diagonal bracing and gable-end strapping to prevent racking.

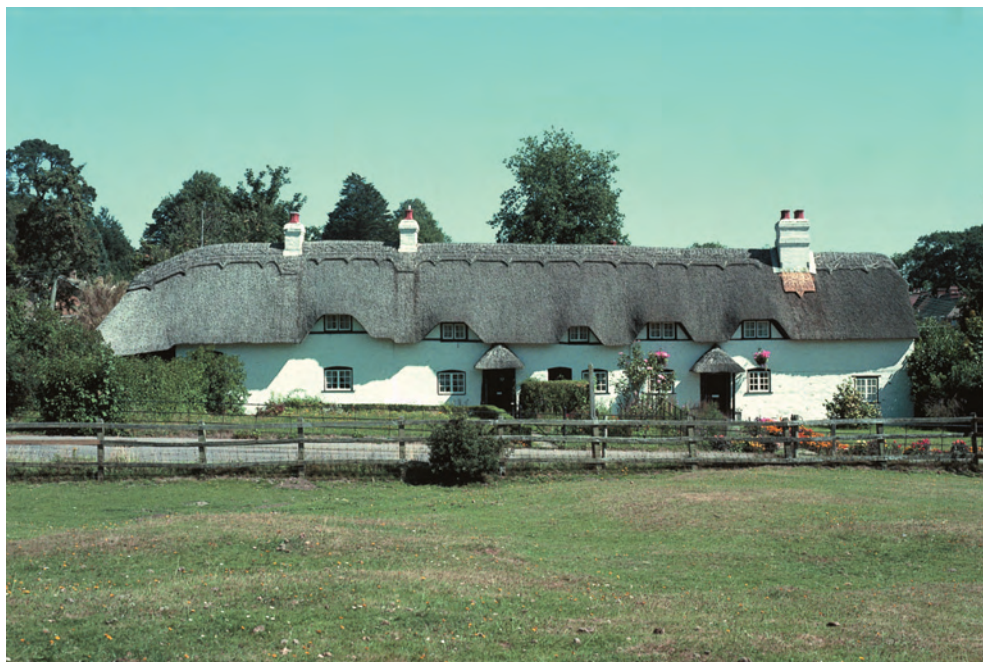
**Fig. 6.4** Hampshire thatch with eyebrow window details.

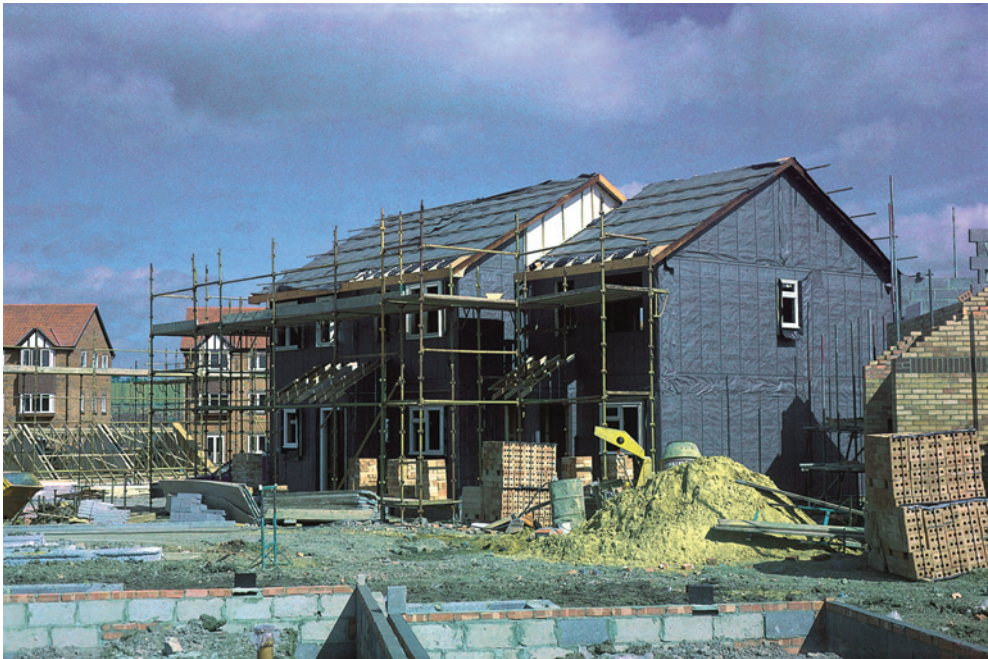
**Fig. 7.1** Timber frame house under construction in an estate. Note the breather membrane over the timber frame inner skin to the prefabricated timber frame construction.

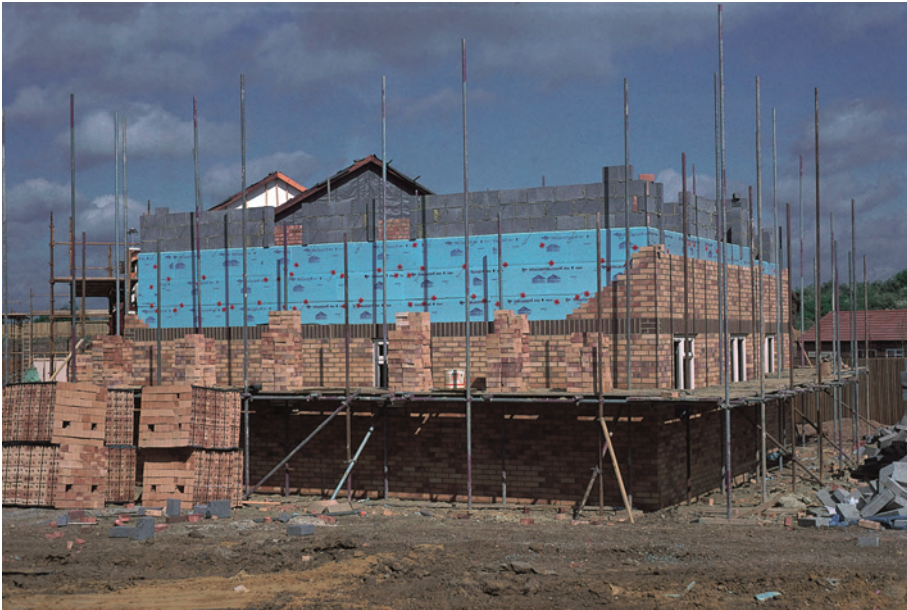
**Fig. 7.2** A traditional brick and block house under construction in the same estate as the house in Fig. 7.2.

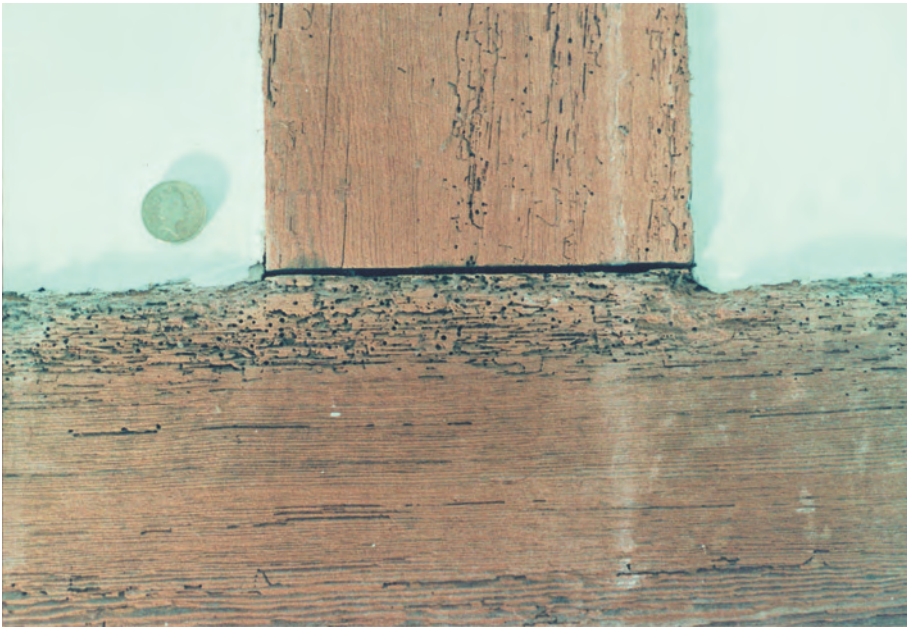
**Fig. 7.3** Flight holes of the common furniture beetle (*Anobium punctatum*) in relation to a £1 coin.

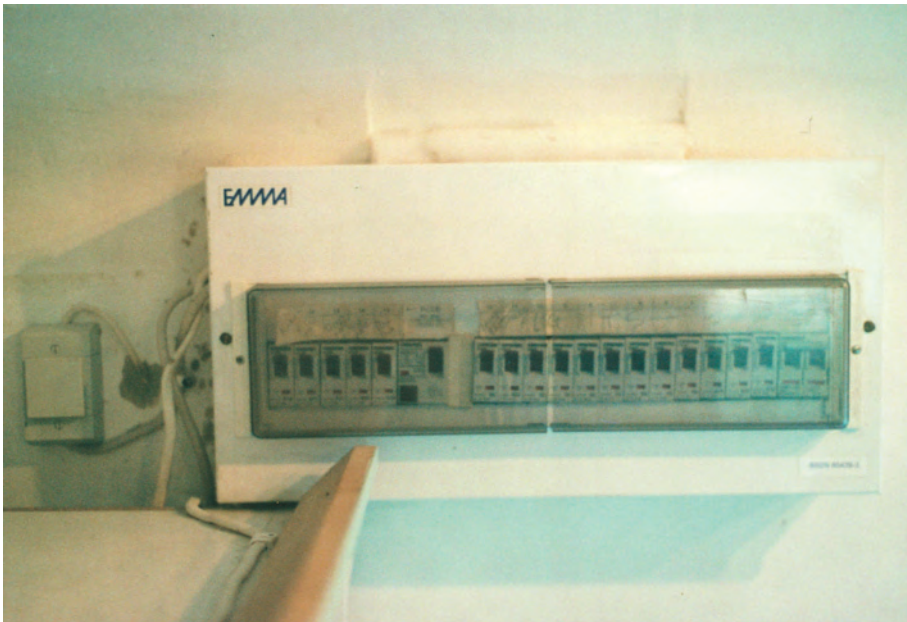
**Fig. 9.1** RCCB unit with circuit breakers and adjacent bell transformer for simple domestic system.

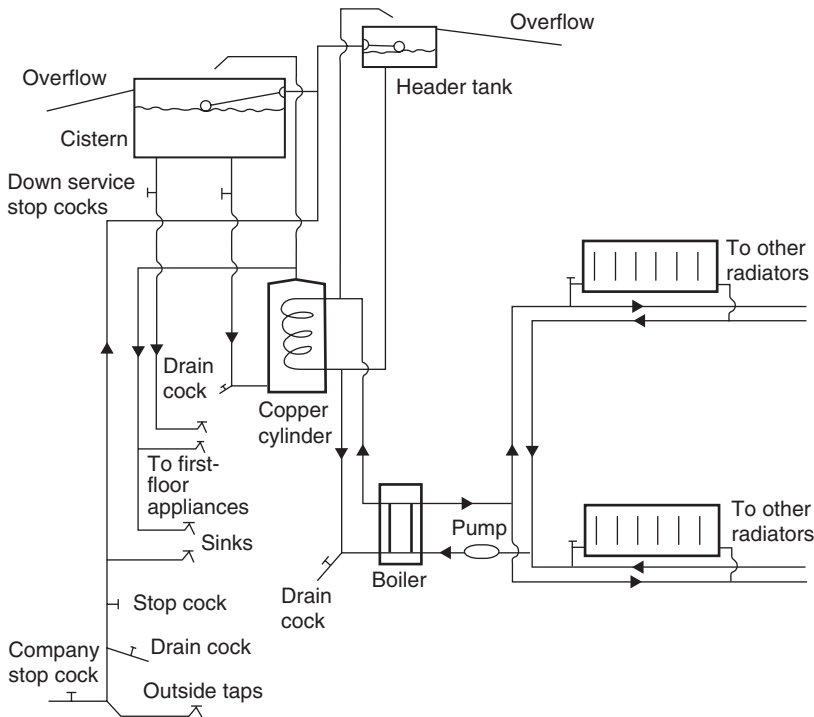
**Fig. 9.2** Diagrammatic layout of a simple domestic water and heating system using copper piping in 15-, 22- and 28-mm diameters. Indirect gravity primary circulation is provided to the cylinder. A pumped heating system is provided in small-bore, two-pipe layout to pressed-steel panel radiators.

Figure 9.2 illustrates diagrammatically the layout of a typical water- and central-heating system likely to be installed in a small residential or commercial property dating from the nineteen-sixties or nineteen-seventies. Such a system is simple with only a single pump on the heating circulation and very little to go wrong. Provided that the system is correctly installed and the radiators and pipework are protected from chemical corrosion by an inhibitor, such a system should prove reliable and serviceable for 20–30 years before major renewals or repairs are needed. Occasional servicing and attention to the boiler and pump may be expected, and a minimum of annual maintenance is recommended before each heating season.

Certain elementary principles apply in such a system. Overflows should be taken separately to the eaves and the header tank overflow should not be run into the main cistern. All expansion pipes should be of greater diameter than corresponding feed pipes and an overflow pipe diameter should be greater than that of the corresponding supply pipe. Cylinders must be indirect otherwise a mixing of circulation water and hot service water will occur. It is essential that this should not occur as the addition of fresh water into the circulation will add oxygen and cause rapid corrosion to steel radiators and fittings. This may happen

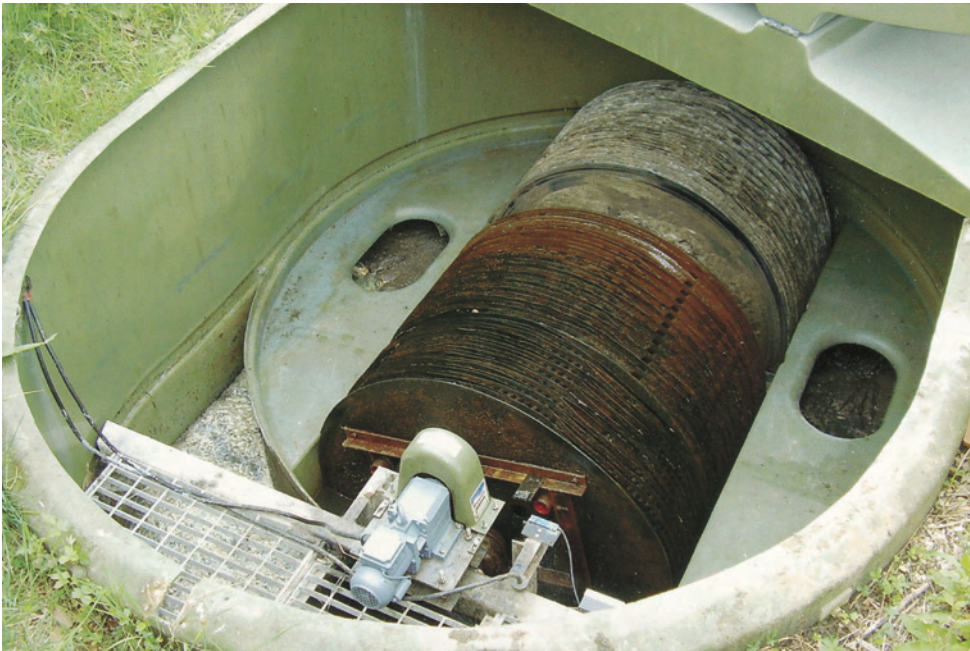
**Fig. 9.3** When mains drainage is not available a modern alternative is the Klargester Biodisk septic tank drainage system. Effluent enters the system and is rapidly broken down by bacteria with the process hastened by the electric motor and rotating disks which increase the exposure to oxygen in the air. The treated effluent emerging from the system is clear water suitable for draining into soakaways or an adjoining water course. Consent to discharge effluent is required from the Environment Agency. Periodic de-sludging is necessary.

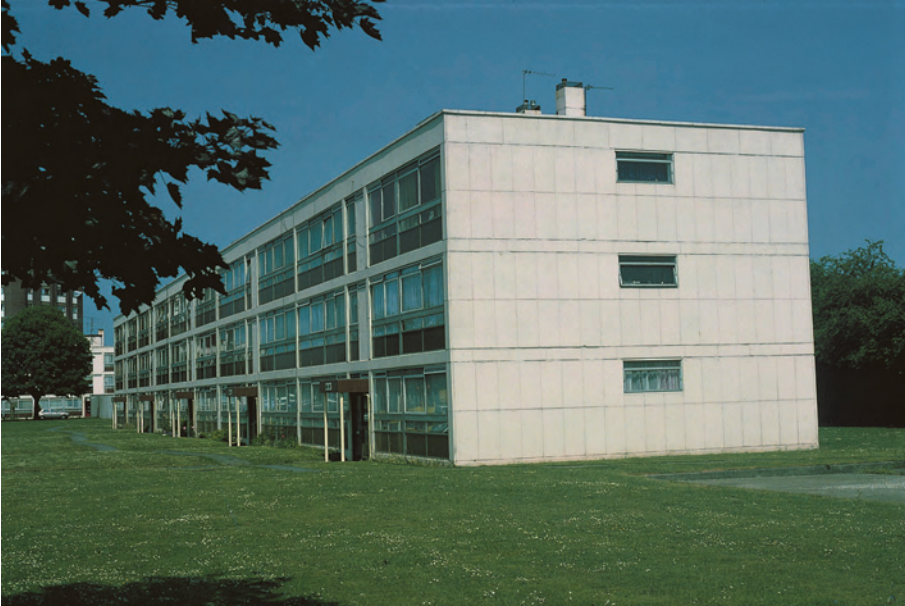
**Fig. 13.1** Flats system built in the 1960s using pre-cast concrete panel construction. This construction may be unacceptable as mortgage security for most mainstream mortgage lenders.

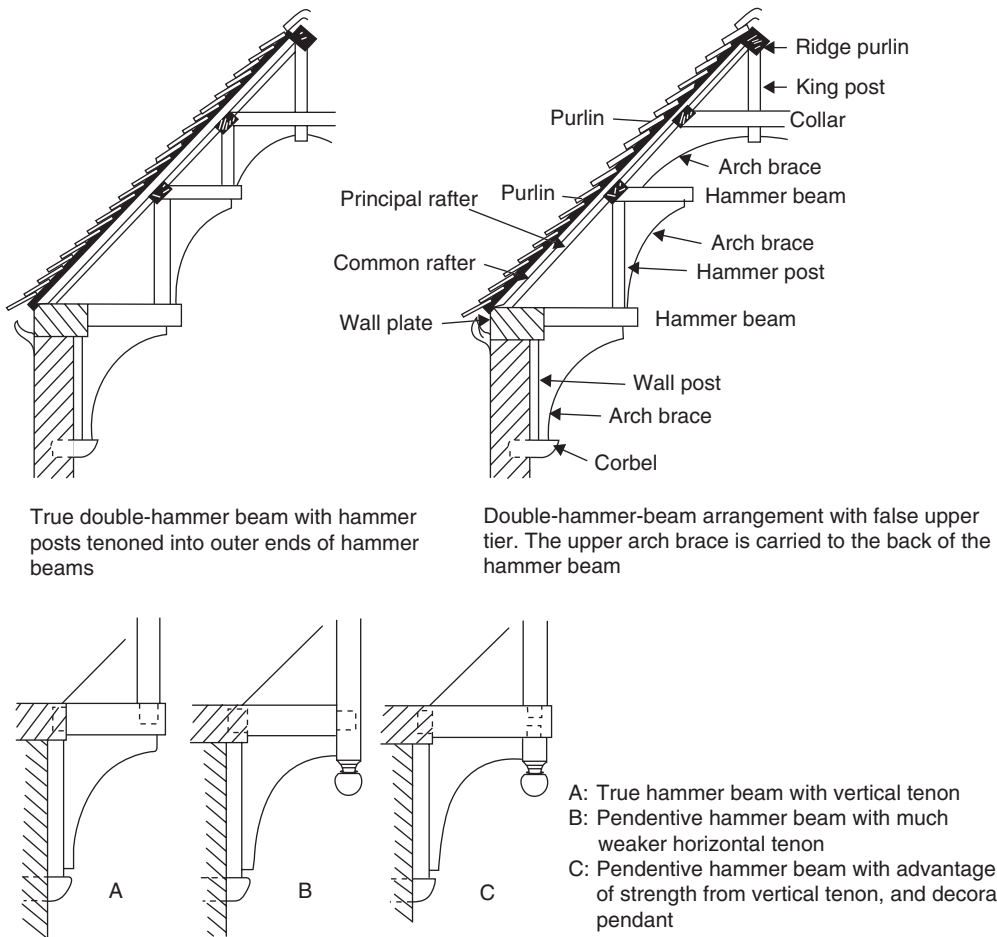
**Fig. 15.1** Typical hammer-beam construction used mainly in churches and cathedrals. Detailed knowledge of this type of construction is essential before an accurate assessment of strength may be made.

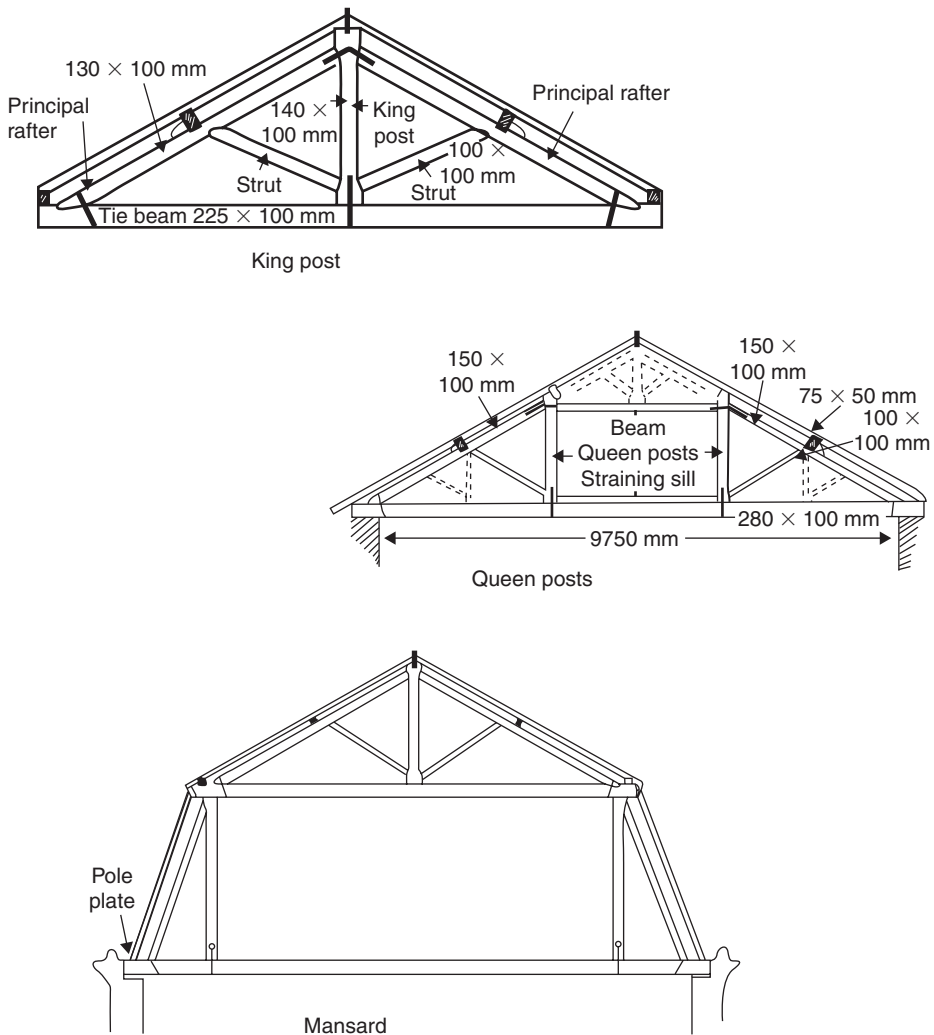
**Fig. 15.2** Early timber trusses, variations of which will be commonly encountered in older buildings.

Traditional queen post and king post roof trusses may be found in this period with roof timbers generally better than in the earlier Elizabethan and Jacobean buildings.

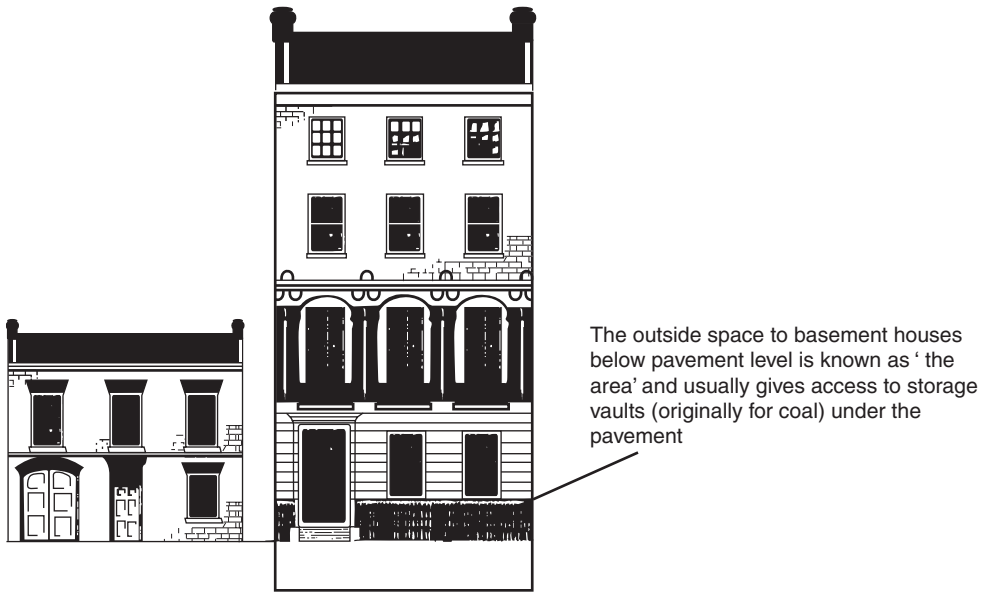
**Fig. 15.3** First Rate house and its mews.

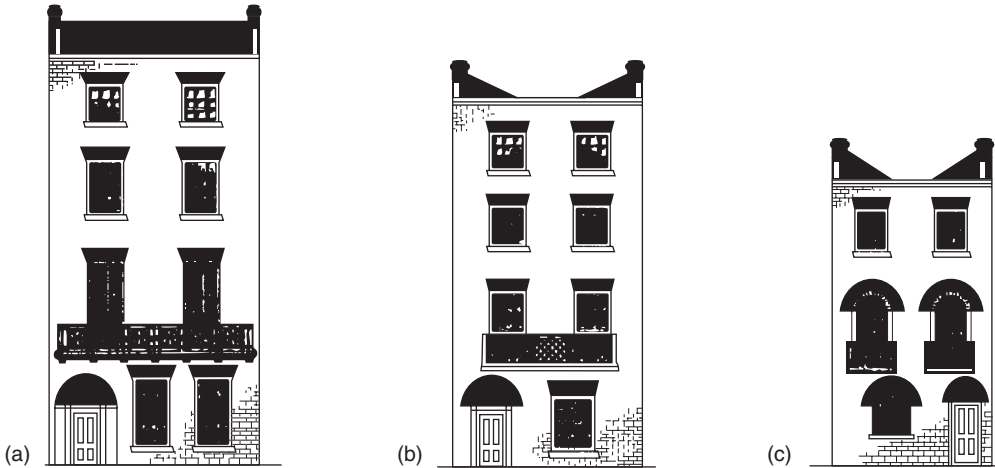
**Fig. 15.4** (a) Second Rate, (b) Third Rate and (c) Fourth Rate.

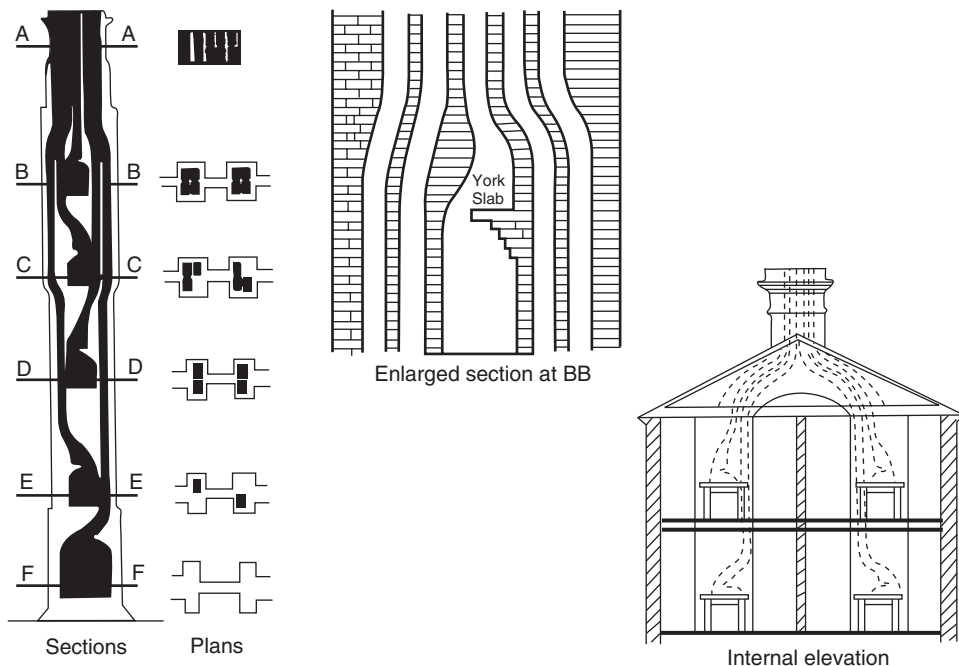
**Fig. 15.5** Nineteenth century flue construction. During inspection it is wise to count the chimney pots and trace the flues within the building. The bringing together of flues to the chimney is called 'gathering'.

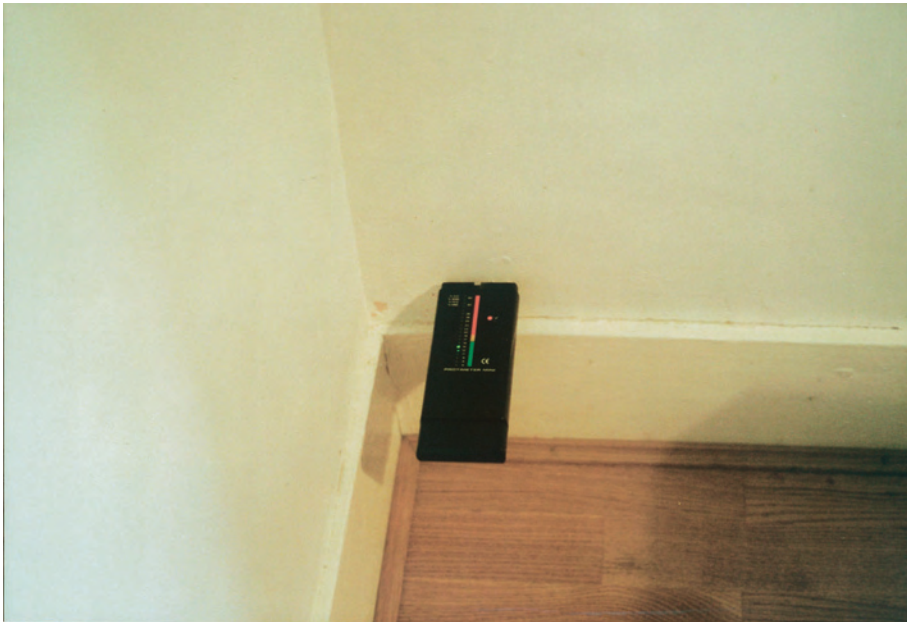
**Fig. 18.2** Testing No. 1 Suburban Road for damp. The green light on the left indicates that the wall is dry. If the light moves up into the red sector it would indicate increasing levels of moisture in the wall plaster. This would not necessarily indicate rising damp due to failure of damp-proof courses however; there are many other reasons why wall plaster could be damp.

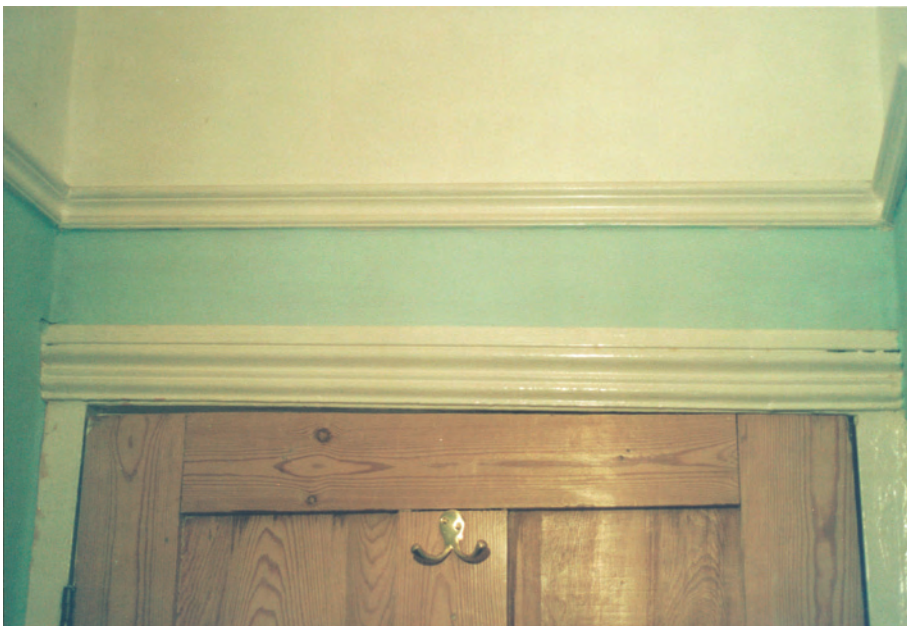
**Fig. 18.3** Sloping door head due to downward settlement of partition walls.

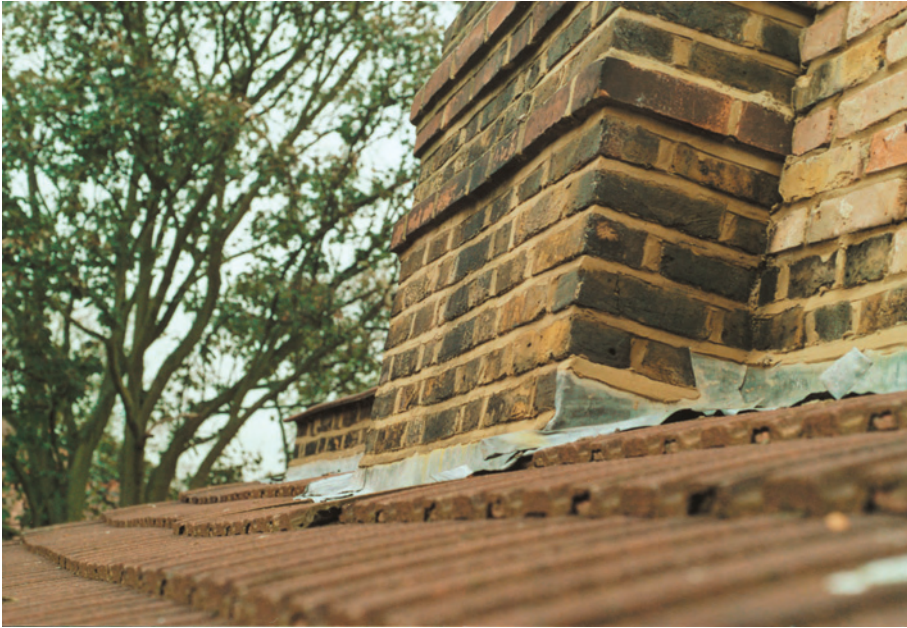
**Fig. 18.4** Loose and lifting lead flashings will allow driving rain to penetrate.

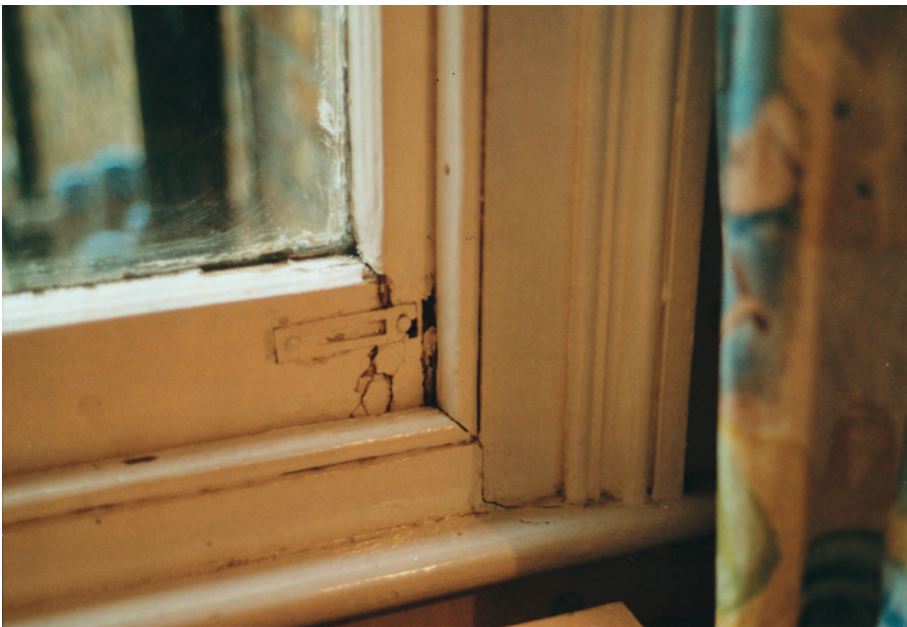
**Fig. 18.5** Significant expenditure on repairs or replacements of window frames will be needed prior to the next redecoration.

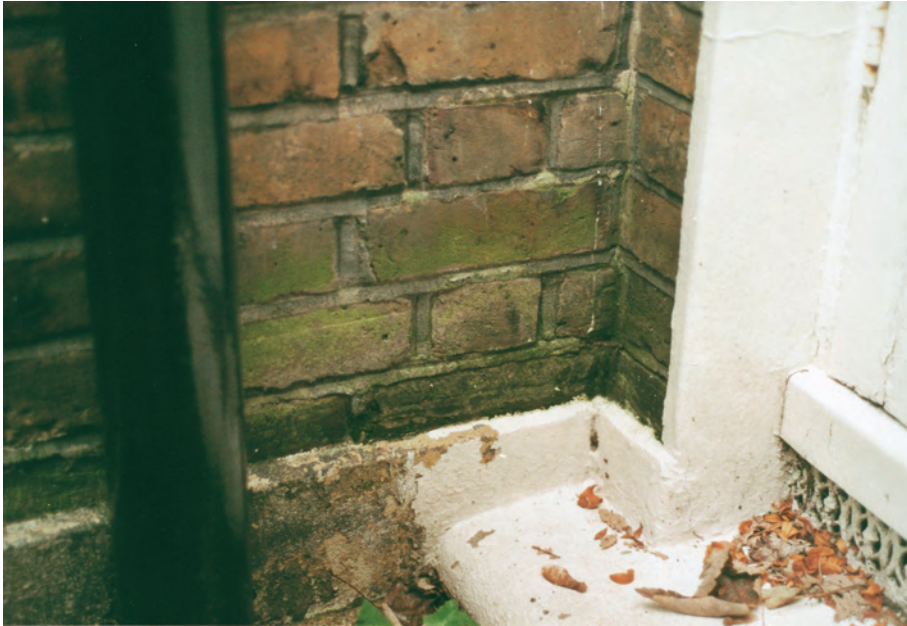
**Fig. 18.6** Green algae and moss growing at the base of a wall due to gutter splash.

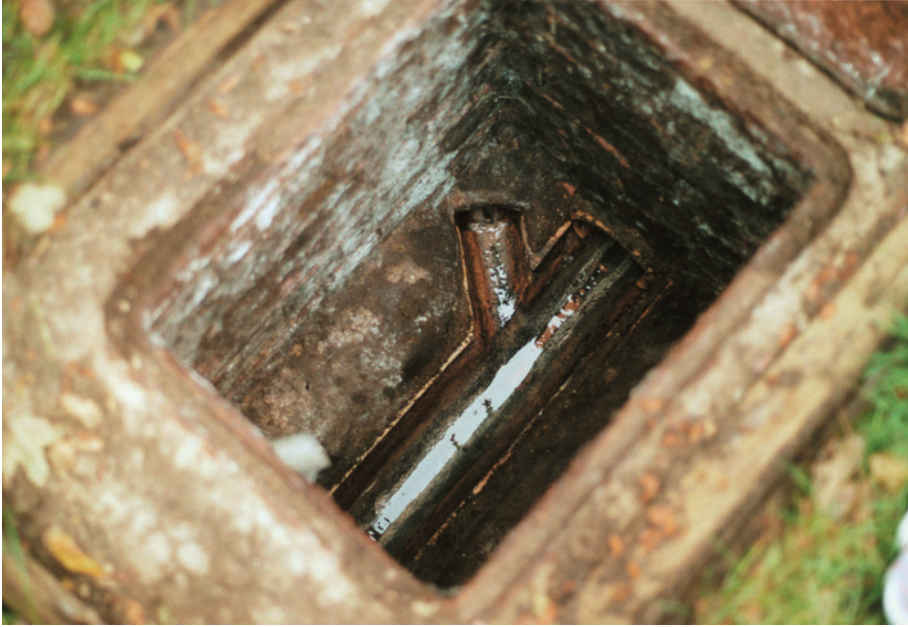
**Fig. 18.8** One hundred years old drains. Drain flow satisfactory.

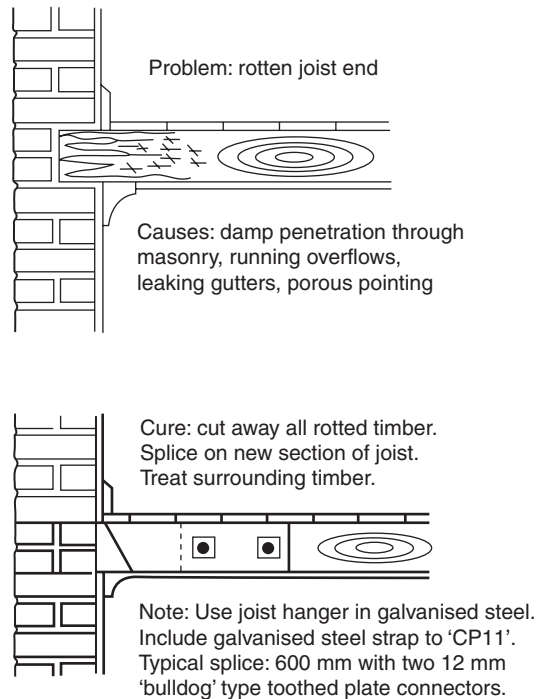
**Fig. 21.1** Conserving floors.

It is important that bearings and floor joists be so constructed as to eliminate the possibility of moisture transference from adjoining masonry and from oversite into timbers. In older buildings, joists are often built into the outer walls where the construction is in solid brickwork and a likelihood of rot attack to joist ends then arises, especially if the wall concerned faces the prevailing weather or is in a porous condition (see Figure 21.1).

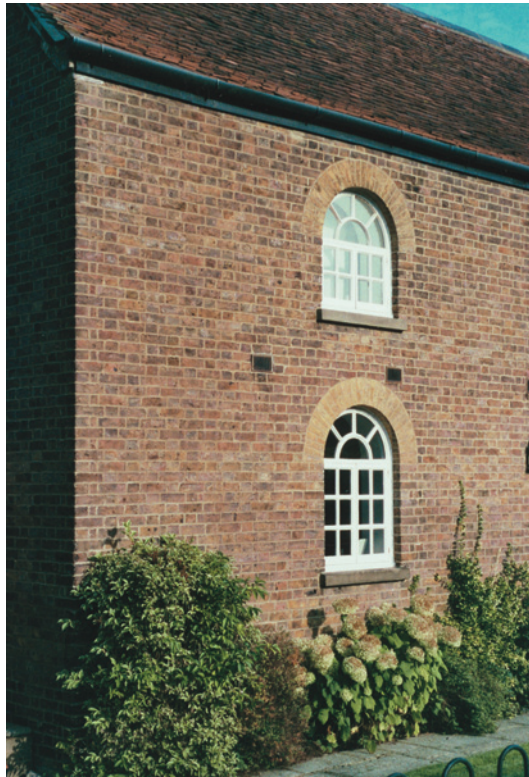
**Fig. 21.3** London Stock brick set in lime mortar to Flemish bond. Properly formed arches are self-supporting and do not need lintels. Bricklayers who set out the corners are known as ‘corner men’ whilst those who infill with the main runs of brickwork are known as ‘line men’. Corner men are the most experienced and the final appearance of the wall depends very much on their skill.

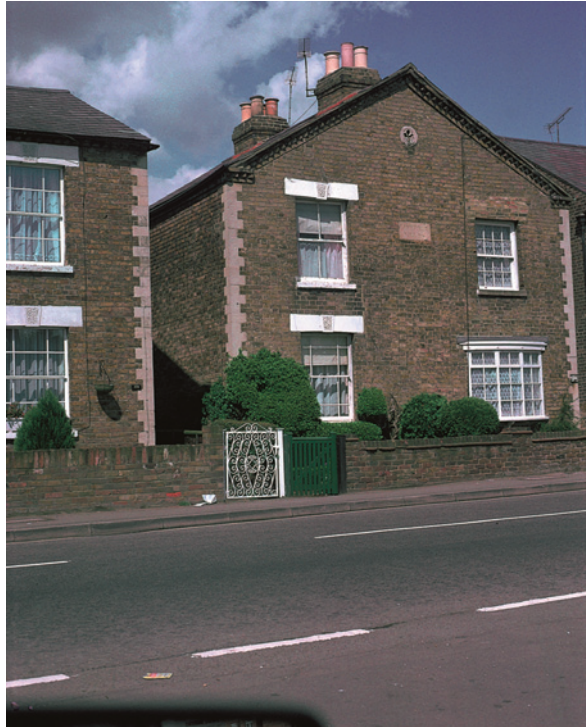
**Fig. 21.4** The arch over first floor window has spread and the lintel has dropped. This section of wall will need to be rebuilt.

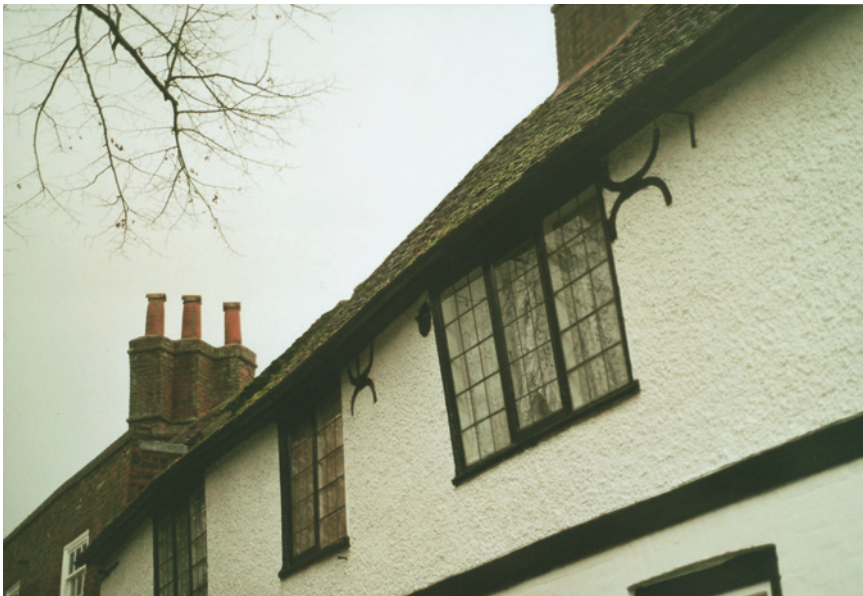
**Fig. 21.5** The wall around this window leans out and has been restrained by the use of tie bars with the painted tie bar plates used as an added decorative feature. The tie bars will only work if the steel rods are in good order and very firmly secured at the other end.

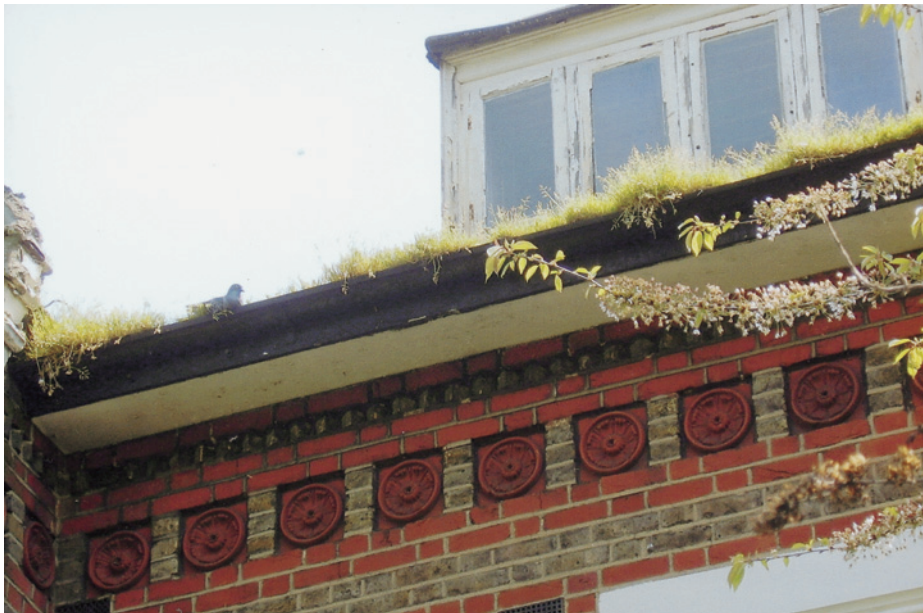
**Fig. 21.6** The grass growing in this gutter results from years of neglect. Sometimes conservation is just a matter of common sense.
