Site notes, field sheets and checklists

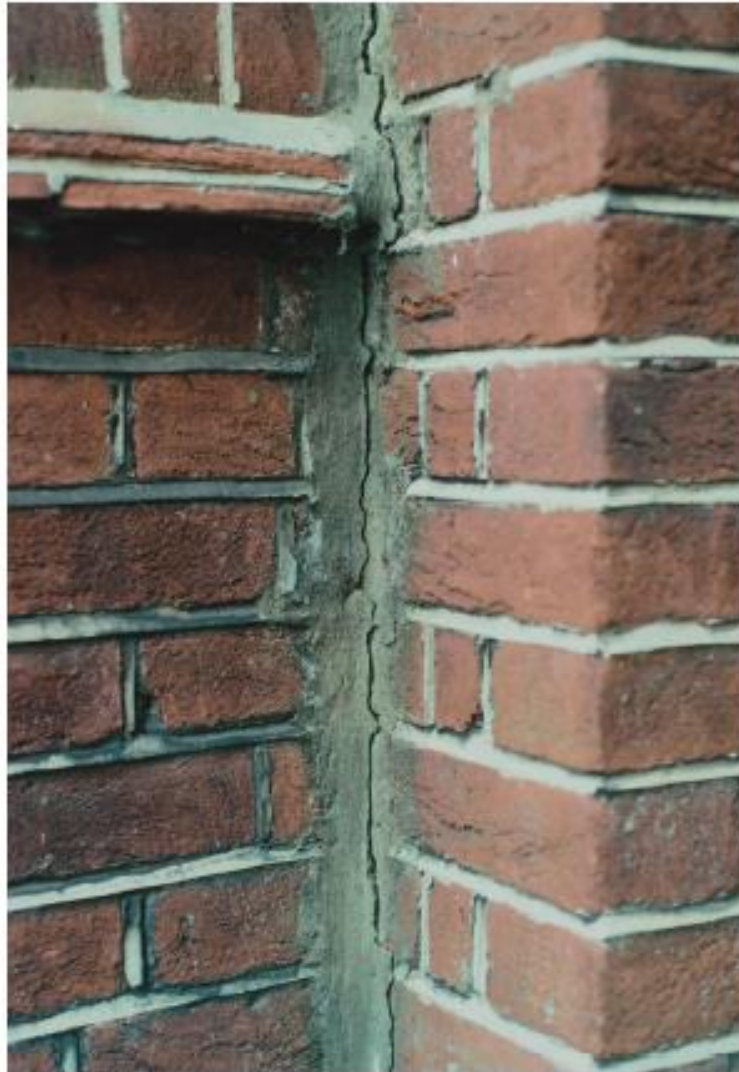
Fig. 3.4 This settlement fracture has been poorly repaired and opened up again indicating continuing movement.

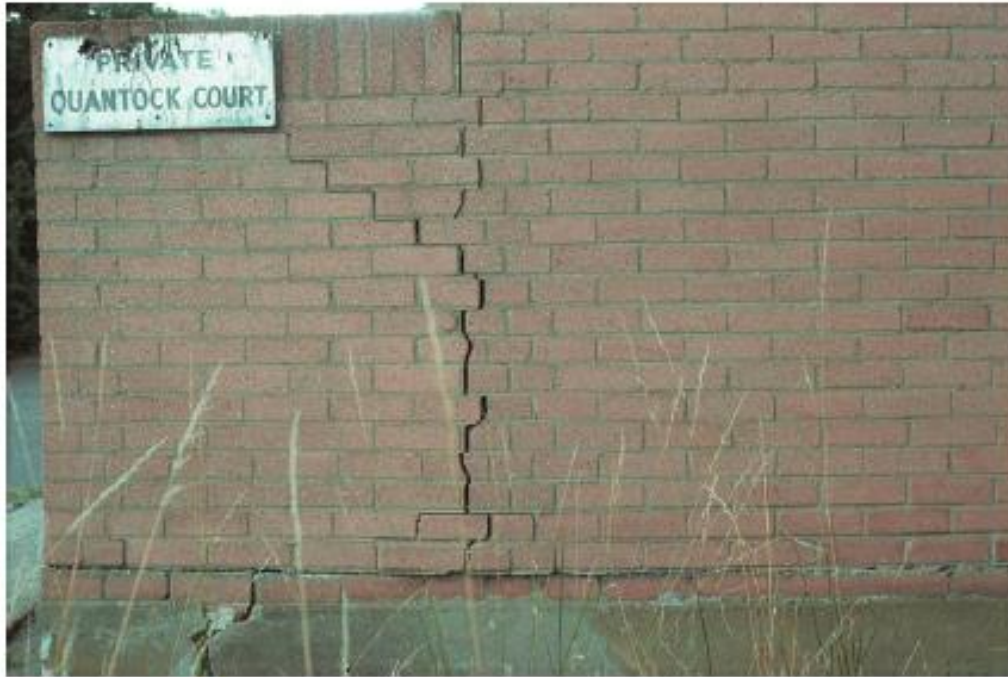
Fig. 3.5 A bulge fracture due to compression not related to foundations.

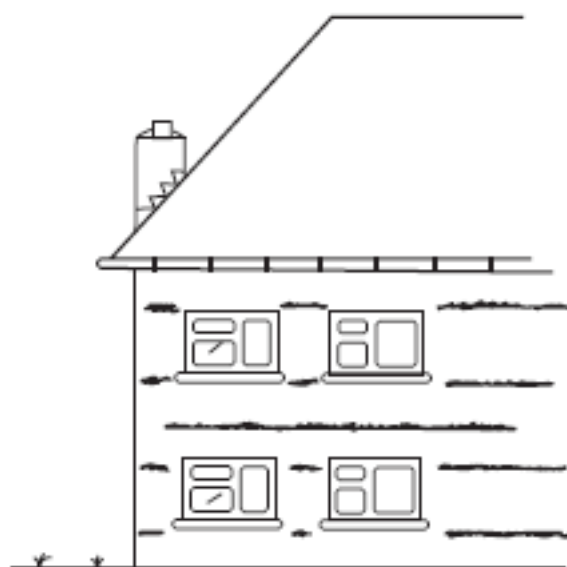
Fig. 3.8 Assessing crack damage – 3.

Rusting wall ties

Pattern of horizontal cracking to mortar joints in cavity wall. There may be bulging and separation of two skins of brickwork.

Cracks tend to appear every six courses, this being typical wall tie spacing.

Gable walls in cavity brick can be pushed up by expansion of metal ties causing 'pagoda' effect to verge tiles.

Vertical cracks to piers indicate compression failure with wall eventually bursting laterally.

Shear failure

Often to bonding between new and pre-existing construction.

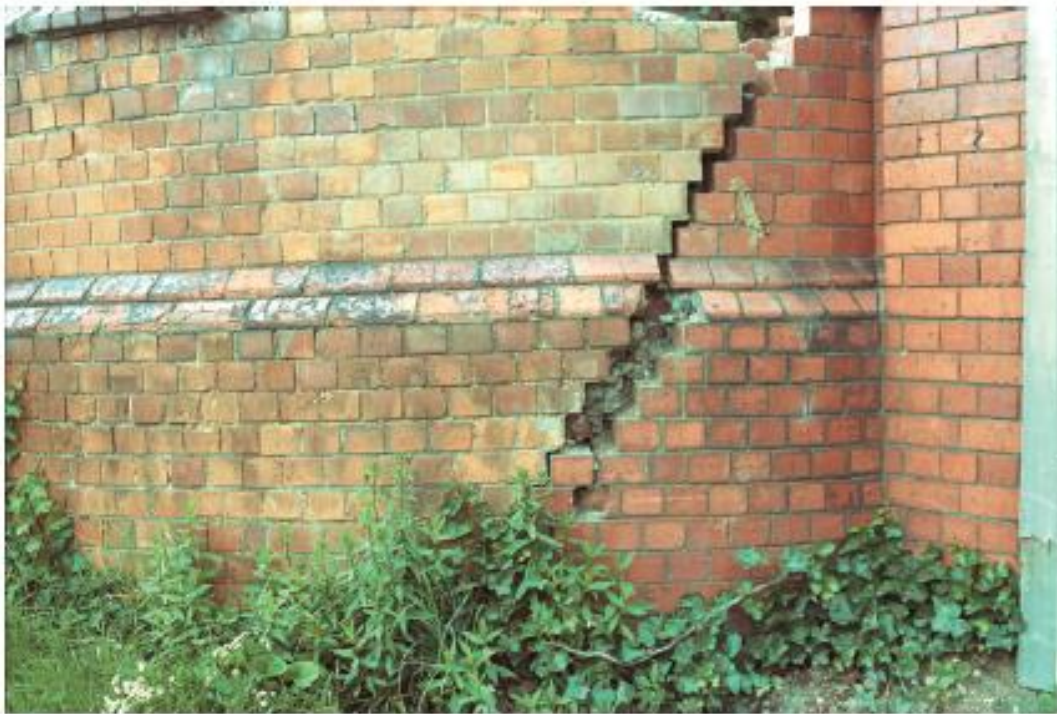
Fig. 3.10 Settlement or subsidence. The crack widens with height.

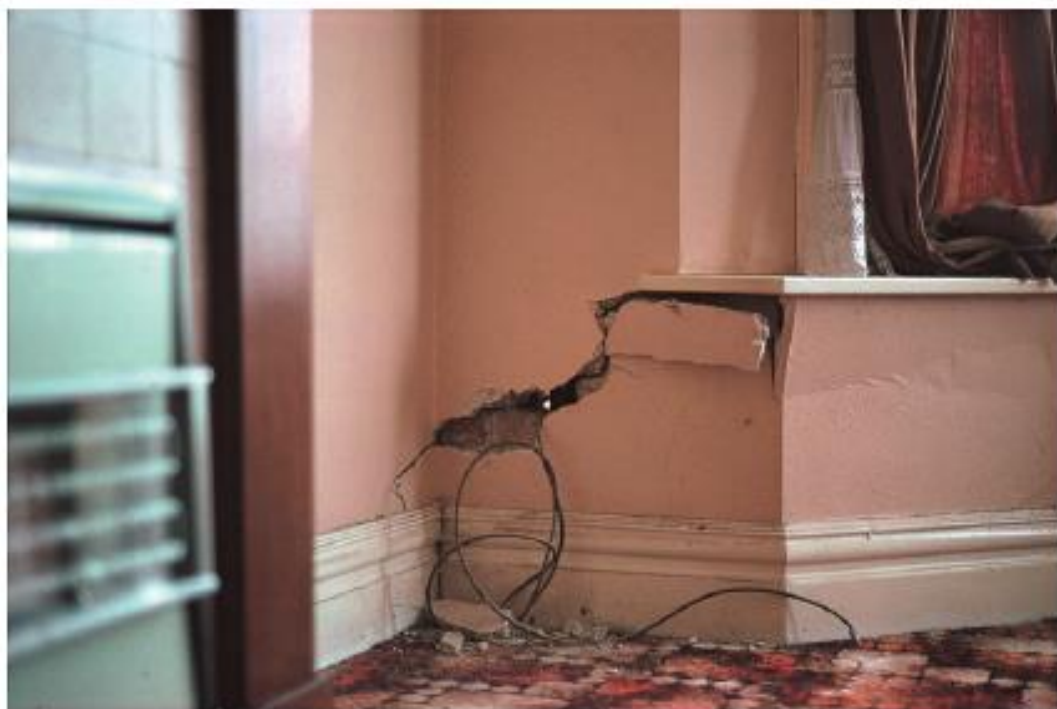
Fig. 3.11 Subsidence damage inside house.

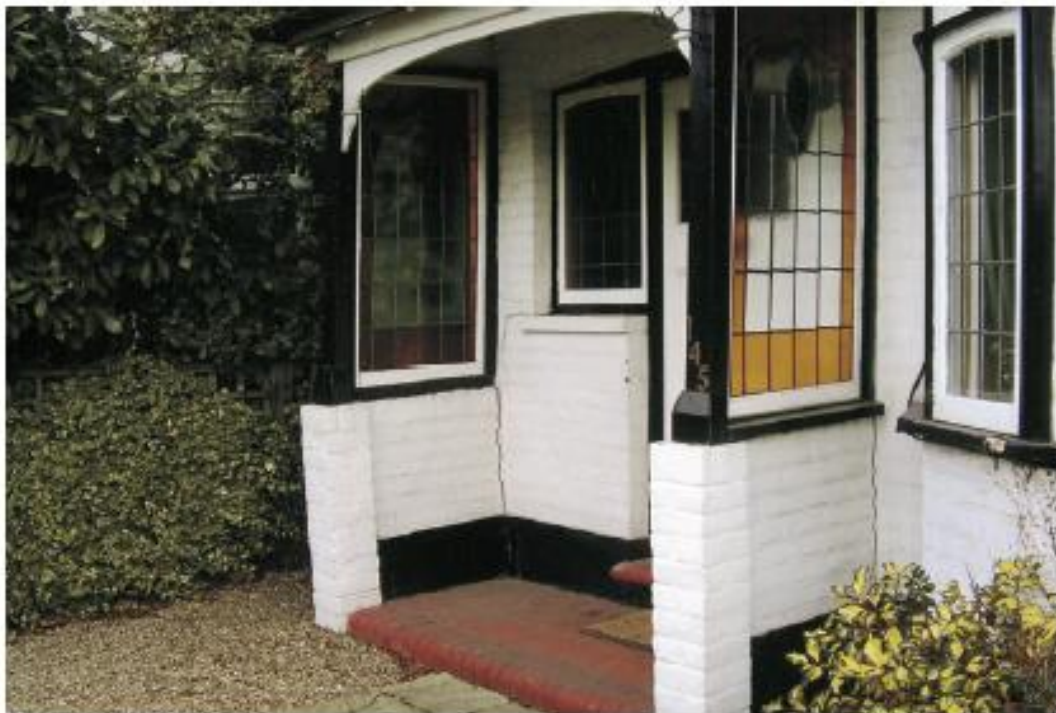
Fig. 3.16 Builders will often use a very shallow foundation for a porch thinking that because the weight is low they do not need to excavate as deeply as for the main house; this is not so and the porch in this case will need to be rebuilt on deeper footings.

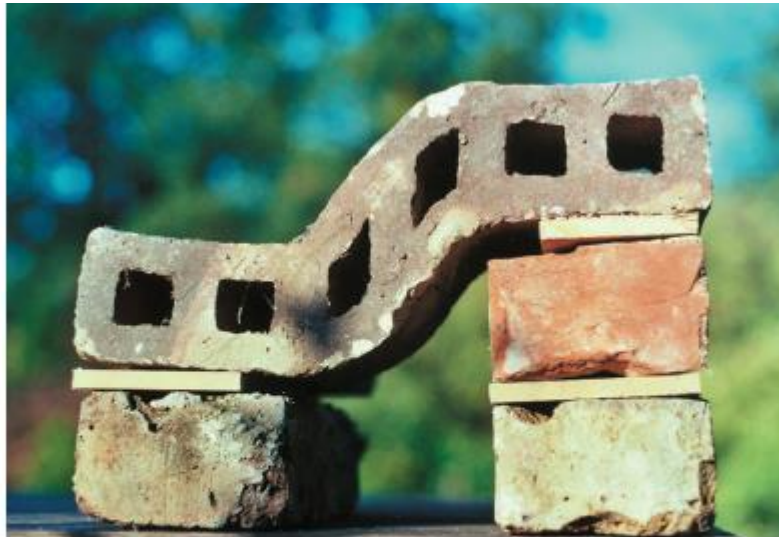
Fig. 4.3 The Victorians used special-shaped bricks as wall ties in their cavity walls.

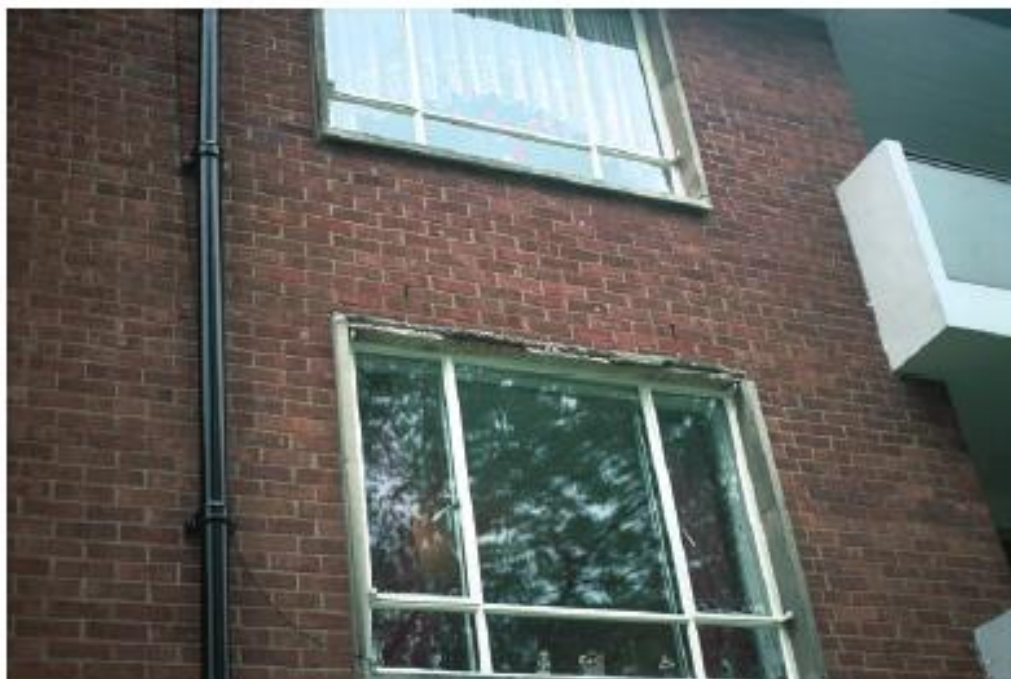
Fig. 4.6 Inadequate cover for steel reinforcement in concrete lintel. Rust can take up to seven times the space of the steel it replaces causing bursting to the concrete surface.

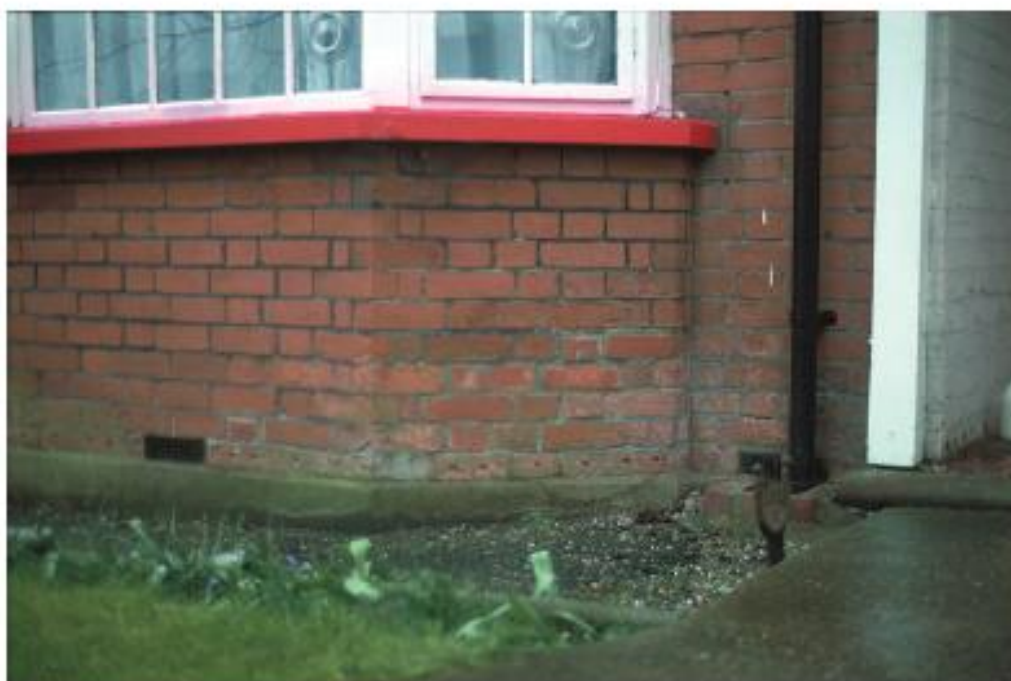
Fig. 4.7 Drill holes at the base of the wall indicate that a chemical injection damp-proof course has been added.

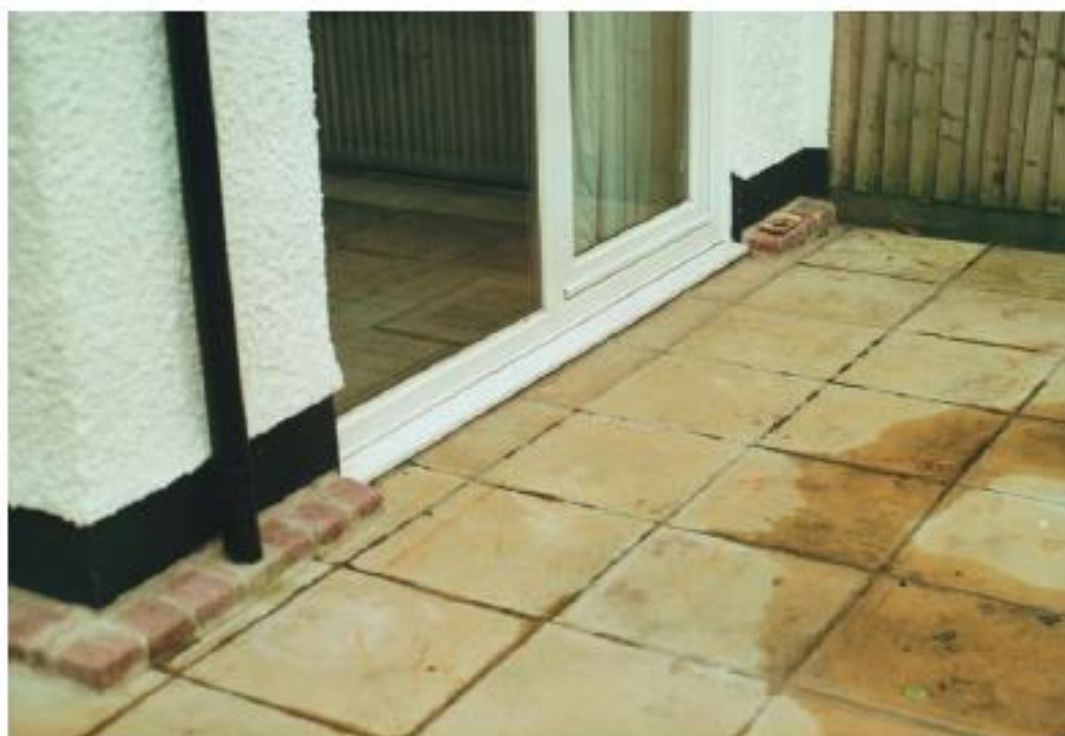
Fig. 4.13 The paving is too high. It should be lowered to at least 150 mm (2 brick courses) below the damp-proof course or internal floor level whichever is the lower, with a slope away from the wall.

The clearance of 150 mm between exterior levels and damp-proof courses is recommended in order to prevent gutter-splash reaching the wall above damp-proof course and to allow some margin of clearance. Experience indicates that the ground levels around houses tend to rise by about 300 mm every 100 years, due to the addition of soil to gardens and the laying of new paving over old. It is essential to resist this trend.

When there is insufficient clearance to damp-proof courses it is recommended that ground levels be lowered. A general lowering of levels is best with the surplus soil or paving being carted away. Alternatively, a channel may be formed alongside the wall, at least 150 mm wide, suitably formed with cementwork sides and benching, and having a fall-away from the main walls and adequate drainage to suitable storm gullies. A channel which fails to drain adequately is worse than useless since it will actually exacerbate any dampness. The brickwork then exposed at the base of the wall should be made good as necessary by pointing, cutting in new bricks or rendering to a suitable standard.

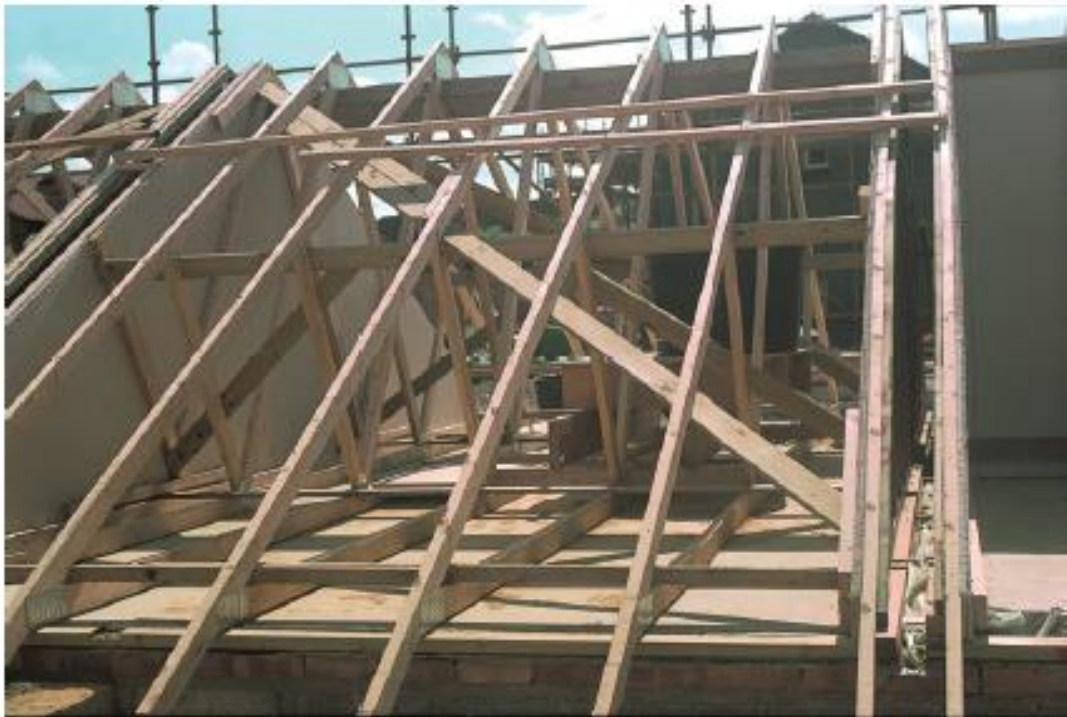
Fig. 6.3 Modern gang-nailed trussed rafter roofs require diagonal bracing and gable-end strapping to prevent racking.

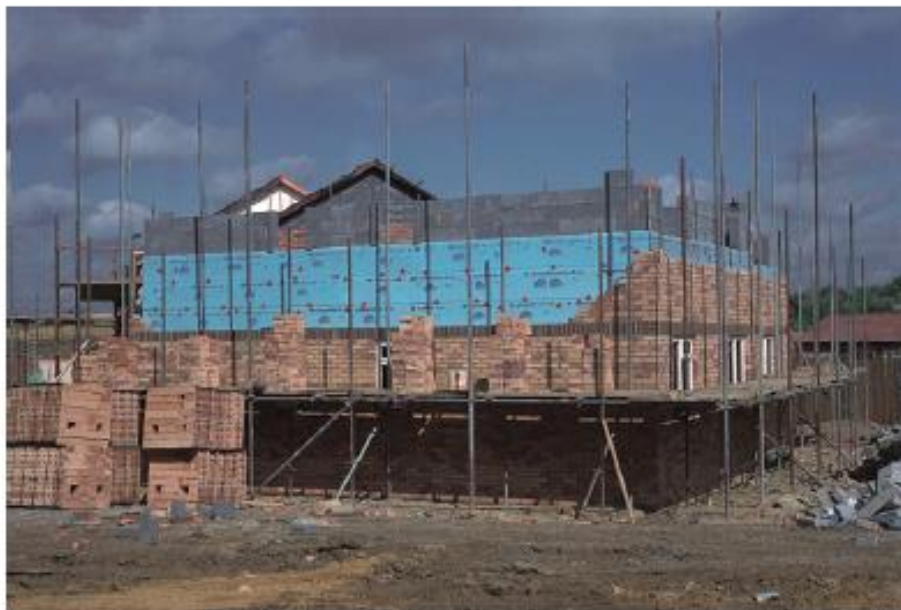
Fig. 7.2 A traditional brick and block house under construction in the same estate as the house in Fig. 7.2.

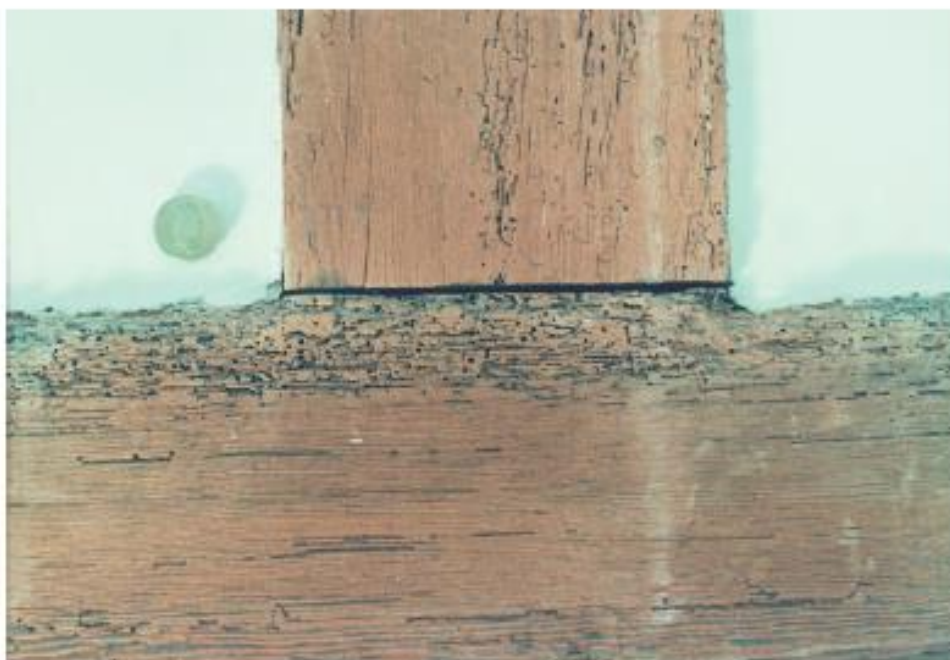
Fig. 7.3 Flight holes of the common furniture beetle (*Anobium punctatum*) in relation to a £1 coin.
