# Building Survey Sample

## A Introduction to the report

## **B About the Report**

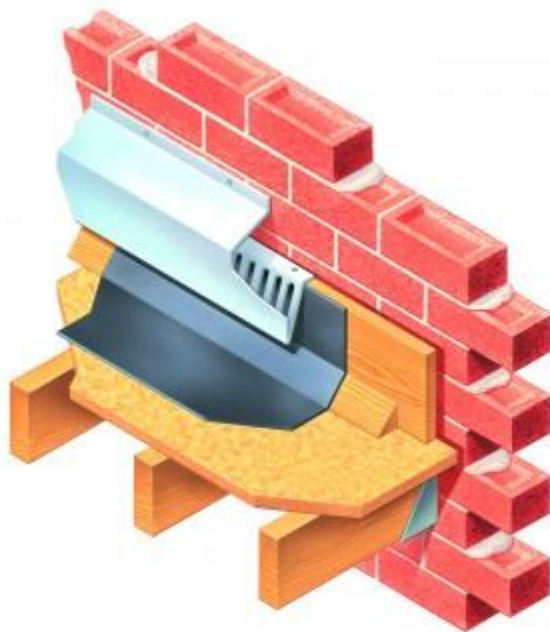
The conservatory which is at the back of the house has led a flashing between the roof to the structure and the main walls. I found no particular problems with this at the time of my inspection, but point out that this is not the best building construction Solution.

When an extension/conservatory is added to existing cavity walls, it is very important to ensure that a cavity tray is fitted within the cavity of the original part of the building, above the line of the extension roof. This is to ensure that any water running down the cavity is prevented from passing into the internal areas of the building. It is good practice to include weep holes (vertical slots in the perpendicular joints of the brickwork) immediately above the line of the cavity tray, to allow any water to escape.
