Designing for Earthquakes

A Manual for Architects

FEMA 454 / December 2006

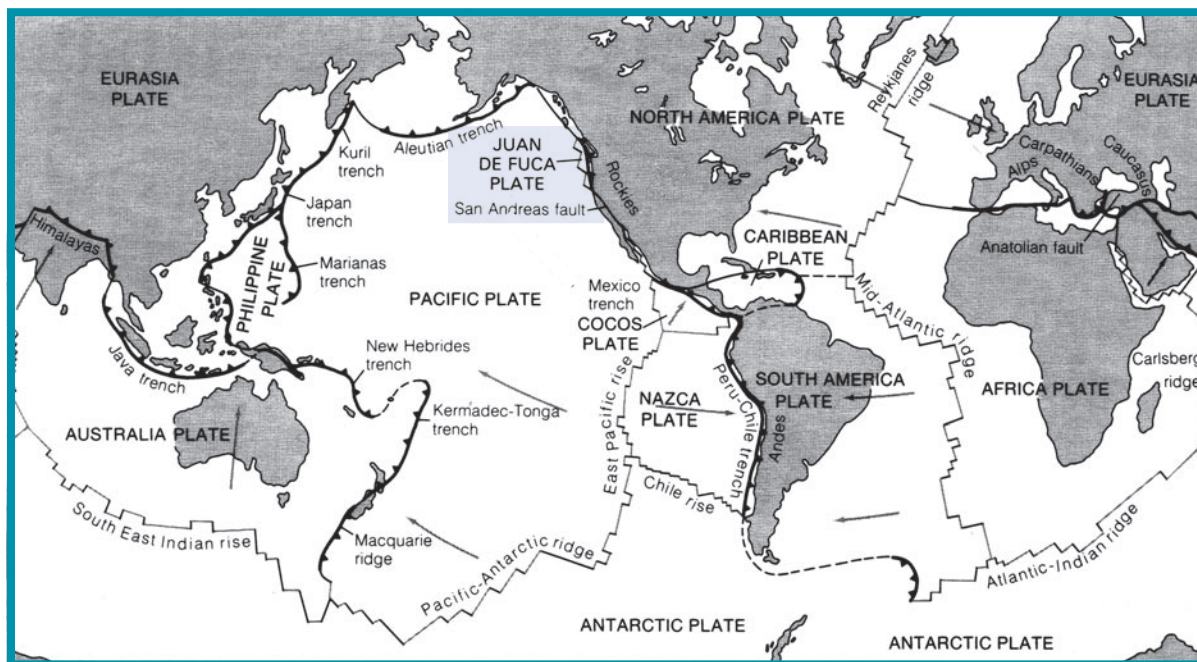
Figure 2-2: The major tectonic plates, midoceanic ridges, trenches and transform faults.

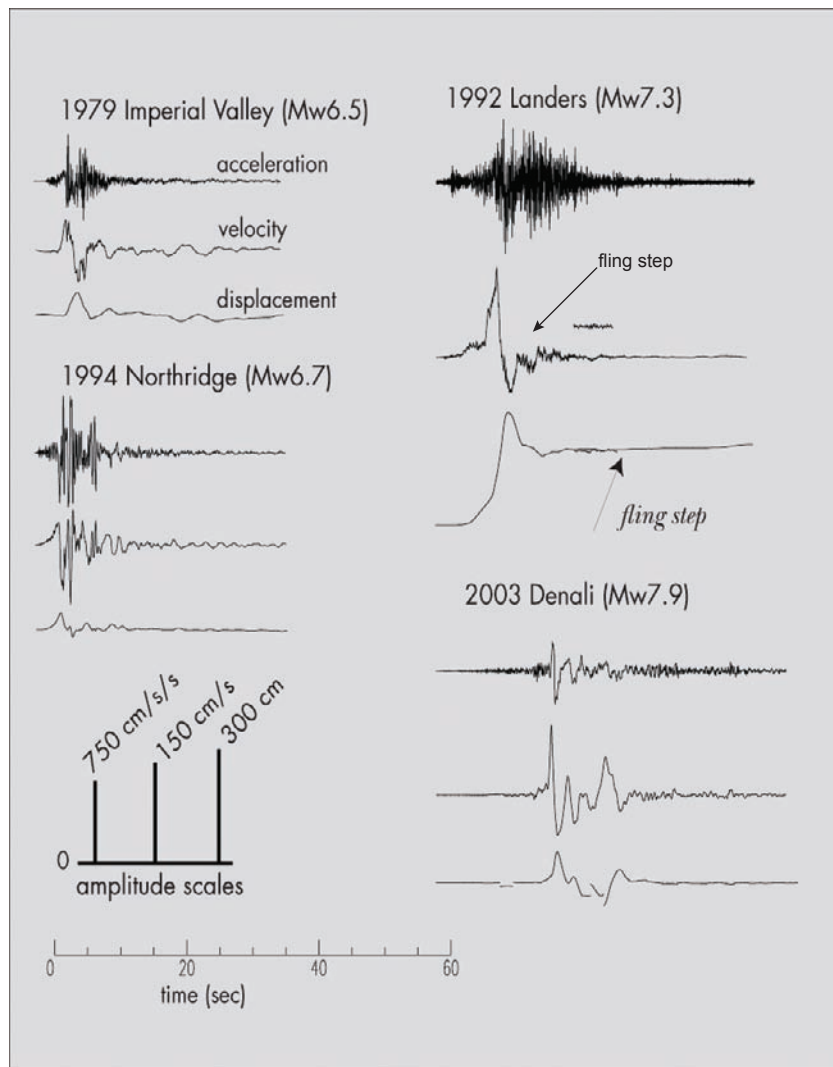
Figure 2-9: Examples of near-fault, large amplitude seismograms (time-histories).

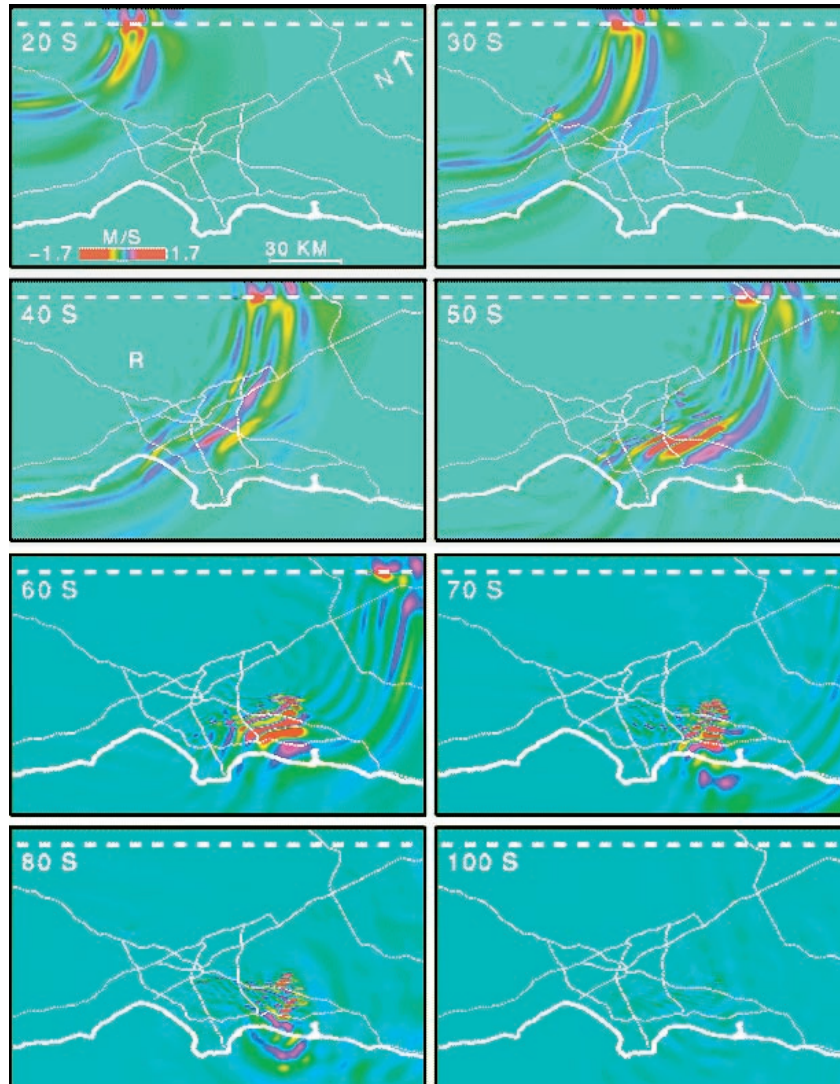
Figure 2-11: Aerial snapshots of a simulated wave propagation in the Los Angeles area.

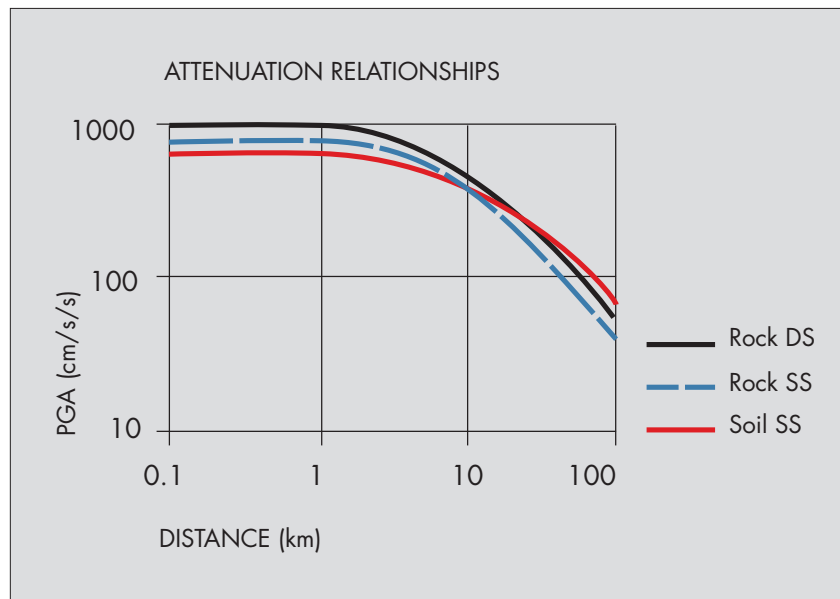
Figure 2-12: Examples of attenuation curves for a $M_W 7$ earthquake obtained by data regression, illustrating the effects of a **site** type: rock (blue dashed) vs. deep soil (red), and **event** type: strike-slip fault (blue dashed) vs. reverse fault (black)

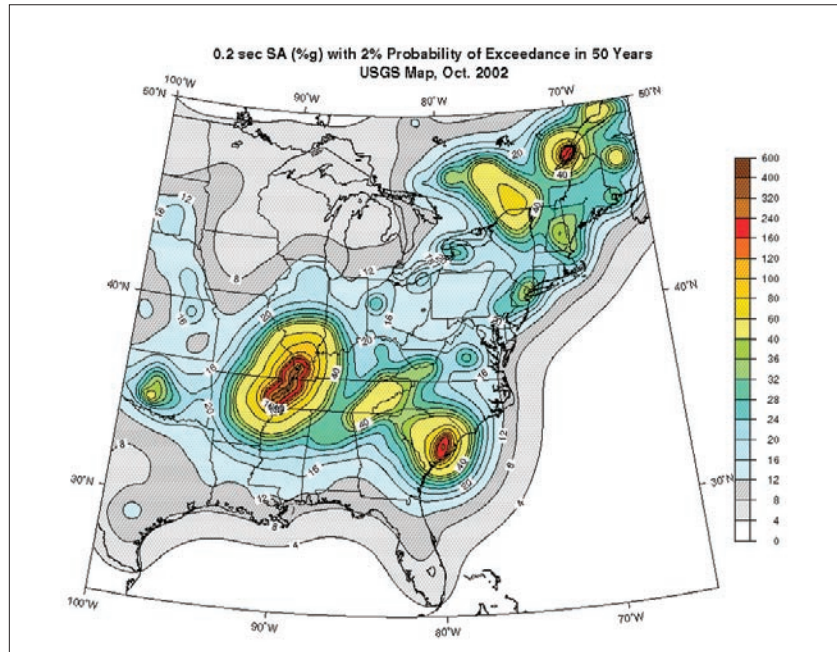
Figure 2-14: 0.2 second (short) period Spectral Acceleration values in %g with a 2% Probability of Exceedance in 50 years for Central and Southern United States.

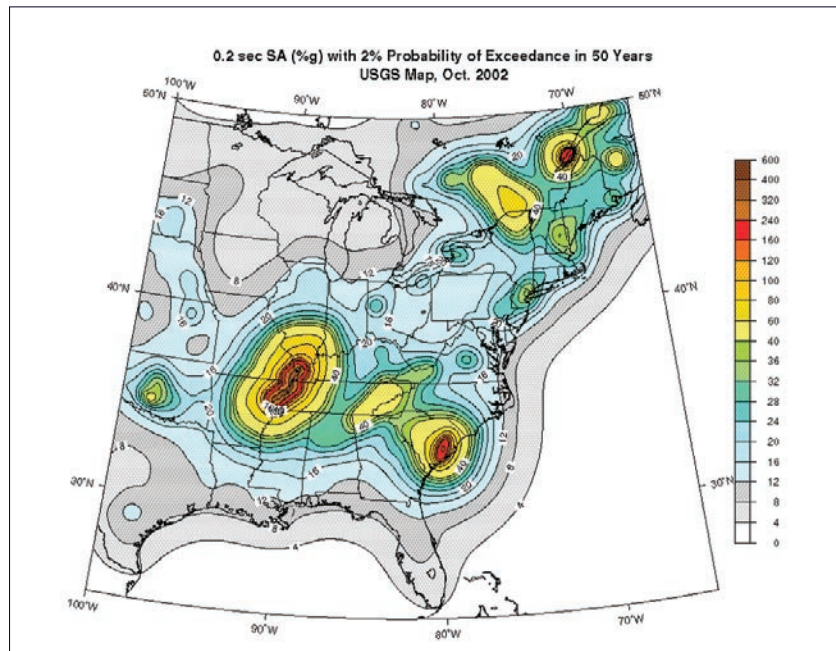
Figure 3-2: USGS Map of 0.2 sec spectral acceleration with a 2% Probability of Exceedance in 50 Years

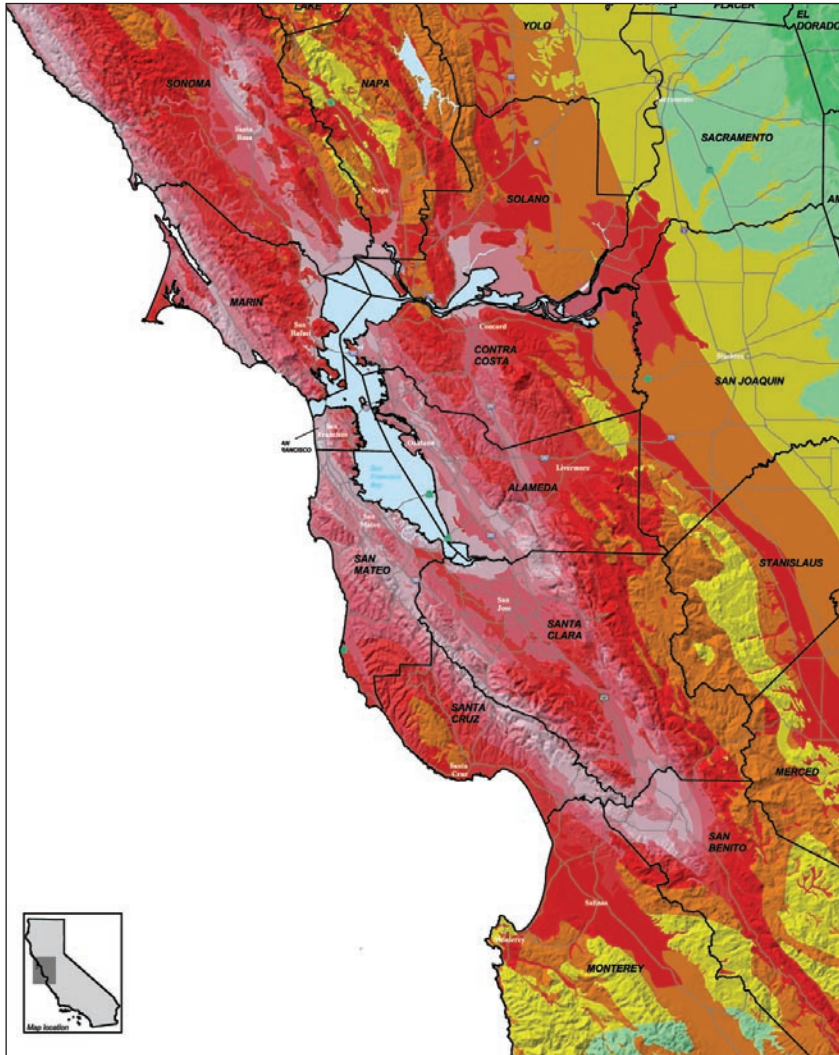
Figure 3-3: USGS and CGS Map of Relative PGA with a 2% Probability of Being Exceeded in 50 Years

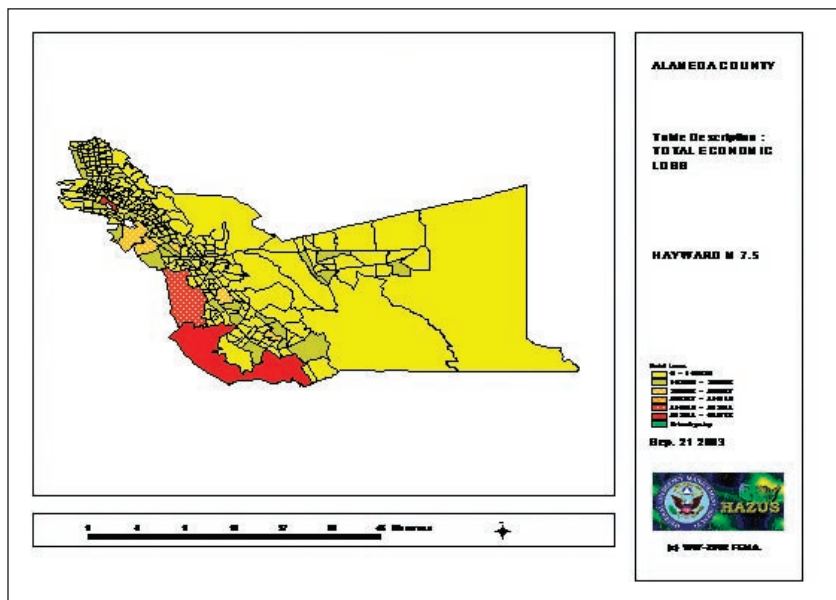
Figure 3-5
HAZUS Estimate of Total
Economic Loss by Census
Tract

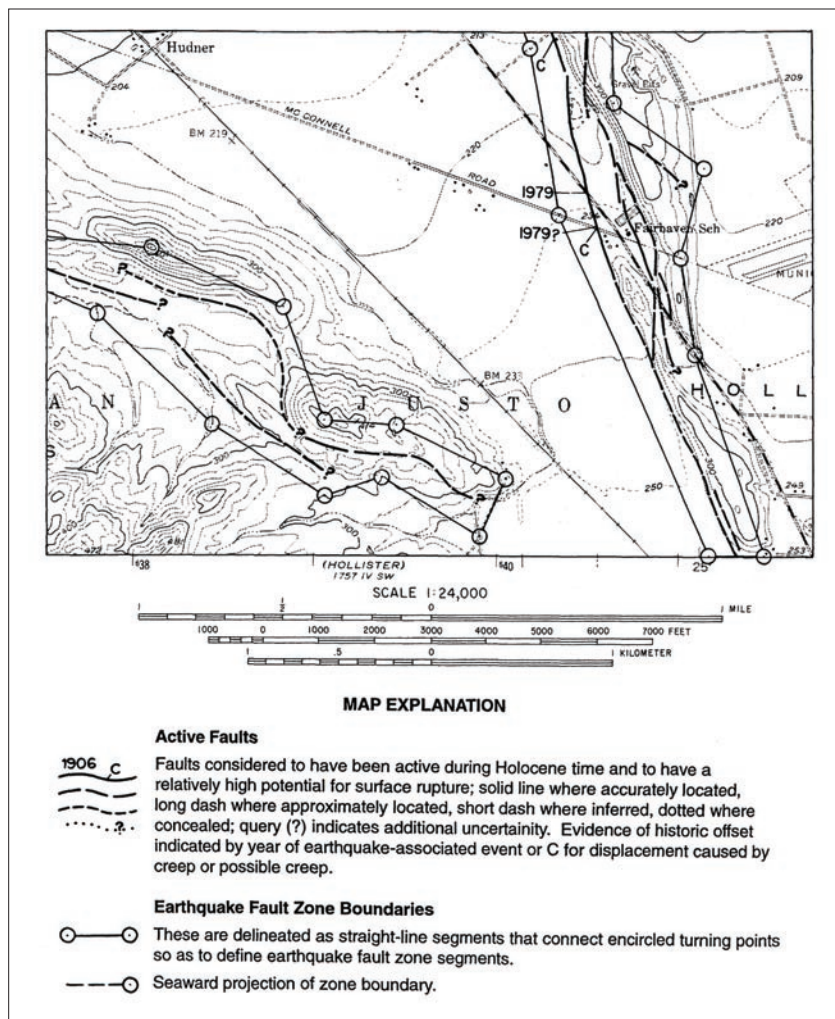
Figure 3-8: Alquist Priola Special Studies Zone (Earthquake Fault Zone).

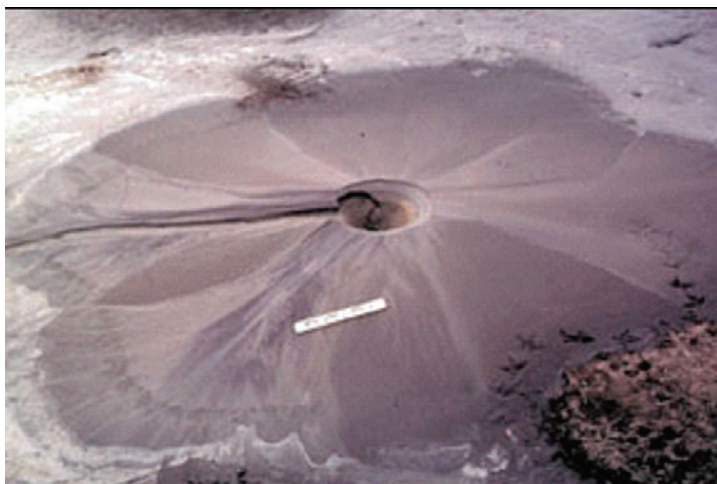
Figure 3-11: Sand Boil.

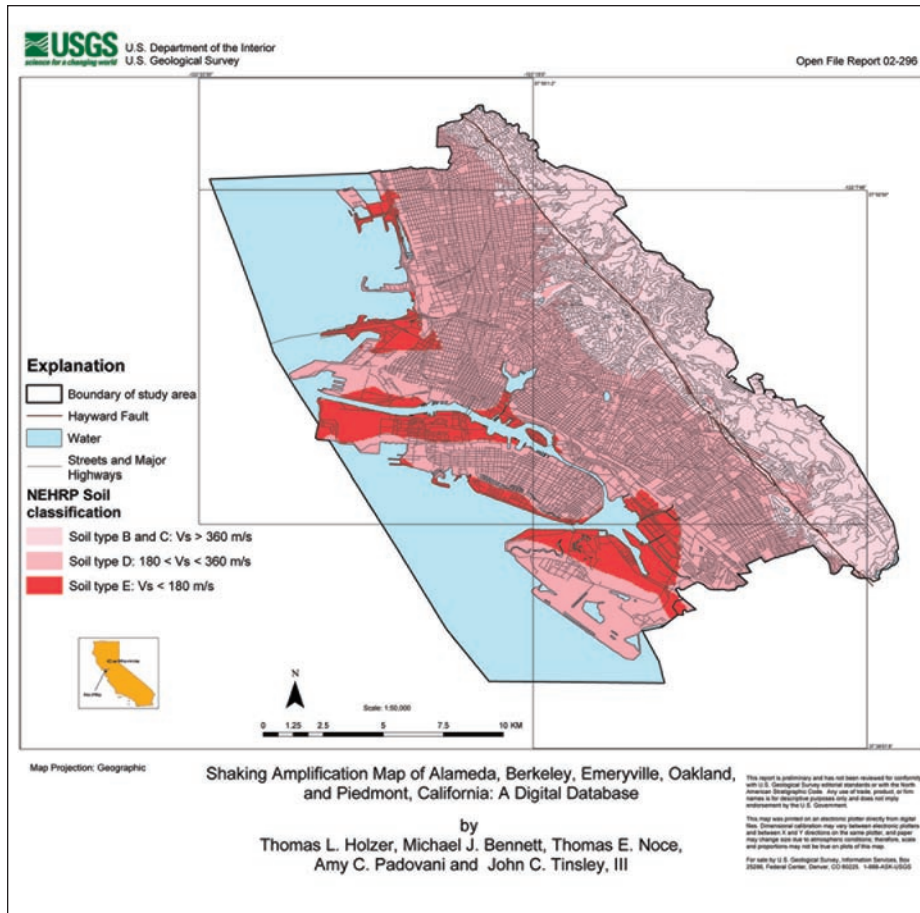
Figure 3-15: USGS Shaking Amplification Map of Alameda, Berkeley, Emeryville, Oakland and Piedmont, California. SOURCE: USGS (HOLZER ET AL.)

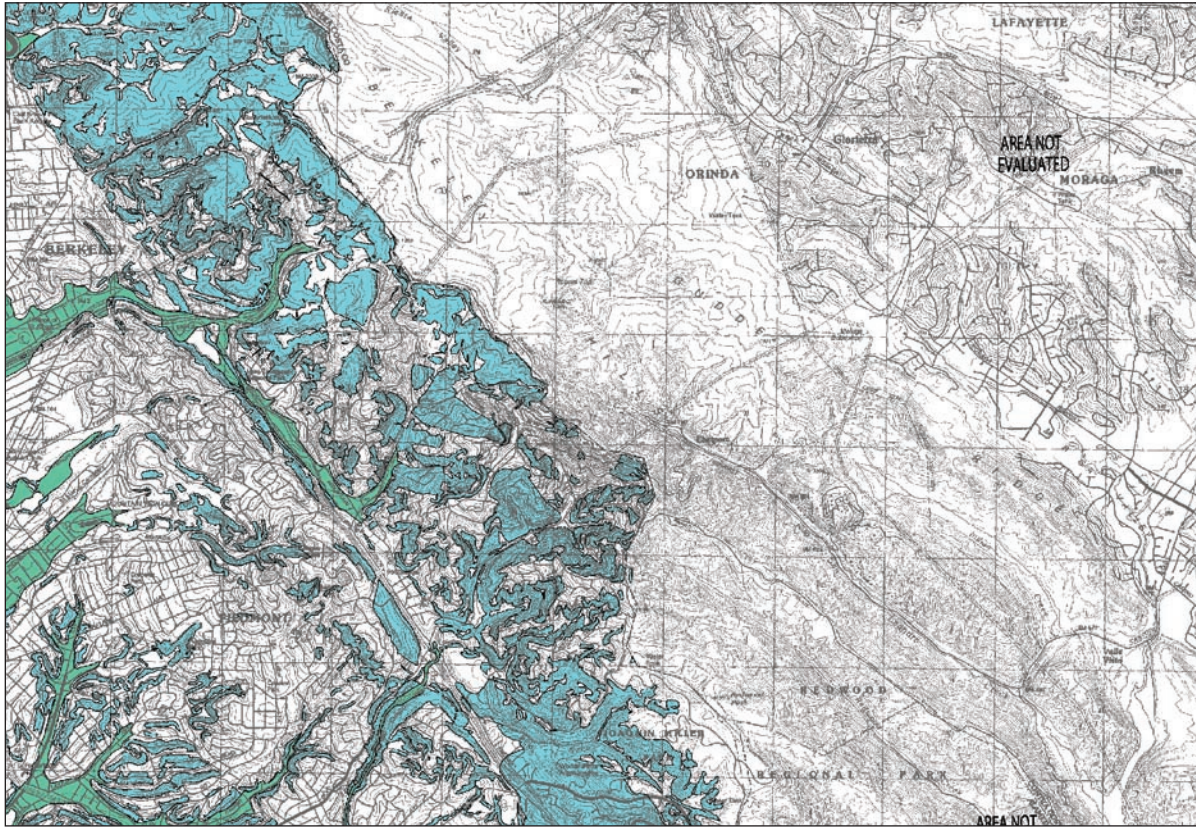
Figure 3-16: Landslide Hazard Zones for Berkeley and Oakland, California. Blue areas are those that are susceptible to earthquake-caused landslides.

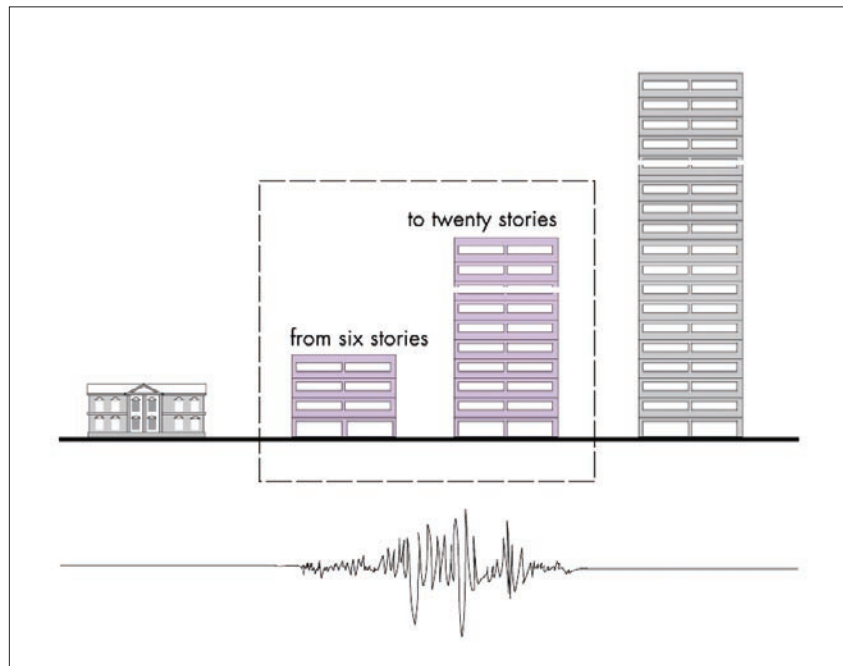
Figure 4-5: The vulnerable group: Mexico City, 1985. The periods of buildings in the 6 to 20 story range resonated with the frequency content of the earthquake.

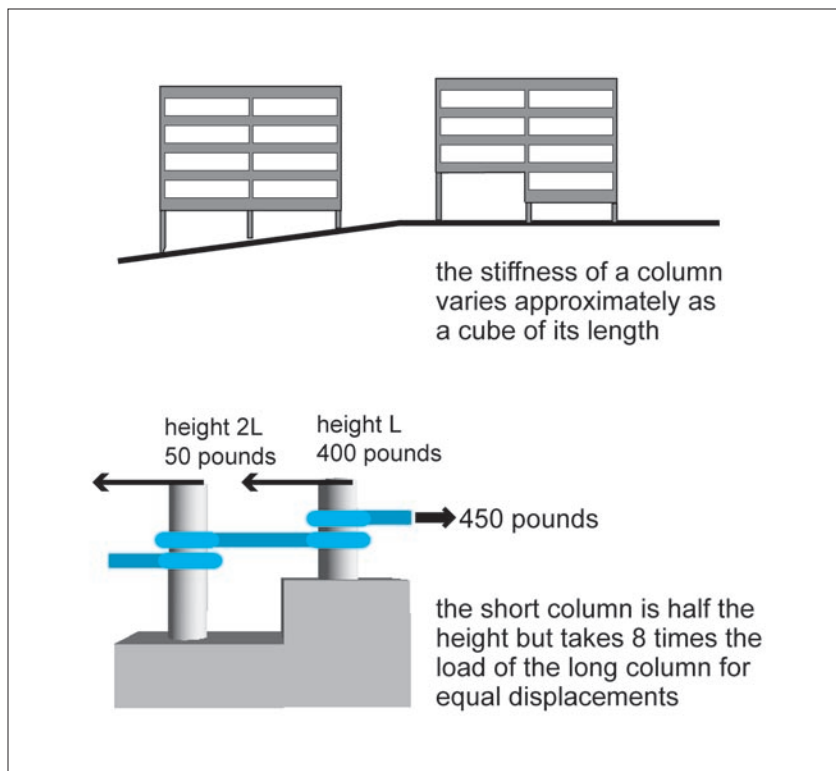
Figure 4-15: The short column problem.

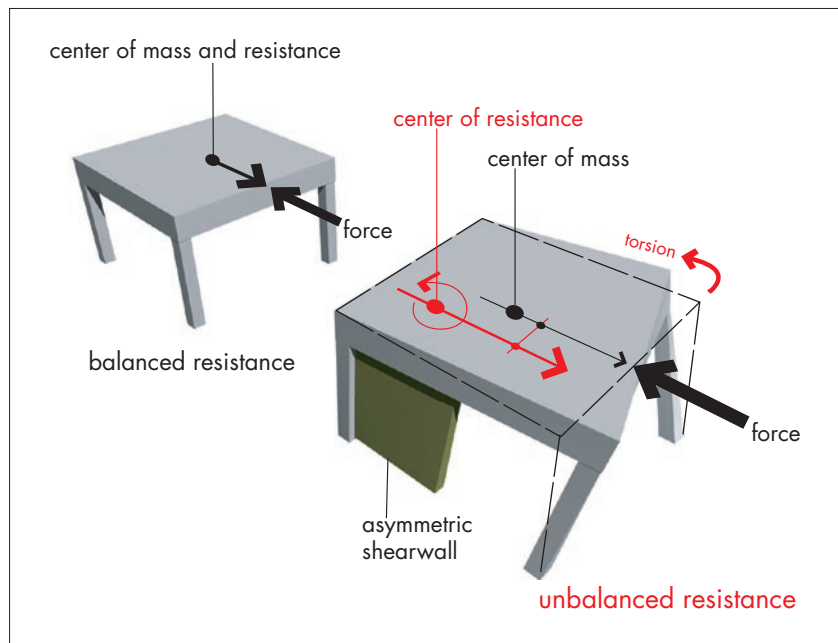
Figure 4-17
Torsional forces.

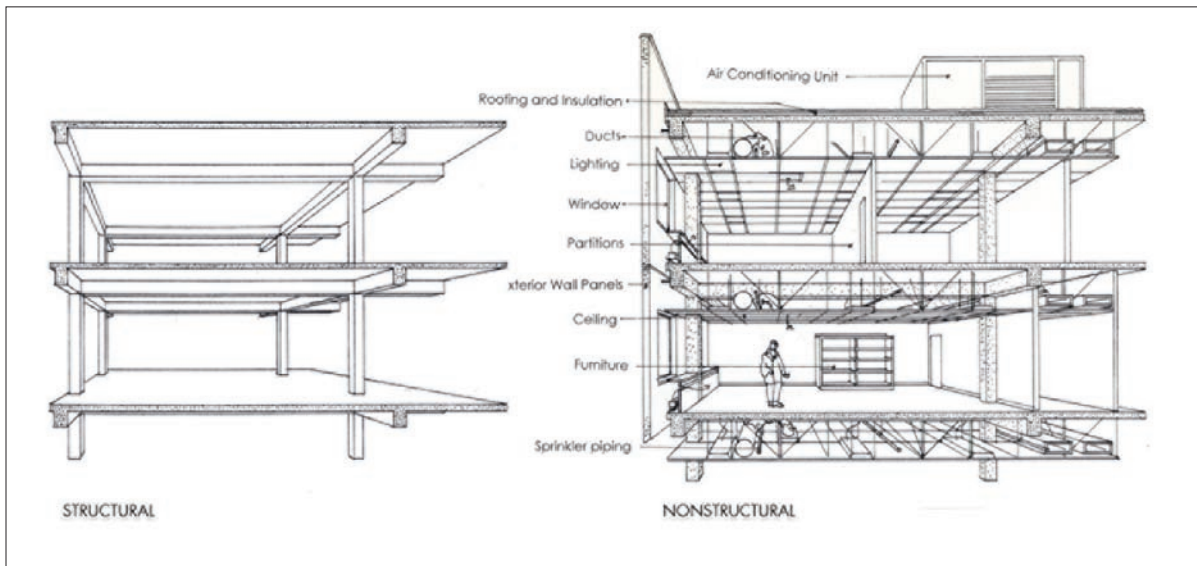
Figure 4-18: Structure (left), nonstructural components and systems (right).

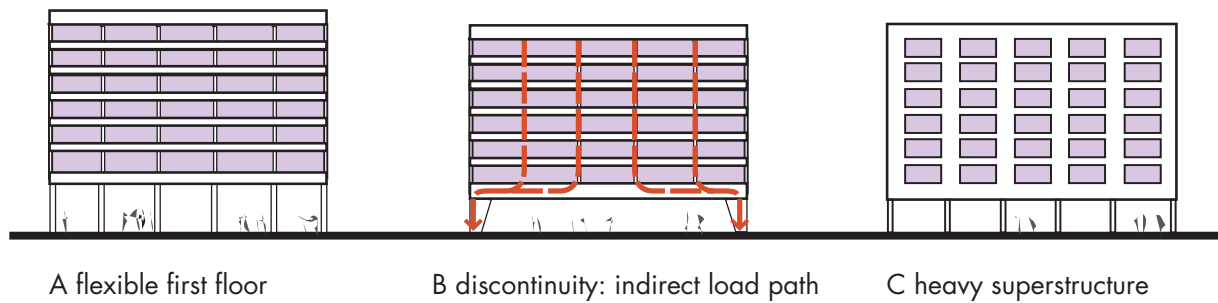
Figure 5-8: Three types of soft first story.

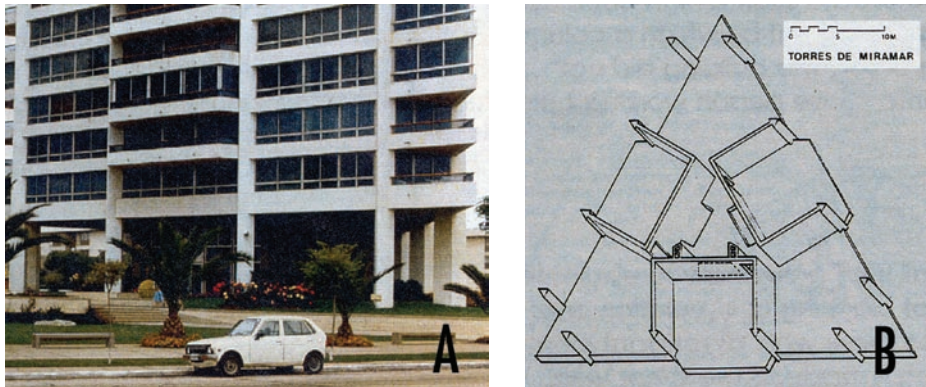
Figure 5-12: This apartment house appears to have a soft first story (Figure 5-12A), but the lateral force-resisting system is a strong internal shear wall box, in which the shear walls act as party walls between the dwelling units (Figure 5-12B). The architect achieved a light and elegant appearance, and the engineer enjoyed an optimum and economical structure.

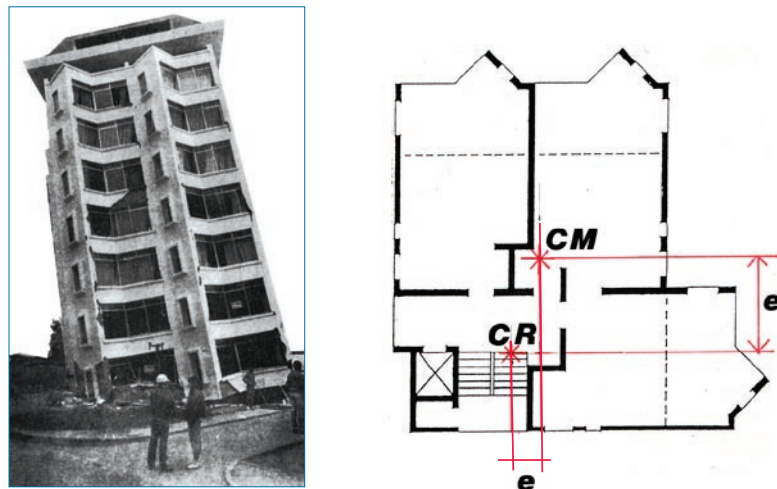
Figure 5-16: Left, the building after the earthquake. Right, typical floor plan showing the Center of Mass (CM), Center of Resistance (CR), and Eccentricity (e) along the two axes. PHOTO SOURCE: EERI

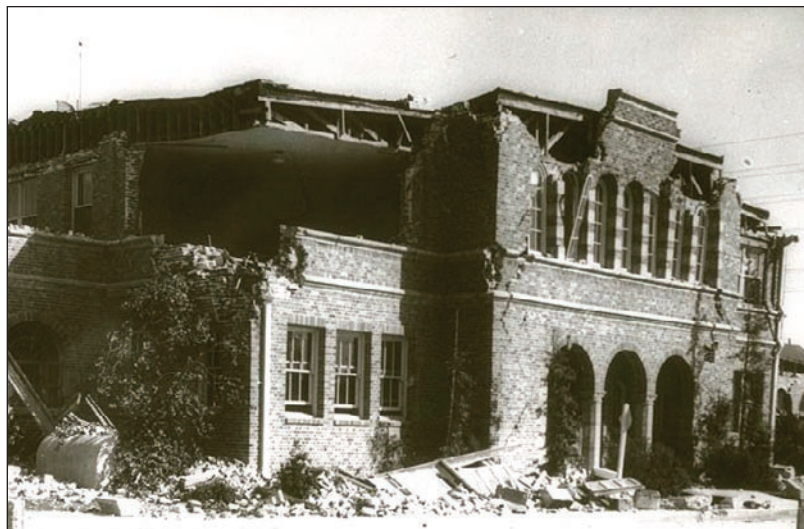
Figure 6-3: Long Beach, 1933, Alexander Hamilton Junior High School.

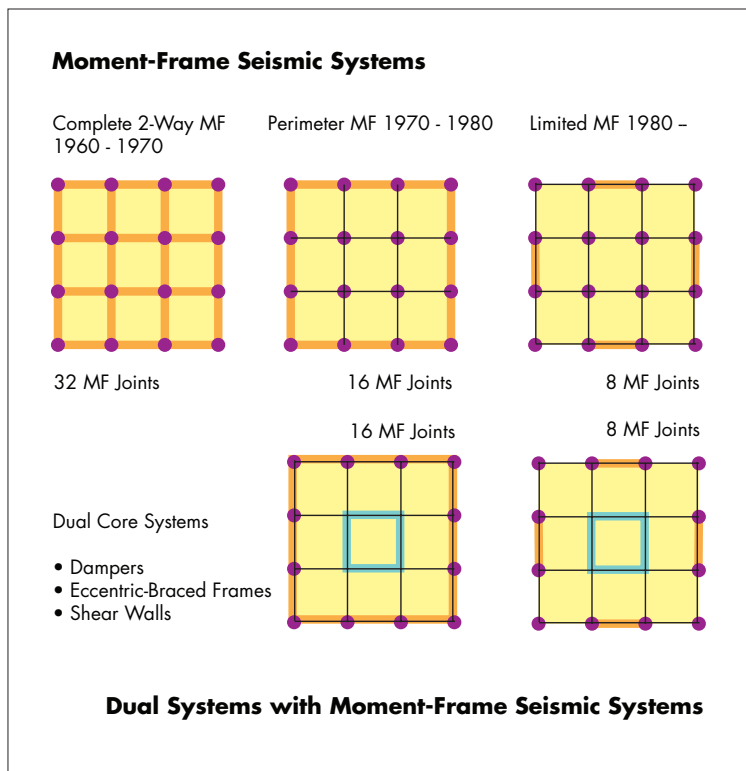
Figure 7-18: Single and multiple system concepts.

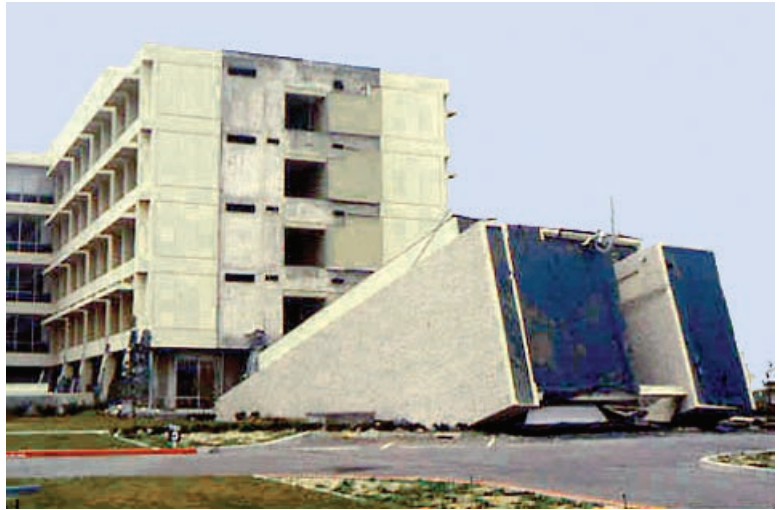
Figure 8-2: Olive View Hospital. A brand new facility that was damaged beyond repair in the 1971 San Fernando earthquake due to a shaking intensity that exceeded what was expected at the site and a design that, although technically complying with code at the time, contained several structural characteristics now considered major deficiencies. The lateral system contained nonductile concrete frames, discontinuous shear walls, and a significant weak story.

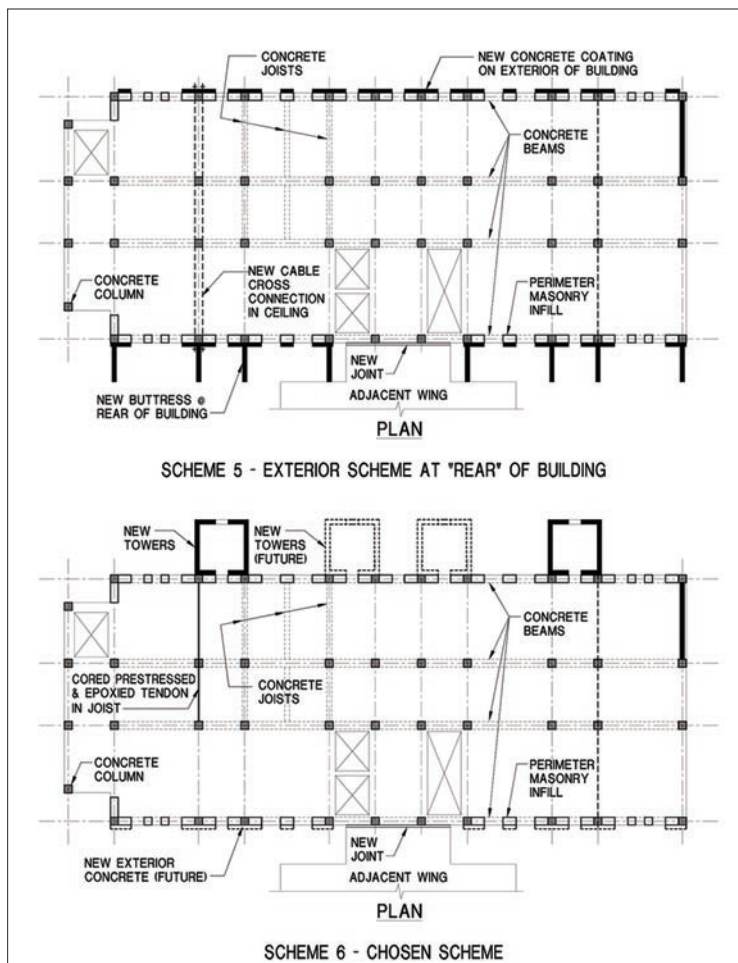
Figure 8-9c: Example of effect of non technical issues on retrofit schemes.

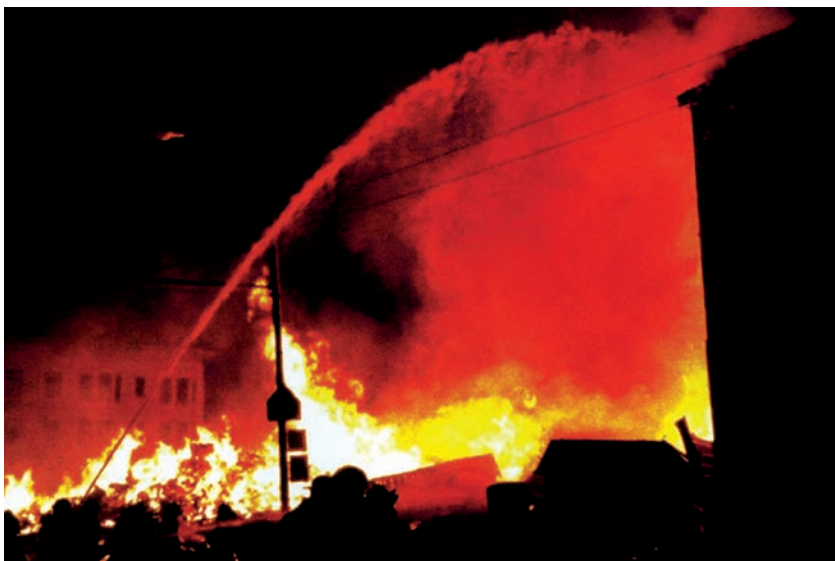
Figure 10-1
Earthquake and Fire,
Marina District, Loma
Prieta, 1989.
